RENEWABLE ENERGY **SURVEY**

Address: 1 QUALITY STREET, UNITED KINGDOM, QU11 8TY

Purpose of Report: ROOF CONDITION SURVEY

Report Reference: RE/MSE/2013

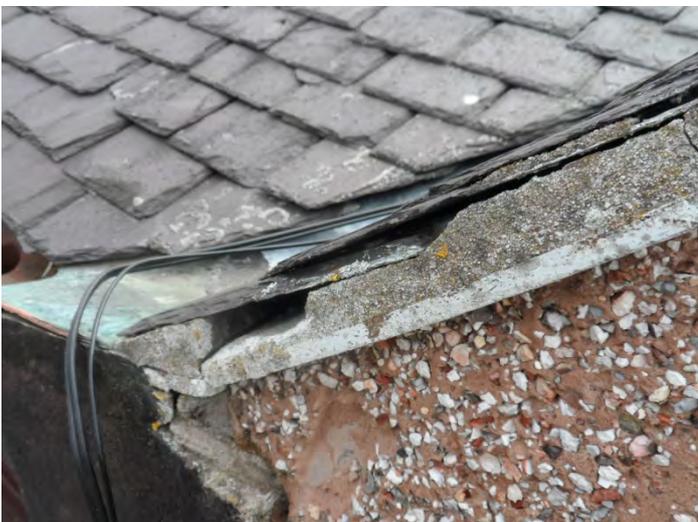
Fault Imagery (external) section A

- On inspection it was noted that the property had a 45 degree dual pitched slated roof with a segmented ridge line. A ladder inspection to the front, side and rear elevation main roof revealed the following defects.
 - A) Historical holed and cracked cement verge to front elevation.
 - B) Historical cracking and missing render from the front elevation chimney breast
 - C) Historical Cracking to the rear elevation mortar hipped end with missing mortar and slates close to the gutter line.

- 1) Supply and erect a chimney scaffold to the front elevation chimney breast
- 2) Remove loose and damaged render from chimney breast
- 3) Apply cement scratch coat to chimney breast
- 4) Apply dry dash chip render to chimney breast
- 5) Supply and fit slates to rear elevation hipped end at gutter line
- 6) Re cement damaged hipped end mortar
- 7) Break out loose and cracked front elevation roof verge
- 8) Apply cement prime coat to front elevation roof verge
- 9) Smooth coat cement finish roof verge

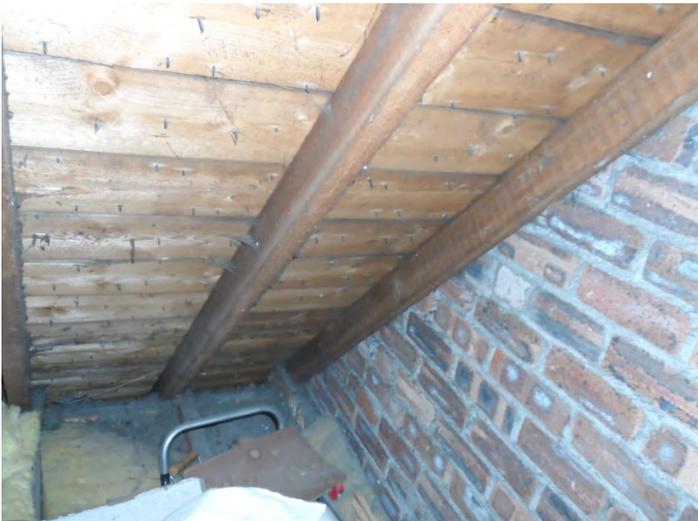
Fault Imagery (internal) section A

- On inspection it was noted that the roof was constructed in off saw timber jack, cripple and hip rafters with a sarking overlay. A close inspection of the loft space roof timber construction and material revealed no ingress or timber decay damage however the following defects were noted
 - A) Settlement sagging to the jack off saw jack rafters on the rear and side main roof elevations due to insufficient support bracing
 - B) Sagging and detached support purlin at hip joint due to no hanging post or secure up rite supports forcing the gang nail fixings to spring from situ

- 1) Supply and install hanging post uprights within the industry standard 2.93m Maximum clear span for off saw timber jack rafters at 125mm x 47mm
- 2) Supply and install up right timber supports to support main rafter purlin into situ at rear elevation roof construction
