INFRARED

SURVEY

Address: XXXXXXXXXXXXXXXXXXXXXXXX, ABERDEENSHIRE, AB42 4PB

Purpose of Report: QUALITATIVE INFRARED ANALISYS

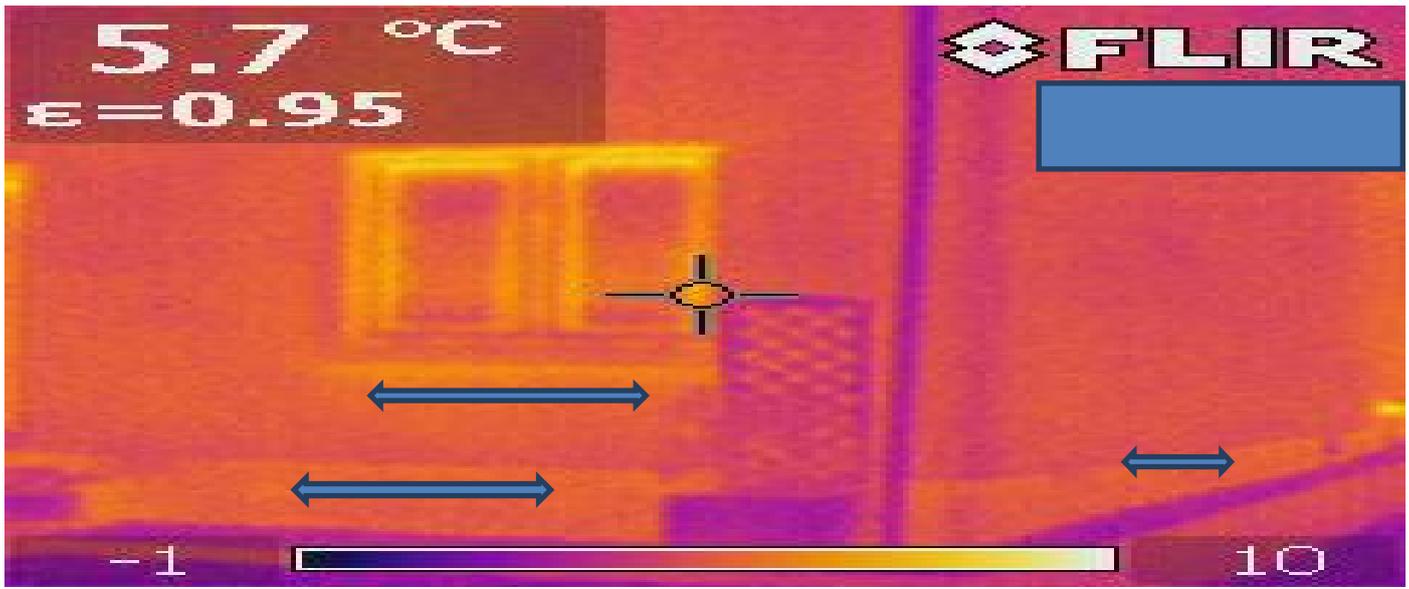
Image (1) (Rear/Side Elevation thermal image)

- Blue markers show excessive heat Signature detected from base course (1)
- Blue marker shows excessive heat Signature detected from area below window sil (2)
- Heat Signature around window frame and vents is consistent with PVCU windows.

Areas of possible thermal bridging, incomplete or missing insulation are marked directly on the internal images within the body of the report noted above. We recommend that a professional contractor carefully review this report. Then, with reference to the images contained herein and the marked areas on the images, these areas should be physically located and given a thorough visual examination. When warranted, these areas should be subjected to a destructive test (core sample) to confirm the analysis.

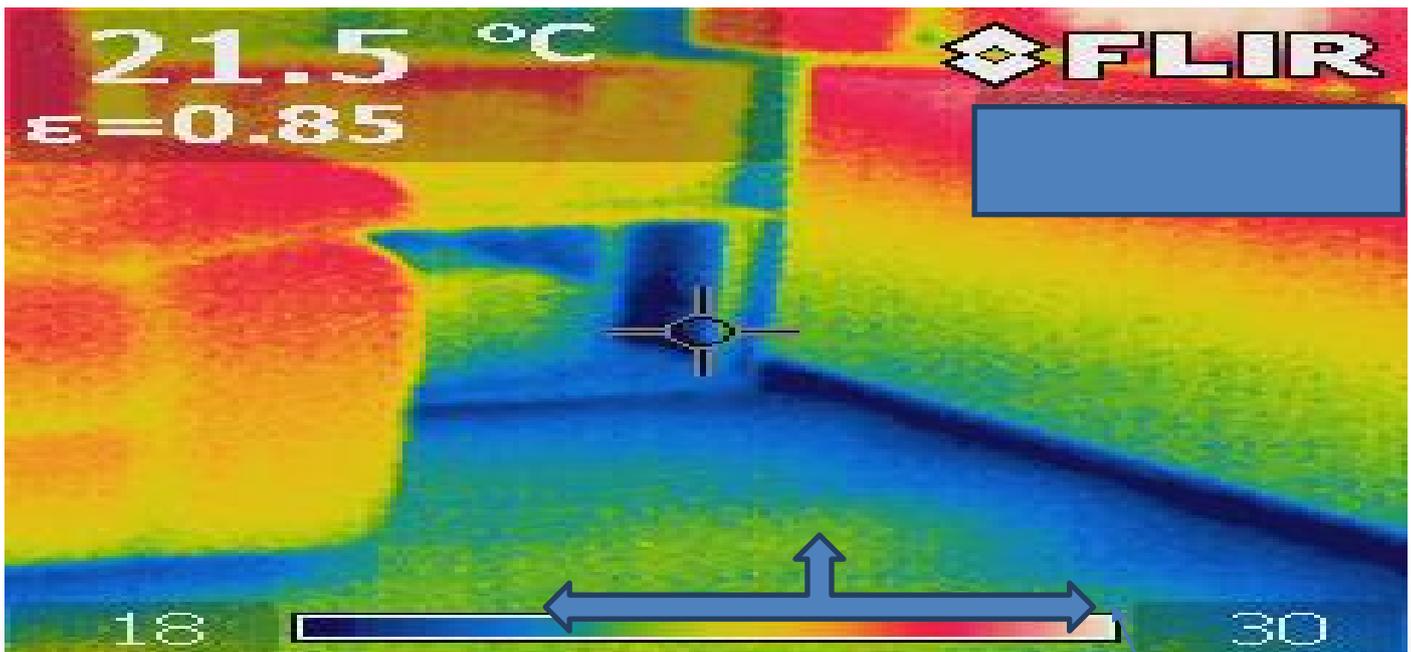
Image (1) of Lounge/Diner (wall floor area below window)

- Blue markers show excessive Draft/Air filtration with significant heat loss.(1)
- Blue markers of this image show that these areas of the ceiling/wall are poorly insulated with significant heat loss detected.(2)
