ASBESTOS **SURVEY**

Address: UNIT A, QUALITY STREET QUIII 8TY

Purpose of Report: ACM Inspection

Report Reference: ACM/MSE/2013

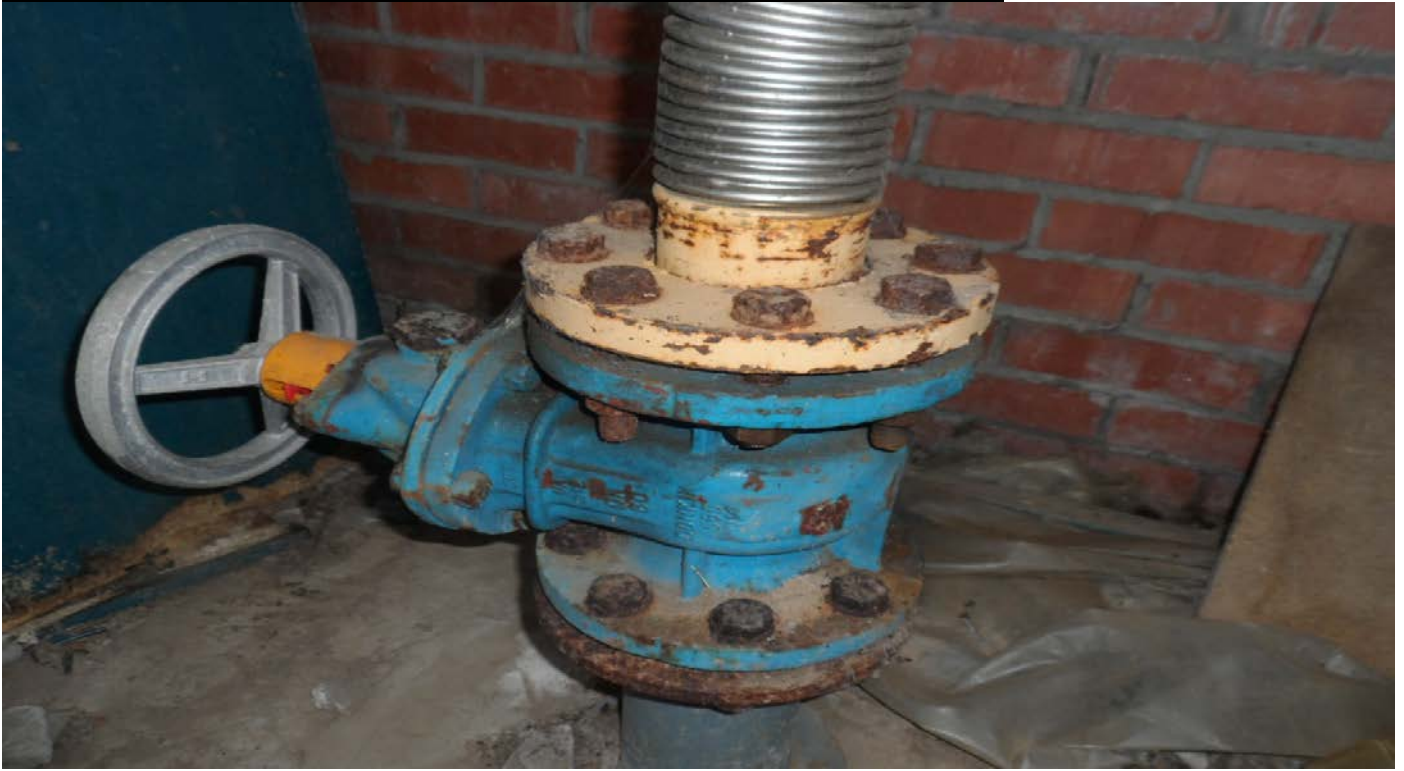
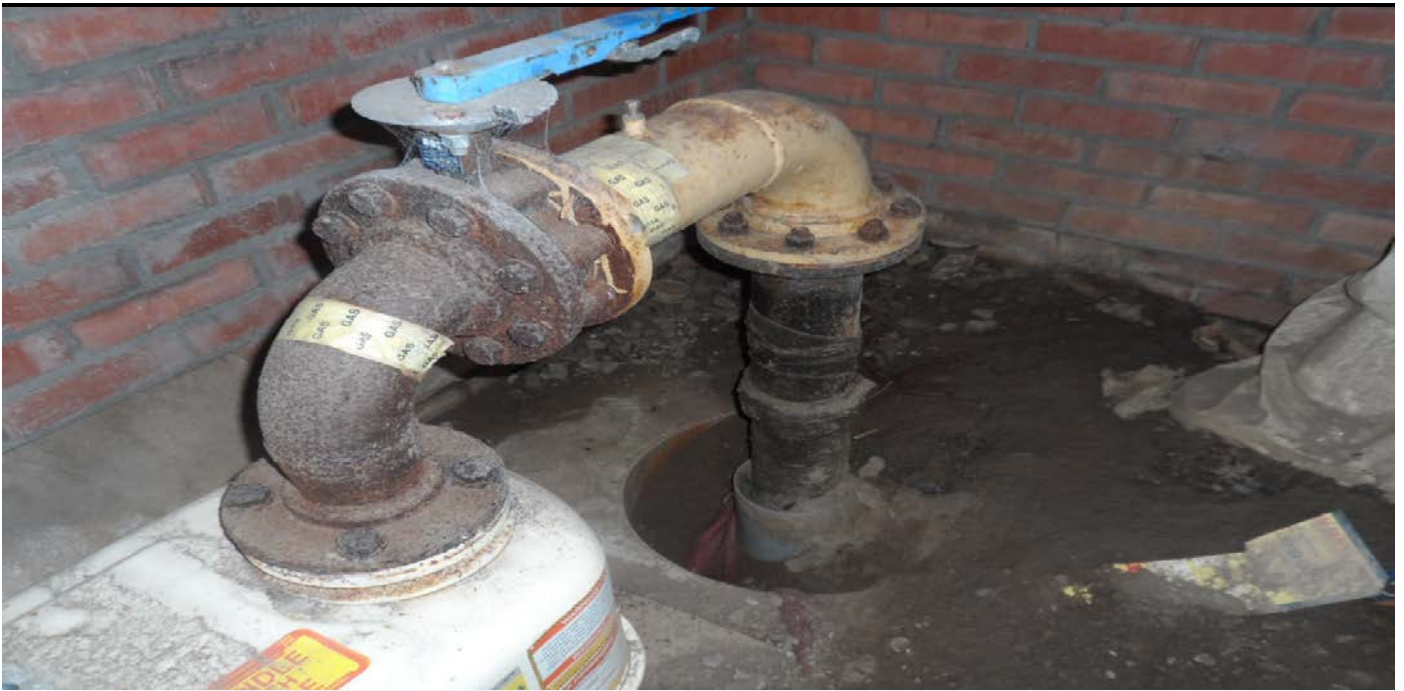
- Following Inspection it was noted that the commercial structure had an insulated profile metal clad finish with a dual pitched roof joined to a metal box gutter located centrally between the roof elevations. The structure was fixed to a concrete slab with a perimeter brick base course.
- A Full inspection of the external of the structure revealed no visible **Asbestos Containing Material**, however an inspection of the outhouse gas meter store located to the West gable end revealed pipe gasket material **Presumed to contain Asbestos Material**.

- Following inspection the material presumed Asbestos Containing Material was found to be in good condition with no visible damaged areas, no samples were taken to confirm/refute the presence of Asbestos Containing Material therefore no **certificate of bulk fibre analysis attached**

Following the onsite inspection a quantifiable assessment of the risk of fibre release has been made using an algorithm, taking into consideration the condition of the potential ACM's revealed, **NO IMMEDIATE ACTION REQUIRED**

Gas Supply Pipe Gasket (presumed asbestos containing material)

- NO IMMEDIATE ACTION REQUIRED

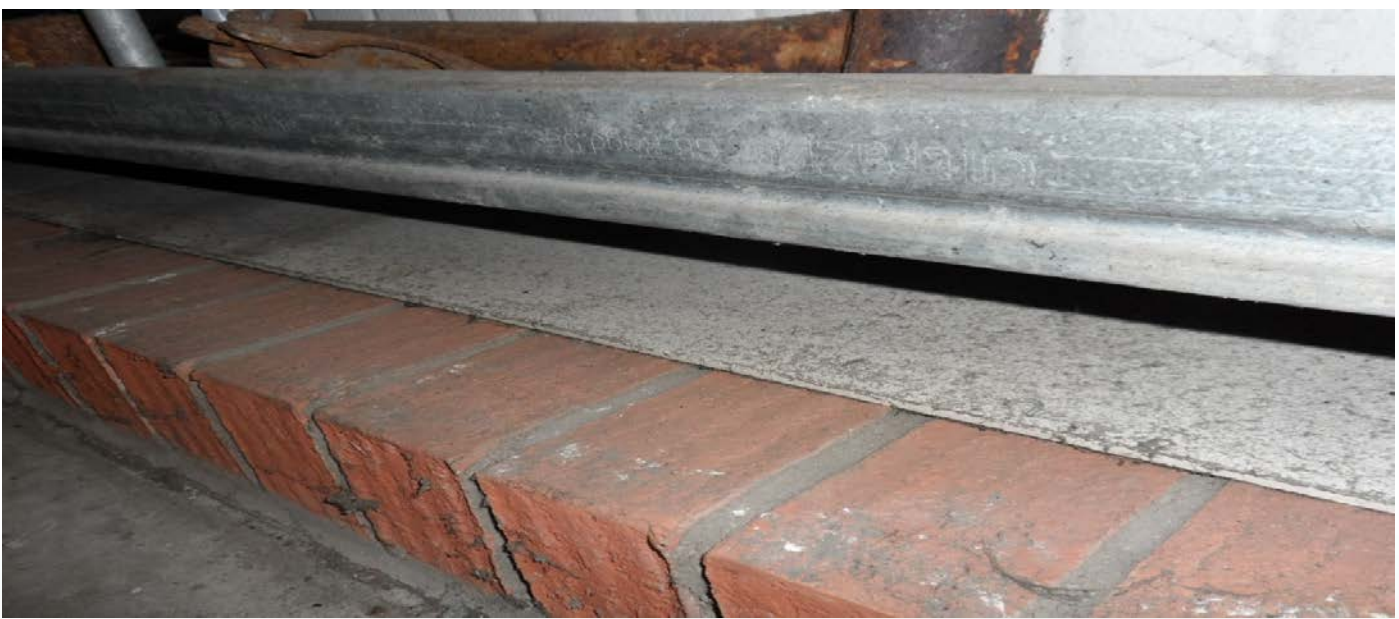
- The Vehicle Storage area had an exposed insulated profile sheet roof and wall covering fixed to a steel frame work/metal purlins secured to a concrete lab/brick perimeter base course.
- Close inspection of the brick base course revealed a fibre cement wall plate located around the structure perimeter approximately 200mm above the concrete floor finish, presumed to be an asbestos containing material.

- Following inspection the material presumed Asbestos Containing Material was found to be in good condition with no visible damaged areas, no samples were taken to confirm/refute the presence of Asbestos Containing Material therefore no certificate of bulk fibre analysis attached

- Following the onsite inspection a quantifiable assessment of the risk of fibre release has been made using an algorithm, taking into consideration the condition of the potential ACM's revealed, **NO IMMEDIATE ACTION REQUIRED**

Fibre Cement perimeter wall plate (presumed asbestos containing material)

- NO IMMEDIATE ACTION REQUIRED

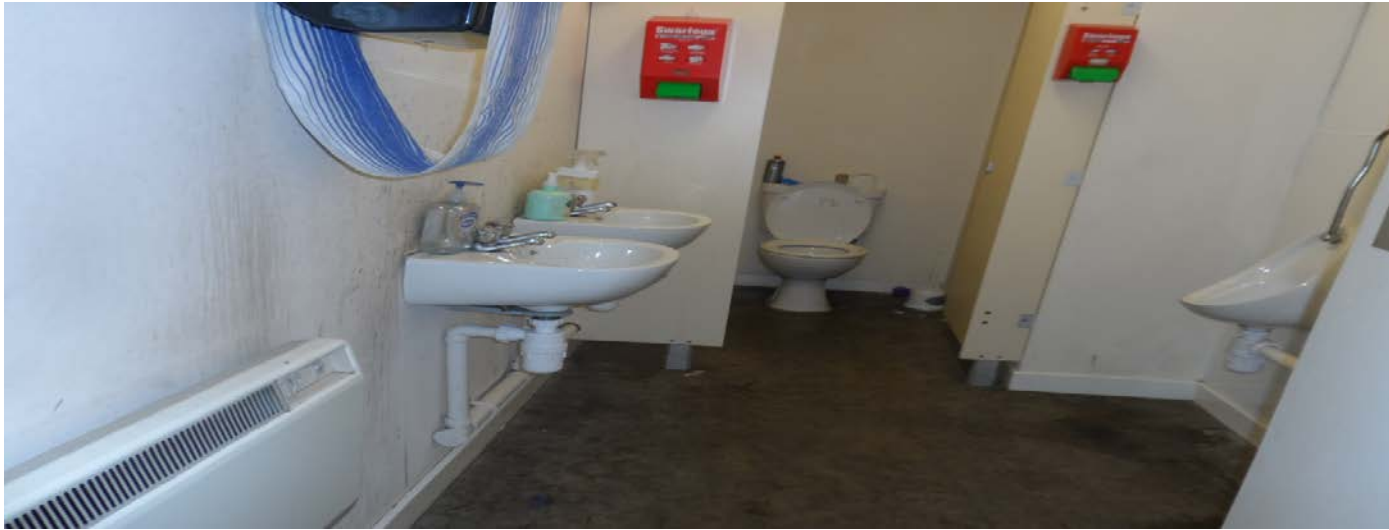
Men's Toilet (5.25m long x 1.61m wide x 2.5m high)

- Following Inspection it was noted that the Toilet had an emulsion smooth plaster ceiling and walls, WC & Wash hand basin, Urinals, Entrance and Exit door and cubical all found to be in a good state of repair with **no visible ACM's**

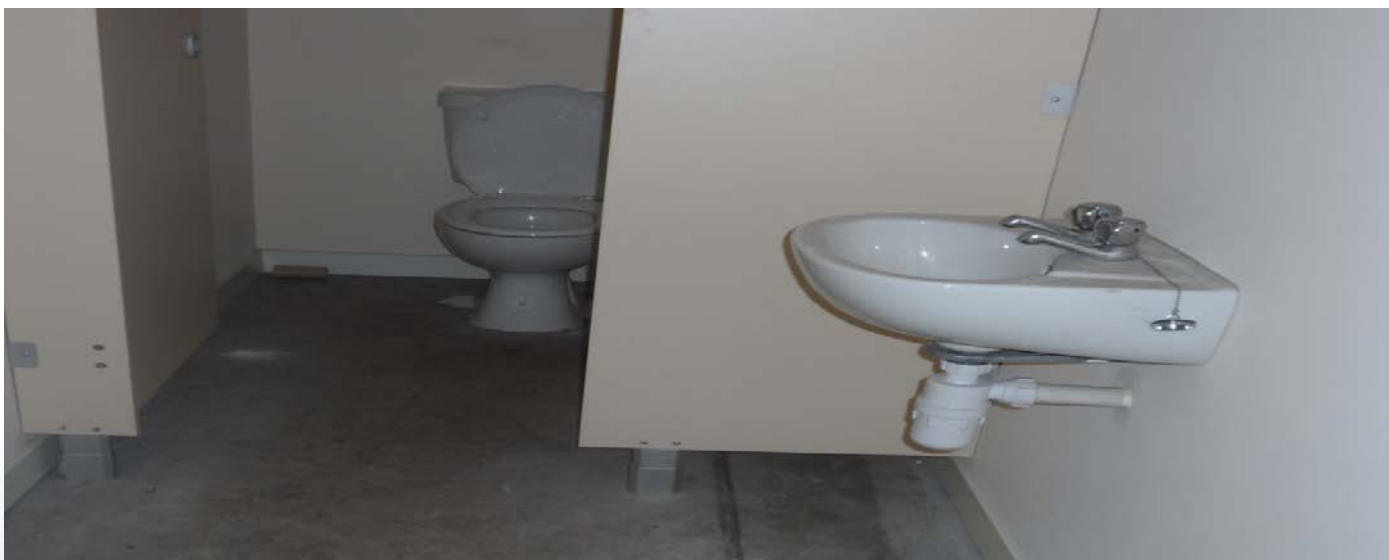
Women Toilet (5.27m long x 1.27m wide x 2.5m high)

- Following Inspection it was noted that the Toilet had an emulsion smooth plaster ceiling and walls, WC & Wash hand basin, Entrance and Exit door and cubical all found to be in a good state of repair with **no visible ACM's**

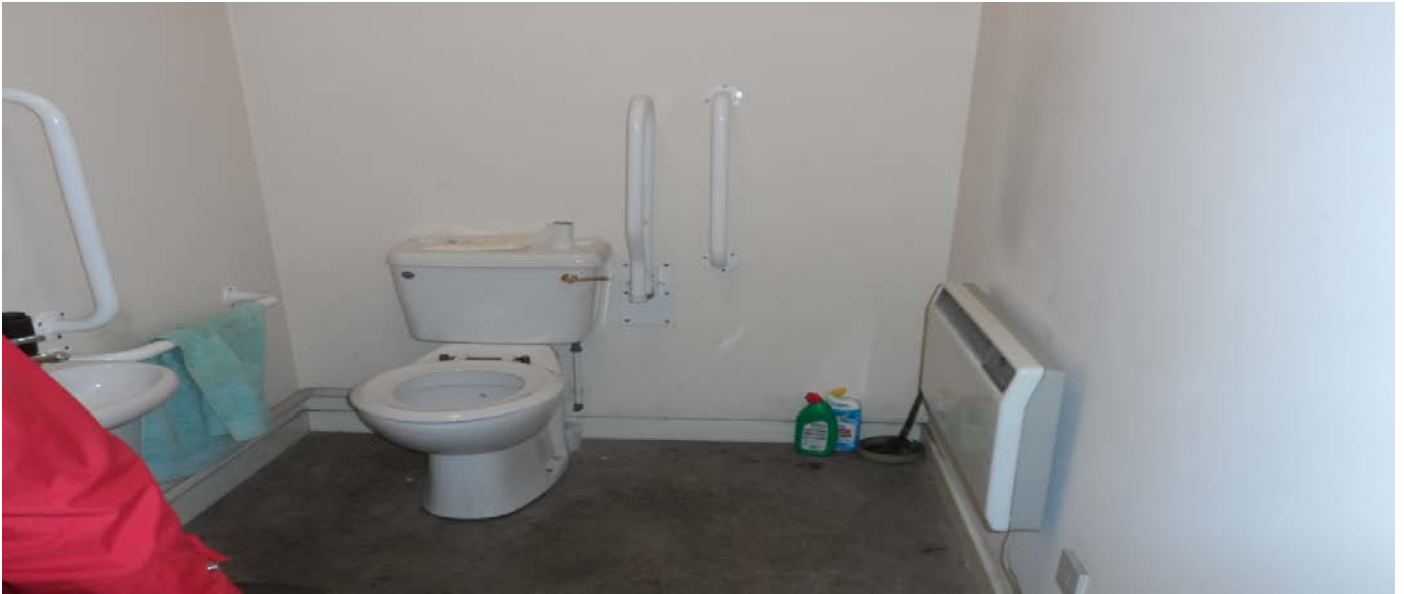
Disabled Toilet (1.96m long x 1.47m wide x 2.5m high)

- Following Inspection it was noted that the Toilet had an emulsion smooth plaster ceiling and walls, WC & Wash hand basin, Handrails, Entrance and Exit door all found to be in a good state of repair with **no visible ACM's**

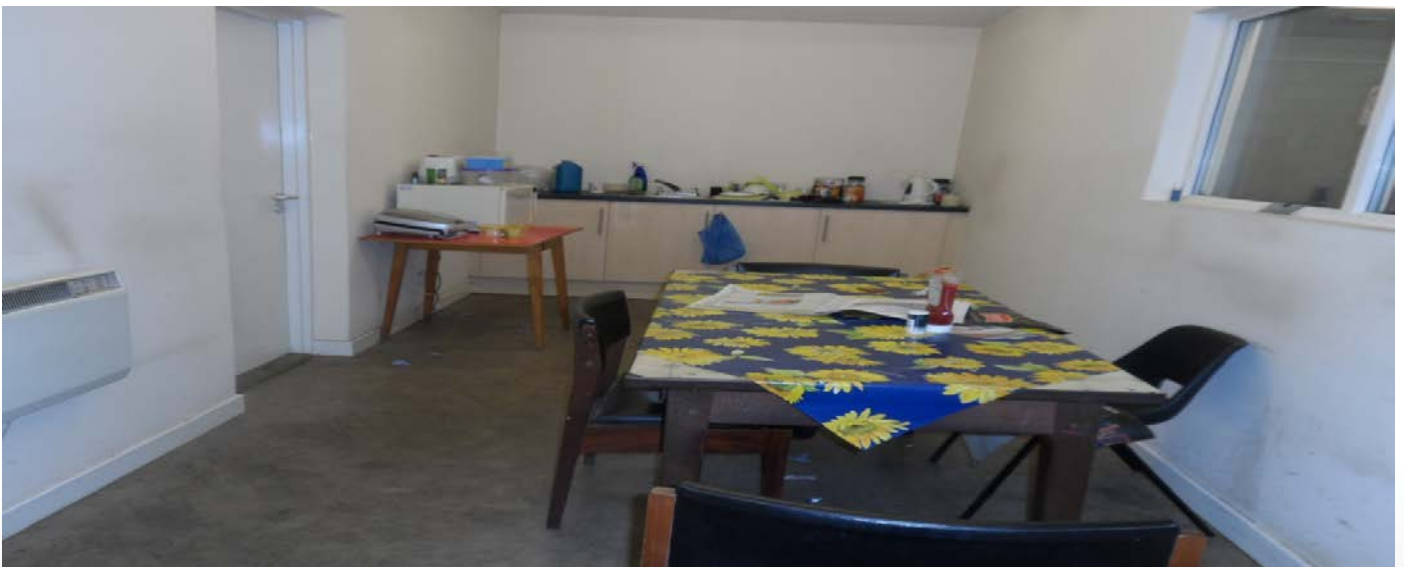
Kitchen (6.77m long x 2.37m wide x 2.5m high)

- Following Inspection it was noted that the Kitchen had an emulsion smooth plastered ceiling and wall finish, Modern base units with inset sink, entrance and exit doors all found to be in a good state of repair with **no visible ACM's**

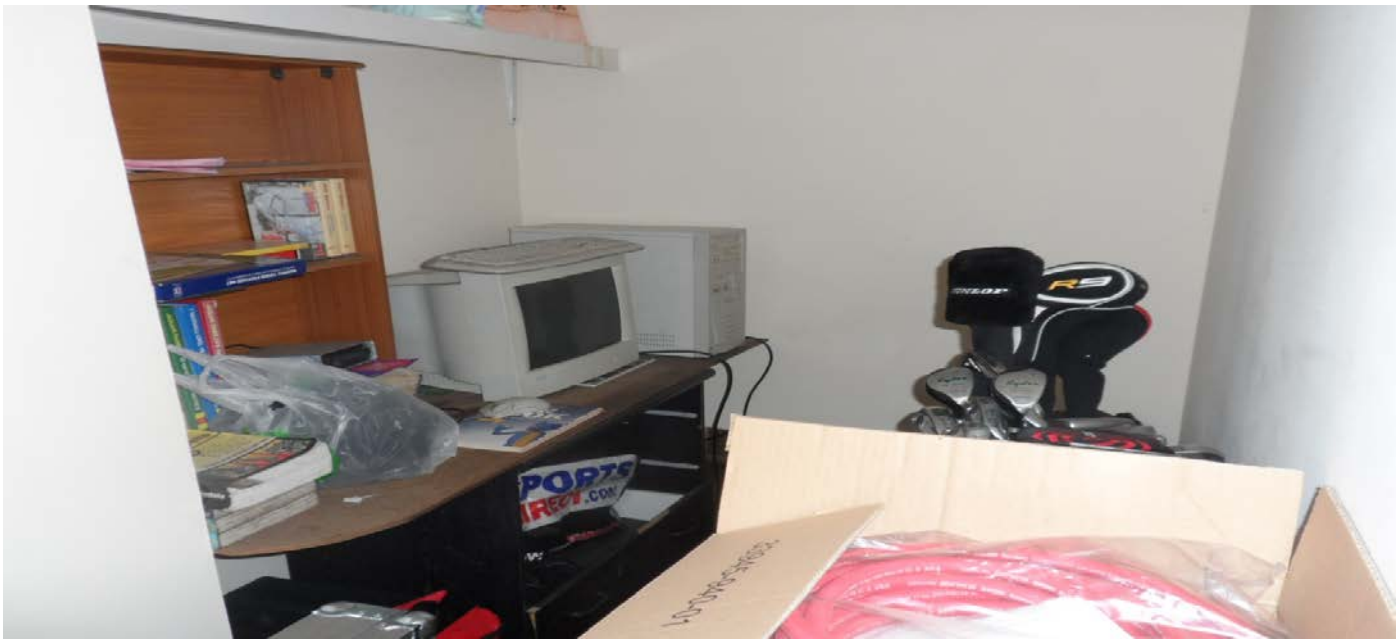
Kitchen/Store (2.95m long x 1.37m wide x 2.07m high)

- Following Inspection it was noted that the Kitchen/store had an emulsion smooth plastered ceiling and wall finish, Shelving, entrance and exit doors all found to be in a good state of repair with **no visible ACM's**

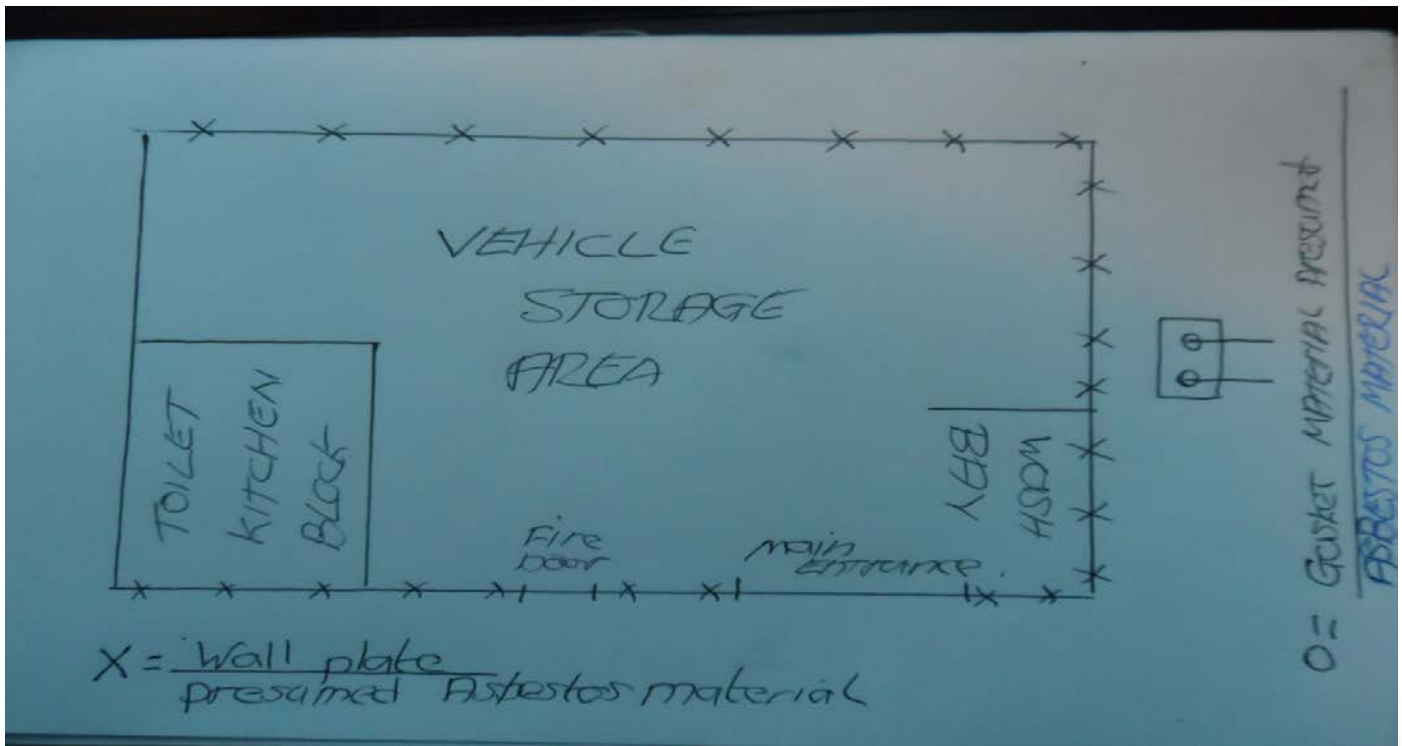
Location Plan of Material Presumed to Contain Asbestos

These Areas Contain Asbestos

- X = Possible Asbestos Containing Material Wall Plate
- 0 = Possible Asbestos Containing Material Gas Supply Pipe Gasket
