# ***SNAGGING*** ***SURVEY***

**Address:** XX XXXXX XXXXXXXX XXXXXXXXXX, EDINBURGH, EH7 5EU

**Purpose of Report:** NEW BUILD SNAGGING

**Inspection Date:** 4<sup>th</sup> November 2016

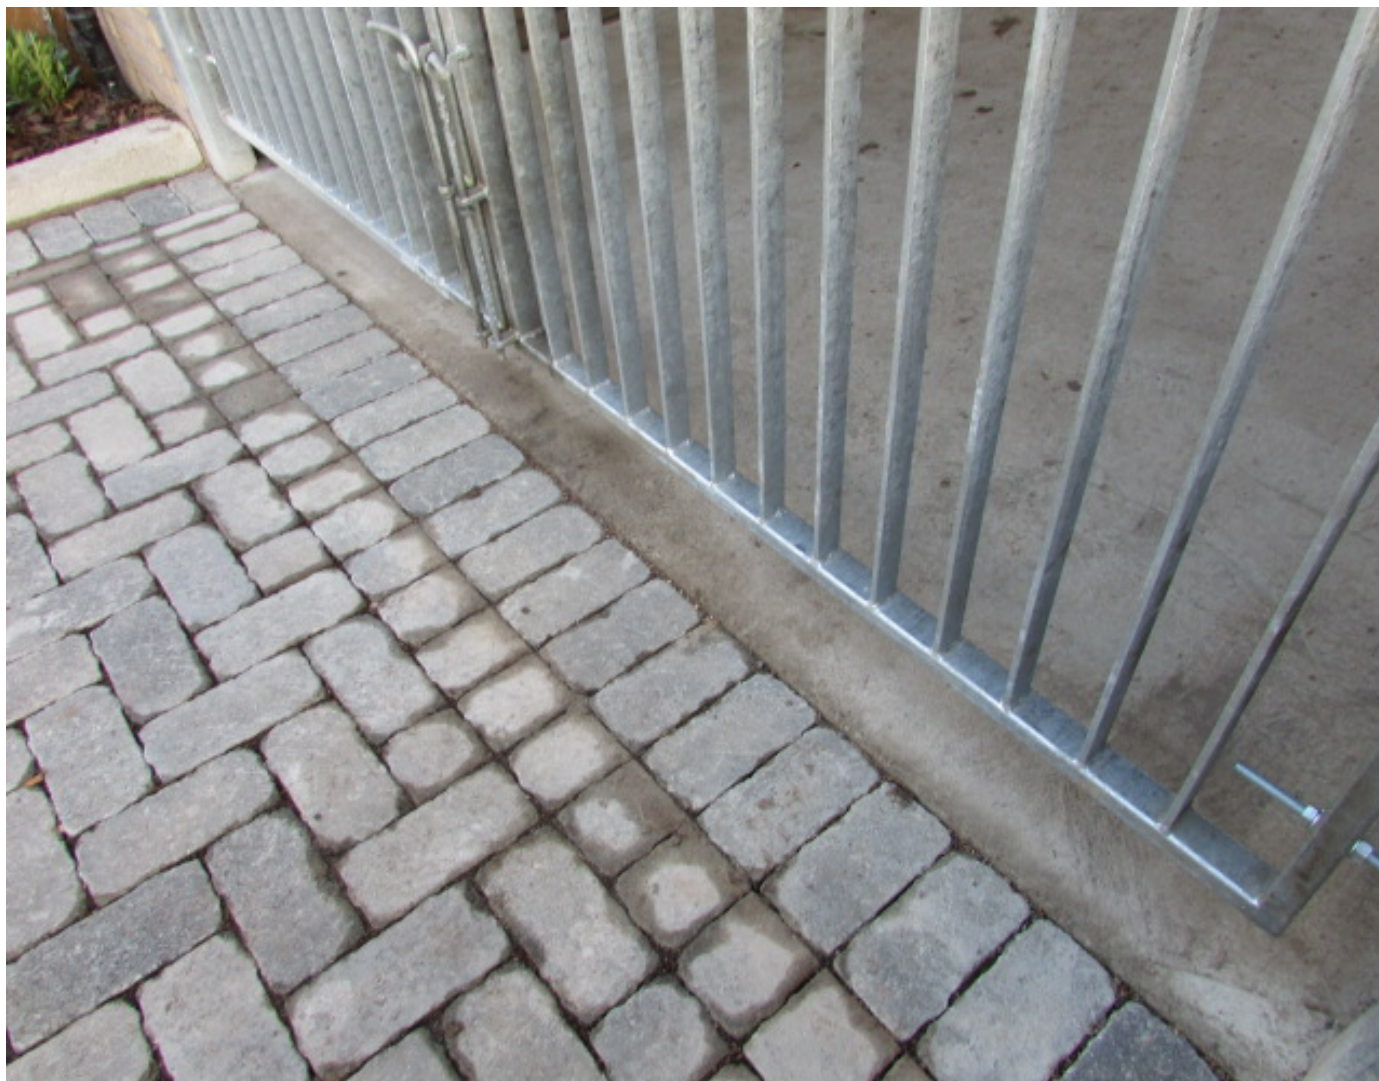
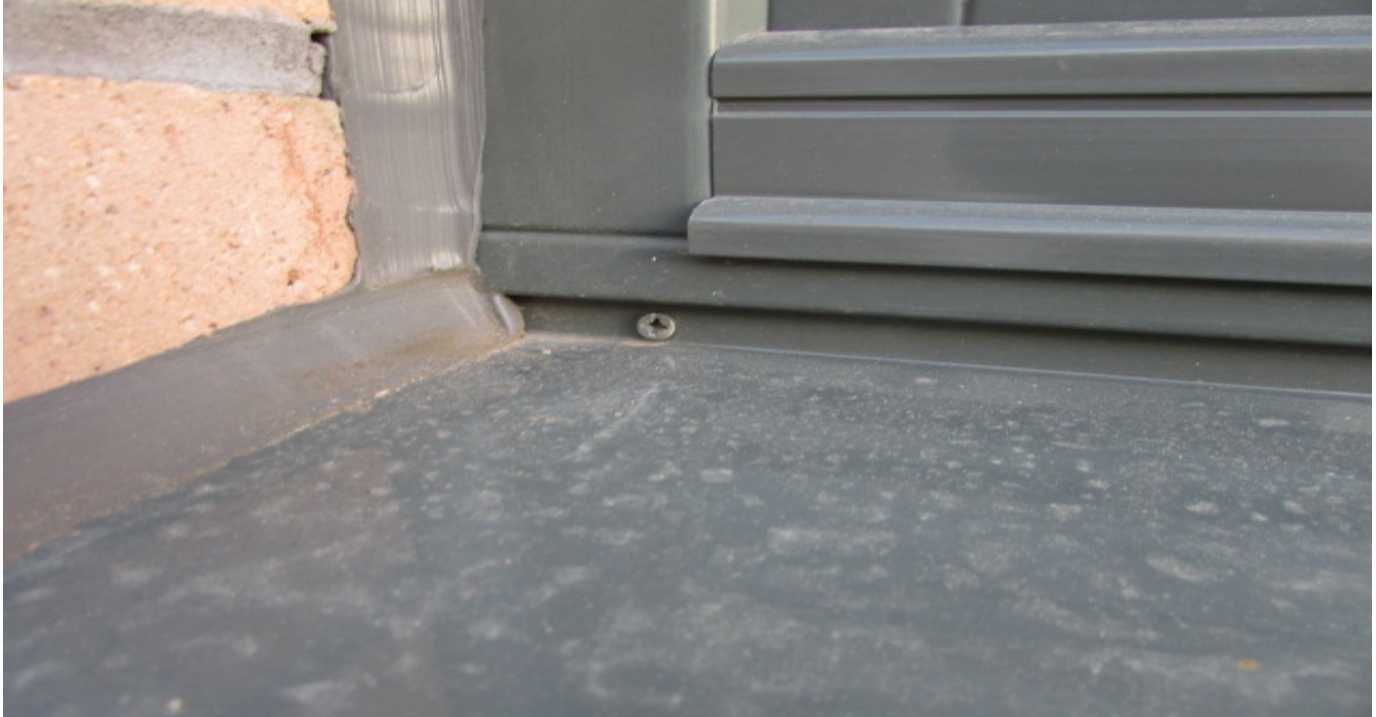
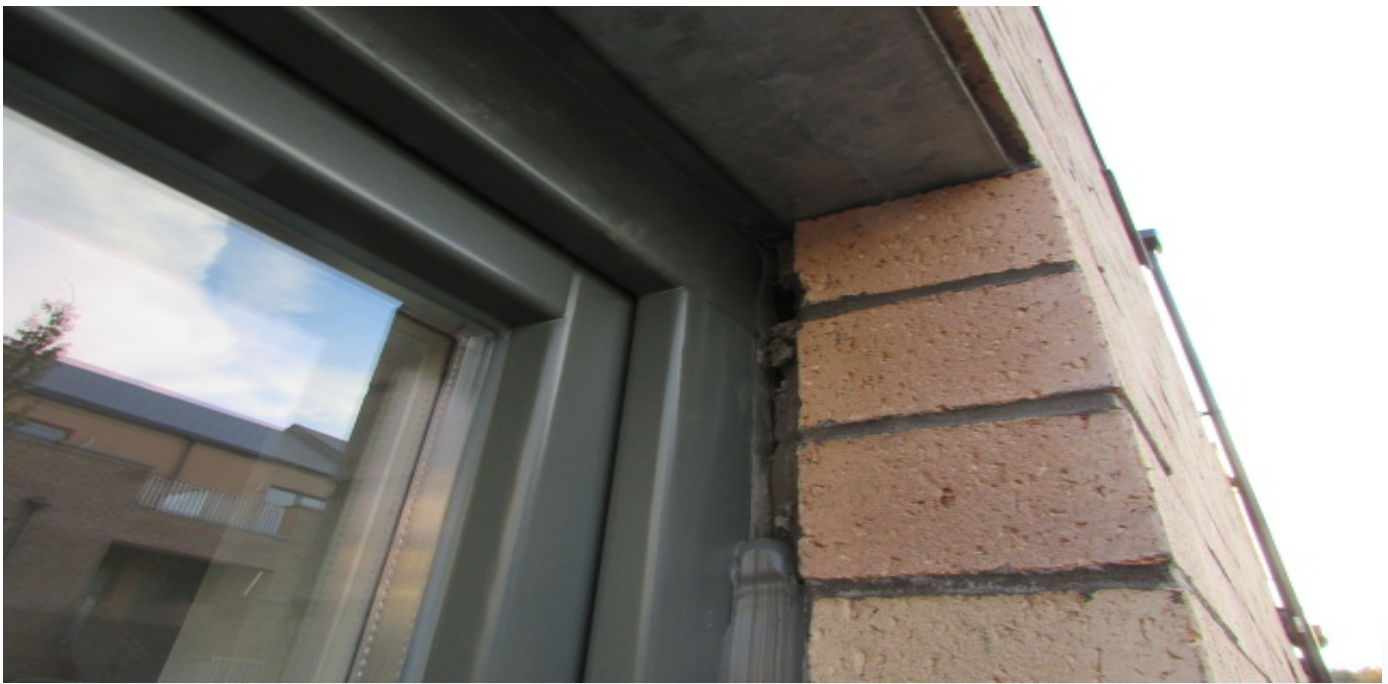
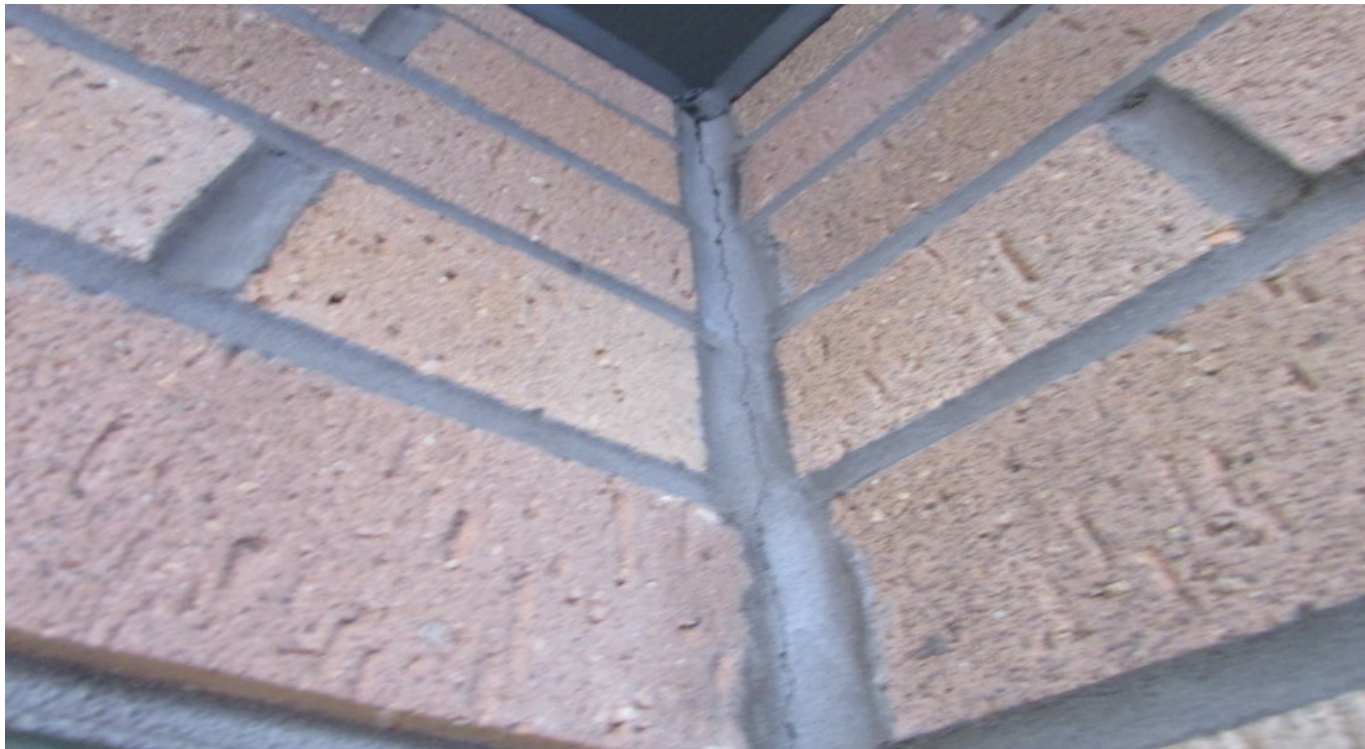
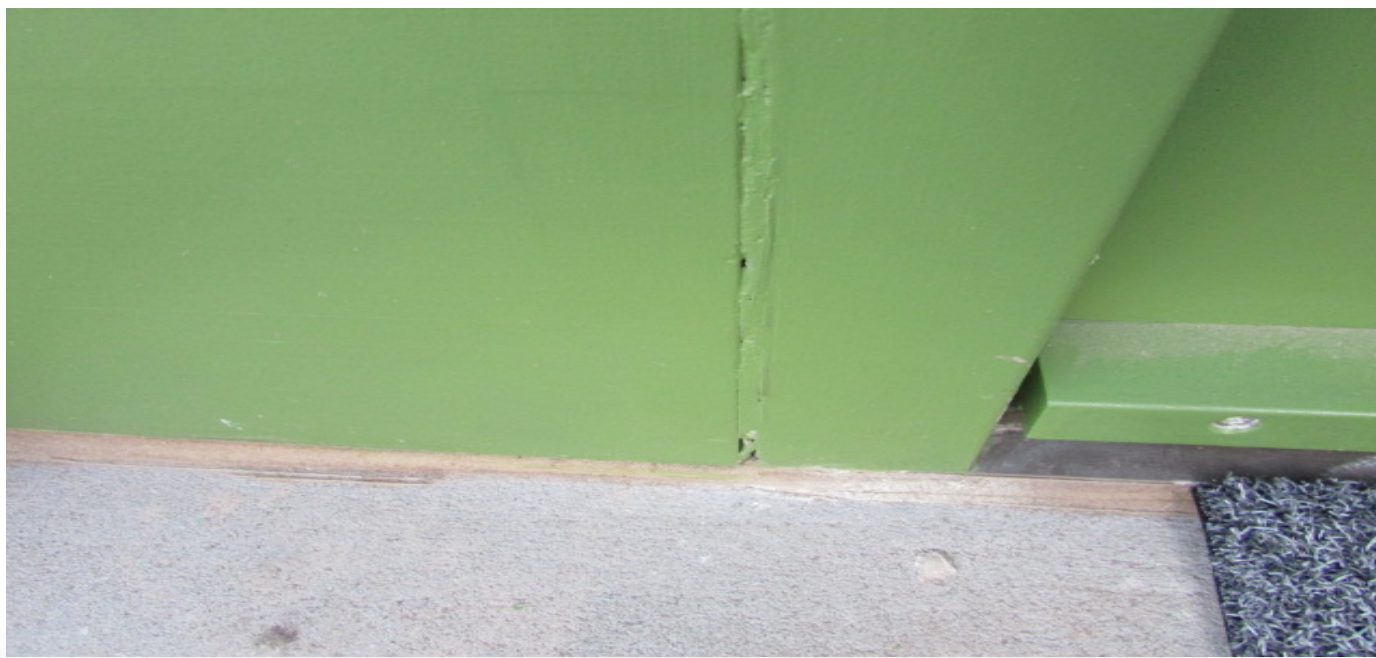
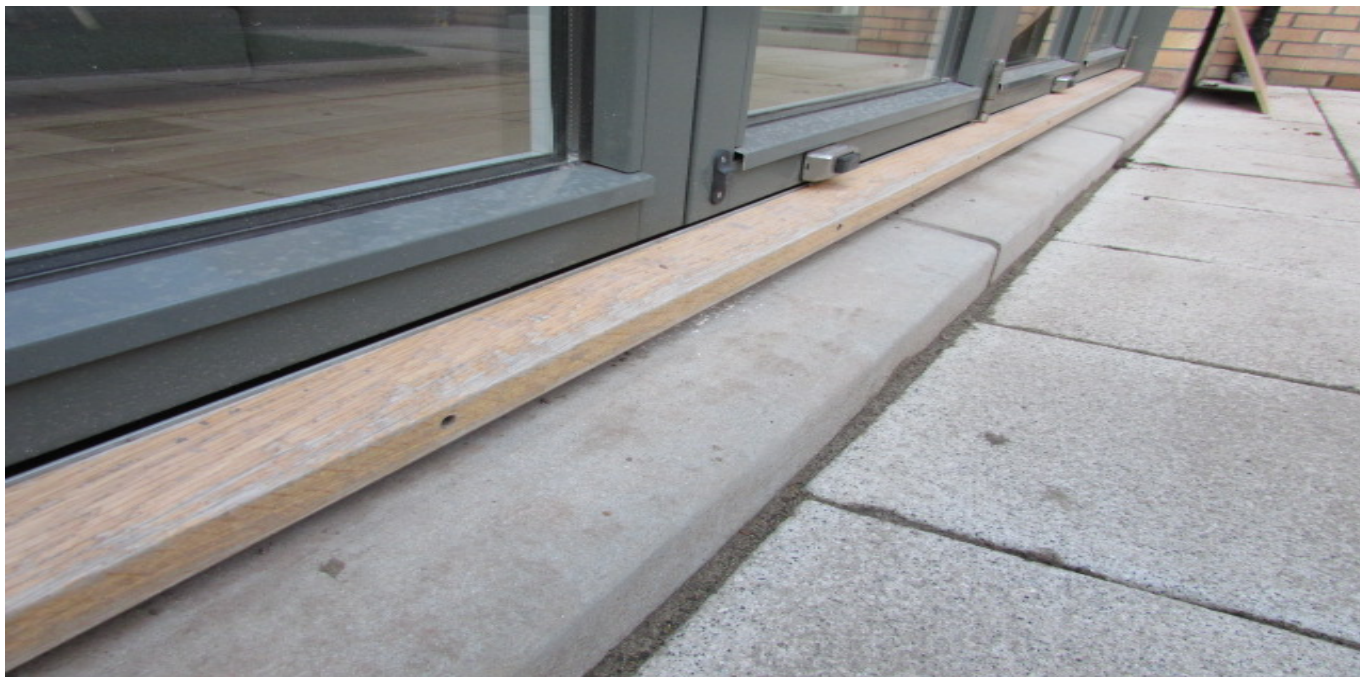
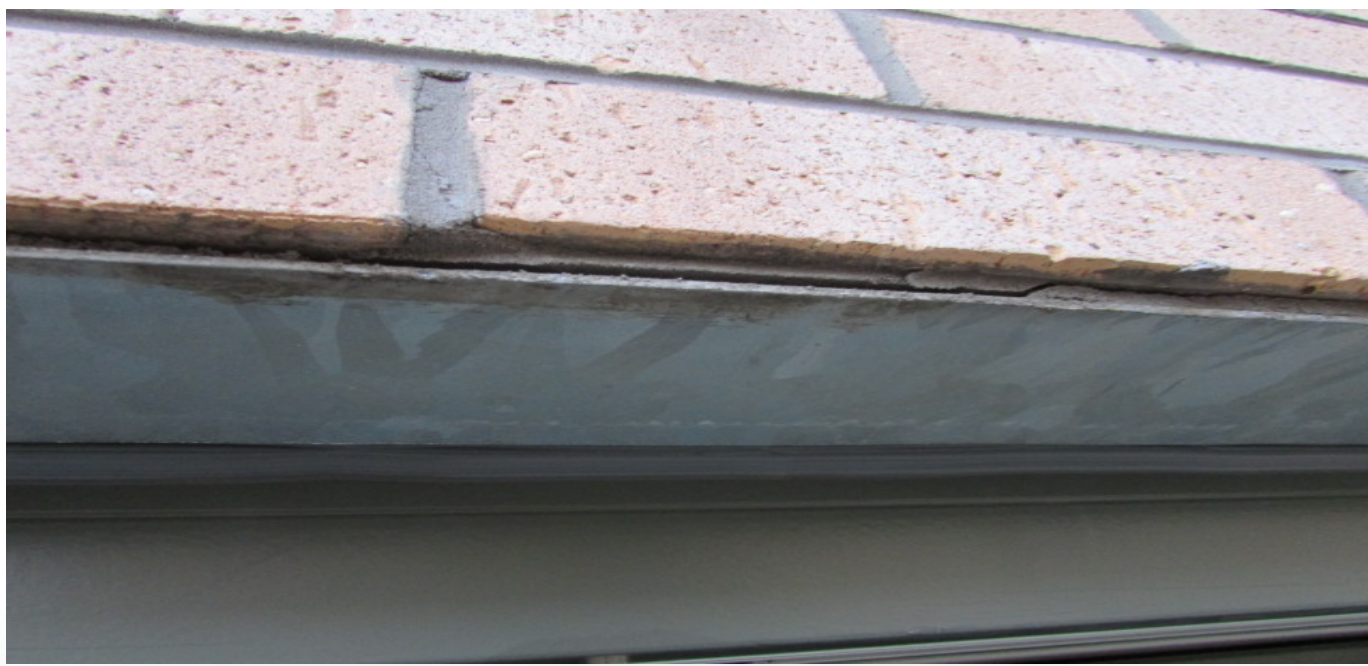
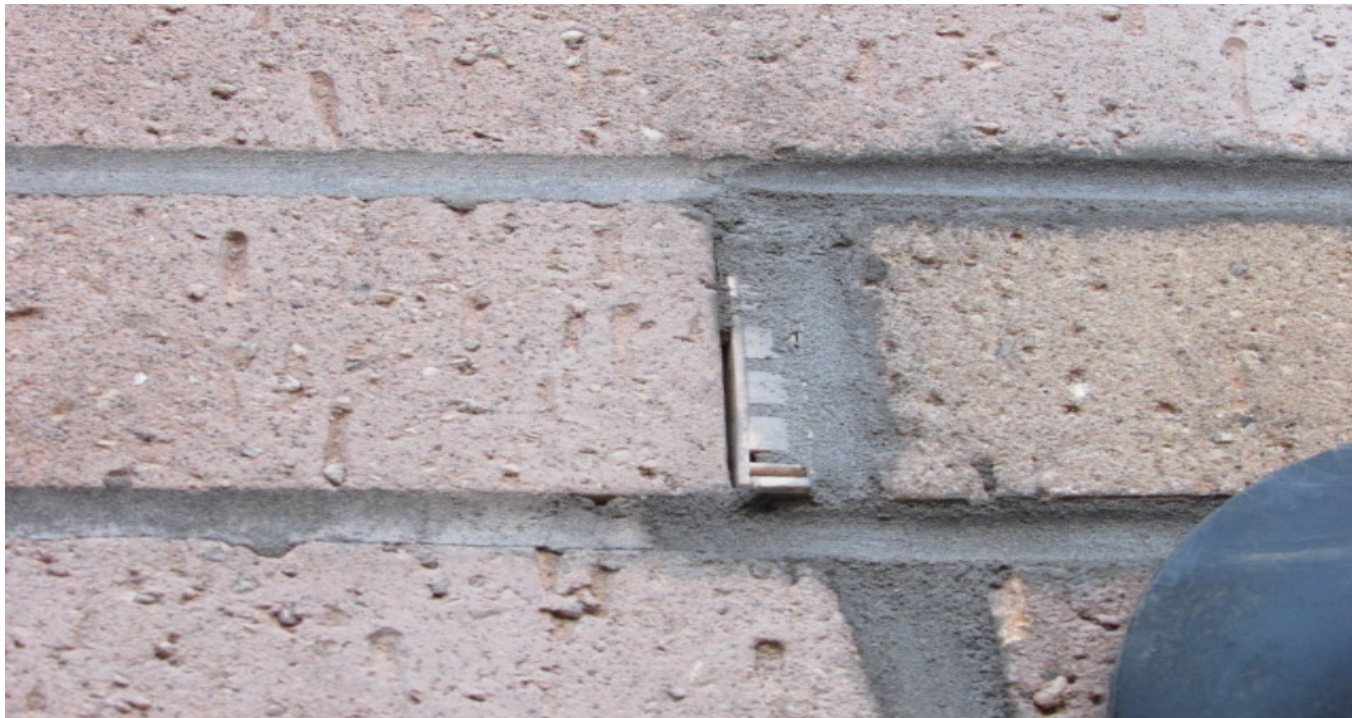
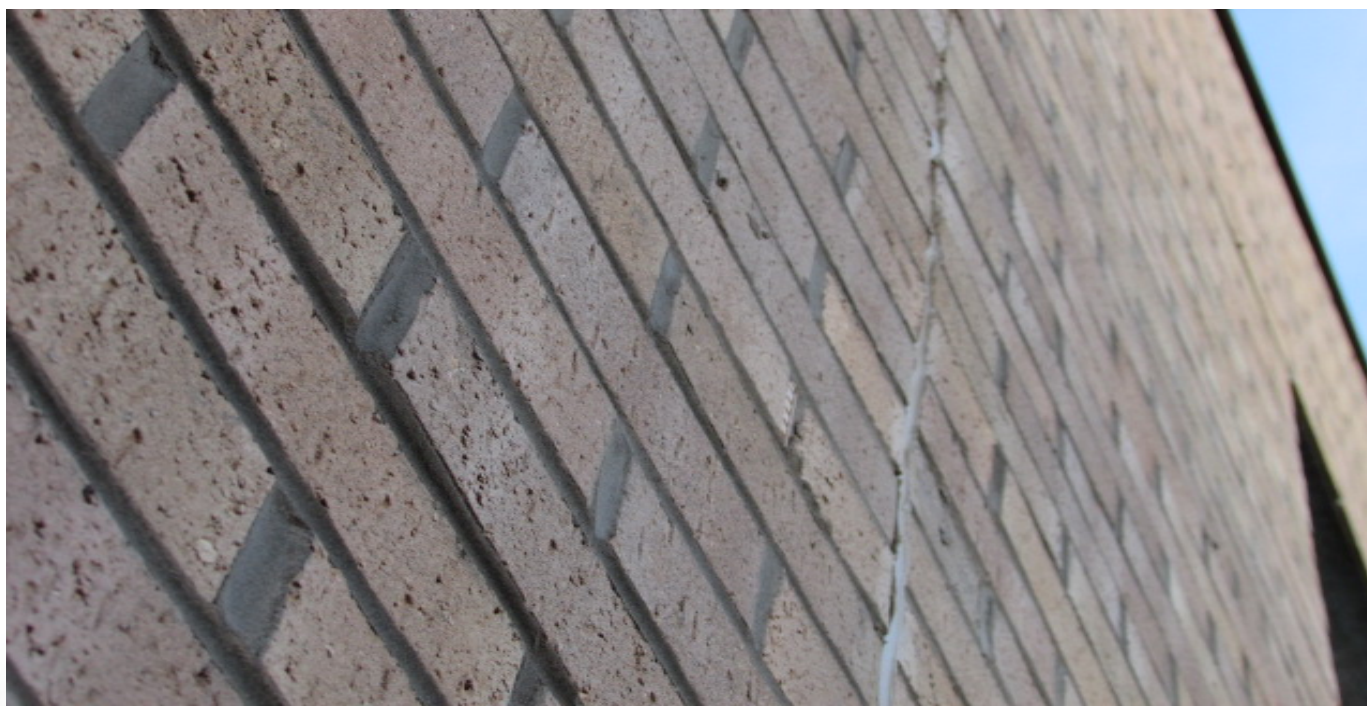
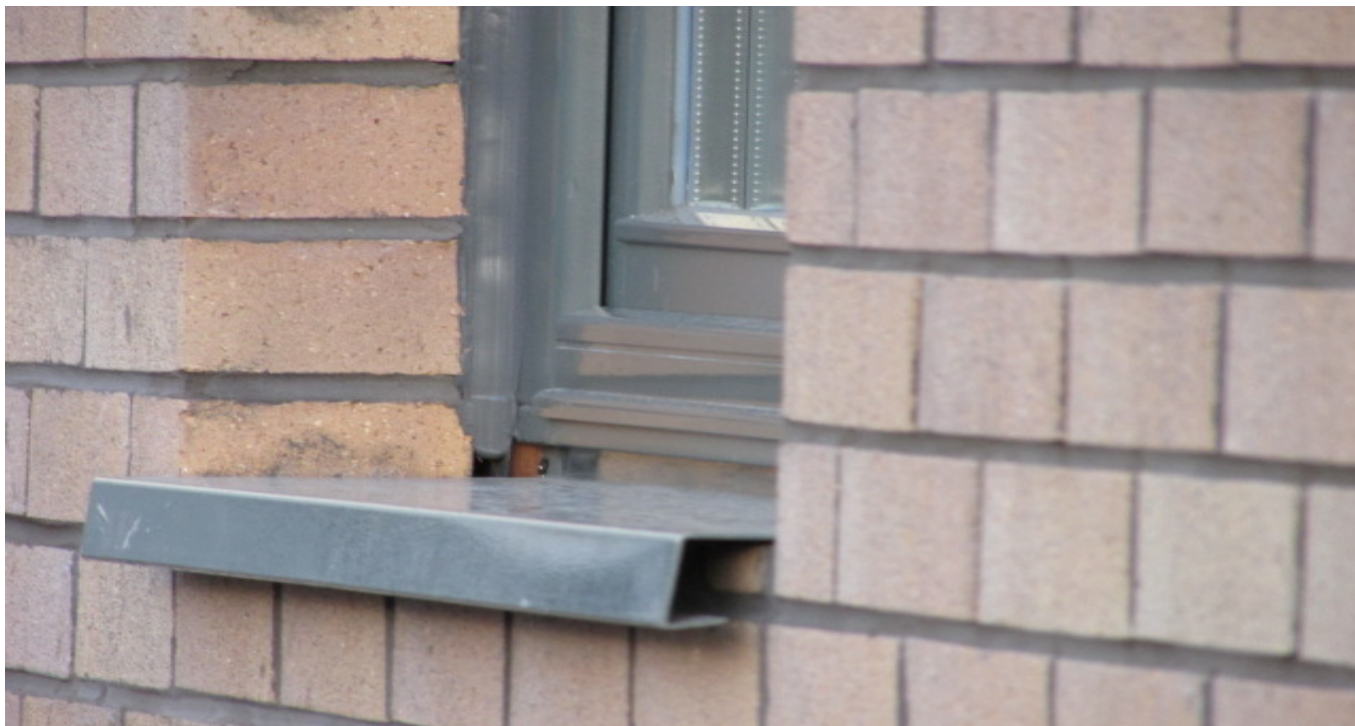
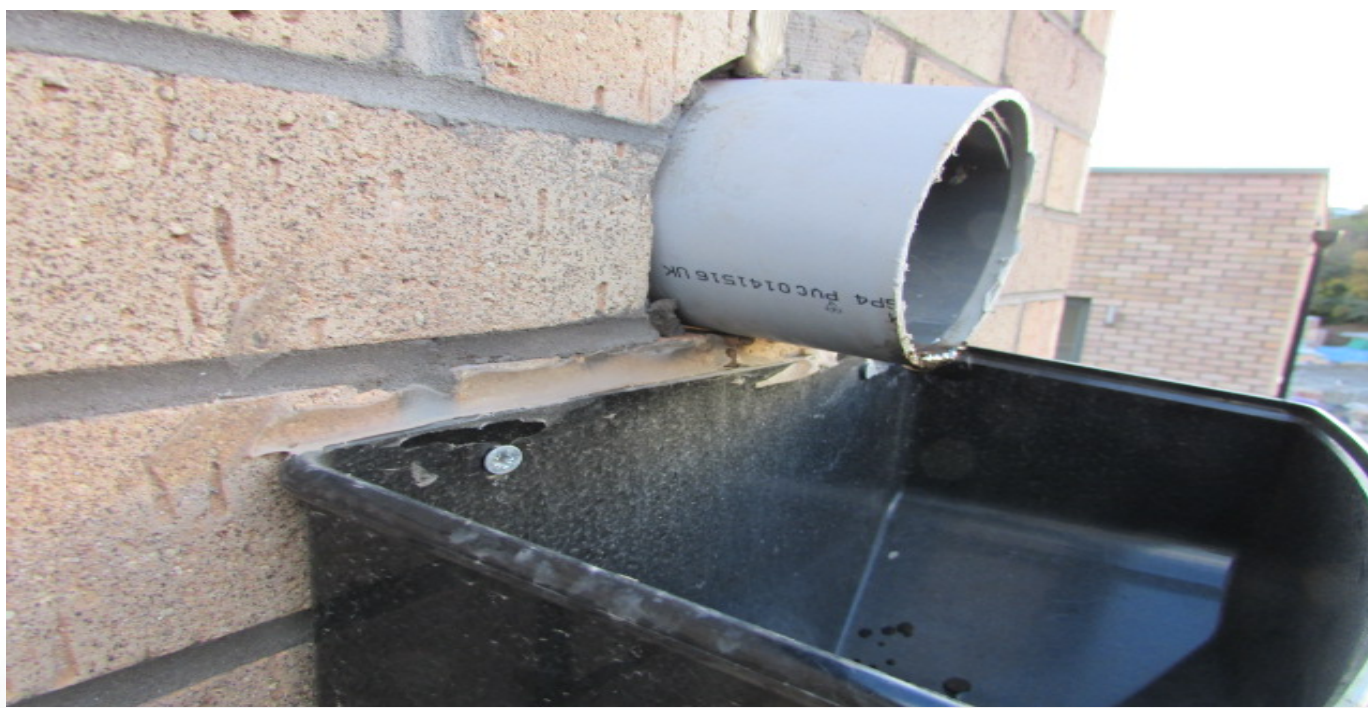
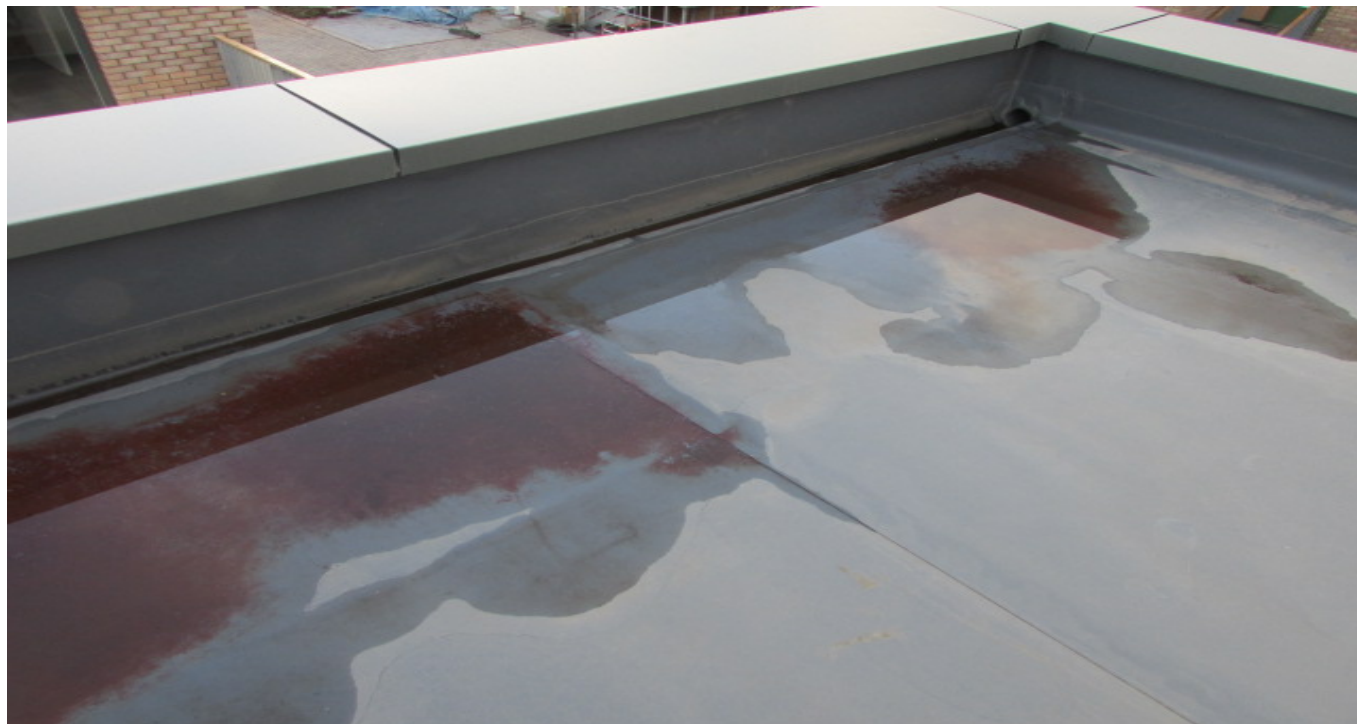
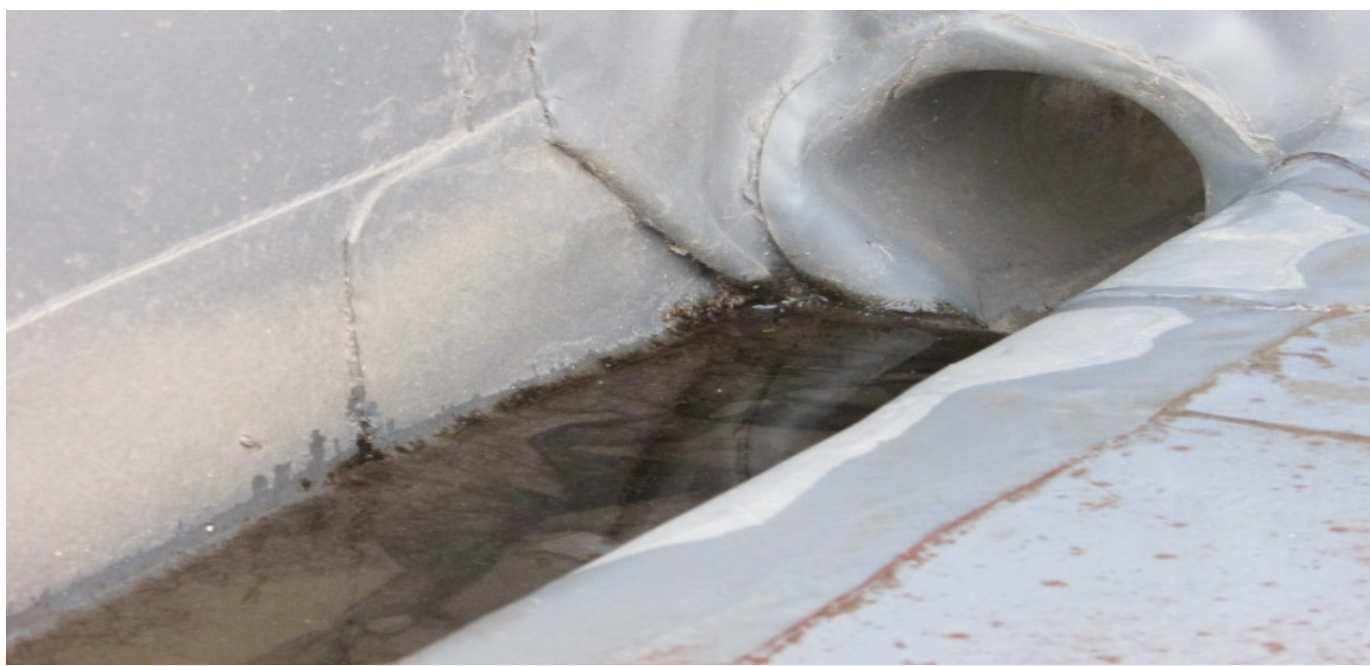
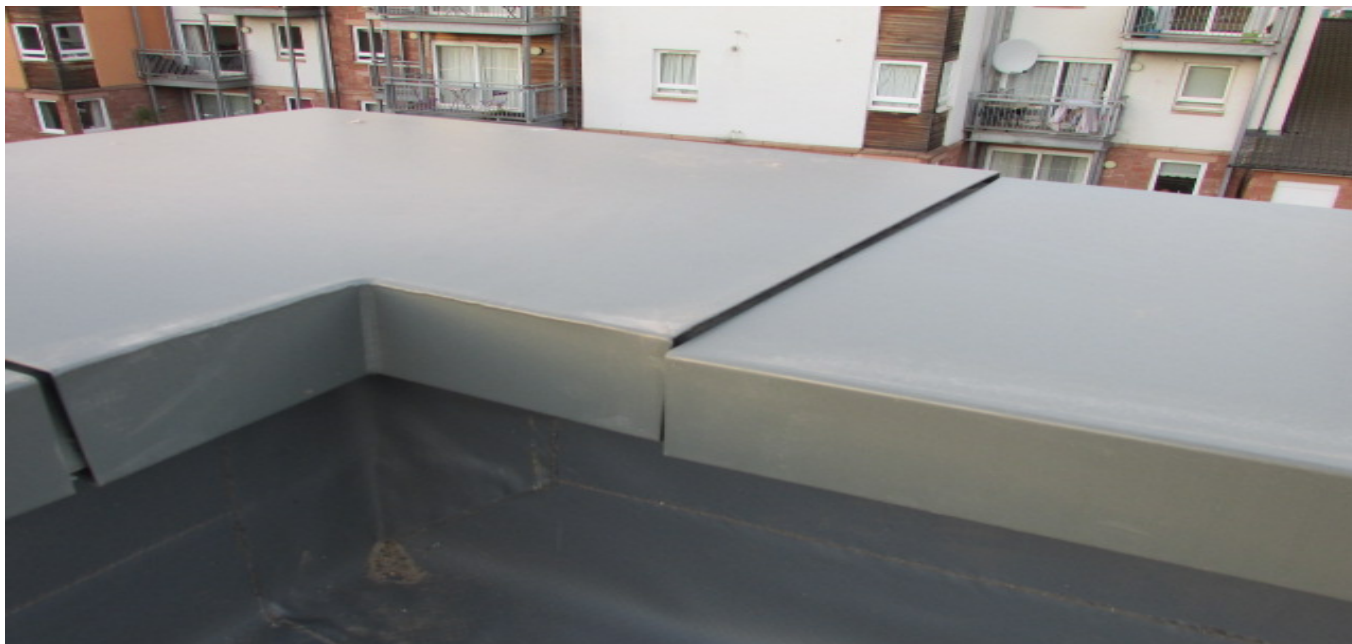
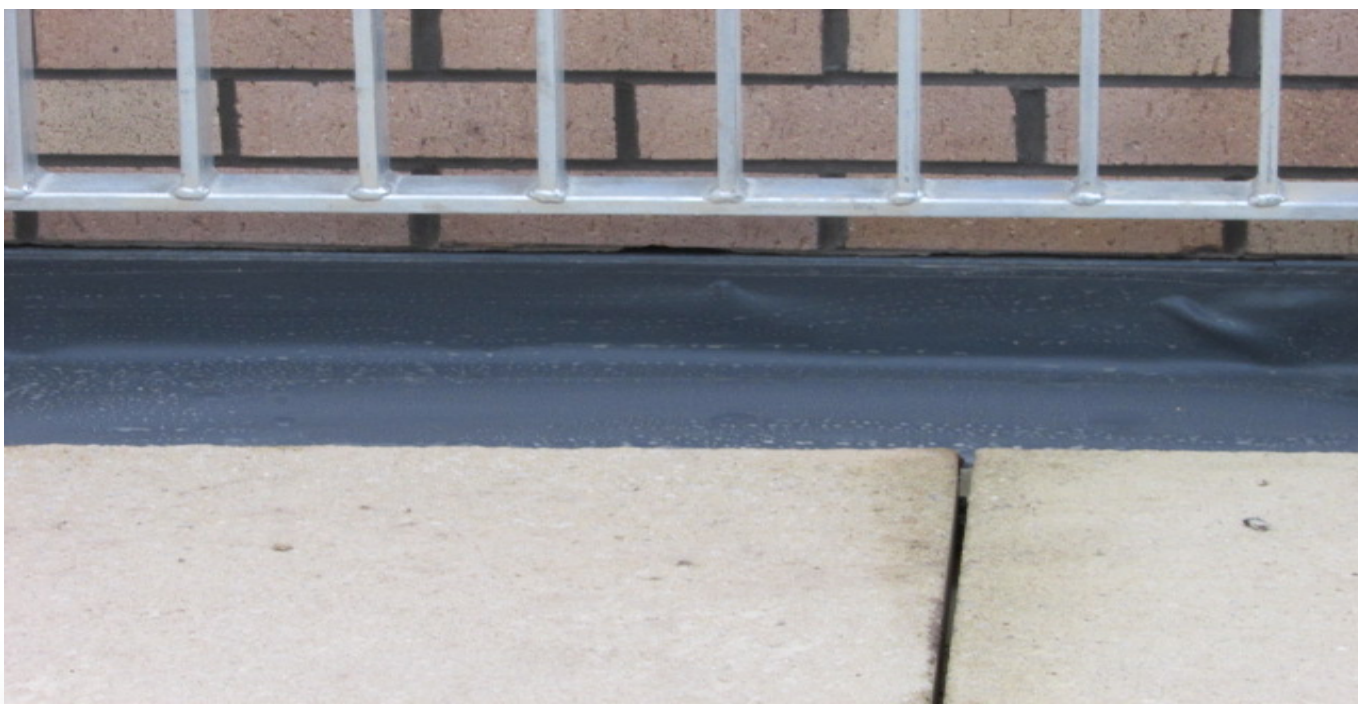
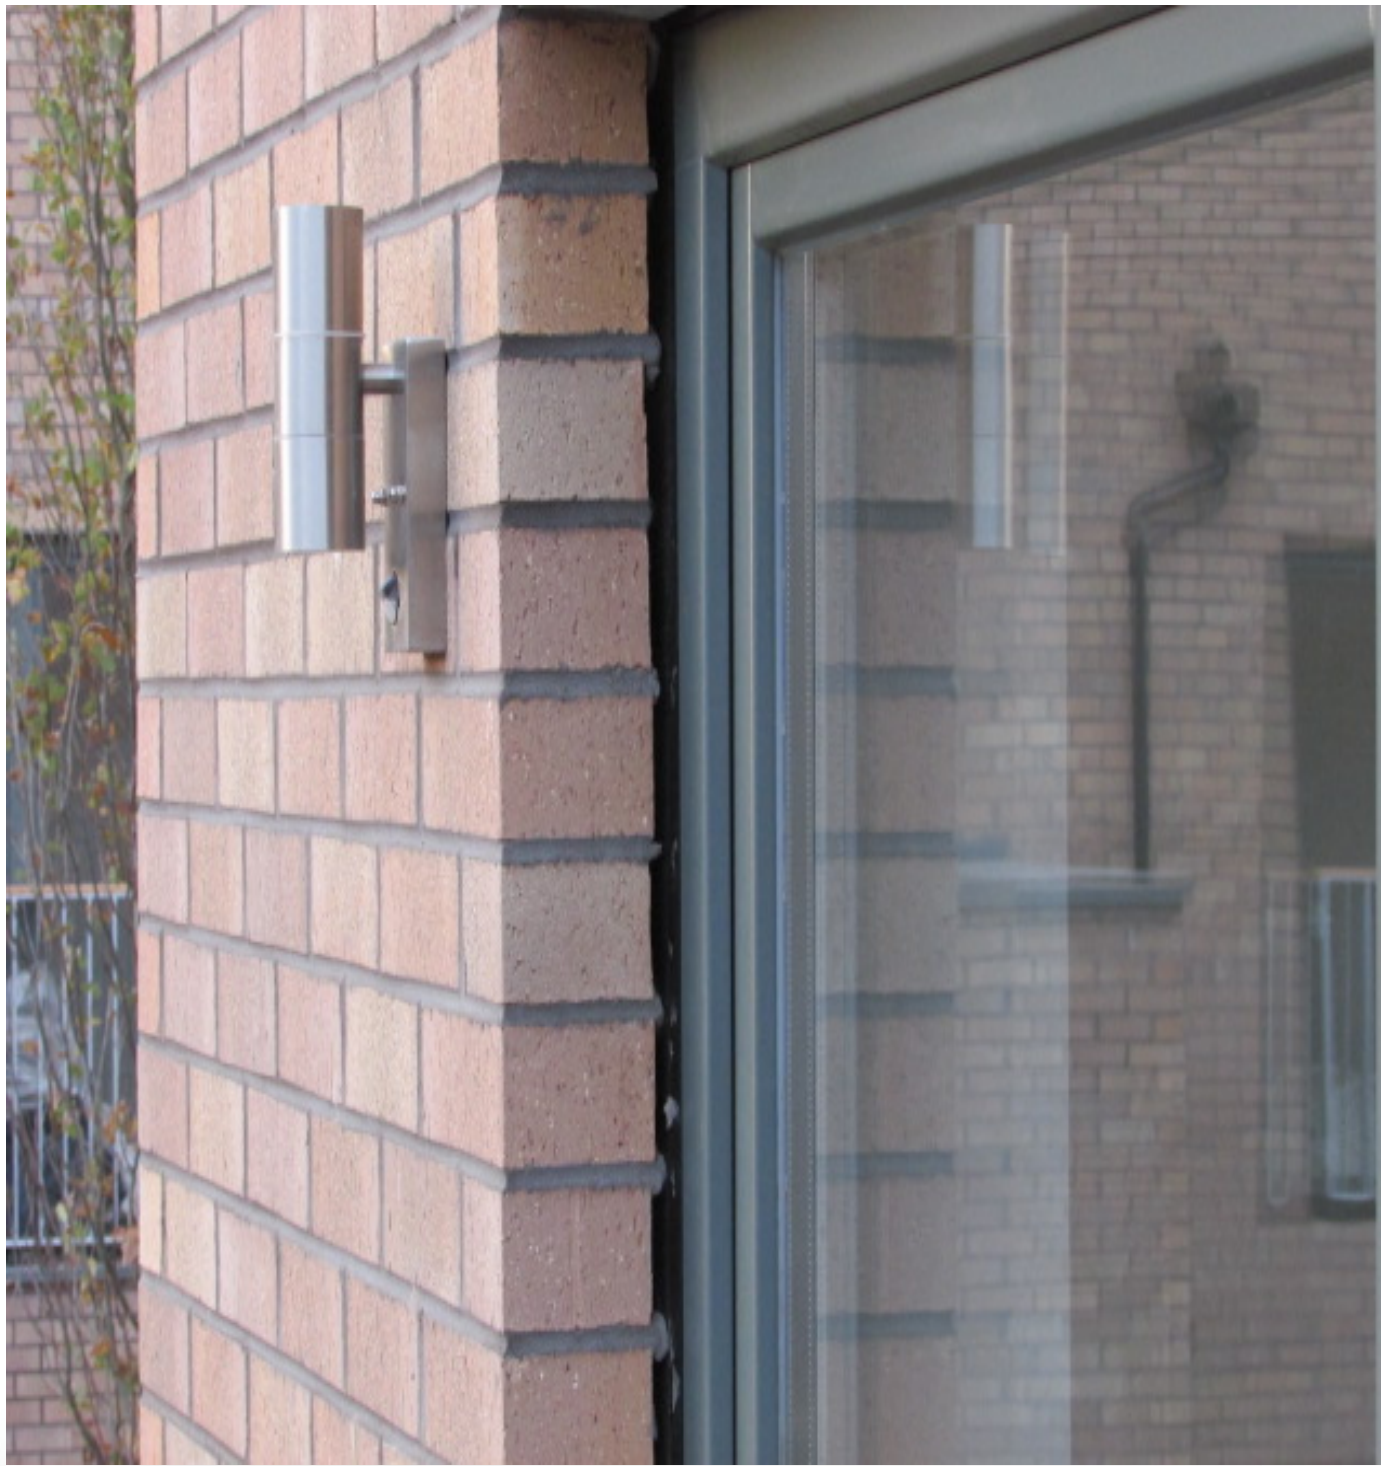
- No drainage trays fitted to sloping driveway carport floor
- Holed and incomplete sealant noted to front elevation windows
- Incomplete seal noted to front elevation window frames

- Mortar cracking noted above front elevation entrance door
- Hole and incomplete seal noted to entrance door and frame joint seal
- Rear elevation by fold door set timber sill damaged and aged

- Mortar cracking noted to by fold door set lintel wall construction
- Rear elevation perpend vents blocked
- Rear elevation wall construction built off line out of plumb line at expansion joint

- Hole and incomplete frame seal to upper floor windows
- Missing lead apron flashing to hopper at rainwater outlets
- Negative water run noted to SANAFILL roof surface leading to gulley rainwater outlet

- Negative water run build up at roof gulley rainwater outlet
- Perimeter metal roof capping loose and insecure fixed
- Balcony SANAFILL upstand raggle seal holed and incomplete

- Missing frame seal to external French door set leading to balcony
- Balcony French door set installed opening inwards instead of outwards

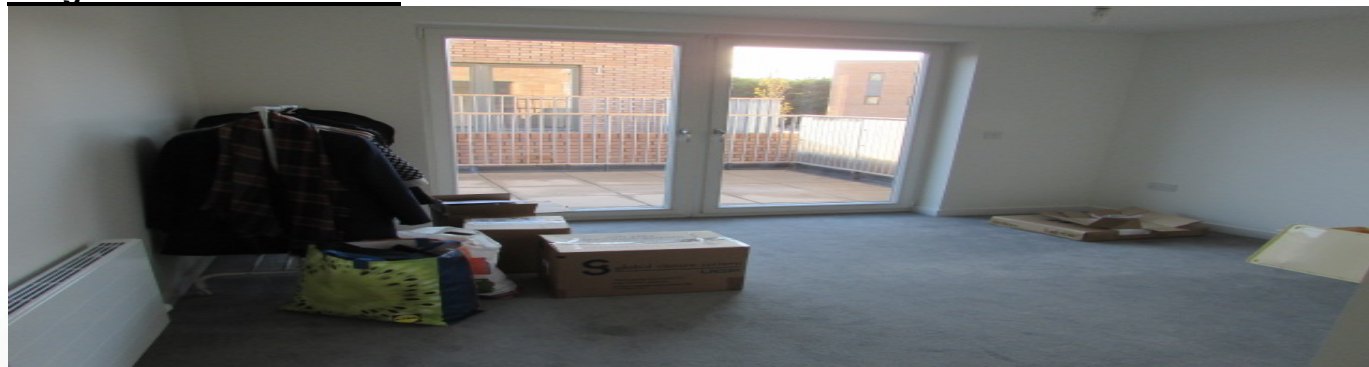
### **Image of Master Bedroom**

- Plaster finish uneven and waved to walls and ceiling
- Wall/ceiling emulsion finish shaded and uneven
- Skirting internal mitres open holed
- Architrave mitres open and insecure fixed
- Window frame seal holed incomplete
- Entrance door opening uneven not in uniform
- Entrance door loose at keeper door chipped at leading edge
- Door stops and frame damaged and Keeper cut out excessive
- Gloss finish to wood work shaded and uneven application
- skirting internal joints butt not mitred
- Radiator secured to wall off level
- Window sill damaged at leading edge off level
- Window damaged at bottom edge
- French door frame butt joint insufficiently sealed
- French door open internally incorrectly
- Right and Left doors catch at bottom edge
- Internal glass seal incomplete holed

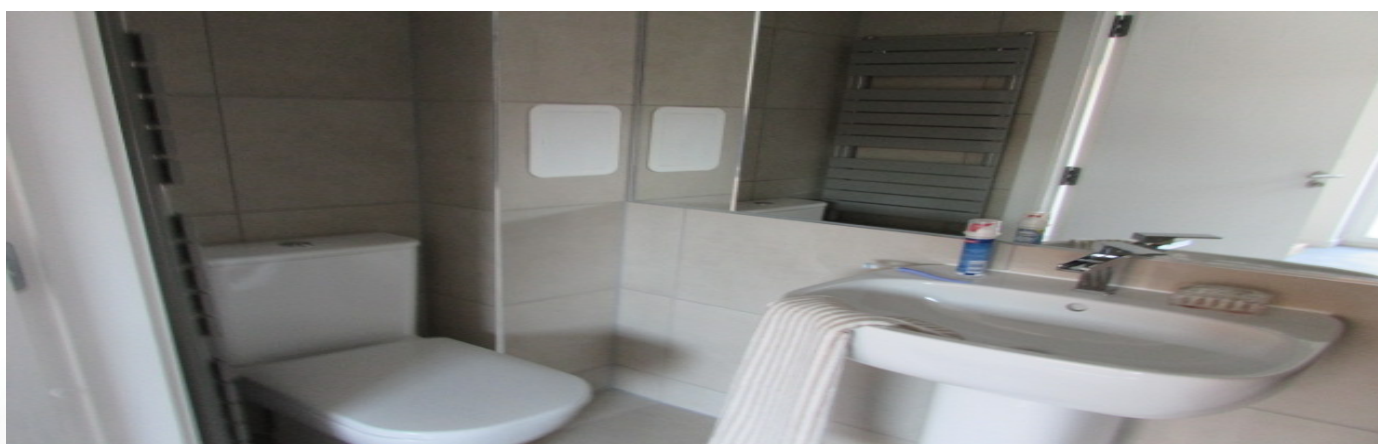
## **Image of En-suite**

- Plaster finish uneven and waved to walls and ceiling
- Wall/ceiling emulsion finish shaded and uneven
- Skirting internal mitres open holed
- Architrave mitres open and insecure fixed
- Entrance door opening uneven not in uniform
- Gloss finish to wood work shaded and uneven application
- Entrance door lock stiff during operation
- Threshold floor bar proud of tile finish
- Perimeter tile seal missing around door post
- No mechanical fixings to pedestal at floor level
- Wall tiles incomplete around pipe work of basin
- Perimeter tile seal incomplete behind wc
- Wall perimeter seal around door holed incomplete
- Down lights proud of ceiling finish
- Excessive hole cuts around towel rail pipes
- No timber supports fitted to shower tray plinth panel
- Pedestal damaged close to basin
- Light box upper seal holed incomplete

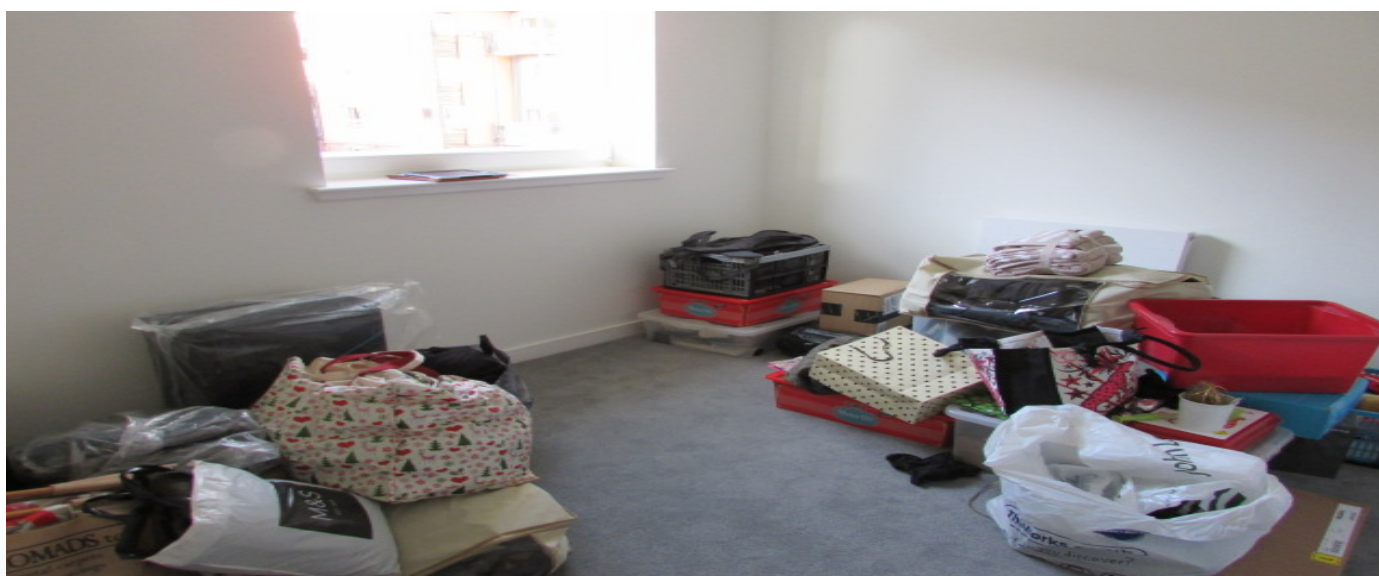
## **Image of Bedroom 2**

- Plaster uneven and waved to walls and ceiling
- Wall/ceiling emulsion finish shaded and uneven
- Skirting internal mitres open holed
- Architrave mitres open and insecure fixed
- Window frame seal holed incomplete
- Entrance door opening uneven not in uniform
- Gloss finish to wood work shaded and uneven application
- skirting butt jointed instead of mitre
- Entrance door loose at keeper
- Entrance door keeper cut excessive
- Window stiff during operation and catches at bottom opening
- Radiator not level
- Door closer cut out excessive

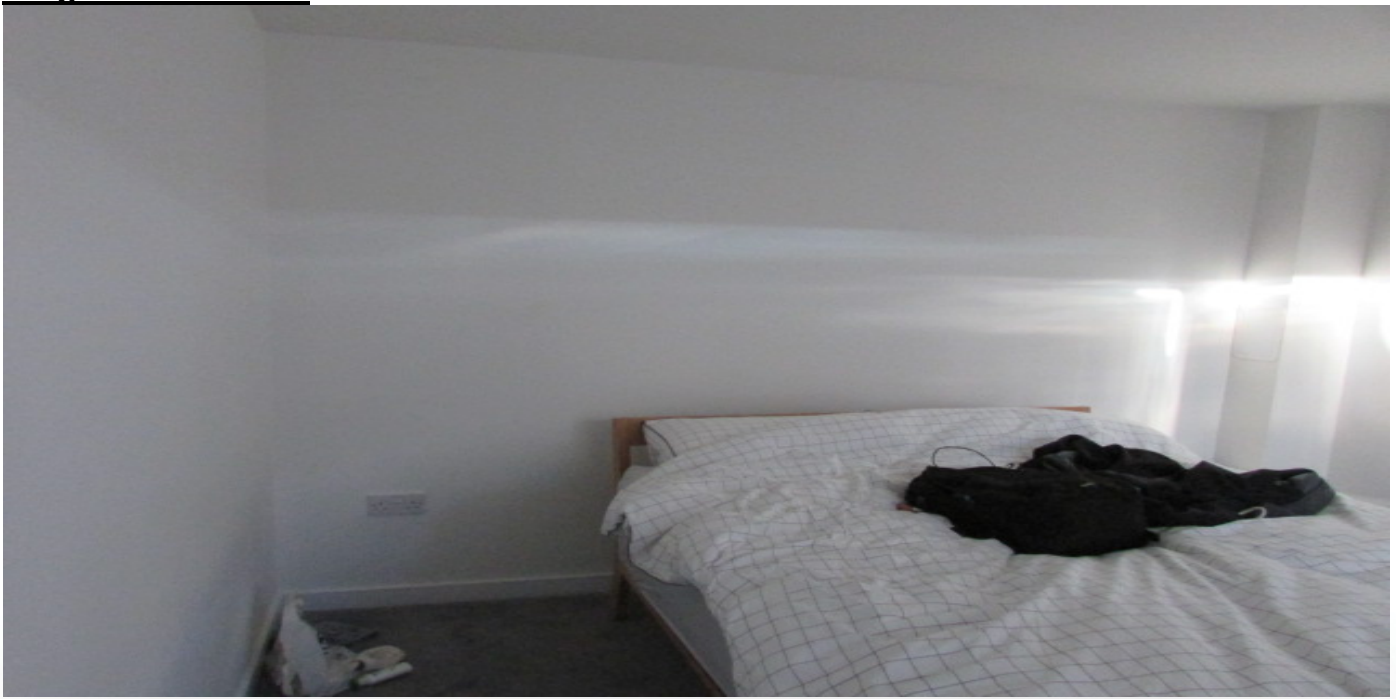
### **Image of Bedroom 3**

- Plaster finish uneven and waved to walls and ceiling
- Wall/ceiling emulsion finish shaded and uneven
- Skirting internal mitres open holed
- Architrave mitres open and insecure fixed
- Window frame seal holed incomplete
- Entrance door opening uneven not in uniform
- Gloss finish to wood work shaded and uneven application
- Entrance door keeper cut out excessive
- Entrance door closer cut out excessive
- Right window hinge cap missing
- Skirting butt jointed instead of mitre

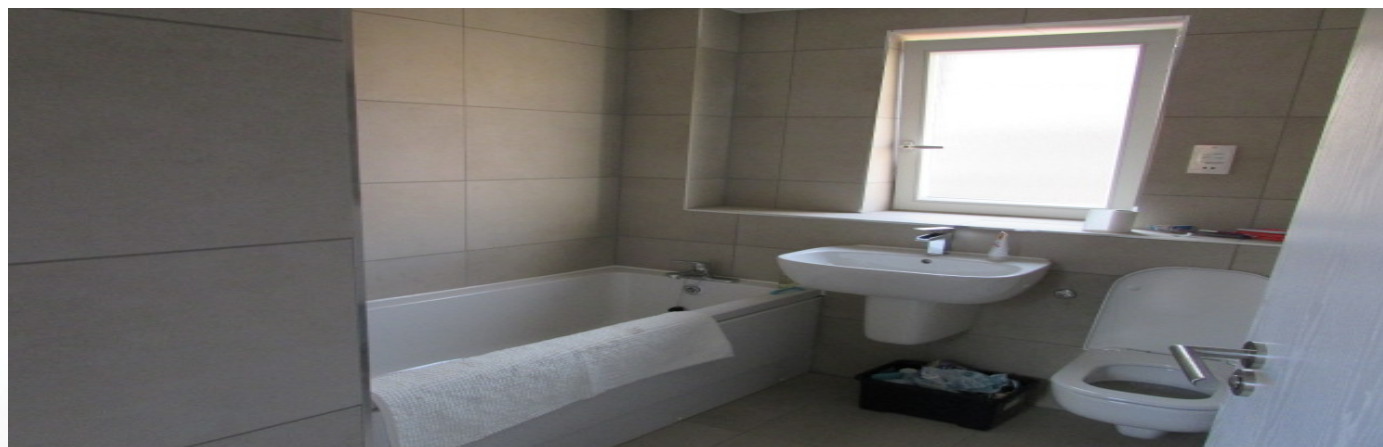
## **Image of Bathroom**

- Plaster finish uneven and waved to walls and ceiling
- Wall/ceiling emulsion finish shaded and uneven
- Skirting internal mitres open holed
- Architrave mitres open and insecure fixed
- Window frame seal holed incomplete
- Entrance door opening uneven not in uniform keeper cut excessive silicon
- Gloss finish to wood work shaded and uneven application
- Threshold proud of floor finish
- Entrance door damaged at upper edge loose at keeper
- Bulkhead tile sil seal incomplete
- Bath panel insecure fixed with no supports
- Bath seal incomplete at corner joints
- Excessive tile hole cuts at towel rail pipes
- Towel rail off plumb
- Window seal incomplete behind hinges
- Window catches at bottom opening
- Basin tap loose
- Downlights proud of ceiling

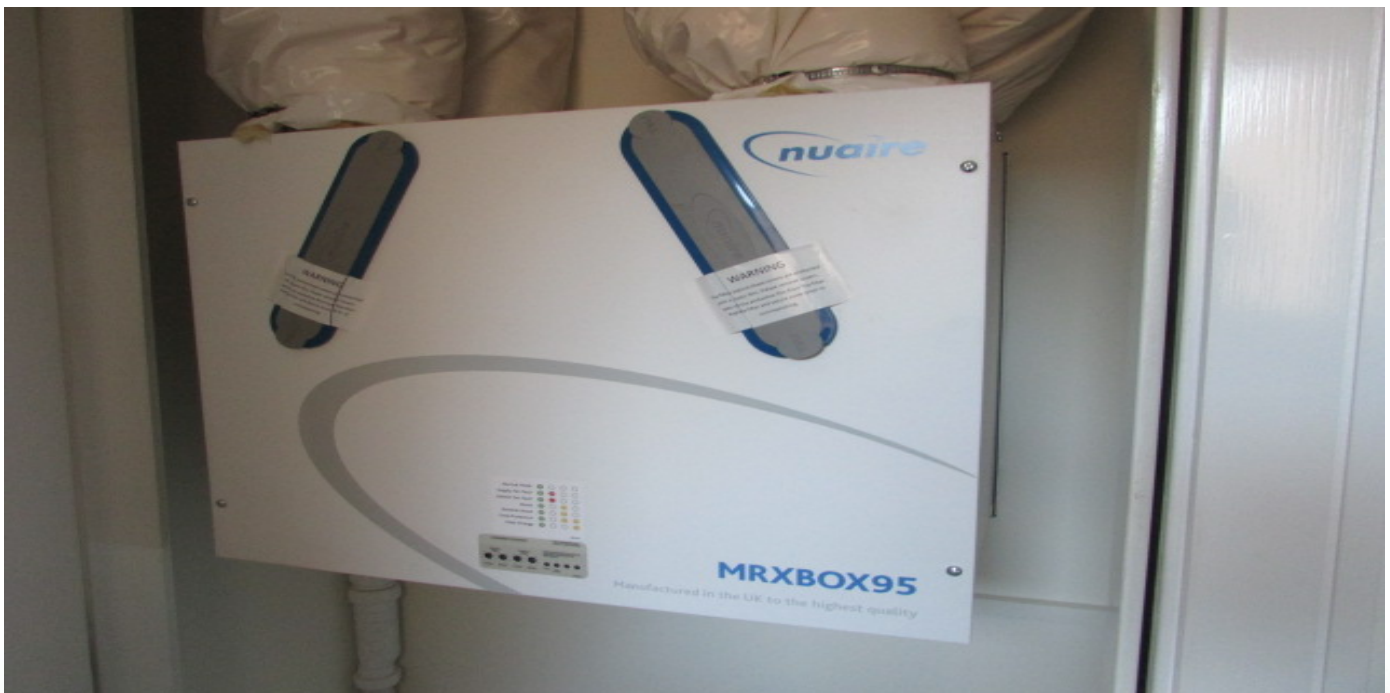
## **Image of Cupboard**

- Plaster uneven and waved to walls and ceiling
- Wall/ceiling emulsion finish shaded and uneven
- Skirting internal mitres open holed
- Architrave mitres open and insecure fixed
- Entrance door opening uneven not in uniform
- Gloss finish to wood work shaded incomplete
- Air conditioning unit pipe work incorrectly installed
