# ***SNAGGING*** ***SURVEY***

**Address:** XX XXXXX XXXXXXXX XXXXXXXXXX, EDINBURGH, EH7 5EU

**Purpose of Report:** NEW BUILD SNAGGING

**Inspection Date:** 4<sup>th</sup> November 2016

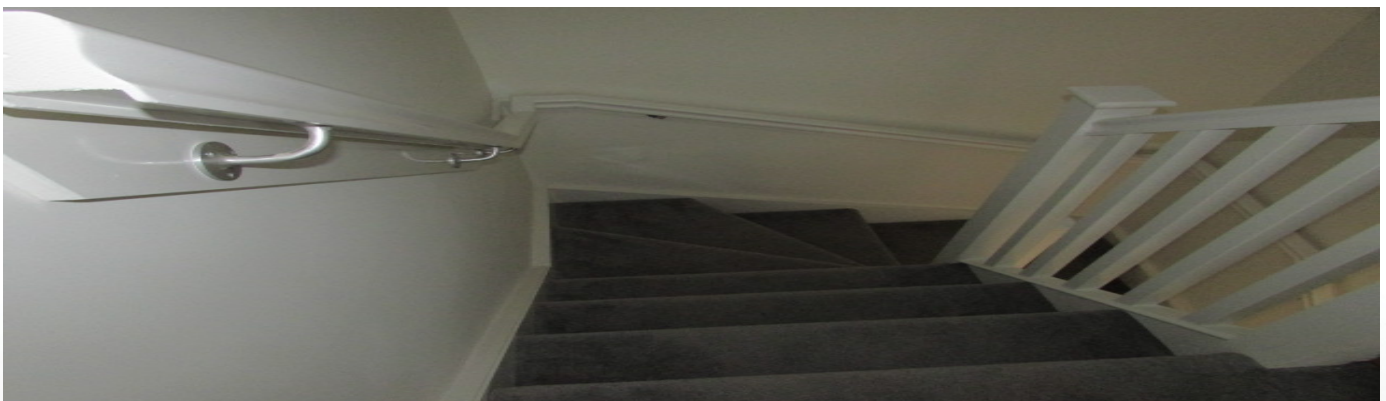
## **Image of HSL**

- Plaster finish uneven and waved to walls and ceiling
- Wall/ceiling emulsion finish shaded and uneven
- Skirting internal mitres open holed
- Architrave mitres open and insecure fixed
- Window frame seal holed incomplete
- Entrance door opening uneven not in uniform
- Gloss finish to wood work shaded and uneven application
- Radiator off level and damaged at corner
- Window catches at bottom opening
- Window seal cracked holed
- Riser facing cracked
- Handrail fixing plates open at joints
- Cracked open joint a newel post riser joint
- Skirting joints open at base of stair riser and damaged
- Entrance door opening uneven
- Sockets secured to wall off line
- Entrance door letter plate damaged internal upper edge
- Downlights proud of ceiling finish

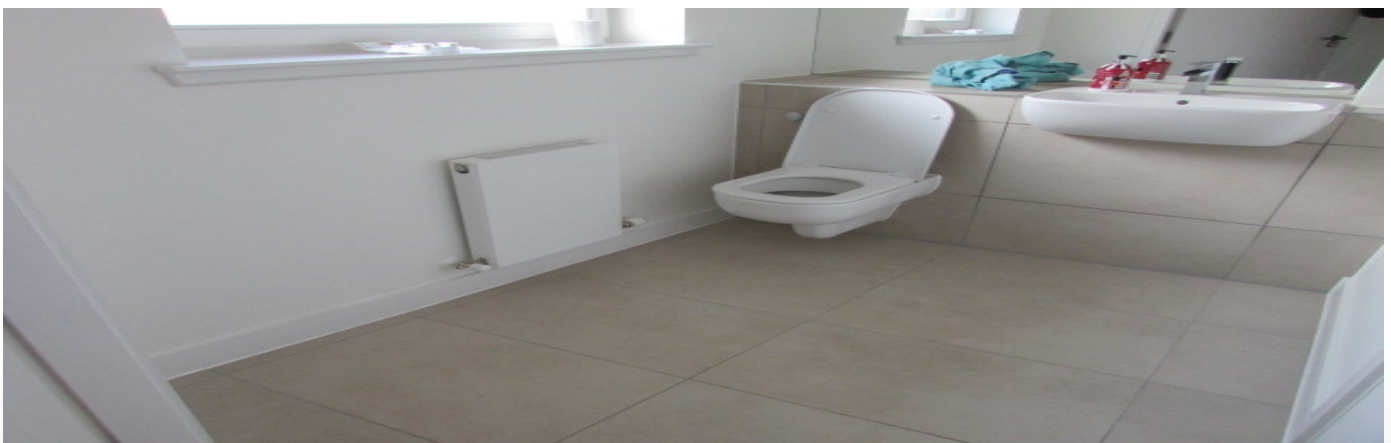
## **Image of Toilet**

- Plaster finish uneven and waved to walls and ceiling
- Wall/ceiling emulsion finish shaded and uneven
- Skirting internal mitres open holed
- Architrave mitres open and insecure fixed
- Window frame seal holed incomplete
- Entrance door opening uneven not in uniform
- Gloss finish to wood work shaded and uneven application
- Downlights proud of finish
- Entrance door damaged at upper edge Loose at keeper
- Entrance door keeper cut out excessive back plate missing
- Skirting butt jointed instead of mitre
- Bulkhead seal uneven holed incomplete
- Floor tile perimeter seal incomplete at door posts
- Radiator secured to wall off level
- Entrance door to meter cupboard damage chipped above handle side
- Window perimeter seal same
- Window stiff and catches
- Entrance door stop damaged on internal hinge side bottom

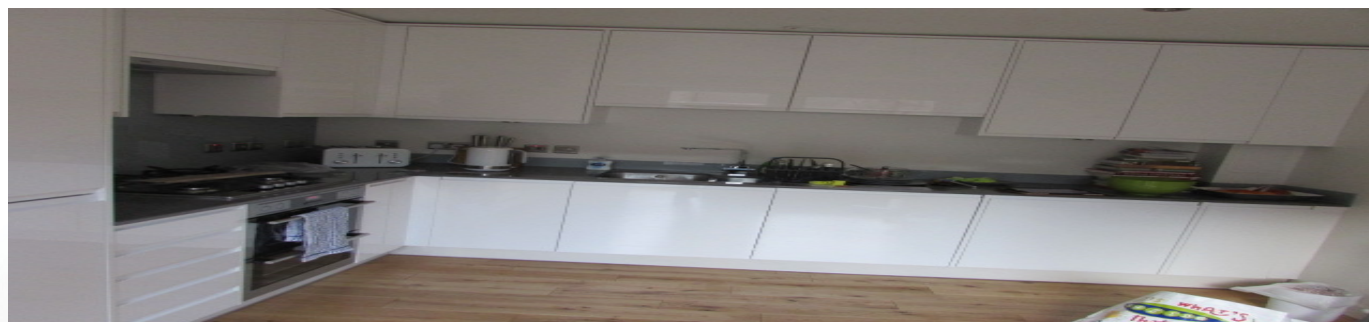
## **Image of Kitchen/Central Heating Cupboard**

- Plaster finish uneven and waved to walls and ceiling
- Wall/ceiling emulsion finish shaded and uneven
- Skirting internal mitres open holed
- Architrave mitres open and insecure fixed
- Window frame seal holed incomplete
- Entrance door opening uneven not in uniform
- Gloss finish to wood work shaded and uneven application
- Base wall unit doors not uniform
- Entrance door keeper cut out excessive
- Cooker hood door catches on opening edge
- Downlights proud of ceiling finish
- Upper cornice chipped at right wall edge
- Sink base shelf missing
- Hob seal holed at front edge
- Drawers stiff during operation
- Plinths loose insecure fixed and short at joint and skirting butt
- French door internal glass seal holed
- Left door jams during operation
- Perimeter seal holed

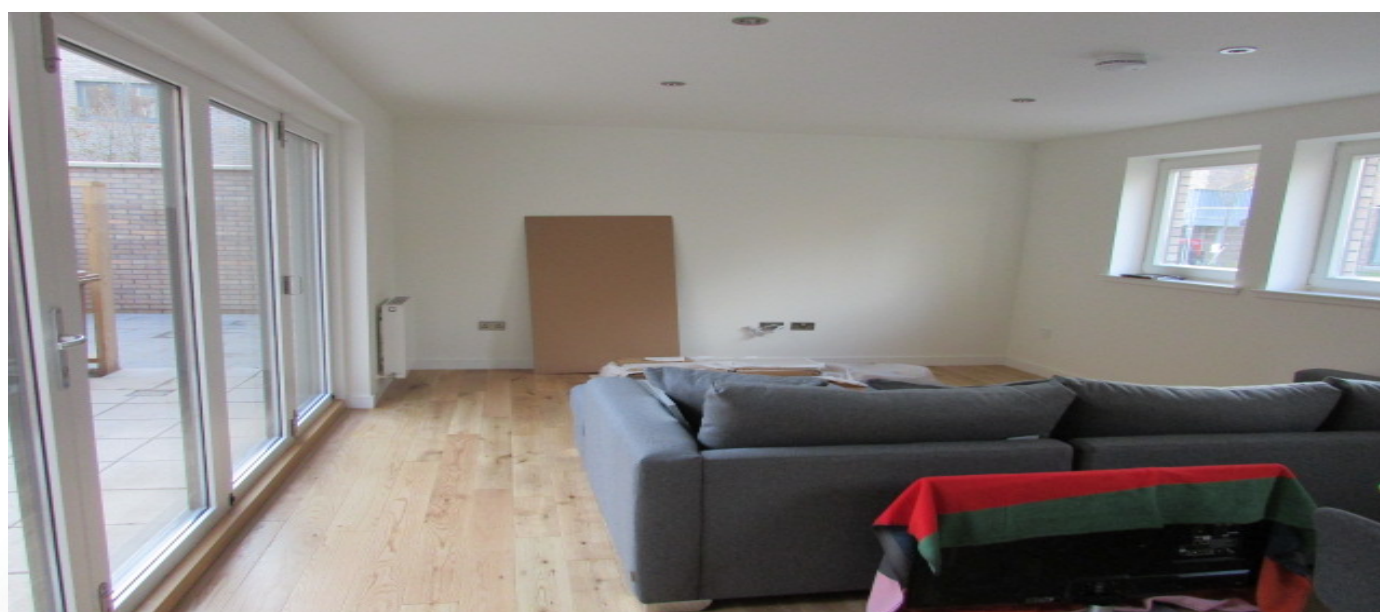
## **Image of Main Lounge**

- Plaster finish uneven and waved to walls and ceiling
- Wall/ceiling emulsion finish shaded and uneven
- Skirting internal mitres open holed
- Architrave mitres open and insecure fixed
- Window frame seal holed incomplete
- Entrance door opening uneven not in uniform
- Gloss finish to wood work shaded and uneven application
- Left radiator secured to wall off level
- Down lights proud of finish
- Entrance door keeper cut out excessive
- Left window sil holed
- Left window glass seal holed incomplete
- Window frame seal holed and cracked
