INFRARED **SURVEY**

Client Name: XXXX XXXXX
Address: XXXX XXXX. XXXXXX
XXXX XXXXXXXXXXXXX
XXXXXXXXXXXXXX
XXXXXXXXXXXXXX
XXX XXX
Purpose of Report: BUILDING HEAT LOSS QUALITATIVE INFRARED ANALISYS
Report Reference: IAS/MXF/XXXX
Inspection Date: 22 Jan 2023
Surveyor Name: Philip Milne ISO 18436-7 & BINDT CM/GEN
Thermographer Name: Philip Milne ISO 18436-7 & BINDT CM/GEN
Average Ambient Temperature: 46.4 Fahrenheit
Imager Used: FLIR CX3

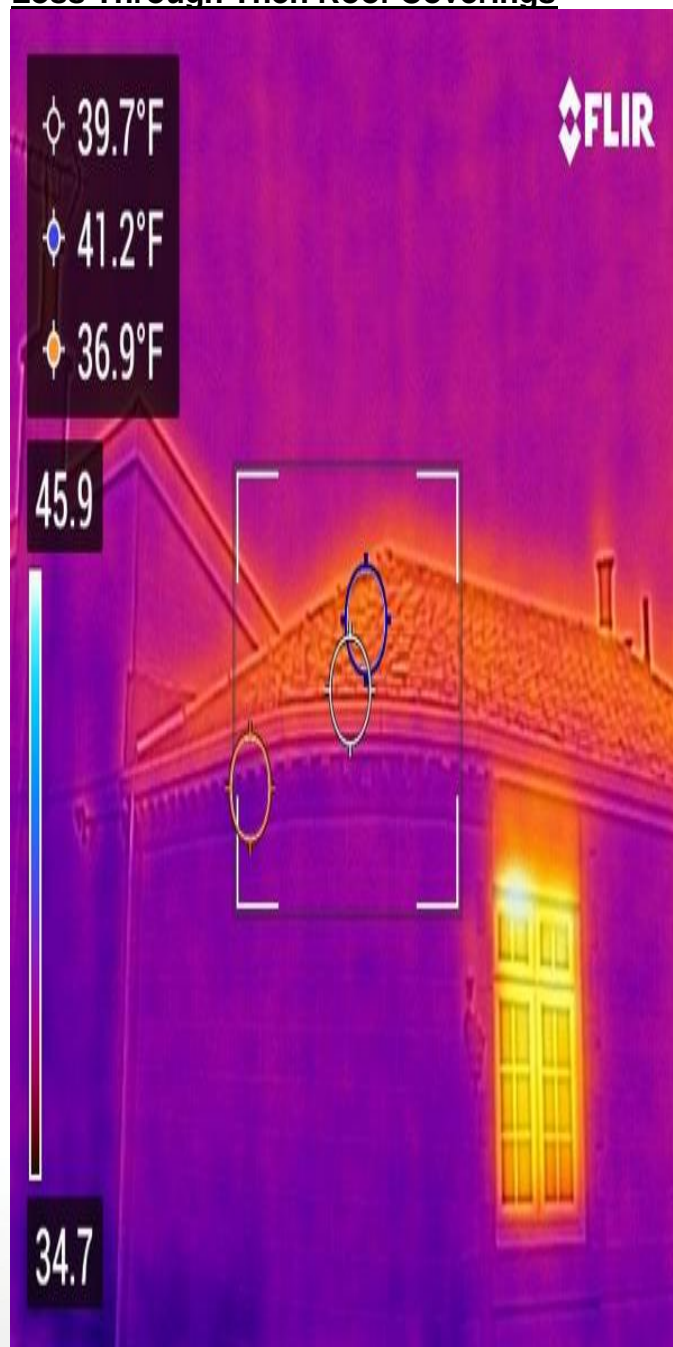
Thermal Image Shows High Levels Of Heat Loss Through Then Roof Coverings

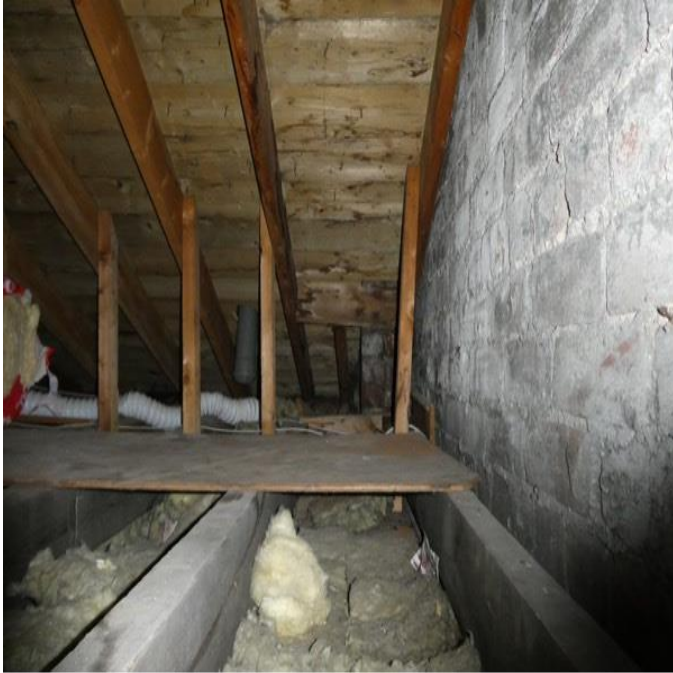
Insufficient Insulation Detected Within The Roof Void

- Inspection within the loft space has found thermal anomalies in loft space area at the time of survey, inspection revealed missing and insufficient insulation material within the ceiling ties resulting in significant heat loss through the room ceilings exiting through the roof coverings.

- Consideration should therefore be given to ensuring that the wool insulation material has an even distribution level of 300mm depth to meet with current building regulation standards.

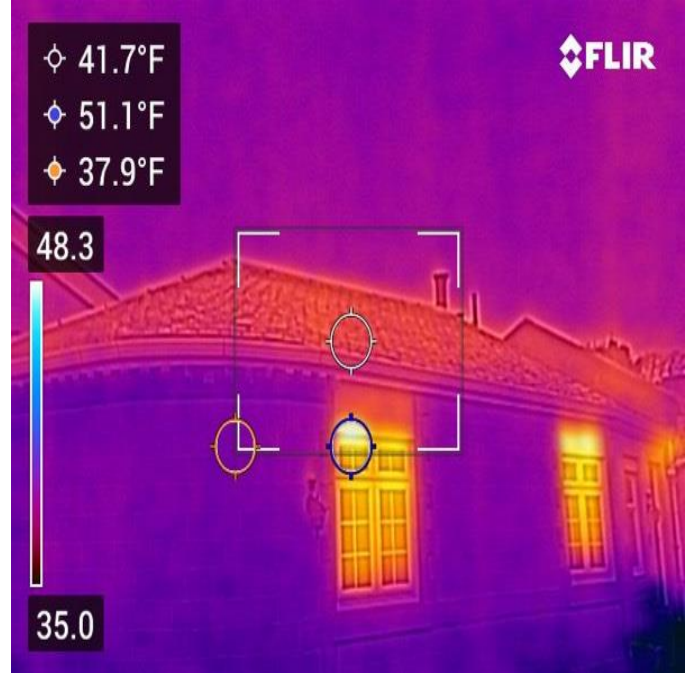
Thermal Image Shows High Levels Of Heat Loss Through The Roof Covering

- A Thermal image inspection of the roof covering revealed high levels of thermal heat loss emissivity to the roof area inspected suggesting missing or insufficient insulating materials, these will require improvement to meet with current building regulations.

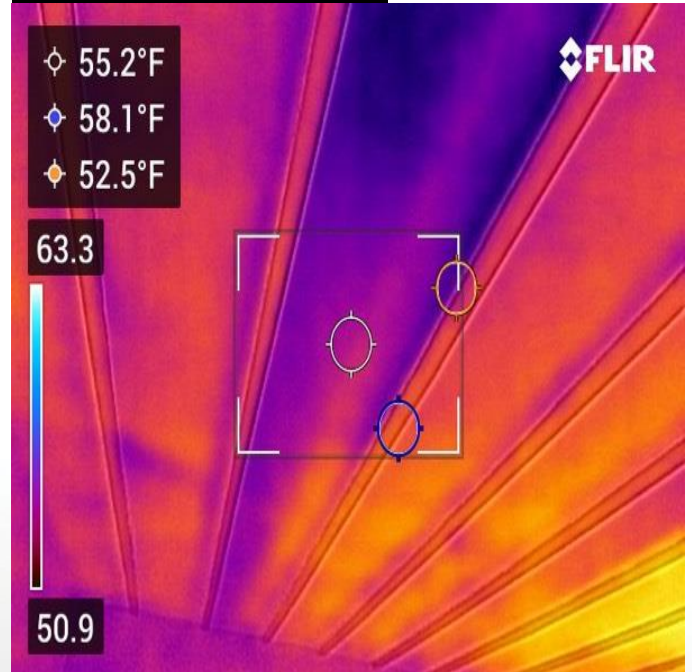
Vaulted Ceiling In Lounge Shows Missing Or Inadequate Insulation

- Inspection of the window frame revealed decay and distortion to the timber construction window frames due to age.
- Thermal images show missing or insufficient insulation to the vaulted ceiling area confirmed by large areas of cold spots detected, recommend that the ceiling is over boarded with the introduction of a 50-75mm Celotex insulation PIR board to enhance the room energy efficiency and increase warm air retention.

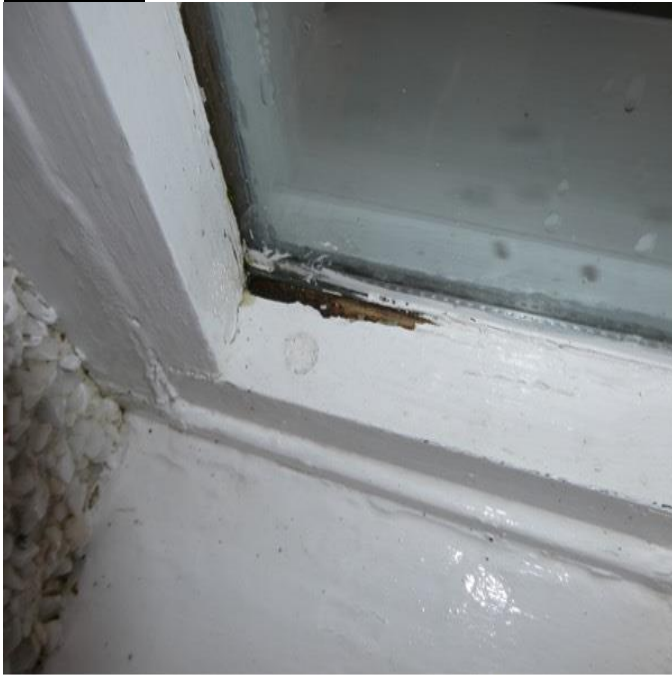
Severe Decay Detected To Lounge Timber Windows

- Inspection of the window and door frames revealed decay and distortion to the timber construction window and door frames due to age.
- Recommend the window frames/seals are replacement or upgraded to a more thermally efficient grade with cam mechanism adjustments carried out mitigate the Heat Loss and create an enhanced compressed seal to all window and door opens to reduce excessive energy loss through the building envelope.

- Consideration should also be given to the replacement of the existing timber construction windows and doors to a modern thermally efficient UPVC high performance secure locking system to enhance the energy efficiency of the building envelope.

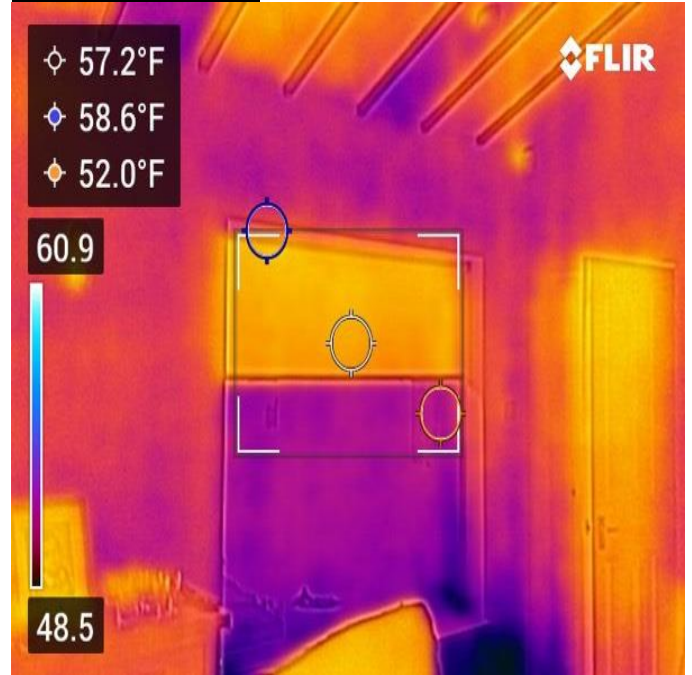
High Levels Of Heat Loss Detected To Lounge Window

- Inspection however has revealed excessive energy loss emissivity around the window and door openings, the dominant cause of break down is confirmed to be resultant from distortion of the UPVC window frame opening sashes, inefficient window seals with holed and missing mortar and mastic seal detected to the frame perimeters at the reveal abutment.

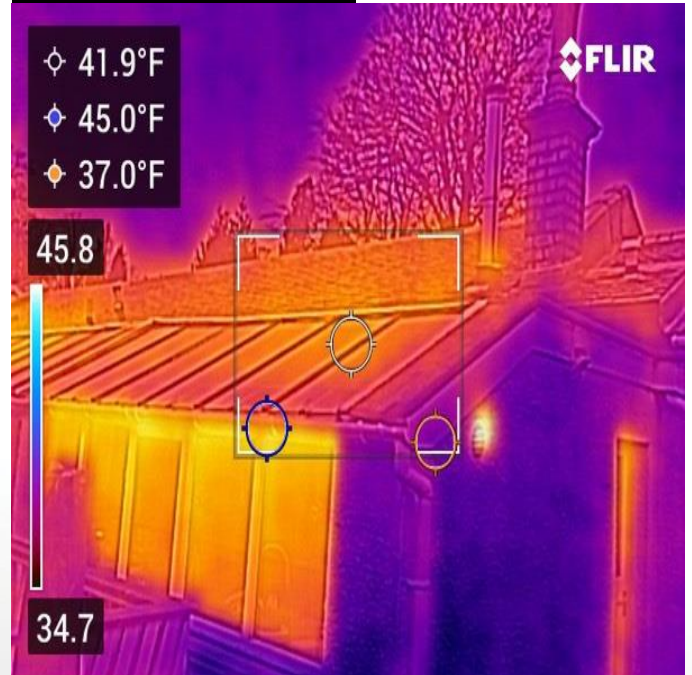
High Levels Of Heat Loss Detected To The Kitchen Glazed Panels

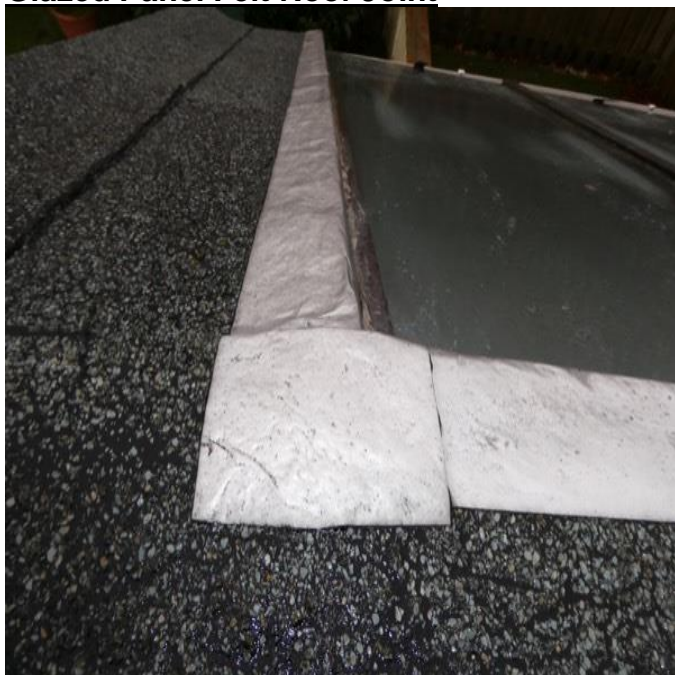
**Aqua Seal Tape Detected To The Kitchen
Glazed Panel Felt Roof Joint**

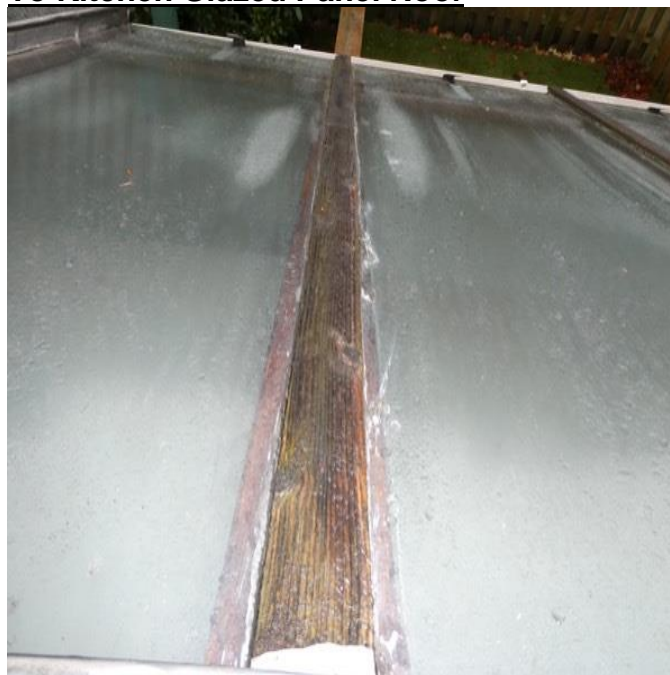
**Exposed Timber Roof Bar Joints Detected
To Kitchen Glazed Panel Roof**

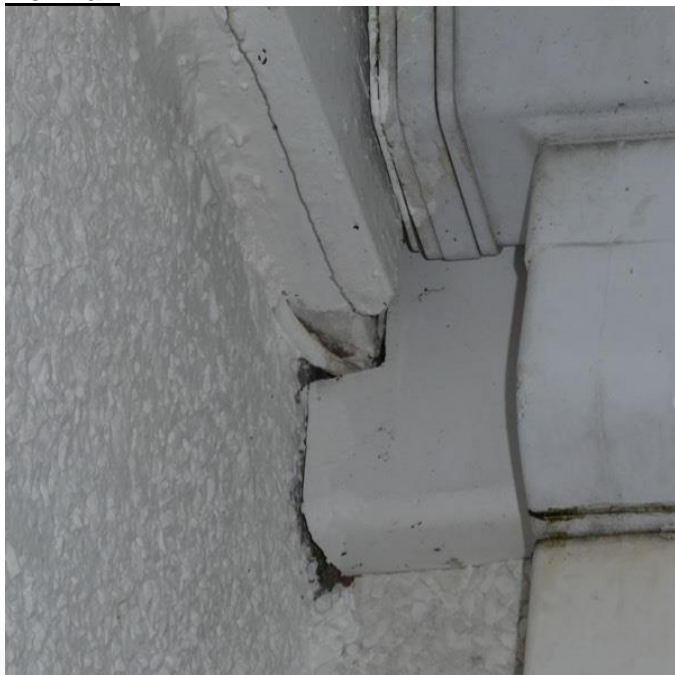
**Unsealed And Open Facia Abutment Joint
To Wall**

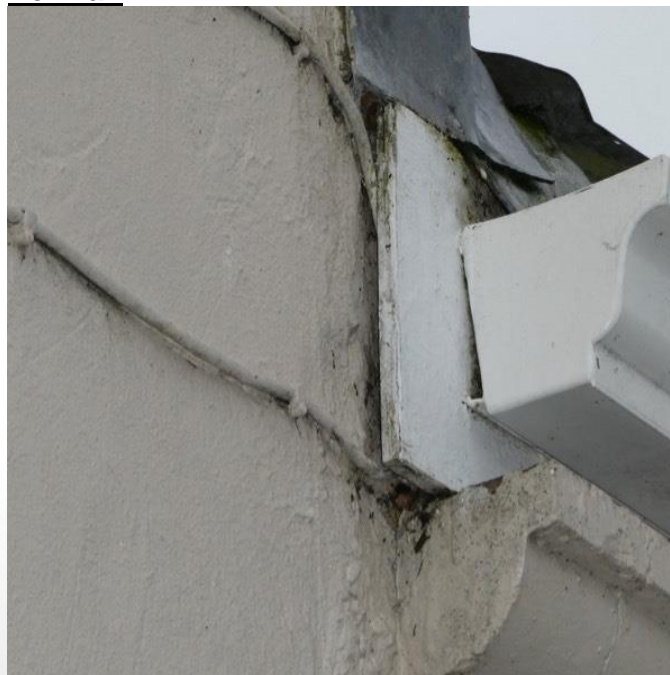
**Unsealed And Open Facia Abutment Joint
To Wall**

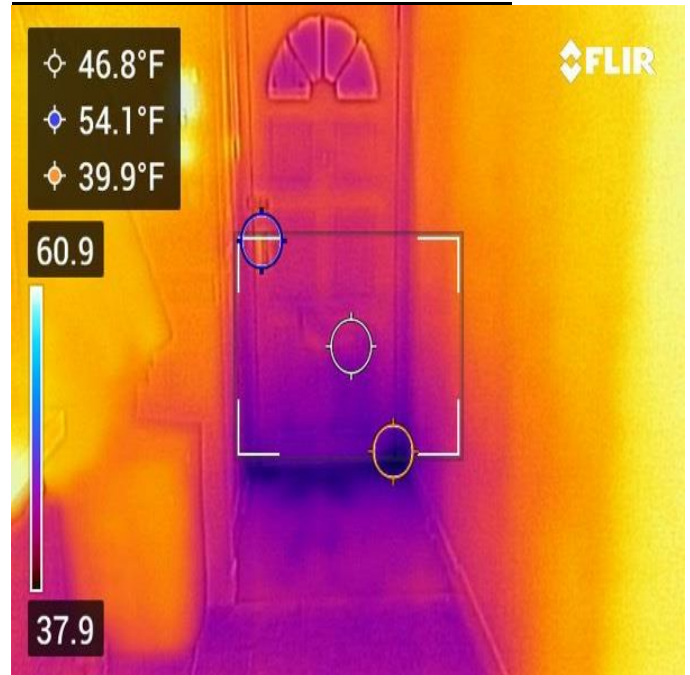
High Levels Of Air Filtration Detected To The Base Of The Door Threshold

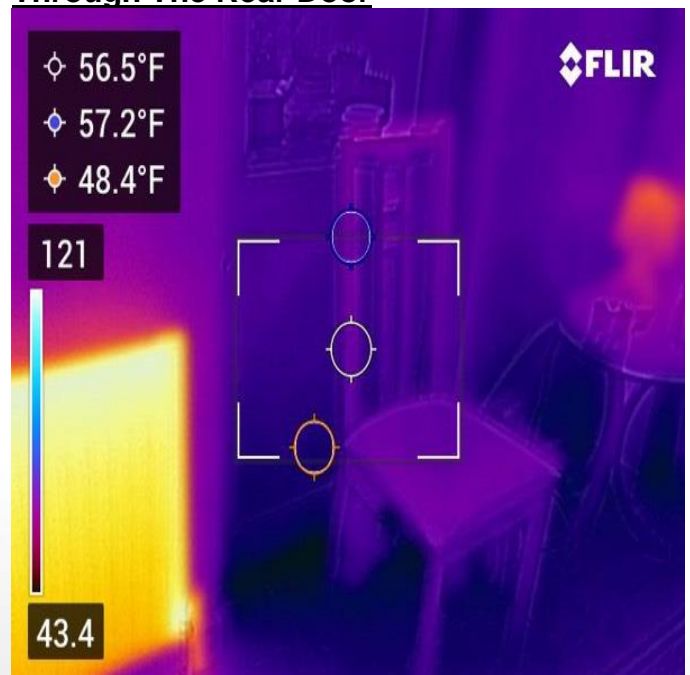
High Levels Of Air Filtration Detected Through The Rear Door

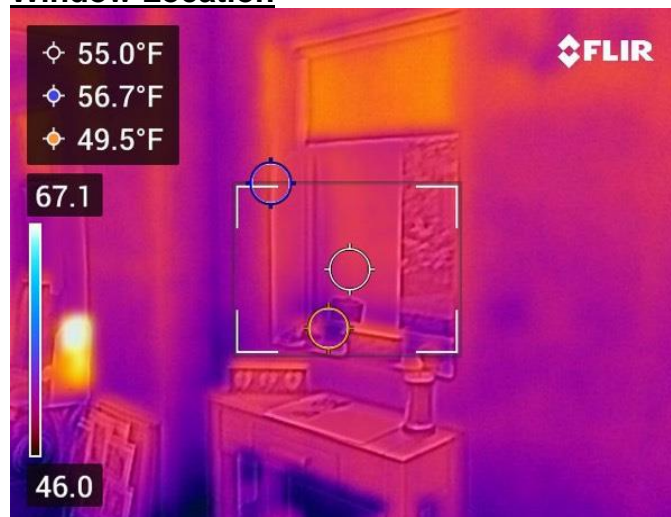
High Levels Of Air Filtration Around The Window Location

- Inspection revealed excessive energy loss emissivity around the window and door openings, the dominant cause of break down is confirmed to be resultant from distortion of the window frame opening sashes, inefficient window seals with holed and missing mortar and mastic seal detected to the frame perimeters at the reveal abutment.

- Inspection of the door frames revealed decay and distortion to the timber construction door frames due to age.
- Recommend the window frames/seals are replacement or upgraded to a more thermally efficient grade with cam mechanism adjustments carried out mitigate the Heat Loss and create an enhanced compressed seal to all window and door opens to reduce excessive energy loss through the building envelope.

- Consideration should also be given to the replacement of the existing timber construction doors to a modern thermally efficient UPVC high performance secure locking system to enhance the energy efficiency of the building envelope.

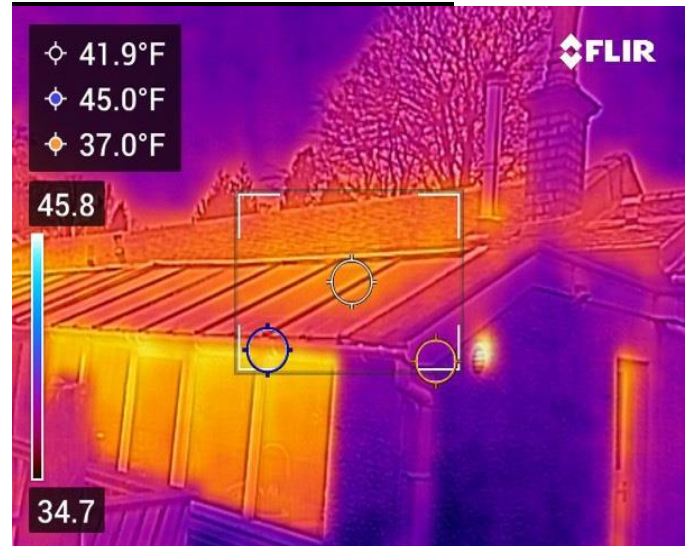
Heat Loss Detected To The Glazed Roof, Windows And Entrance Door

- Inspection revealed excessive energy loss emissivity around the vertical and sloping window and door openings.
- Inspection of the door frames revealed decay and distortion to the timber construction door frames due to age.
- Consideration should also be given to the replacement of the existing timber construction doors to a modern thermally efficient UPVC high performance secure locking system to enhance the energy efficiency of the building envelope.
- Consideration should also be given to replacement of the felt flat roof due to age related decay, this would facilitate the introduction of additional Celotex insulating boards to further enhance the room energy efficiency reducing heat loss significantly

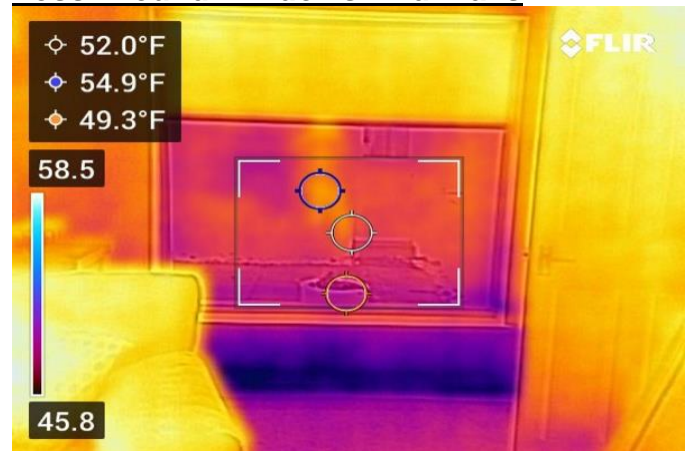
Thermal Image Shows High Levels Of Heat Loss Around Windows And Walls

- Inspection revealed excessive energy loss emissivity around the window and door openings, the dominant cause of break down is confirmed to be resultant from distortion of the window frame opening sashes, inefficient window seals with holed and missing mortar and mastic seal detected to the frame perimeters at the reveal abutment.

- Recommend the window frames/seals are replacement or upgraded to a more thermally efficient grade with cam mechanism adjustments carried out mitigate the Heat Loss and create an enhanced compressed seal to all window and door opens to reduce excessive energy loss through the building envelope.

- Consideration should also be given to the replacement of the existing timber construction window to a modern thermally efficient UPVC high performance secure locking system to enhance the energy efficiency of the building envelope.

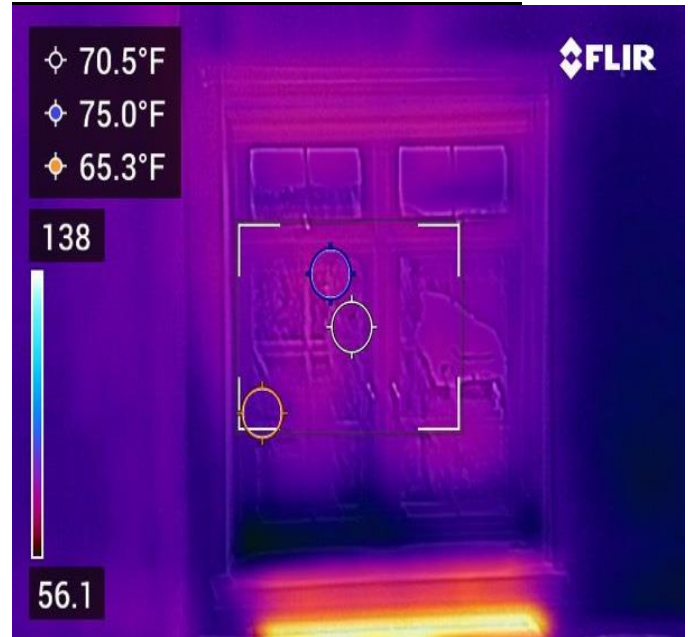
Thermal Image Shows High Levels Of Heat Loss And Excessive Air Filtration

- Inspection revealed excessive energy loss emissivity around the window and opening, the dominant cause of break down is confirmed to be resultant from distortion of the window frame opening sashes, inefficient window seals with holed and missing mortar and mastic seal detected to the frame perimeters at the reveal abutment.

- Thermal images show missing or insufficient insulation to the ceiling area confirmed by large areas of cold spots detected.
- Consideration should therefore be given to ensuring that the wool insulation material has an even distribution level of 300mm depth to meet with current building regulation standards.

- Recommend the window frames/seals are replacement or upgraded to a more thermally efficient grade with cam mechanism adjustments carried out mitigate the Heat Loss and create an enhanced compressed seal to the window sash to reduce excessive energy loss through the building envelope.

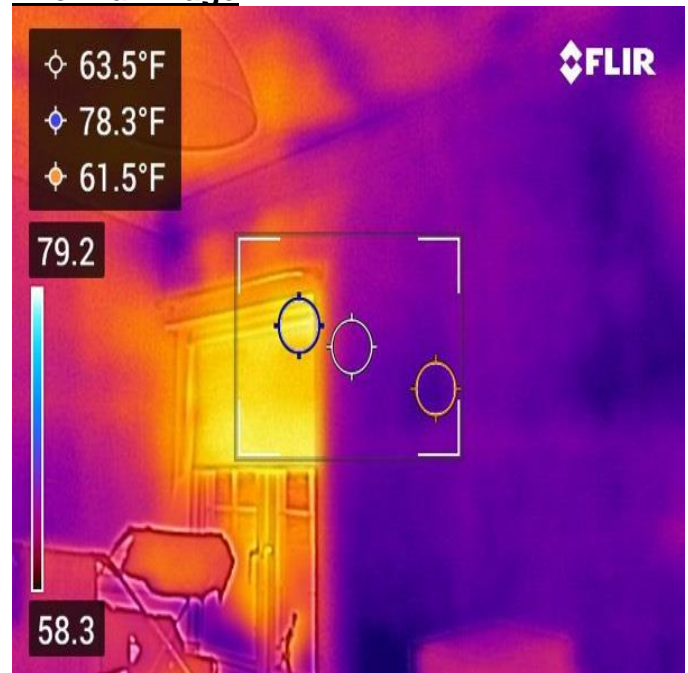
Thermal Image

- Inspection revealed excessive energy loss emissivity around the window and opening, the dominant cause of break down is confirmed to be resultant from distortion of the window frame opening sashes, inefficient window seals with holed and missing mortar and mastic seal detected to the frame perimeters at the reveal abutment.

- Thermal images show missing or insufficient insulation to the ceiling area confirmed by large areas of cold spots detected.
- Consideration should therefore be given to ensuring that the wool insulation material has an even distribution level of 300mm depth to meet with current building regulation standards.

- Recommend the window frames/seals are replacement or upgraded to a more thermally efficient grade with cam mechanism adjustments carried out mitigate the Heat Loss and create an enhanced compressed seal to the window sash to reduce excessive energy loss through the building envelope.

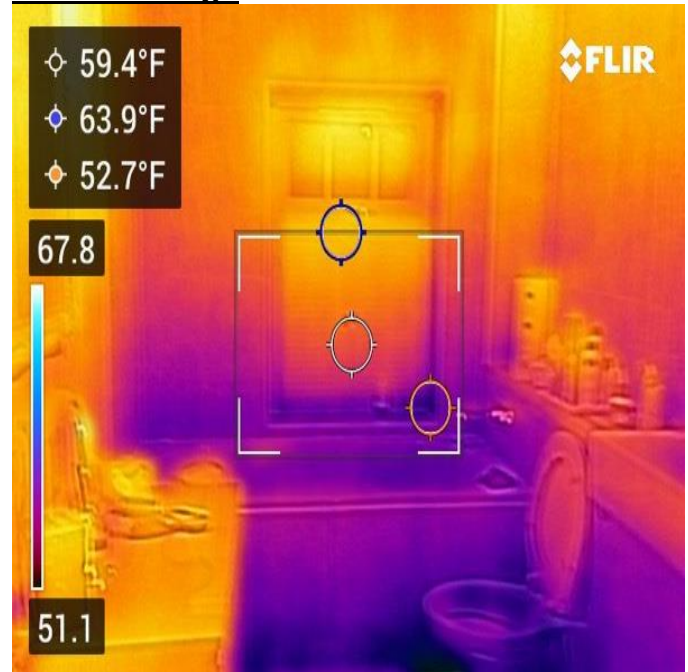
Thermal Image

- Inspection revealed excessive energy loss emissivity around the window and opening, the dominant cause of break down is confirmed to be resultant from distortion of the window frame opening sashes, inefficient window seals with holed and missing mortar and mastic seal detected to the frame perimeters at the reveal abutment.

- Thermal images show missing or insufficient insulation to the ceiling area confirmed by large areas of cold spots detected.
- Consideration should therefore be given to ensuring that the wool insulation material has an even distribution level of 300mm depth to meet with current building regulation standards.

- Recommend the window frames/seals are replacement or upgraded to a more thermally efficient grade with cam mechanism adjustments carried out mitigate the Heat Loss and create an enhanced compressed seal to the window sash to reduce excessive energy loss through the building envelope.
