# **PROPERTY** **SURVEY**

**Address:** 15 XXXXXXXX, XXXXXXXX, XXXXXXXXXXXX, RH12 1QN

**Purpose of Report:** STRUCTURAL BUILDING SURVEY

**Report Reference:** SBS/XXX/2019

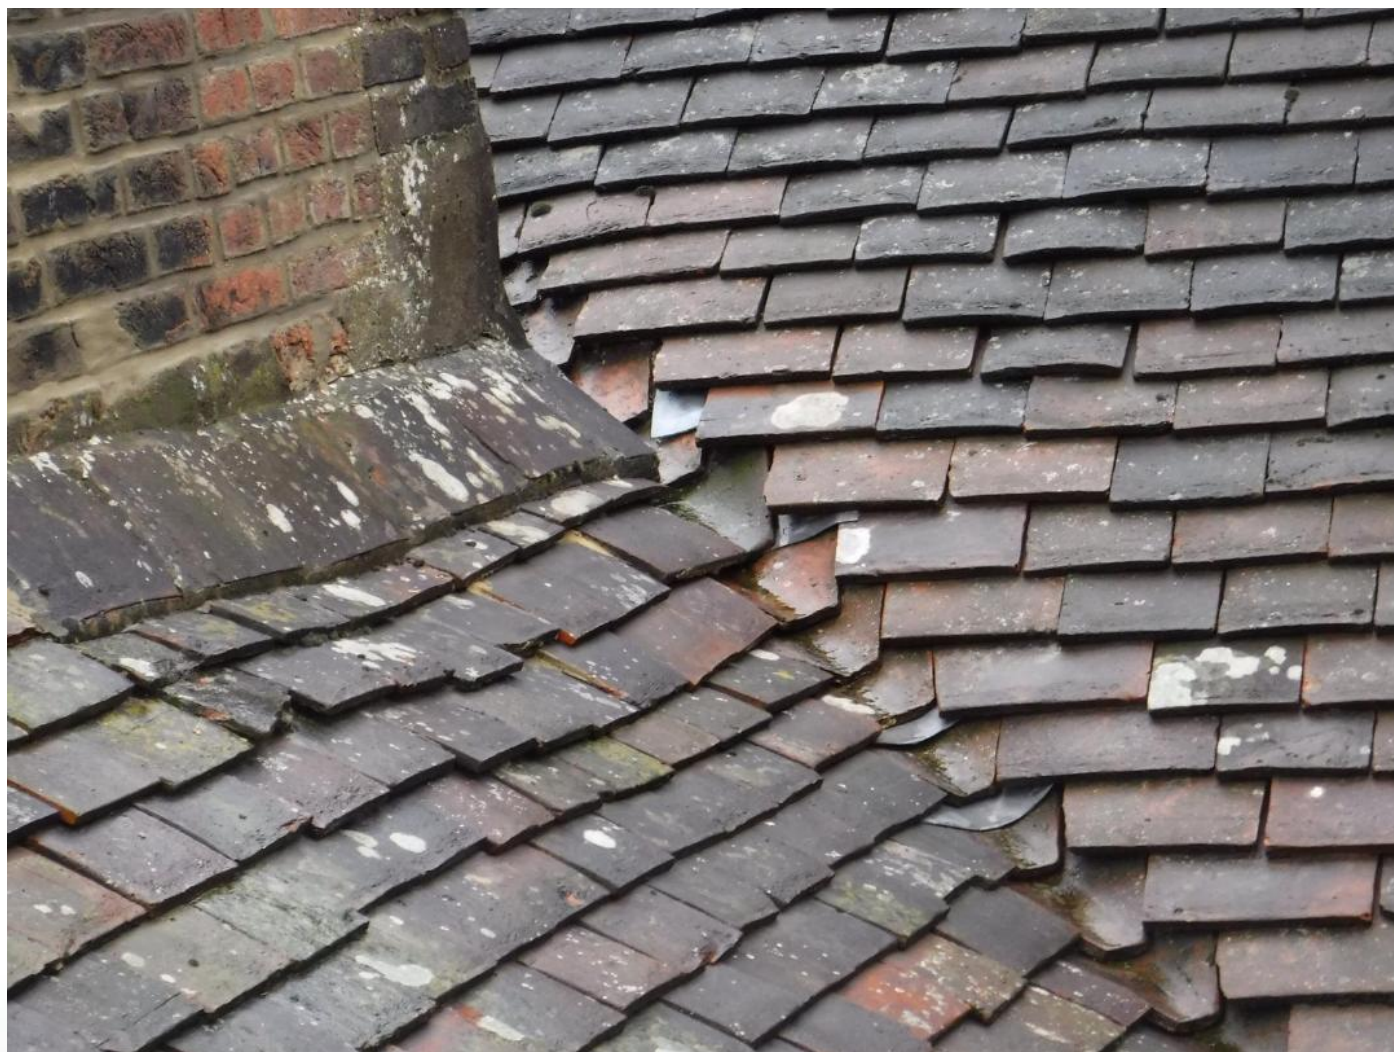
- The main tiled roof covering is in poor condition, there is evidence of some slipped tiles caused by shailing and age related decay,
- deterioration was observed to the verge mortar, and junction adjoining the neighbouring public house,

## Fault Imagery (slipped and deteriorated tile and mortar areas detected)

- Recommend repairs are carried out to the felt batten and ties in several areas with mortar works carried out to the ridge line, neighbouring junction and verge.

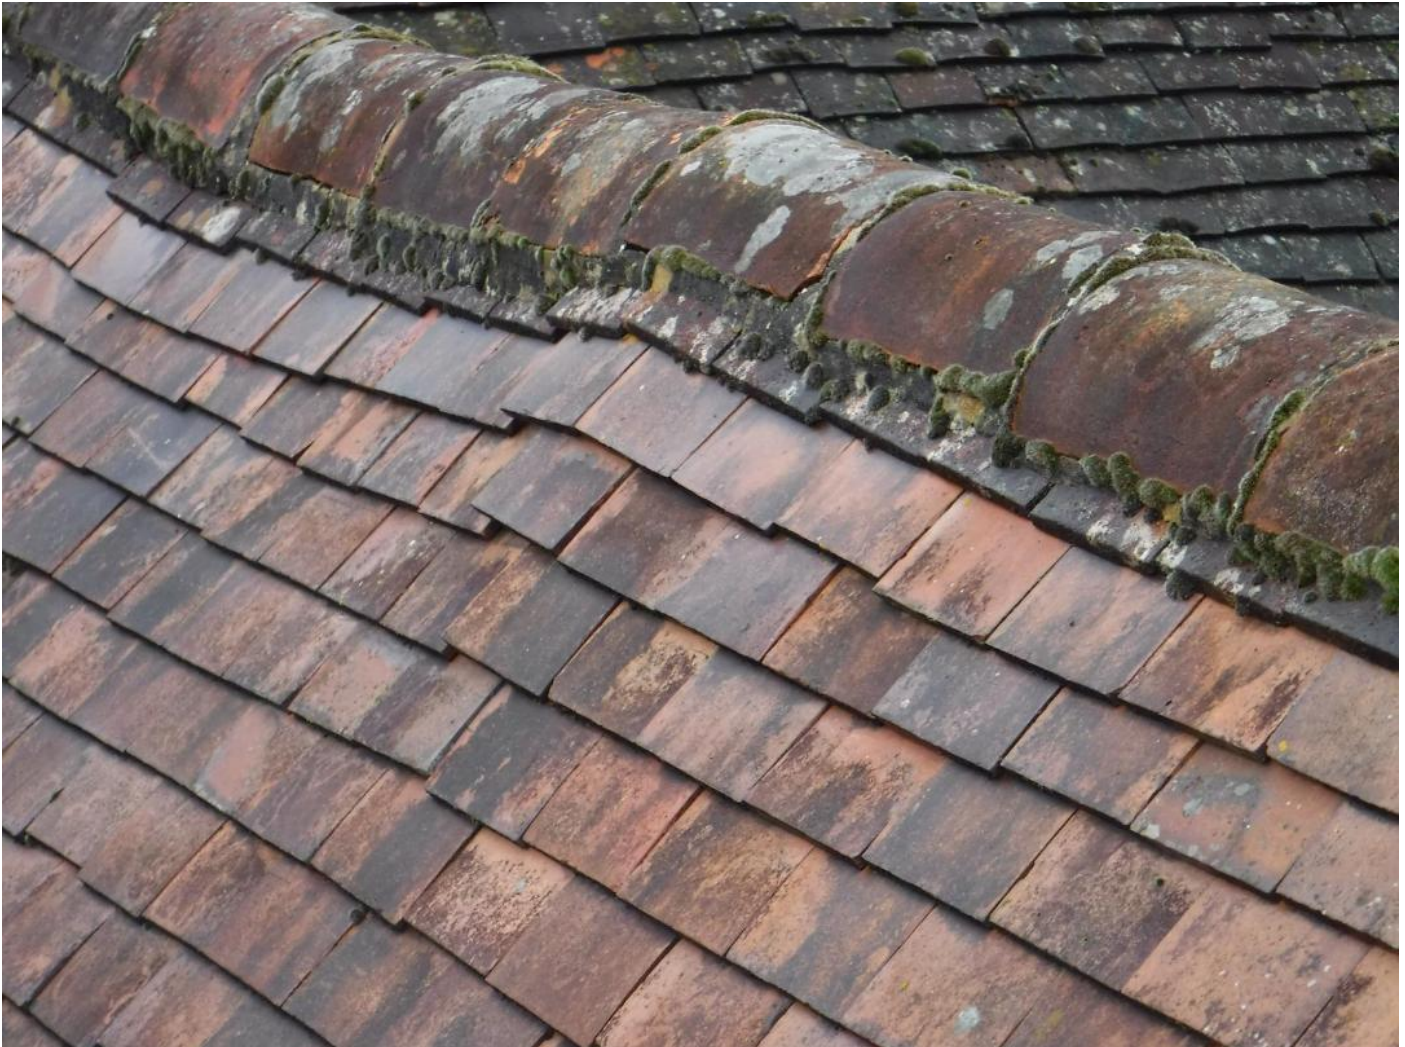
**Fault Imagery (cracked and holed mortar and sagging noted to main roof ridge line)**

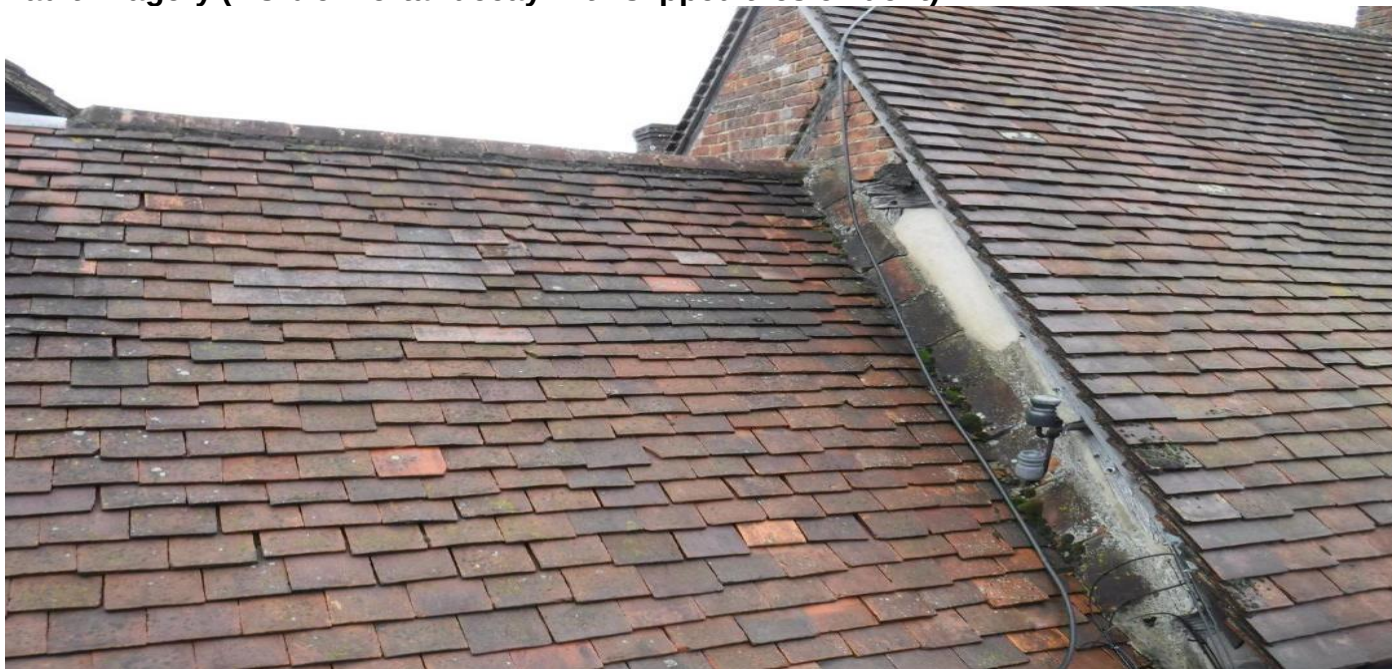
**Fault Imagery (visible mortar decay with slipped tiles evident)**

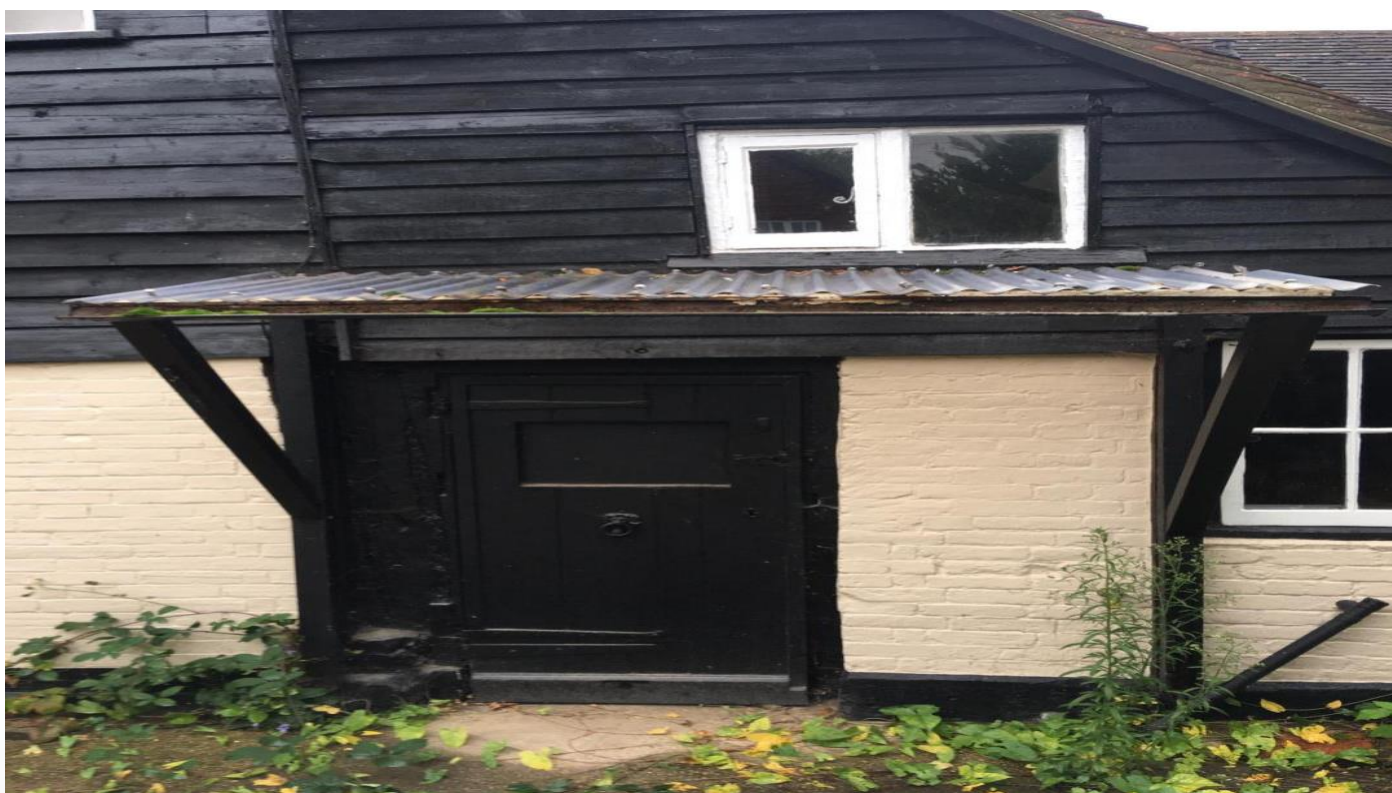
**Fault Imagery (age related decay detected to the canopy roof covering)**

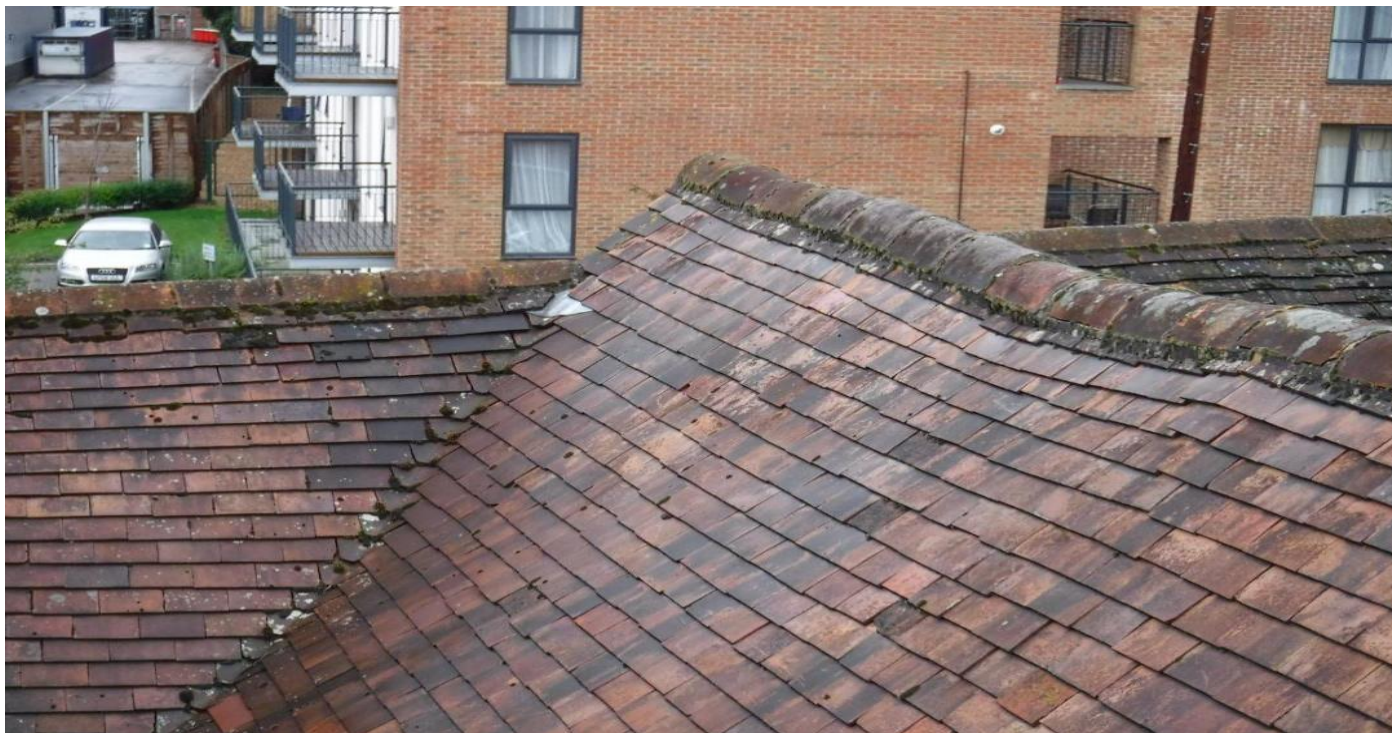
- Inspection of the roof revealed physical evidence of roof spread to main roof and ridge line, there is also evidence of roof sag detected to the timber truss supporting structures to all elevation roof slopes.

**Fault Imagery (evidence of main roof sag detected to the ridge and roof slope)**

- The timbers to the main roof so signs of decay and worm infestation, old repairs and strengthening was also observed.
- Recommend structural strengthening by way of timber web support propping and strapping of timber supporting roof structures, this to prevent any further spread and or sag occurring.

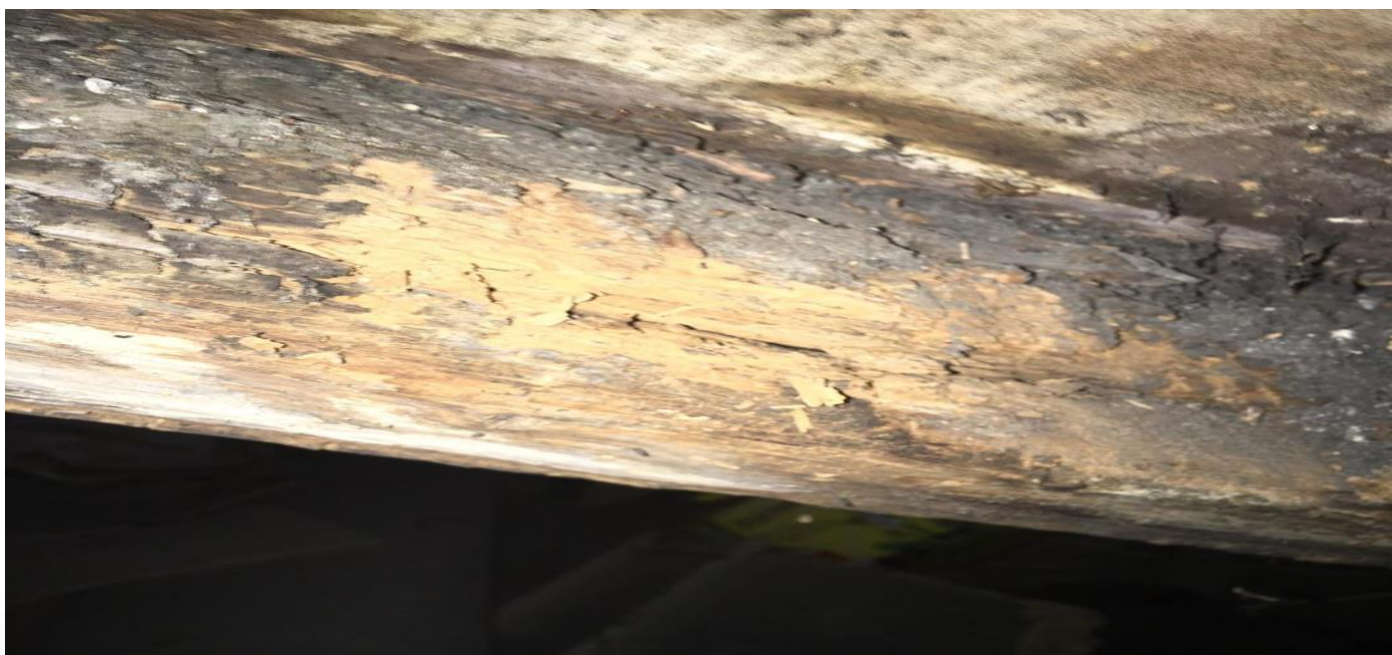
**Fault Imagery (decay detected to the roof timber supporting structures)**

- A BWPDA Timber and Damp Proofing specialist should be asked to inspect the property, commenting in particular in regard to works required to remedy any decay or worm infestations.

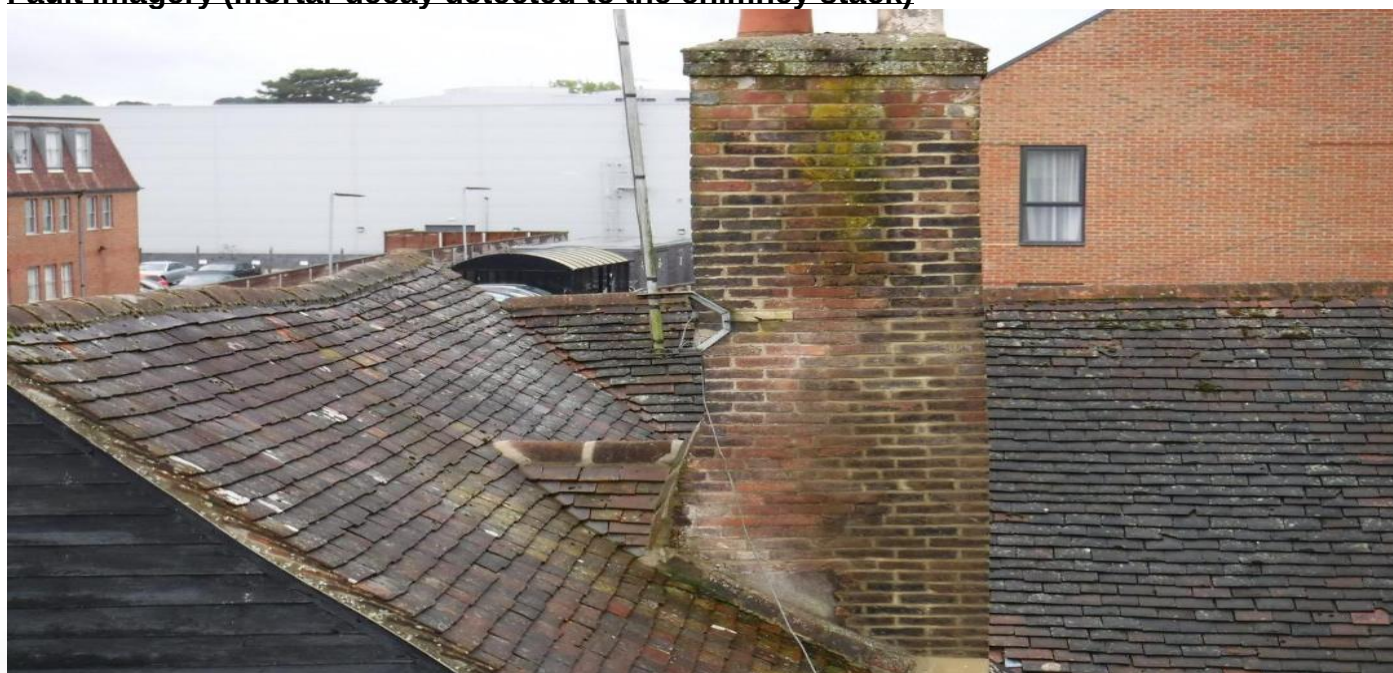
## Fault Imagery (mortar decay detected to the chimney stack)

- A full inspection revealed the large chimney stack to the rear roof slope shows evidence of spalling, the pointing will need to be checked and repointed if necessary, no lead flashings exist to the chimney roof junction, it is recommended the mortar flashing is replaced with lead flashings.
- The four original fire places were not checked for working order, as the building has been empty for some time it is recommended these areas are checked and serviced with a chimney sweep to all flues.

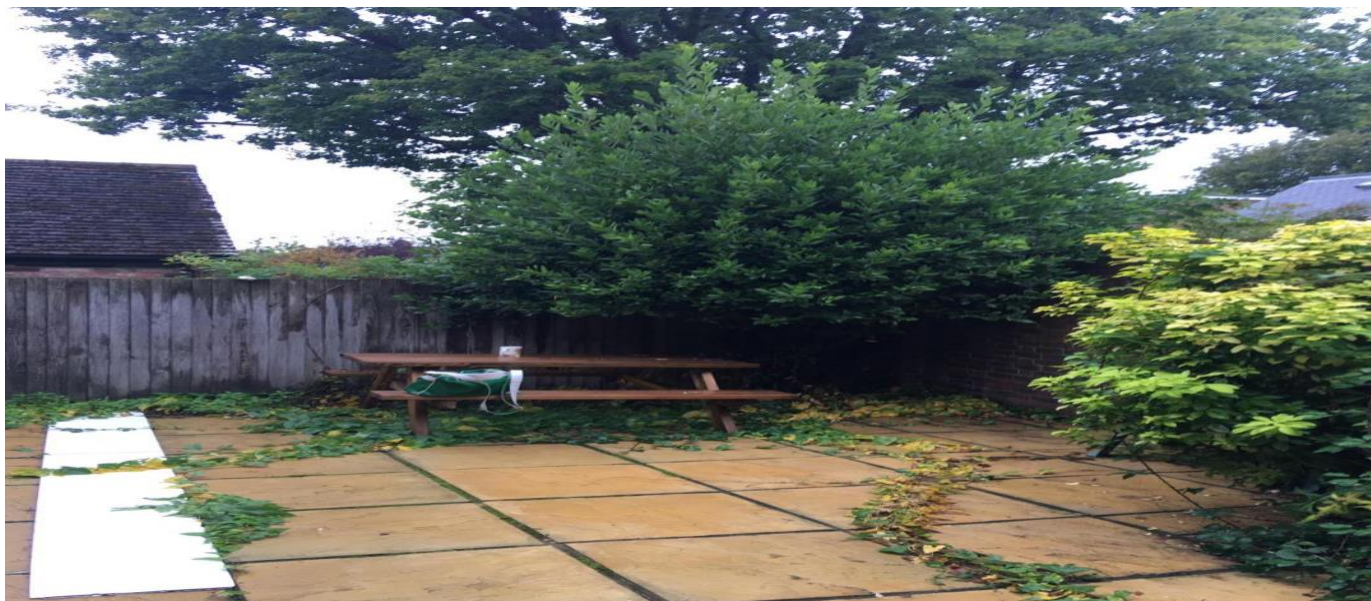
### **Fault Imagery (weed growth and undulation detected to the pathways)**

- The driveways and paved areas are adequate however these will need clearing of weeds and checked for movement.

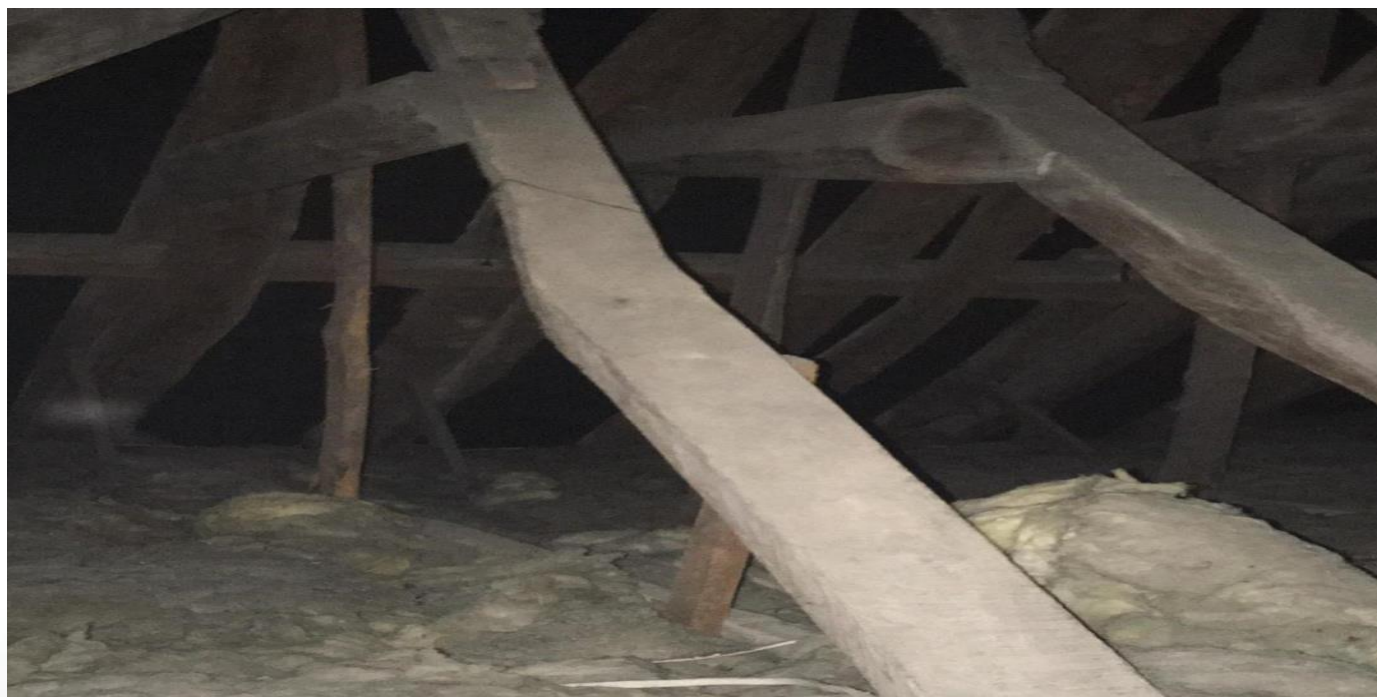
**Fault Imagery (limited rolled wool insulation detected in loft space)**

- From the limited inspection of the roof space I noted glass wool fibre insulation laid between the ceiling joists, the visible parts of the insulation revealed in-complete areas requiring attention.
