# PROPERTY SURVEY

**Purpose of Report:** SELF ASSESSMENT BUILDING SURVEY

**Report Reference:** SABS/MXP/20XX

The Subject Property is a Detached Bungalow approximately 50+ years old of block/brick solid wall construction with a block/brick painted render finish situated in a semi-exposed suburban location. Living accommodation is on two floors.

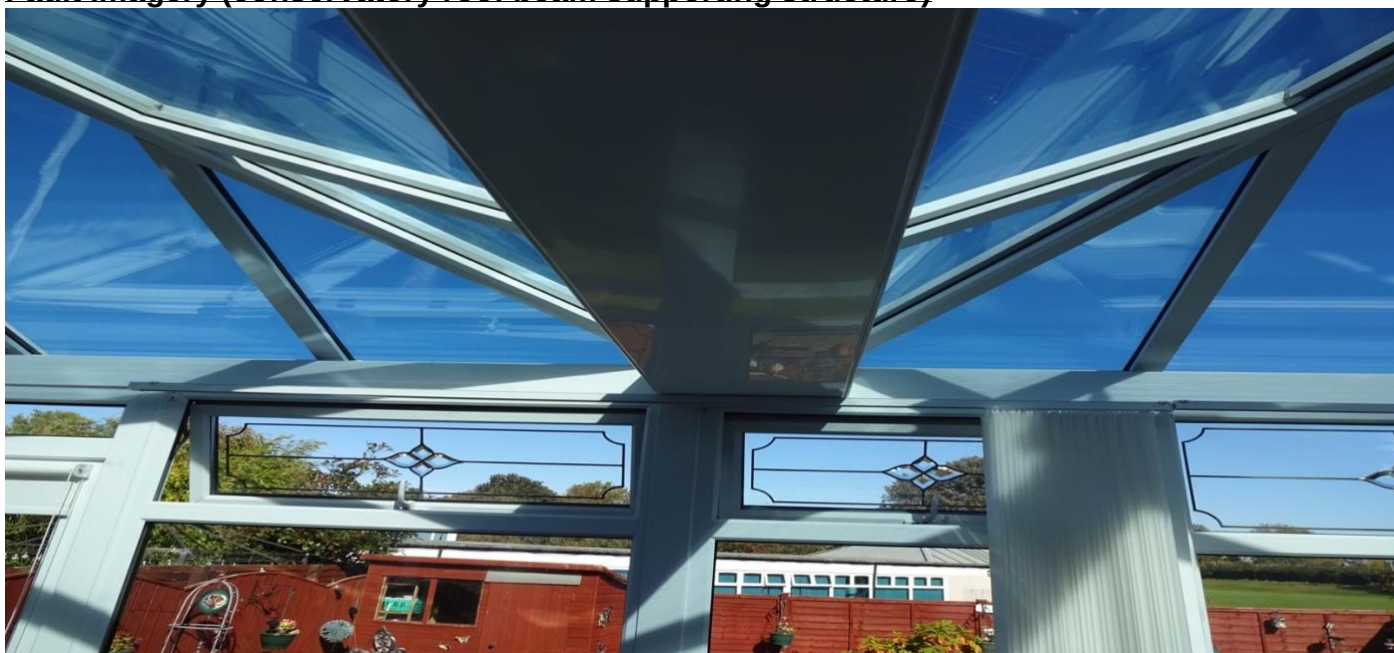
- Inspection revealed physical evidence to support that steel has been added to the sides of the beam along its full length however we cannot determine whether it is flat bar, angle iron or u channel or if the seating is adequate without a more intrusive investigation.

- I would surmise that PVCU cladding around the beam has been replaced to cover the extra width added by the steel.
- The windows however were not replaced following a decision by the contractors that the steel supports within the PVCU frames would be sufficient to support the dead weight loads of the beam and roof structures.

**Fault Imagery (conservatory roof beam supporting structure)**

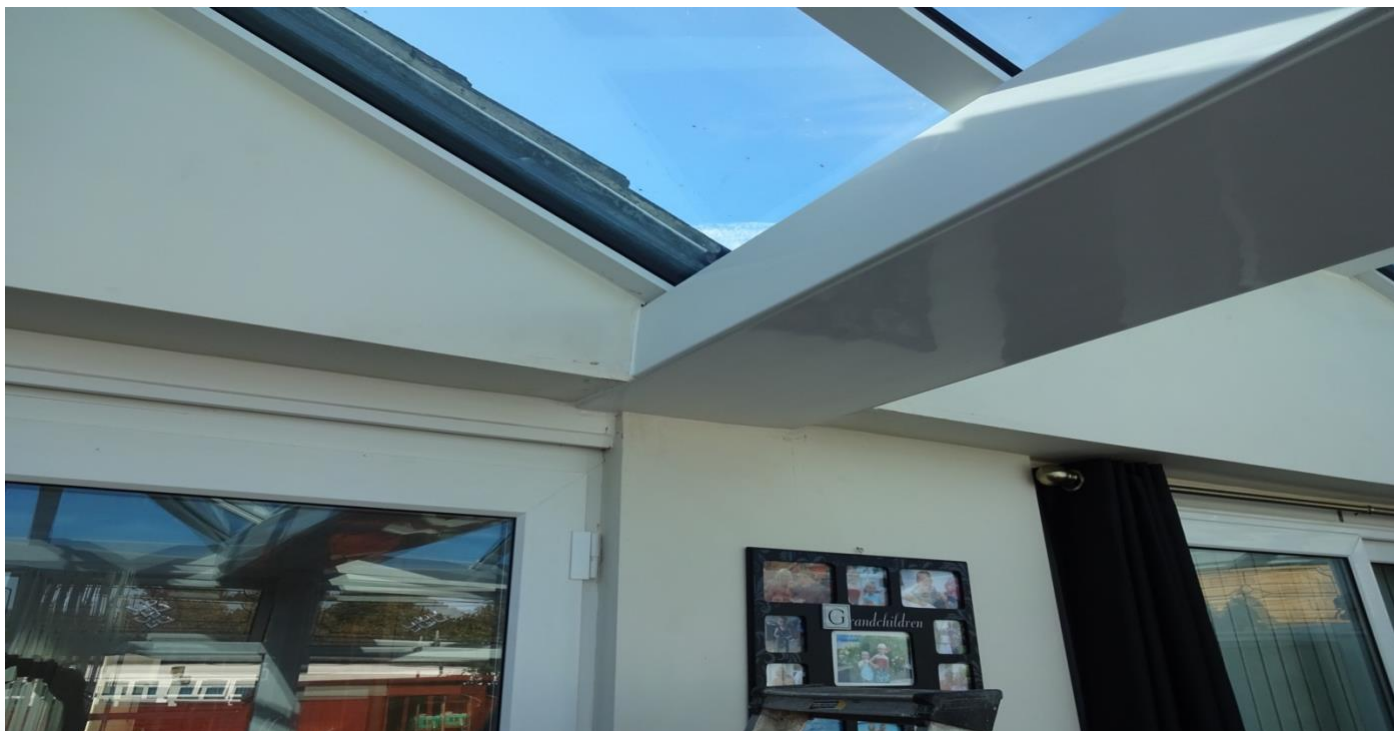
- Cutting into the house wall and installing 2x angle irons to the sides and under the beam supporting the conservatory roof at approximately 3m in length, presumably seated on the brickwork at one side and window frames at the other.
- Replacing uPVC cladding internally to cover the beam and its extra width and depth and making good with plaster.
- Installing approximately 2m of flash band.
- Pointing approximately 3m of Verge.

**Fault Imagery (conservatory support beam fixing location to main building)**

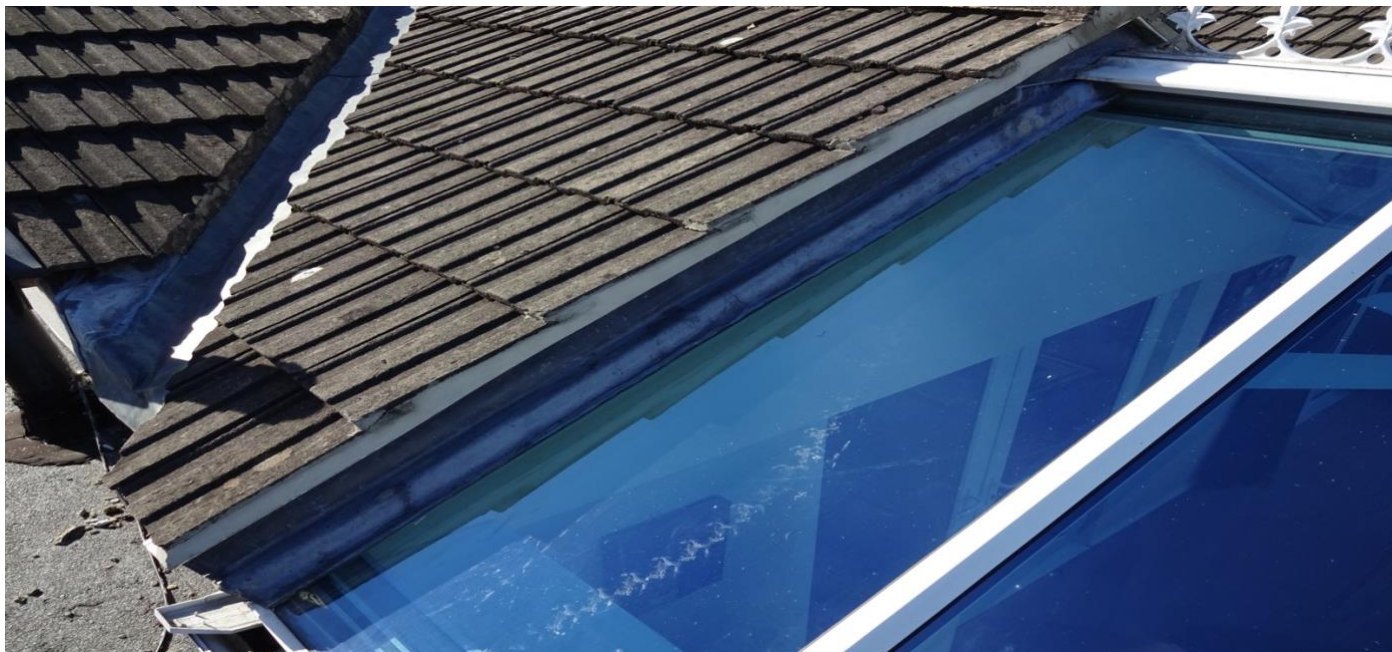
- The contractor has opted to use a bitumen aqua seal tape instead of the correct code 5 lead flashings that should have been dressed and fitted correctly to maintain the water proof values of the conservatory roof coverings.

- Aqua seal is used as a temporary fixing material as an emergency repair aid during adverse weather conditions, the material is soft and supple and is used to bond or seal minor external defects, however the material does have a limited life expectancy and therefore is not suitable for any permanent repairs such as required in this case.

**Fault Imagery (conservatory roof abutment joint with bitumen aqua seal tape finish)**

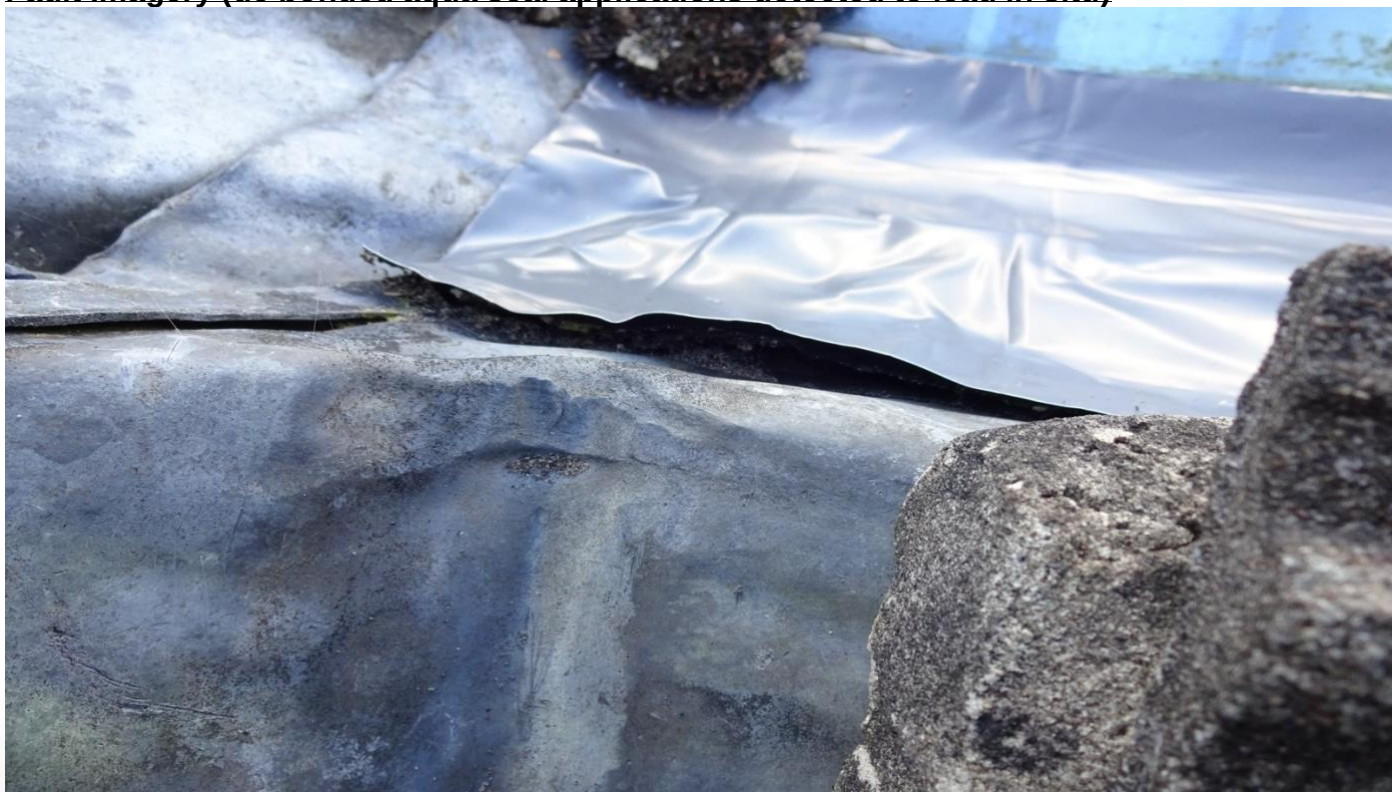
**Fault Imagery (de bonded aqua seal applications detected to lead in situ)**

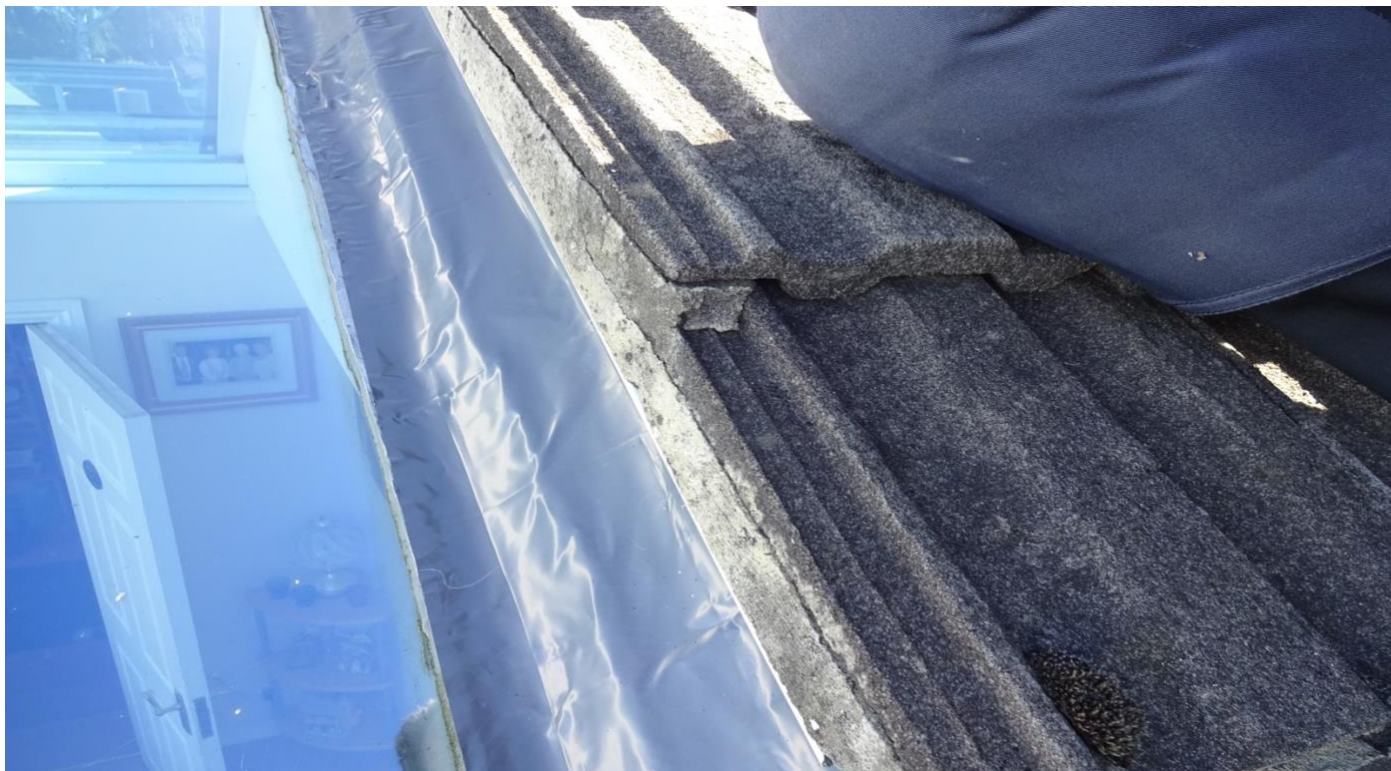
### **Fault Imagery (aqua seal tape application detected to abutment upstand joint)**
