# Building Survey

## Customer Details

## Property Image

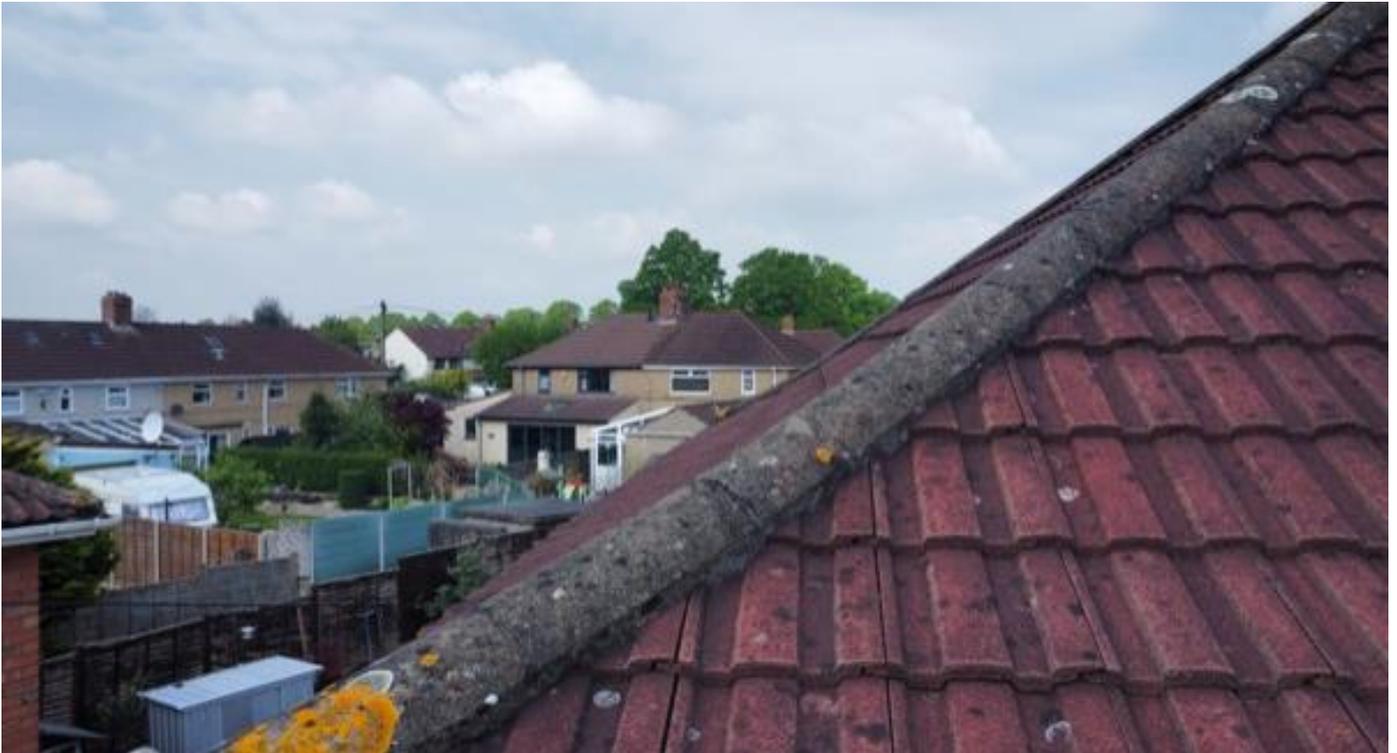
## Main Roof

- The coverings are in satisfactory condition and consistent with age, and no damaged or slipped units noted. The ridge tiles appear to be well bedded with no immediate issues noted around the mortar joints.

- The stack is in poor condition with vegetation growth noted to front, side, and rear. There have been remedial repairs carried out to the neighboring side.

- Internally, there is little evidence of weakening of the timber structure, principally the only indication of roof spread is from horizontal cracks or 'shakes' to one of the purlins. This could also be historic and would be difficult to ascertain as the other timbers appear sound. The roof structure was found to be generally sound with only slight deflection on the underside of the original timber rafters which appears to be within tolerable limits.

- Recommend structural strengthening by way of timber web support propping and strapping of timber supporting roof structures, this to prevent any further spread and or sag occurring.

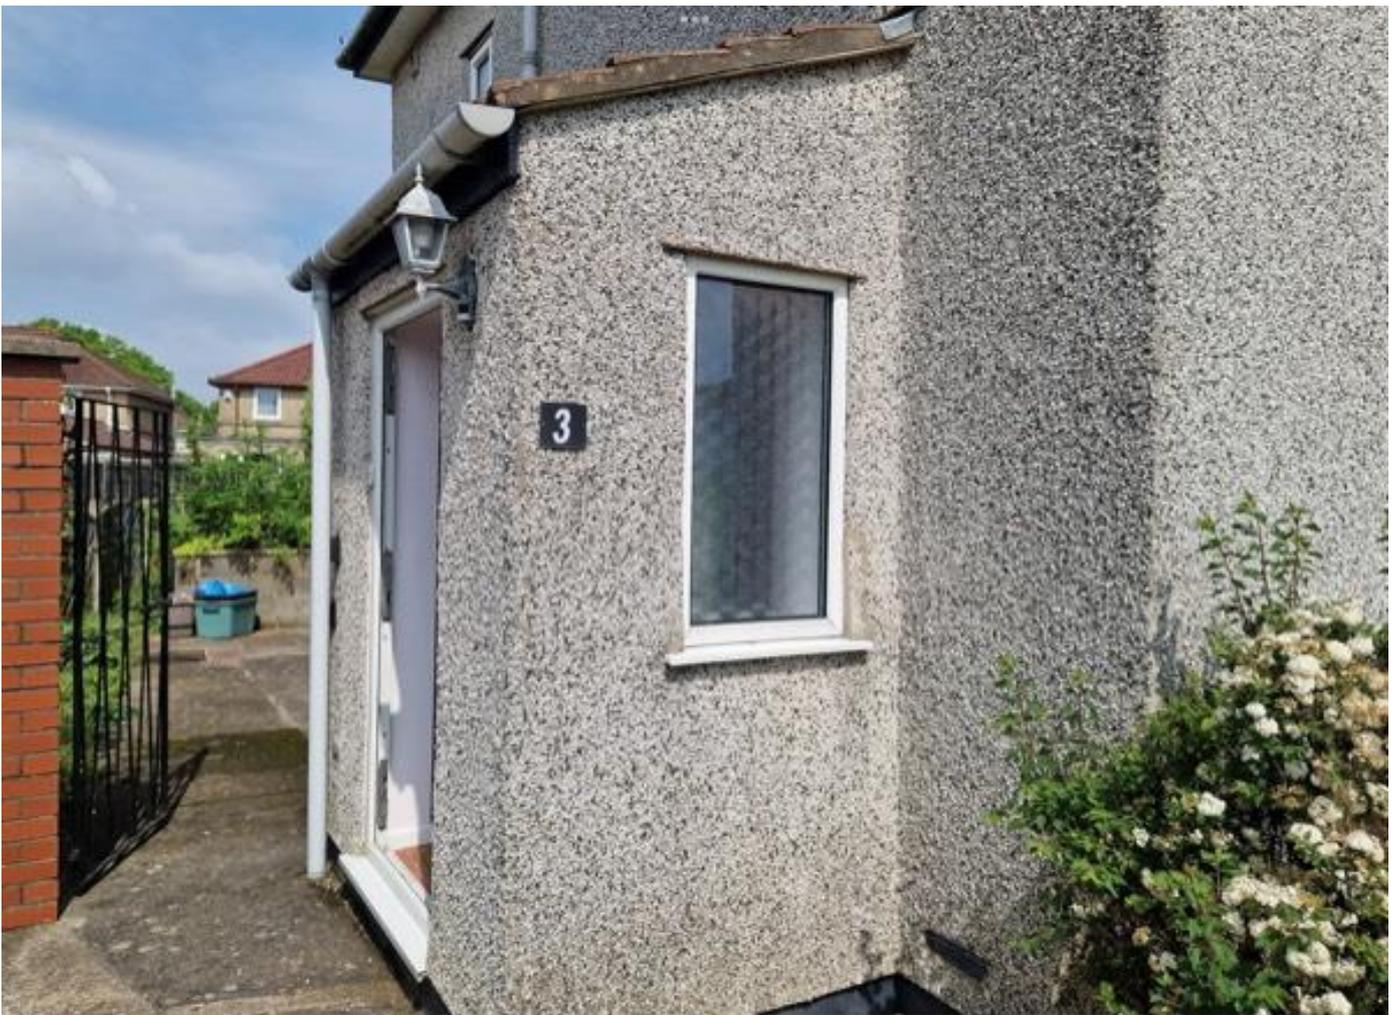
## Secondary Roof

- There is a secondary cut timber roof to the ground floor porch. This is a mono pitched roof with gabled finish with the same concrete interlocked roof coverings as the main roof.
- The roof was noted to be in satisfactory condition with no evidence internally to suggest issues with the waterproof values of the structure or 'know on' effects flowing slight spread of the main roof.
- Water is discharged from the roof via a PVCU gutter section rainwater system with outlet downpipes hold fast fixed to the external elevations.
- The gutter section rainwater system shows physical evidence of blockages with debris causing restrictions to the water flow leading to the rainwater outlets.
- Recommend these are cleared and repaired to prevent water penetration to the building.

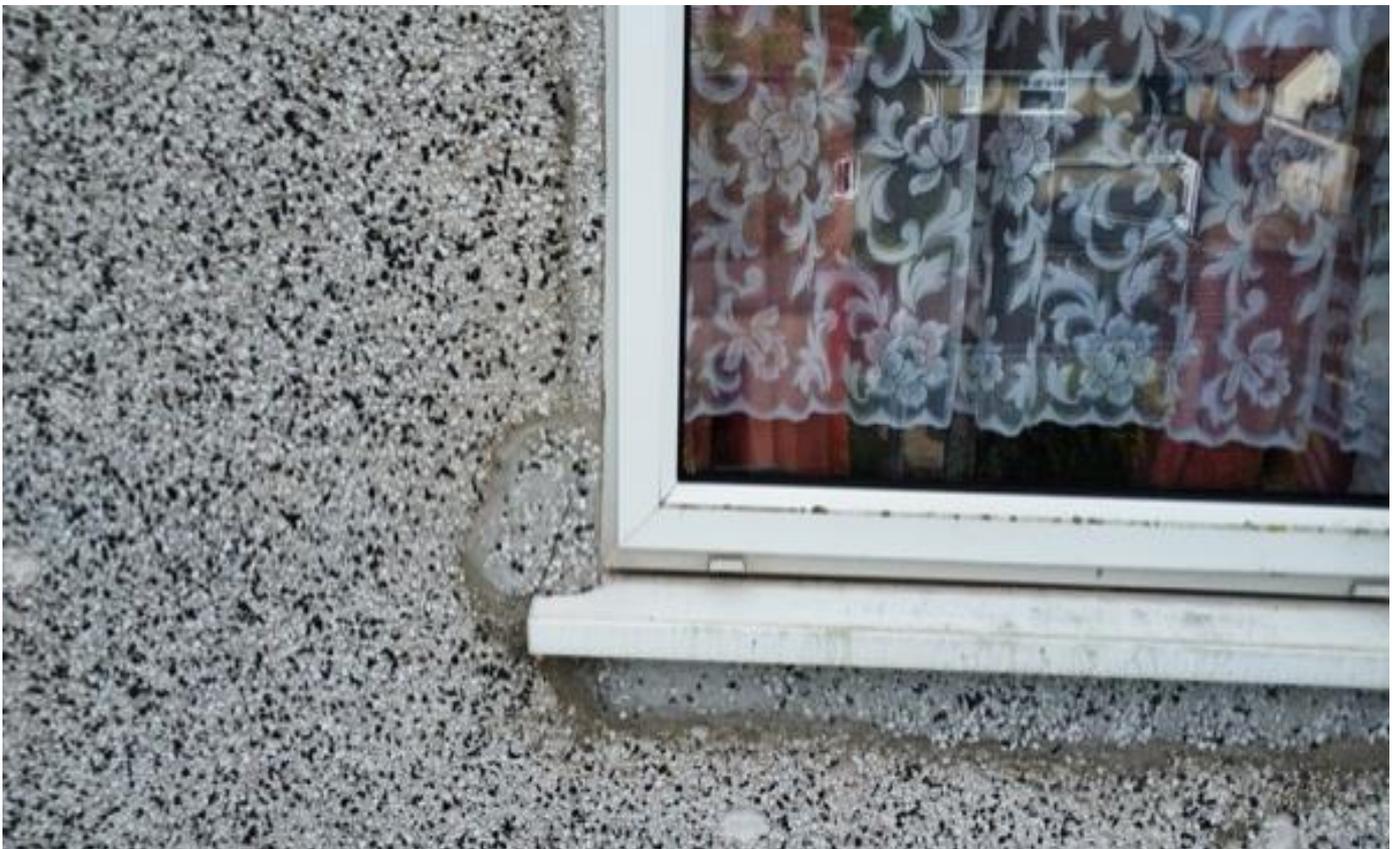
### General condition of Render and Window Install.

- 1: Remove Vegetation Growth from Chimney Stack (See Main Roof)
- 2: Repoint defective ridge tiles and areas of missing mortar (See Main Roof)
- 3: Unblock gutters and ensure Rainwater Goods operate effectively (See RWG)
- 4: Repair hairline cracking around window reveals and poor render (render approaching the end of its lifespan, replacement should be considered). (See photos attached)
- 5: Windows are poorly installed due to depth of window reveals (consider replacing). (Photos attached)

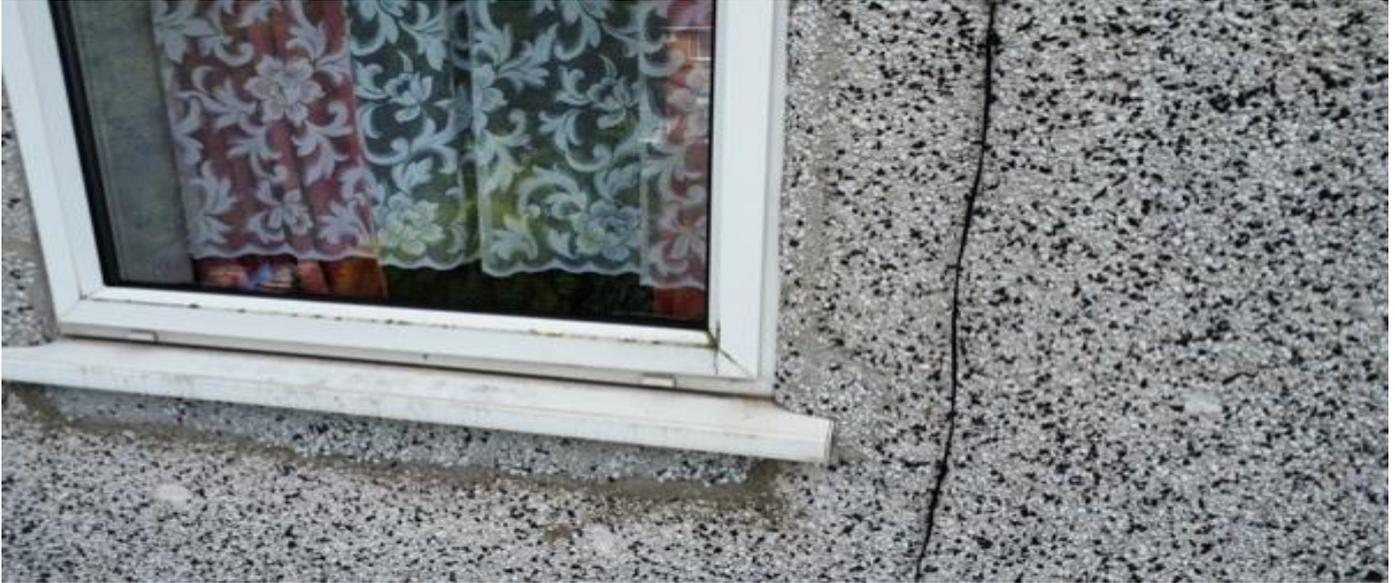
## General condition of Render and Window Install/Repairs.

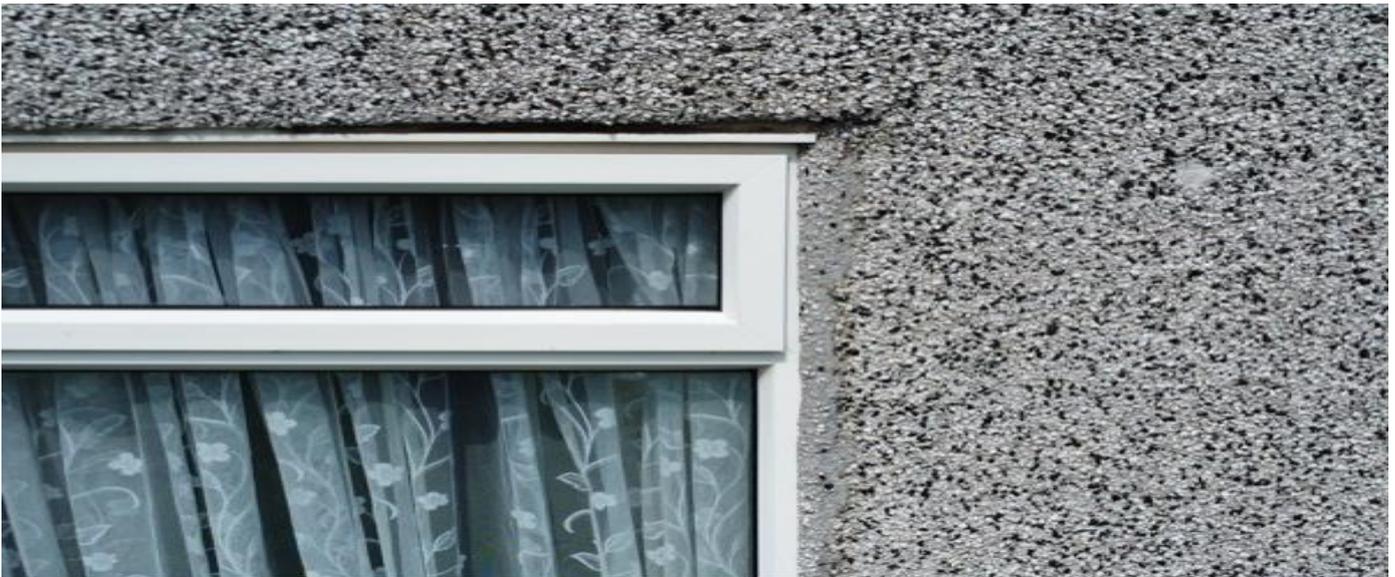
## General condition of Render and Window Install/repairs

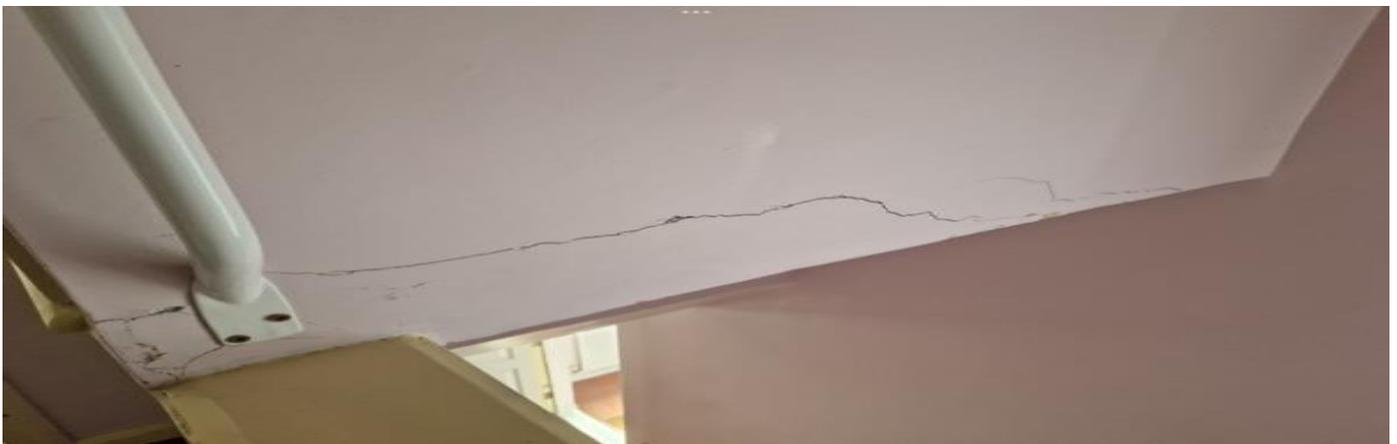
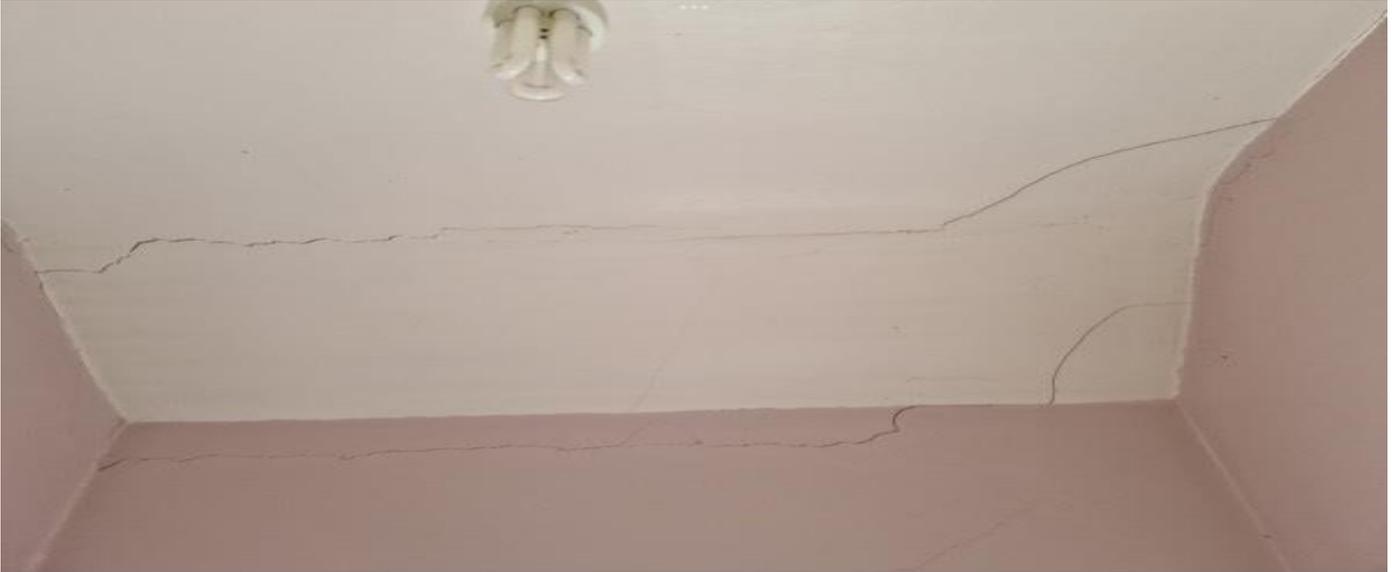
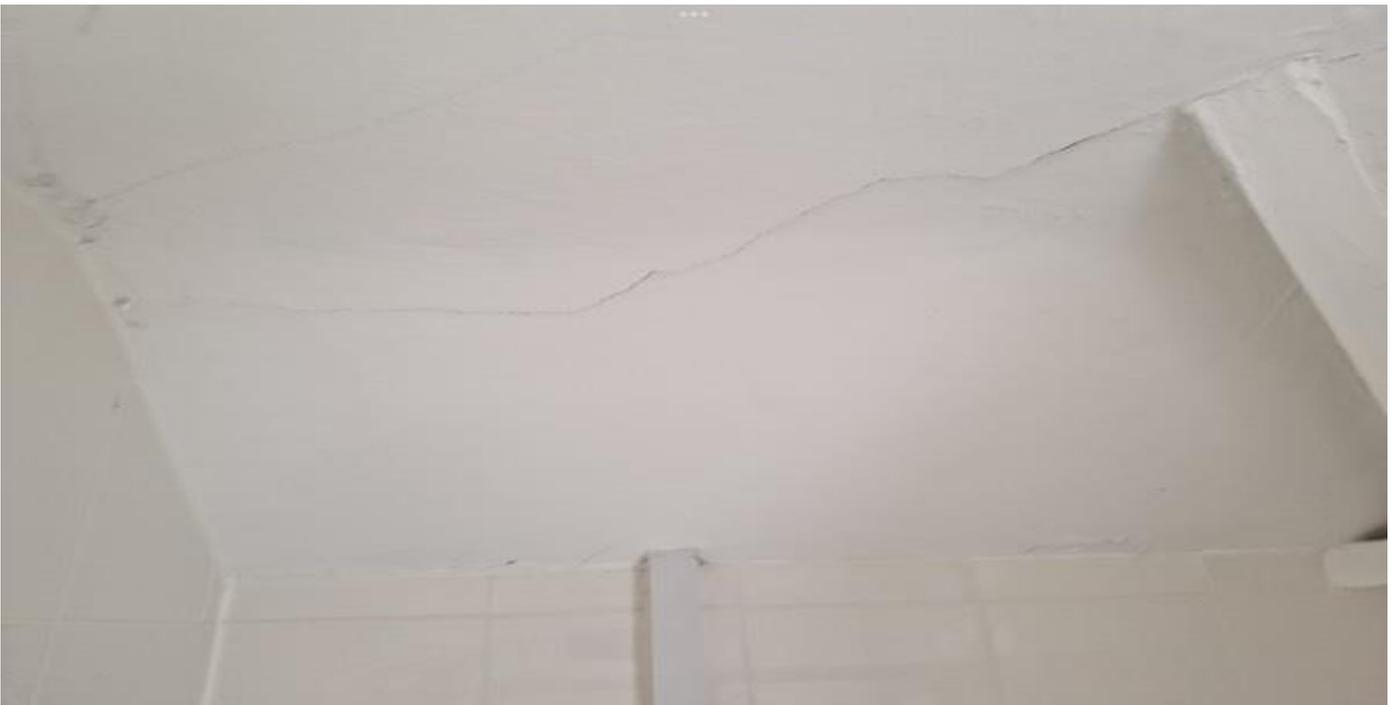
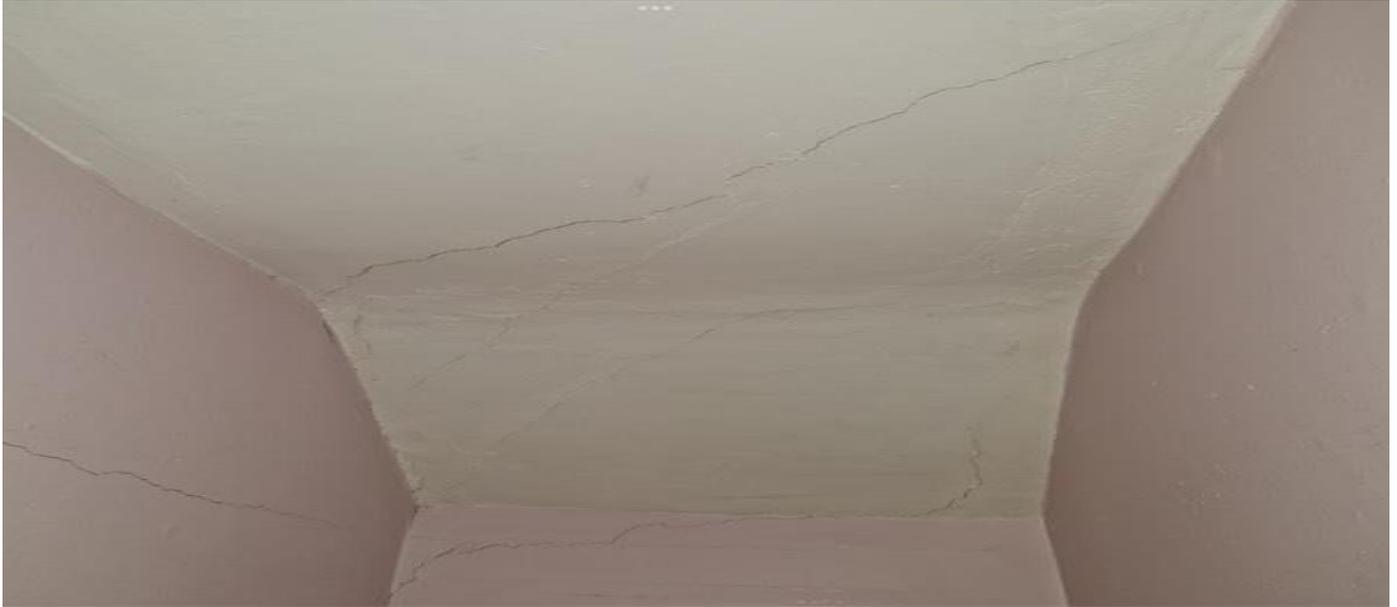
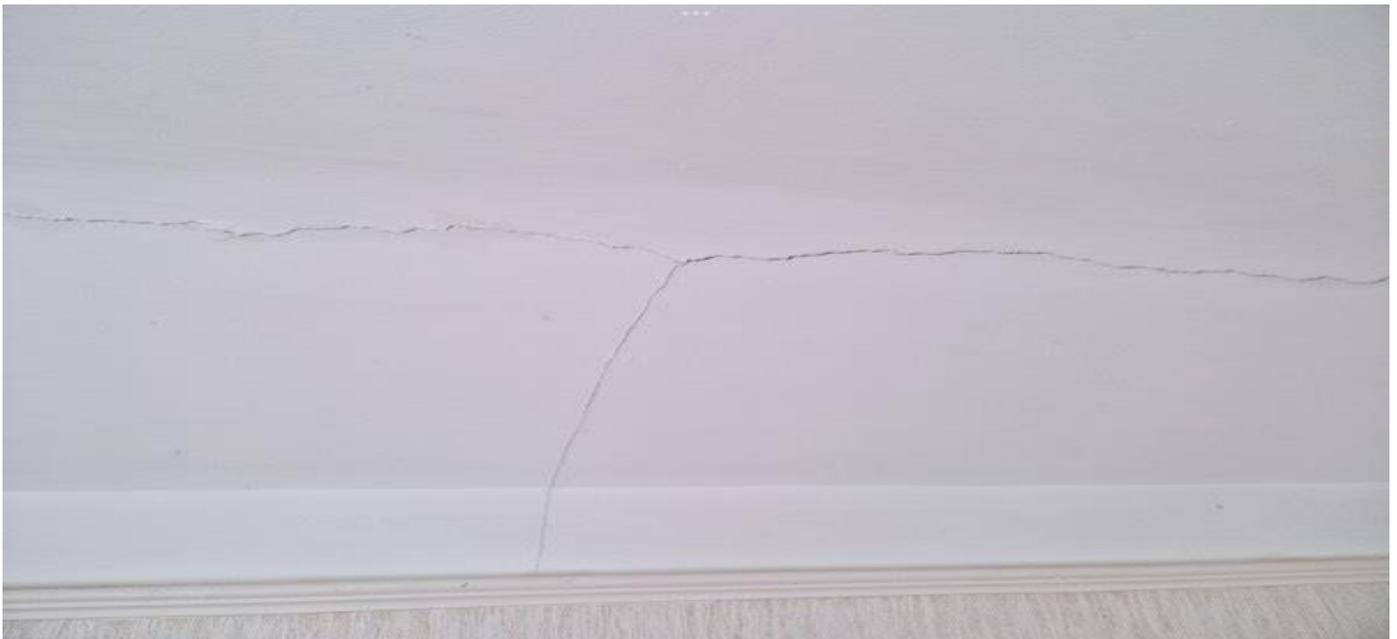
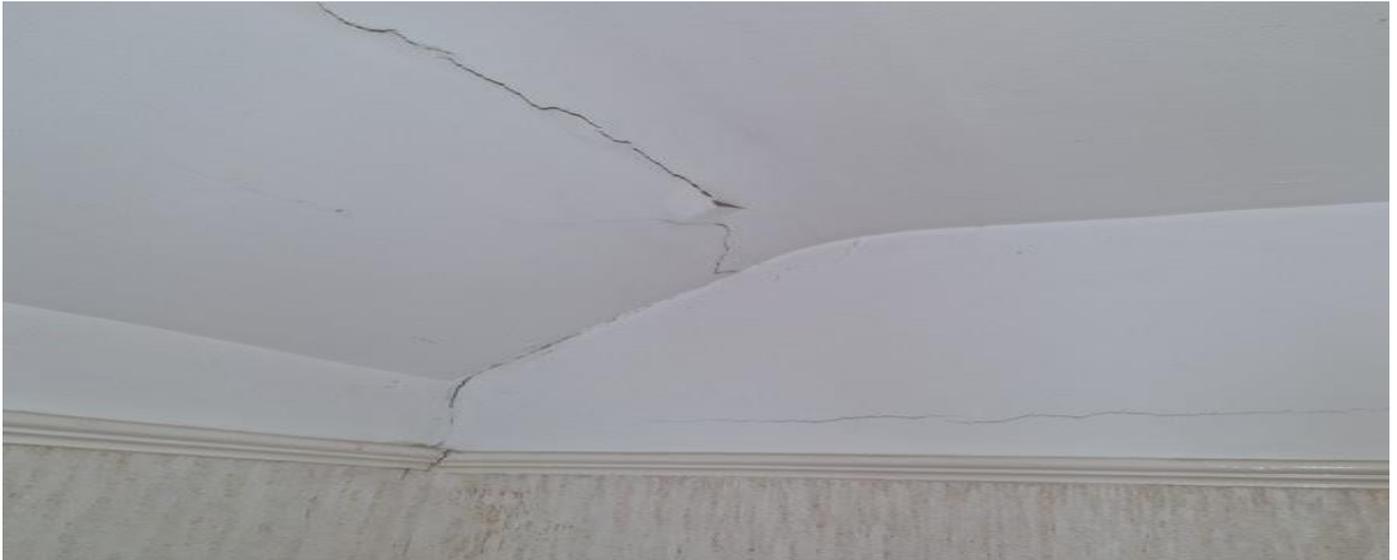
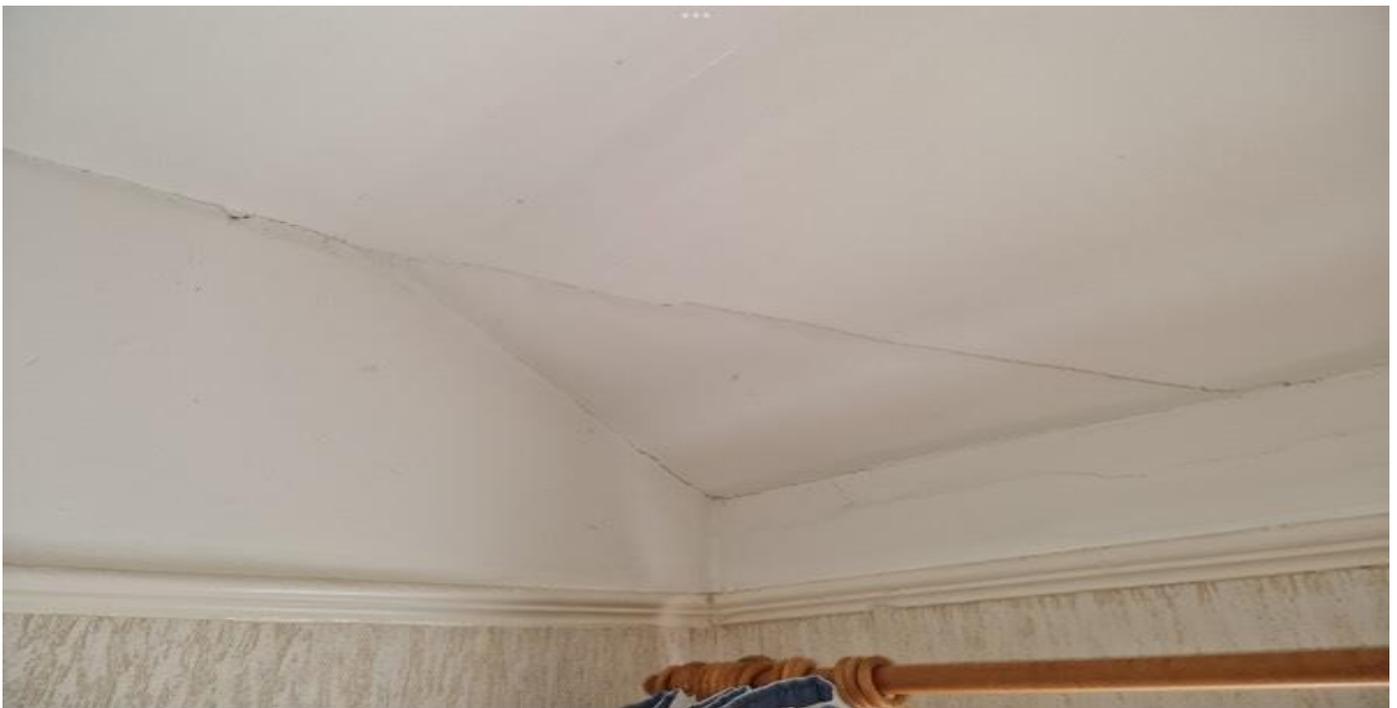
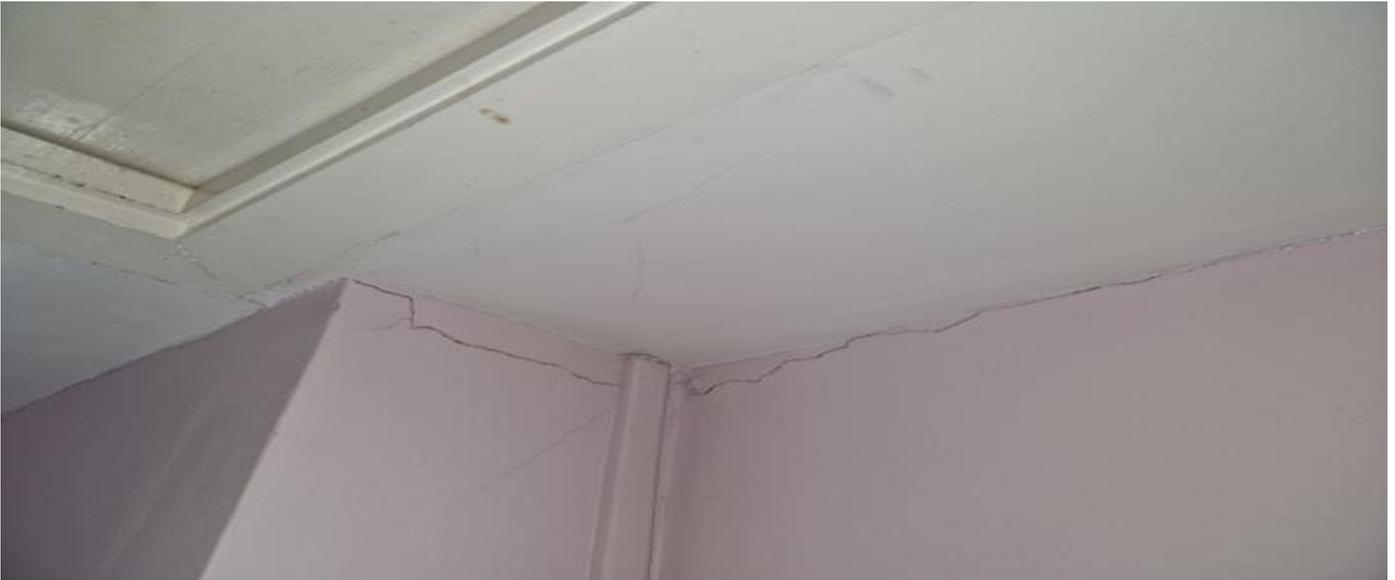
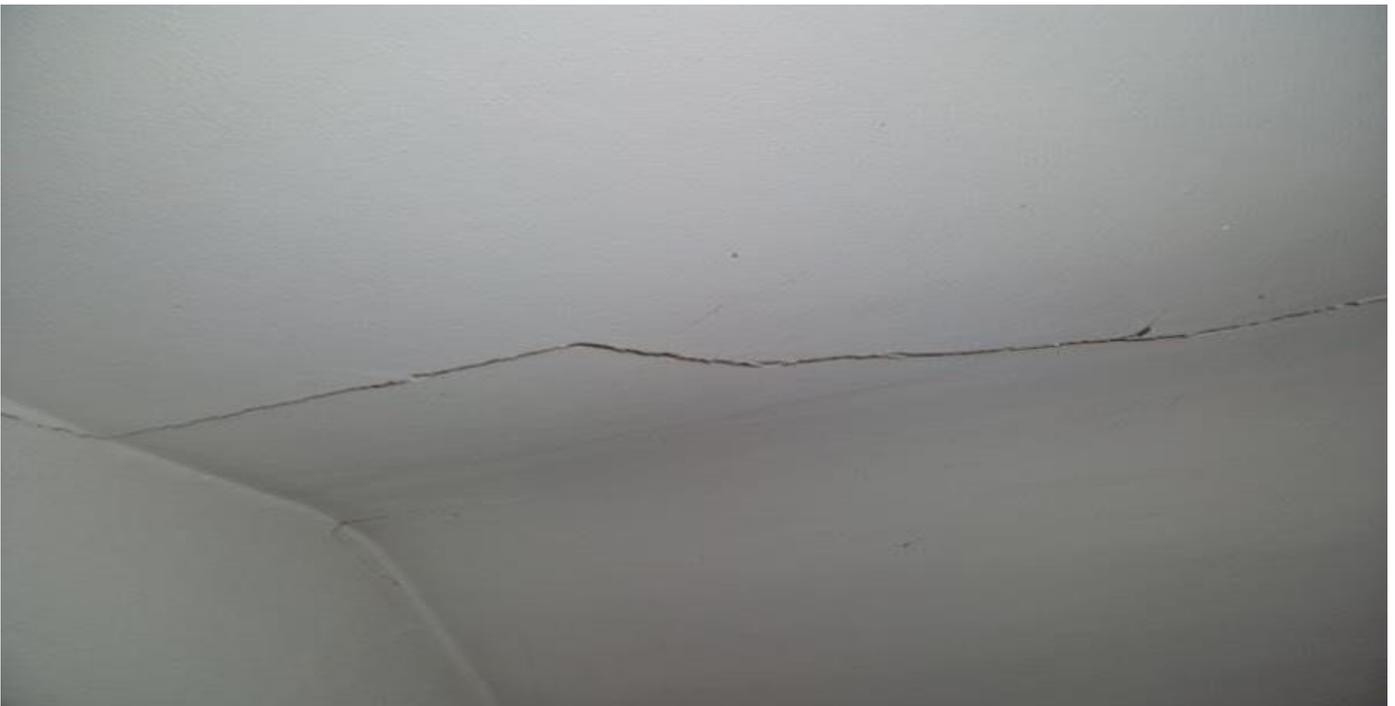
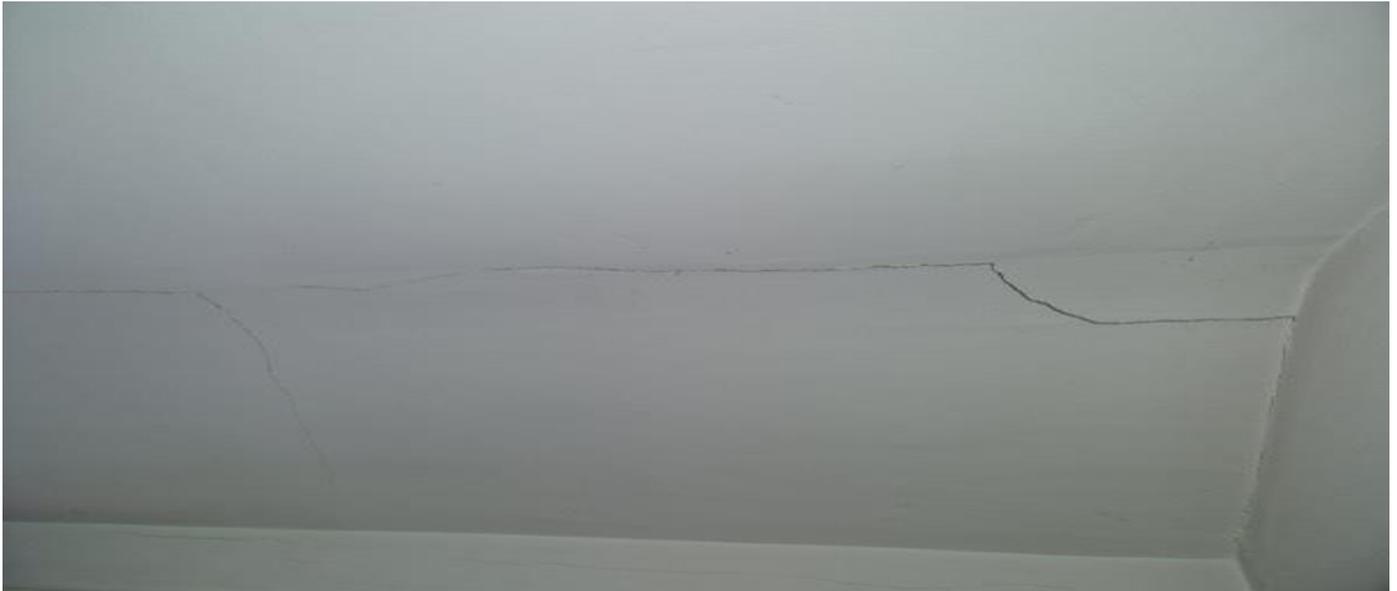
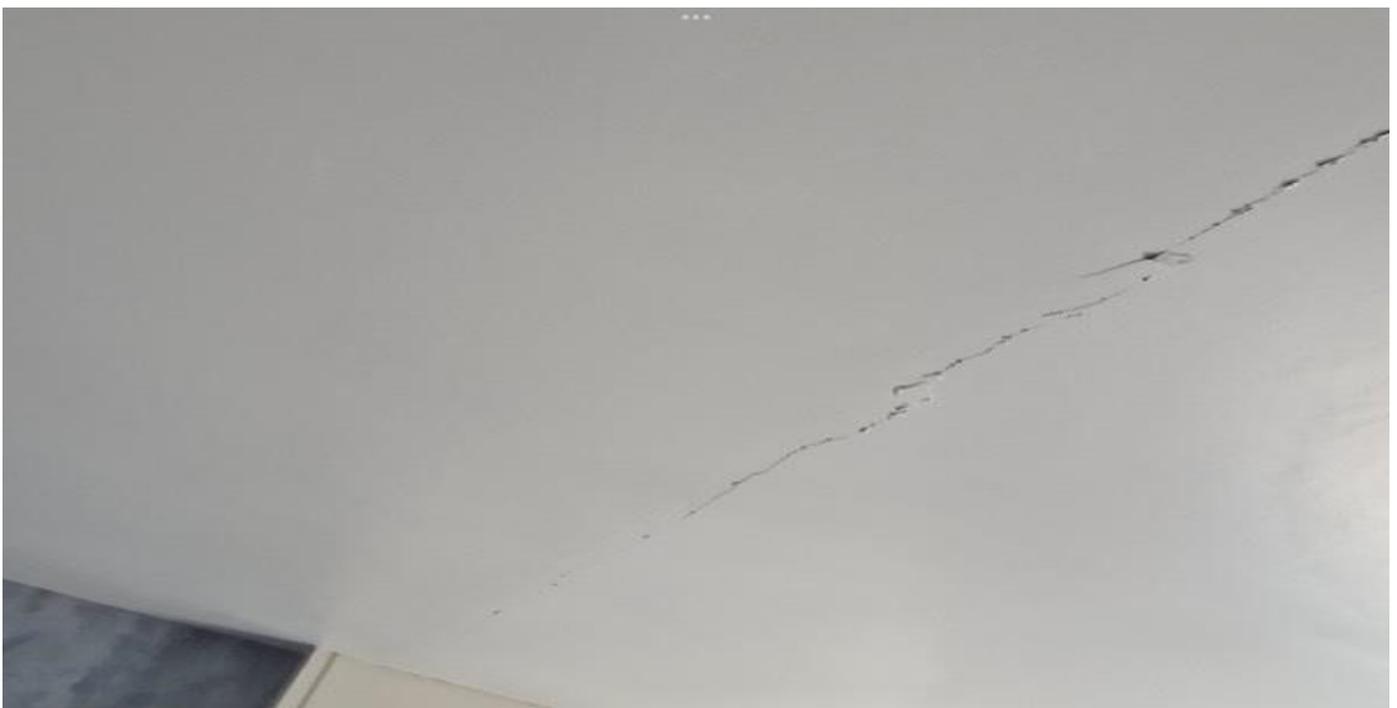
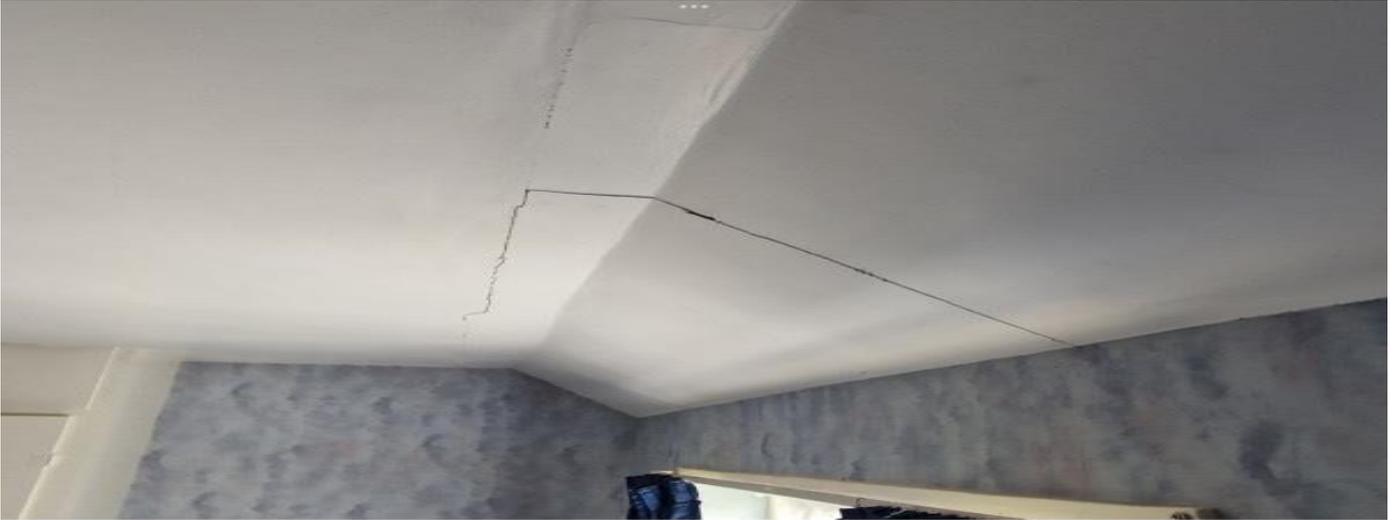
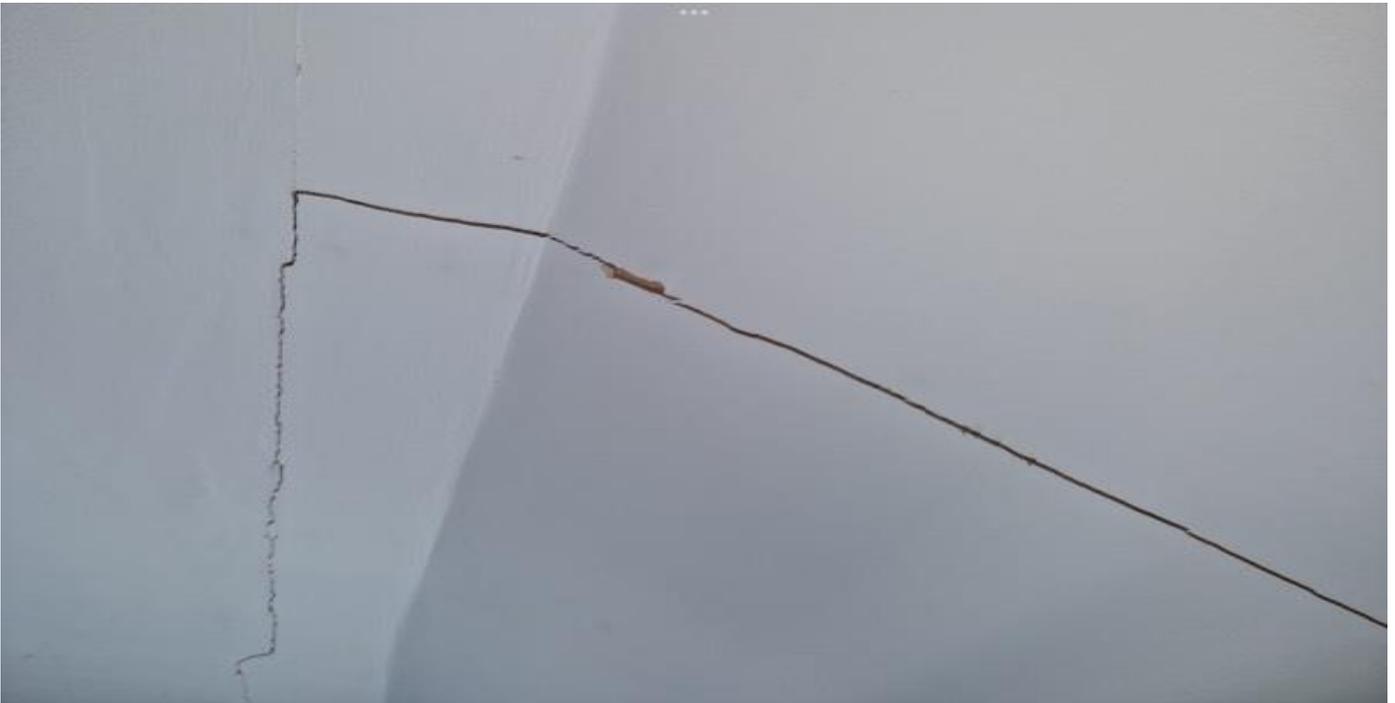
- The ceilings are of a plaster board, lath and plaster and skim finish. Issues detected concerning cracking to the first-floor rooms and landing, this is detected around the wall ceiling junctions and to some of the partitions of the first floor (photographs included in the repairs section below).

- The walls are a mixture of solid and stud partition with plaster finishes.
- There is physical evidence of cracking detected to the wall and ceiling junction joints consistent with thermal movement and roof spread.

- The property has cracking around the 1st floor internal ceilings/soffits and some historic damage to the top of the external wall which is consistent with roof thrust.

## Internal Cracking to Ceiling & Wall Surfaces (consistent with roof spread)

- Recommend these are repaired following full repairs to the dominant cause of break down (roof thrust/spread as indicated in the structural movement section).

- Recommend these are repaired to a serviceable standard following repair to the roof.
- The decoration comprised of simple type papered and painted wall surfaces and gloss painted woodwork, all found to be in an average condition consistent with age in need of modernisation.
