# Building Survey

## Customer Details

## Property Image

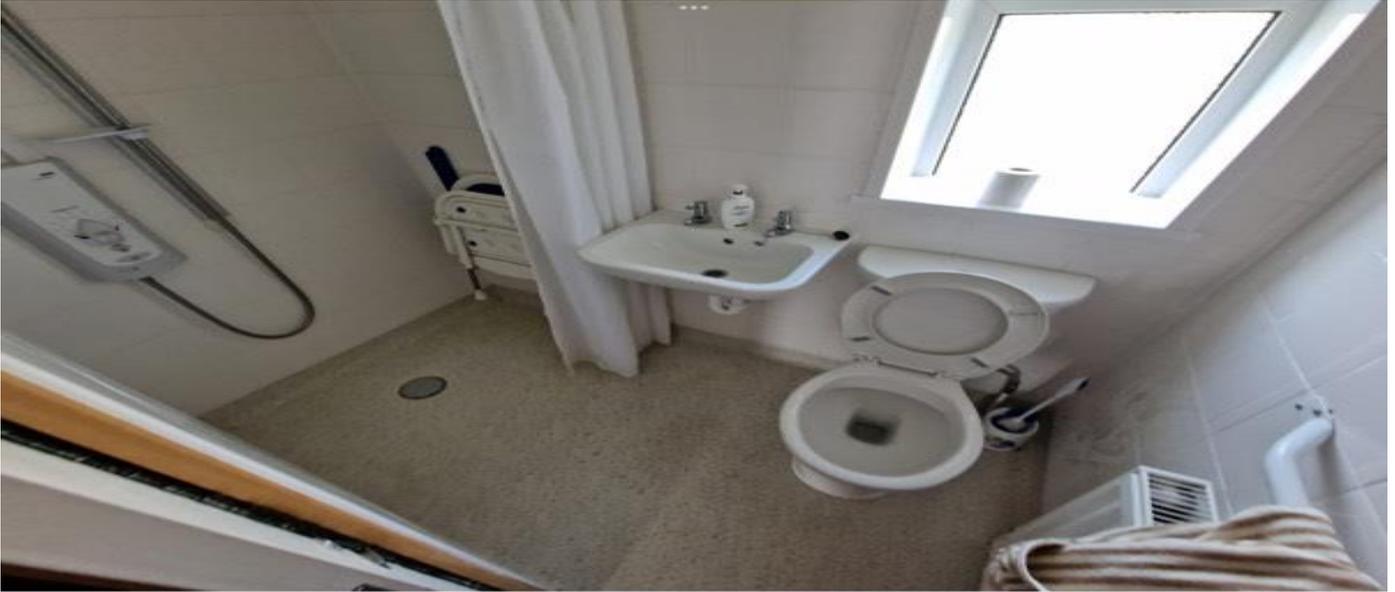
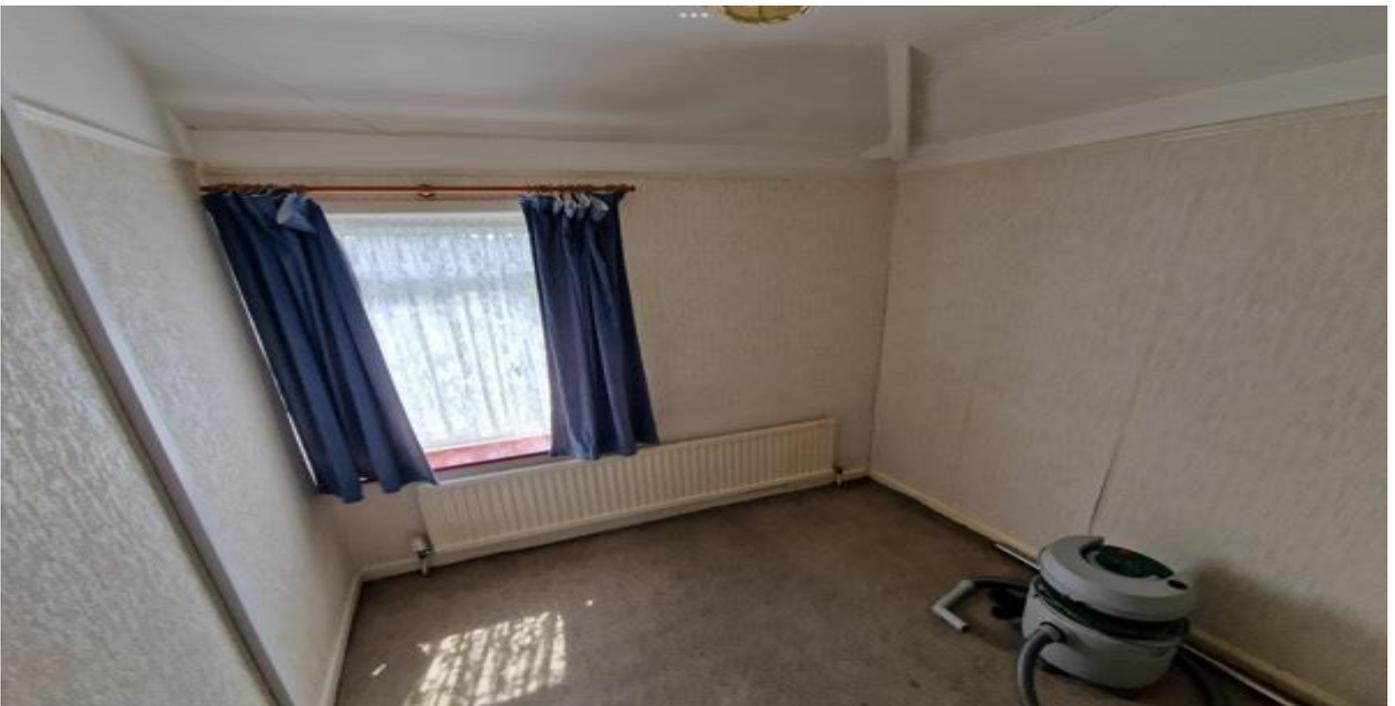
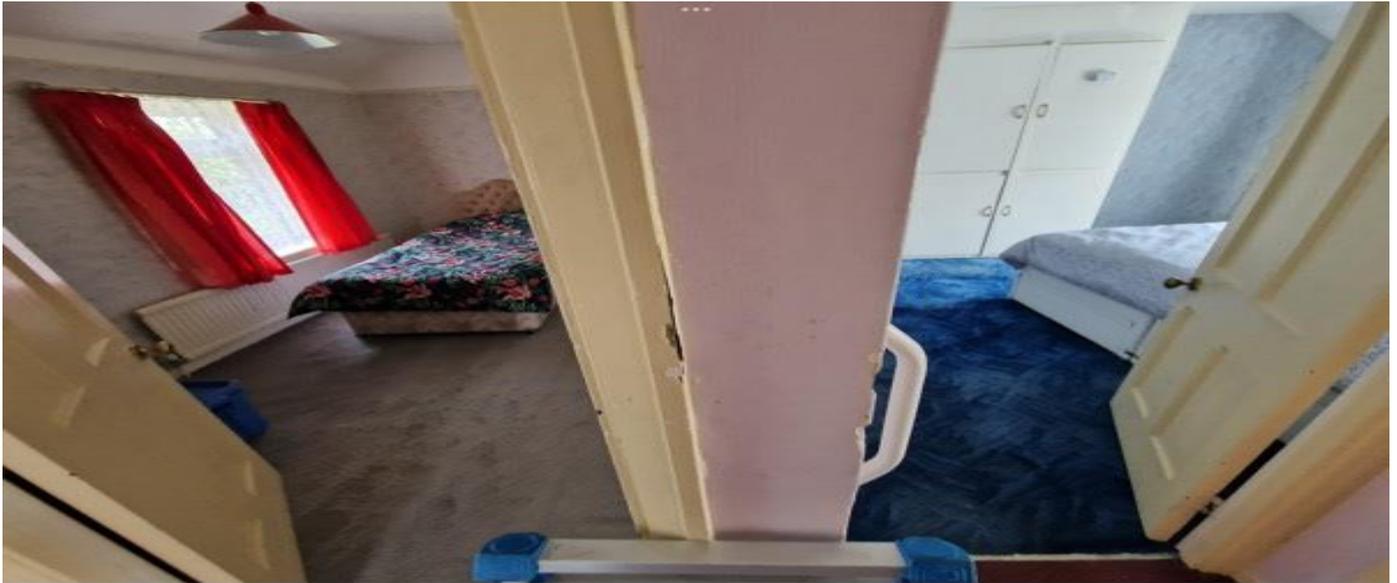
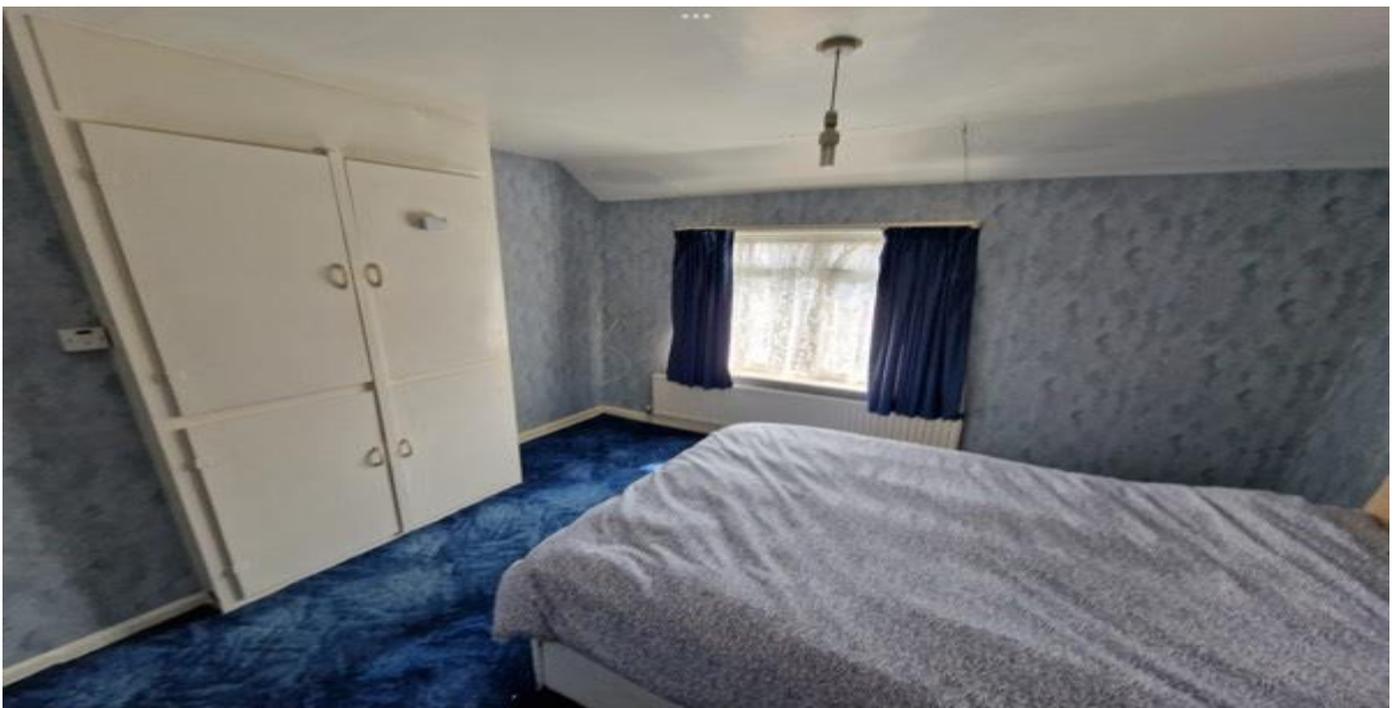
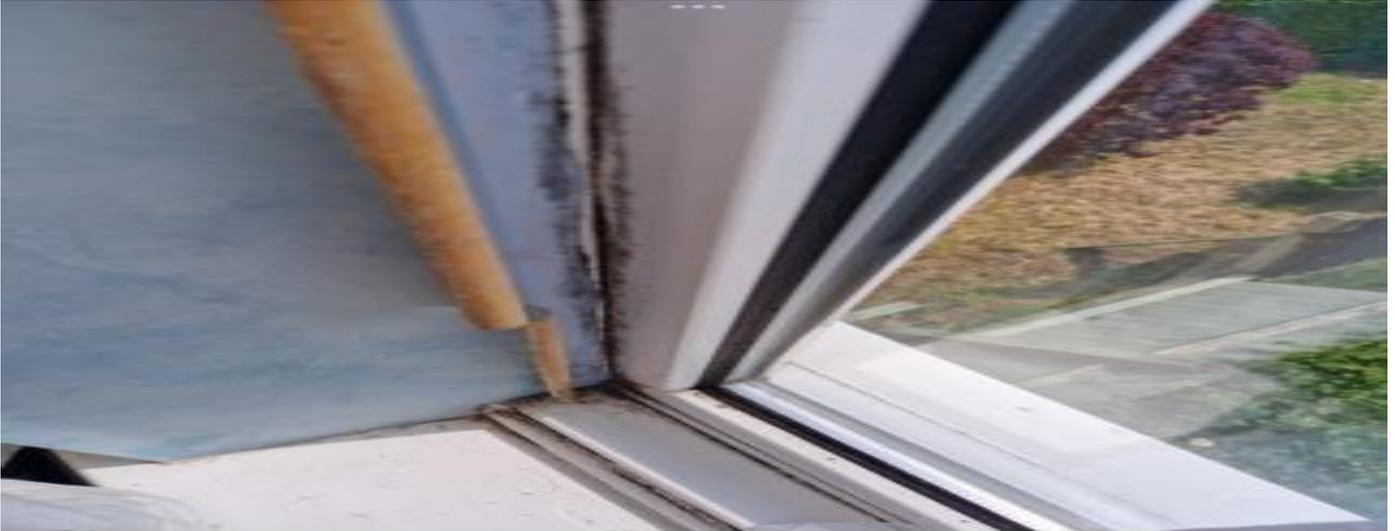
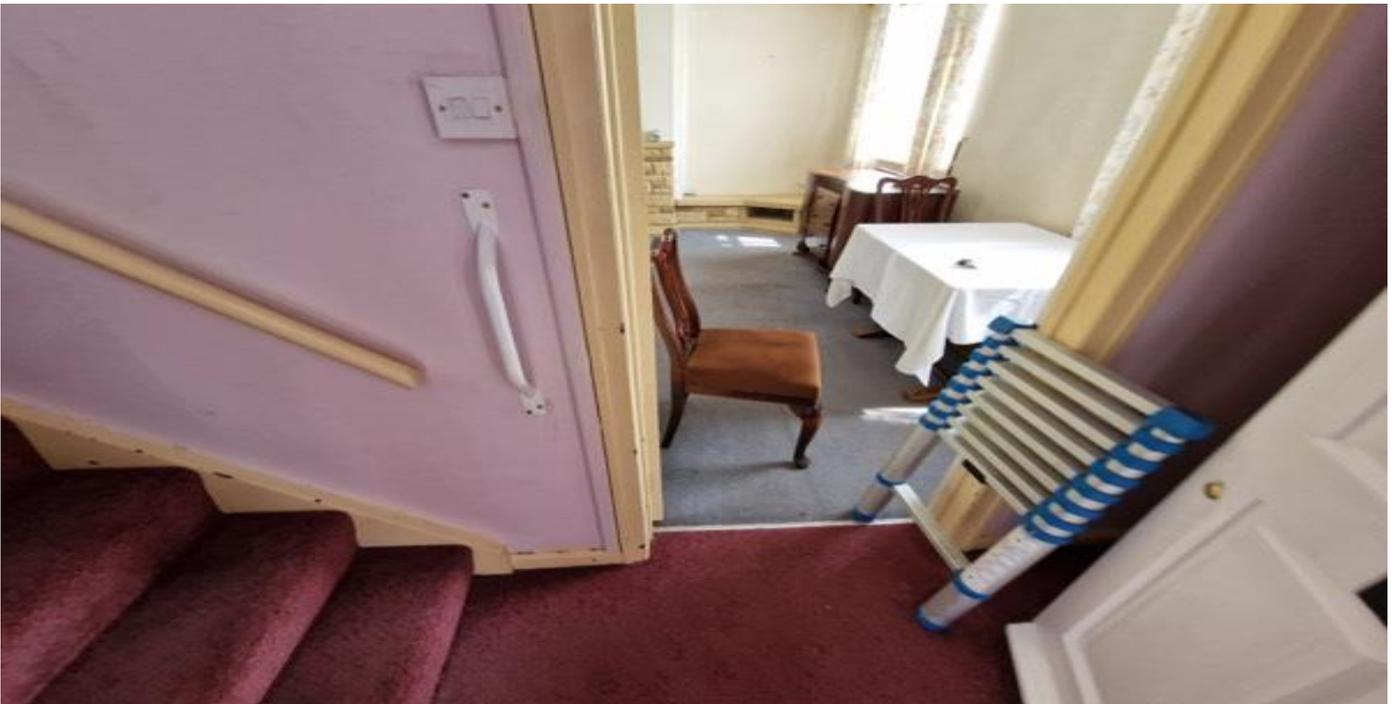
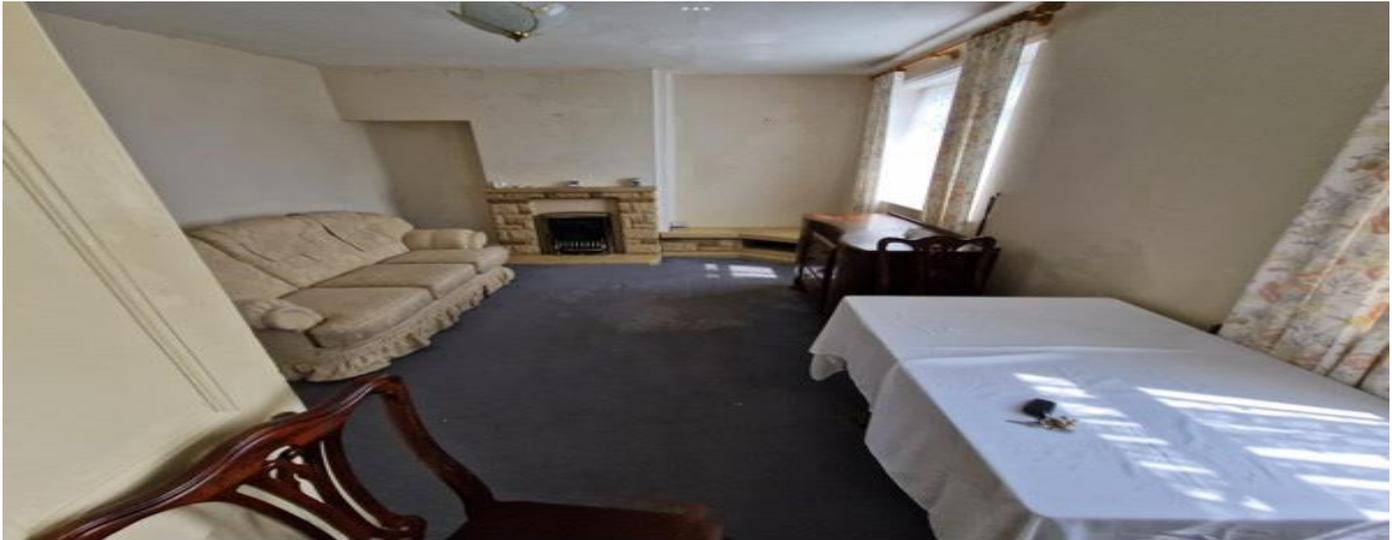
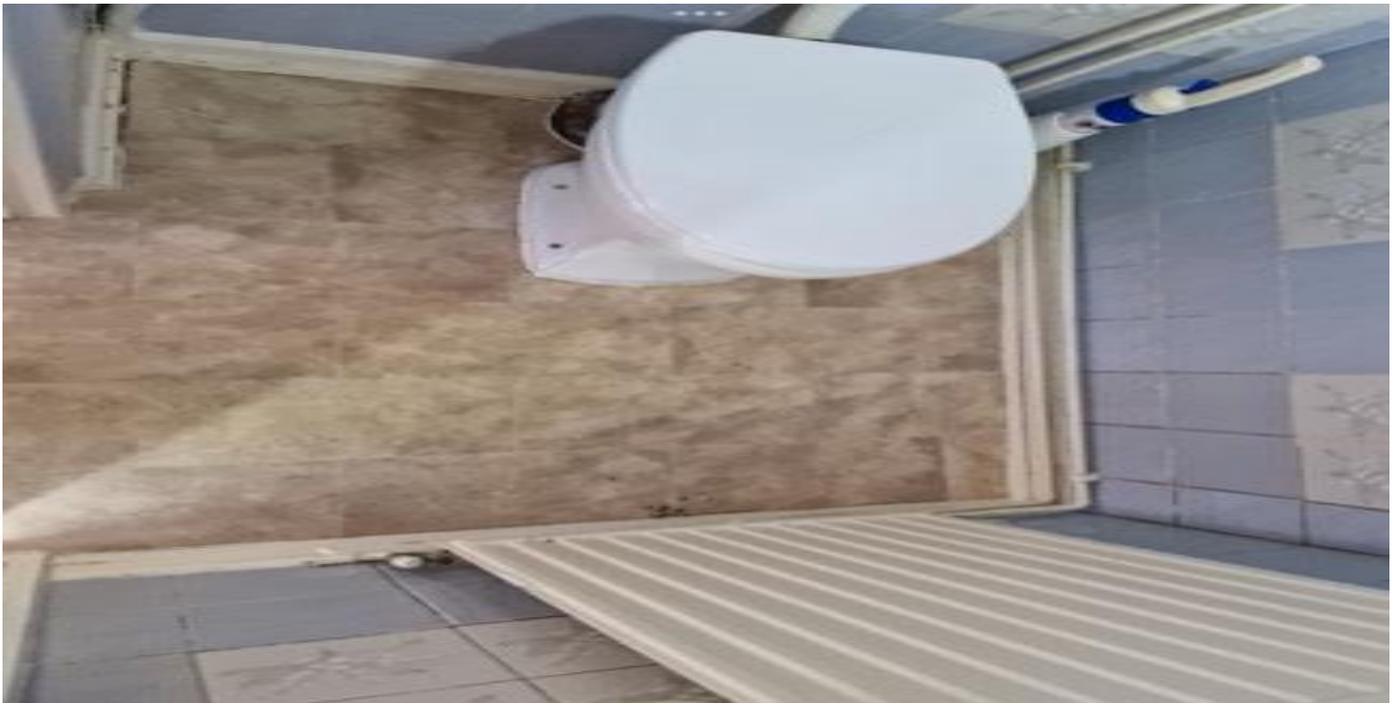
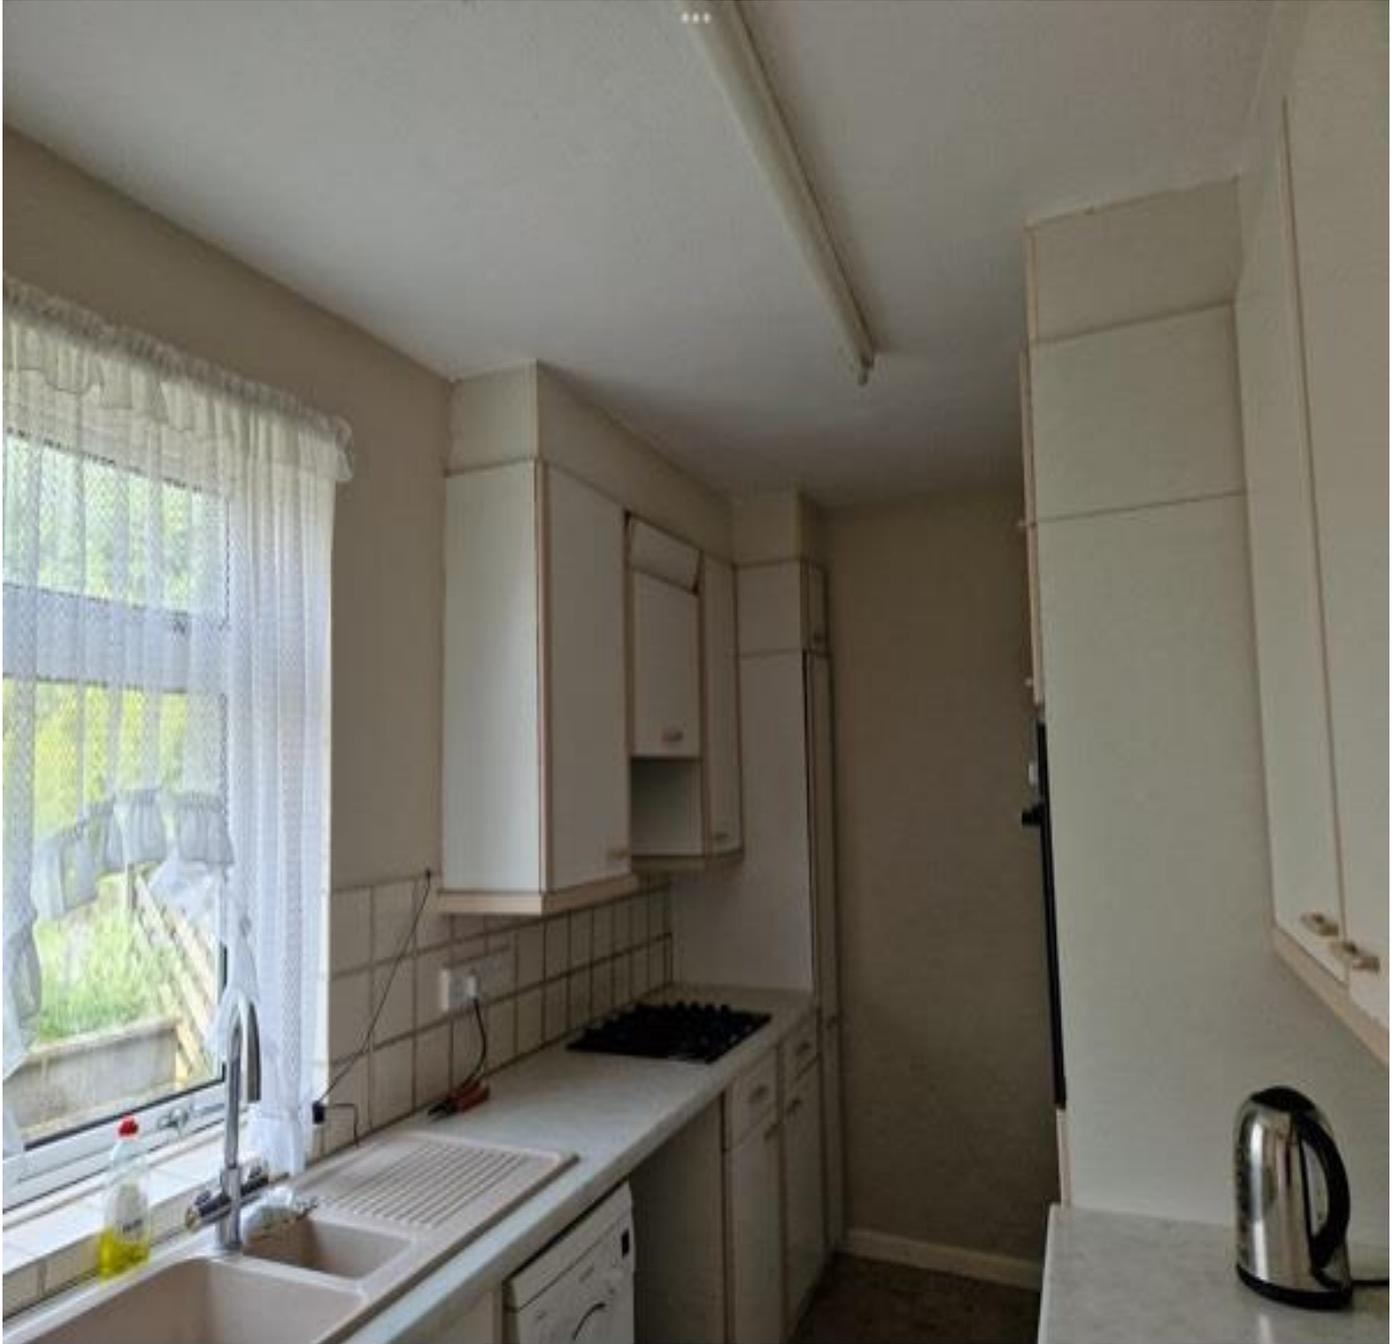
## General Internal Condition
