INFRARED **SURVEY**

Client Name: XXXXX XXXXXXXXXX
Address: WXXCROXX
PEXX FOXXXX
XXXX
SK17 8EG
Purpose of Report: BUILDING HEAT LOSS QUALITATIVE INFRARED ANALISYS
Report Reference: IAS/XXX/2022
Inspection Date: 28 Feb 2022
Surveyor Name: XXXXXX XXXXX BSc (Hons), ASSOC RICS, BCI, CII, BDMA
Thermographer Name: Xxxxxx xxxxx ISO 18436/7 & BINDT CM/GEN
Average Ambient Temperature: 37.40 Fahrenheit
Imager Used: FLIR ONE PRO

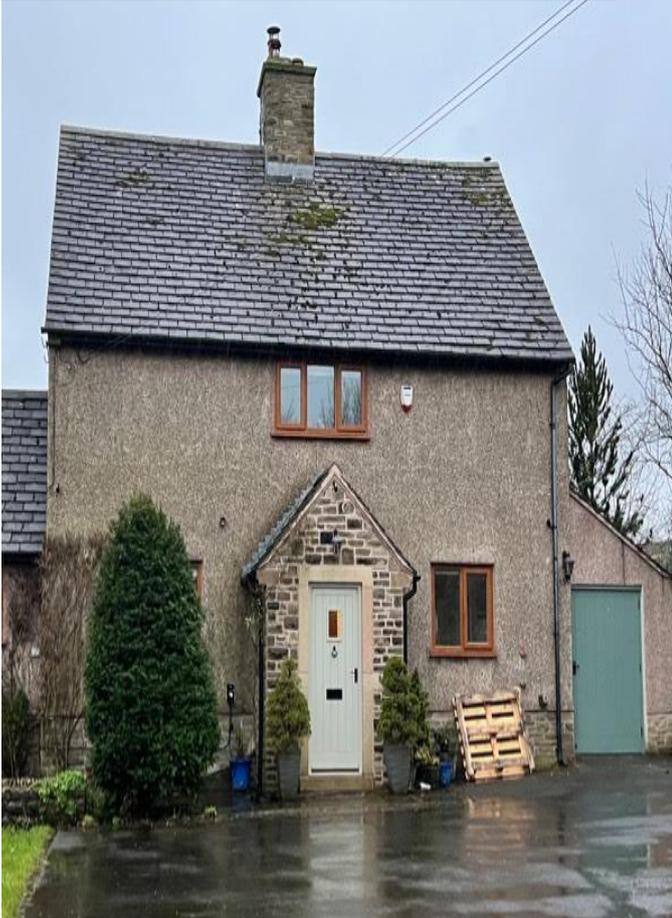
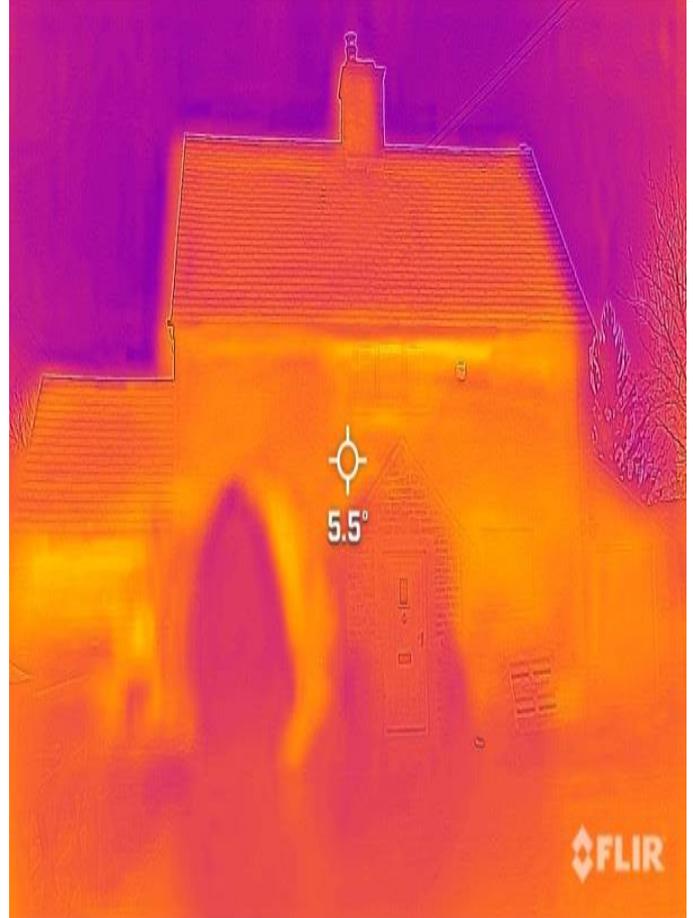
View Of The Main Building At The Front.

Thermal Image Of The Building At The Front.

- The thermal assessment of the external elements found there to be no excessive heat loss from the building. I have been advised the walls have been retrofitted with cavity insulation which appears to be working efficiently with an even distribution of thermal qualities across the surfaces.
- There is however slight heat loss to roof space due to missing insulation from the clipped eaves which has not been installed in this area. Heat is rising up through the clipped eaves level within the upper portion of the building and is escaping the loft space at the ridge line however the heat loss is minimal.
- The window units appear to be performing well again with an even distribution of thermal qualities.

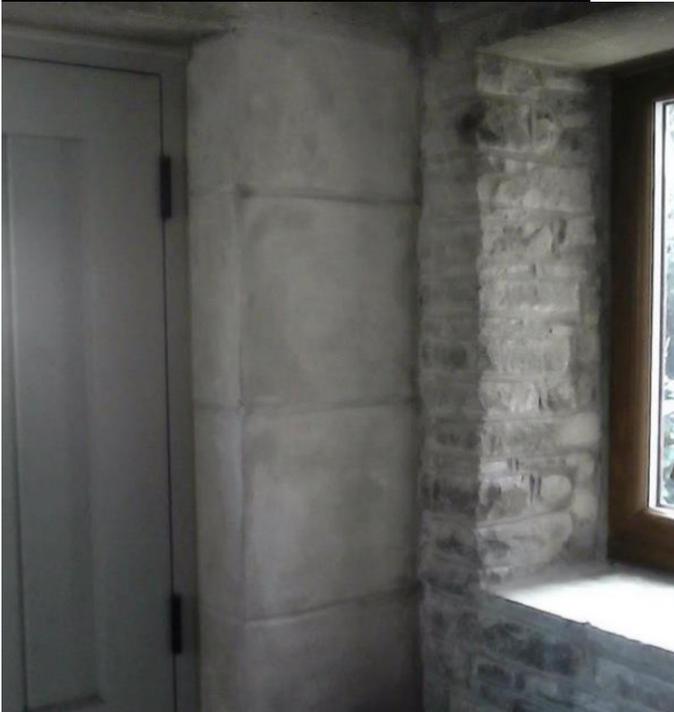
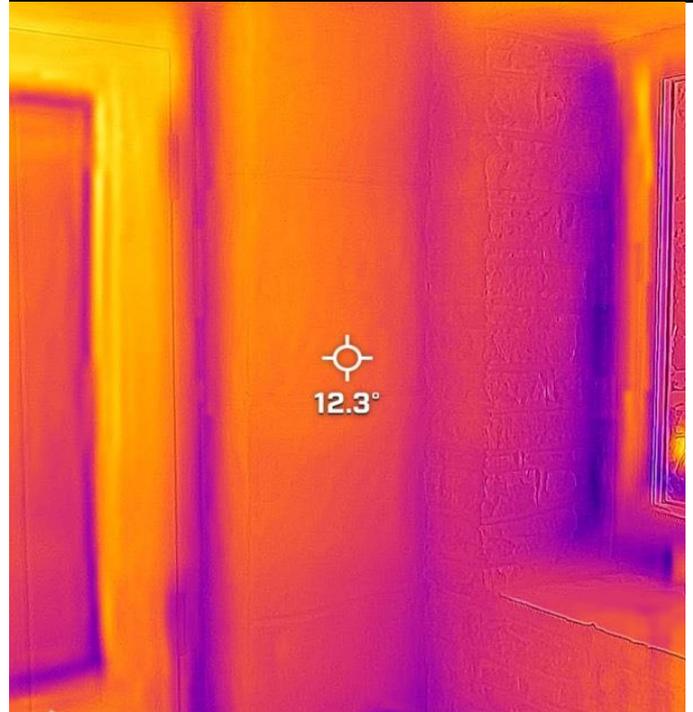
Regular Image Of The Entrance Porch.

Thermal Image Of The Front Entrance Porch.

- The room was found to be colder than the rest of the property and the main cause for concern was to the window frames which had been sealed both externally and internally with a mortar pointing.
- There is a cold bridge around the window frames due to the mortar having a high level of temperature conductivity resulting in cold spots around the windows which would benefit from raising out and sealing with a putty externally and an internal sealant.

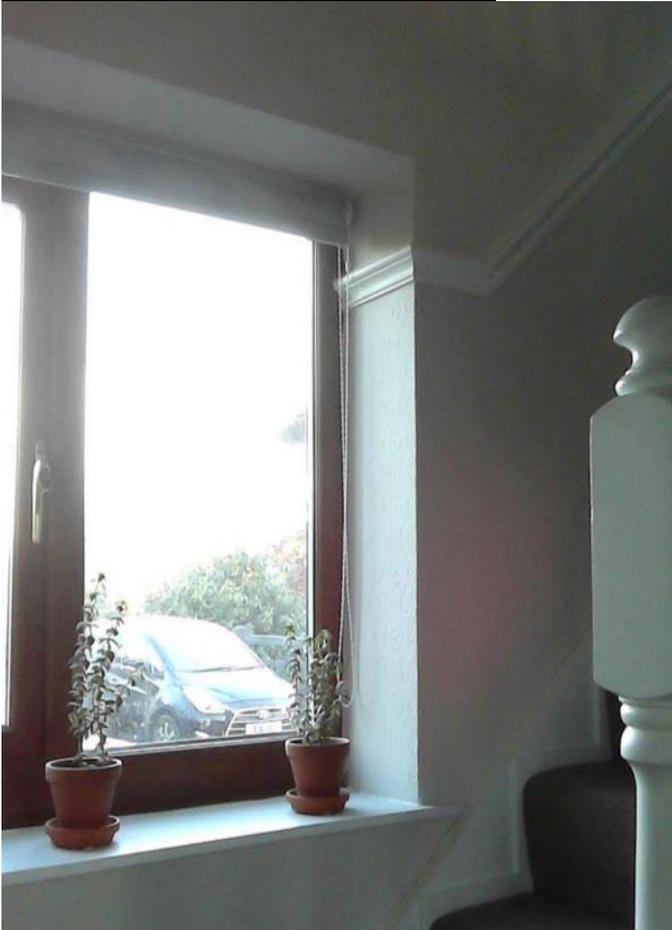
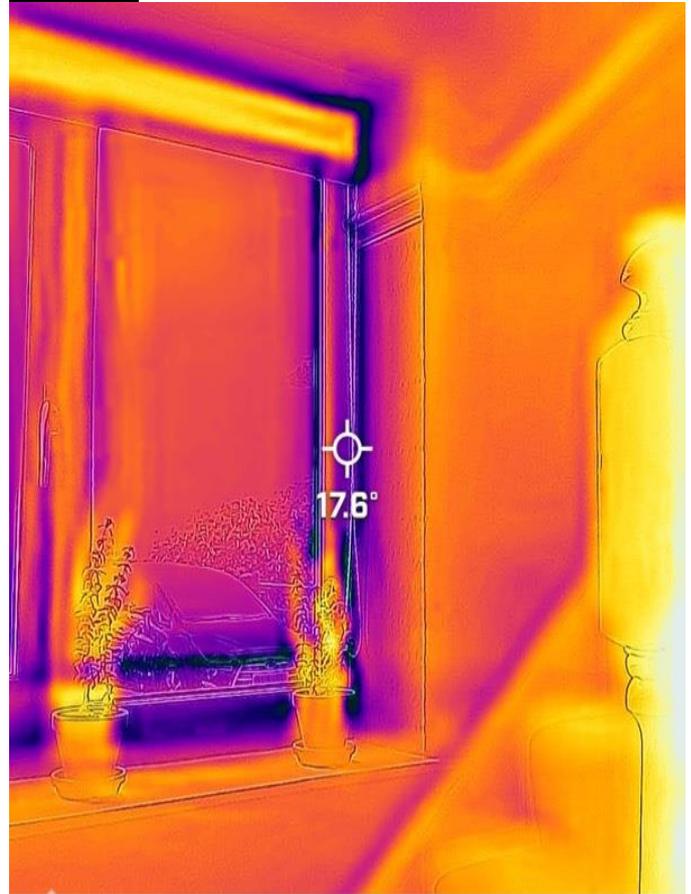
View Of Window To The Hallway

Thermal Image Of The Window To The Hallway.

- The inspection of the hallway found there to be no significant heat loss throughout the fabric of the building however there is a cold bridge around the window frames which is resulting in negative temperature variations within the space. The external inspection found that the render had been formed up to the frame which provided a clear pathway for cold bridging through the window frame.

- There is also concern to the window installation where the render externally has been formed with a bullnose detailing upto the window frame which is causing a cold bridge and causing negative temperature variations around the windows.

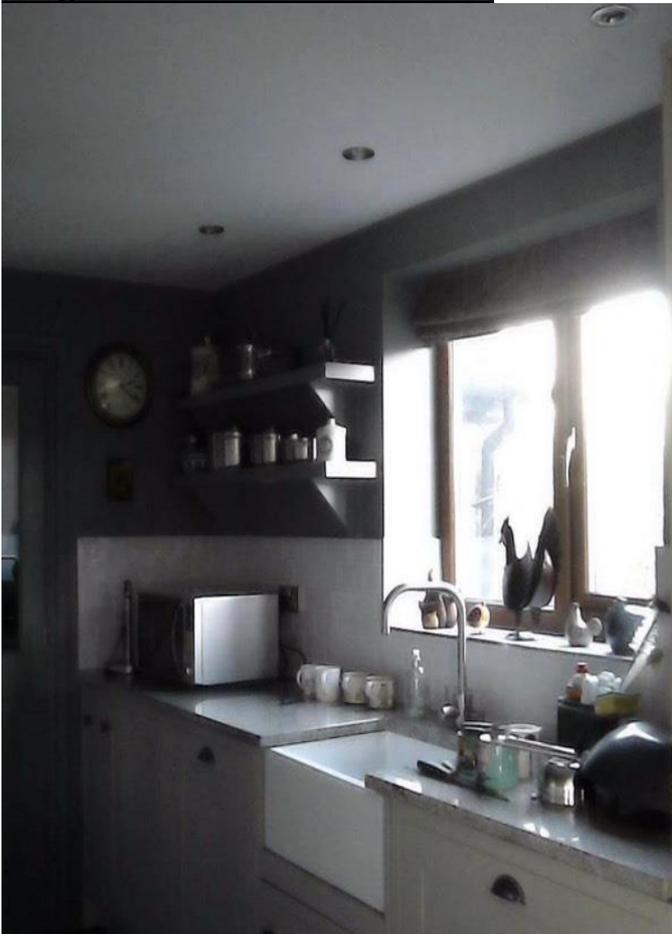
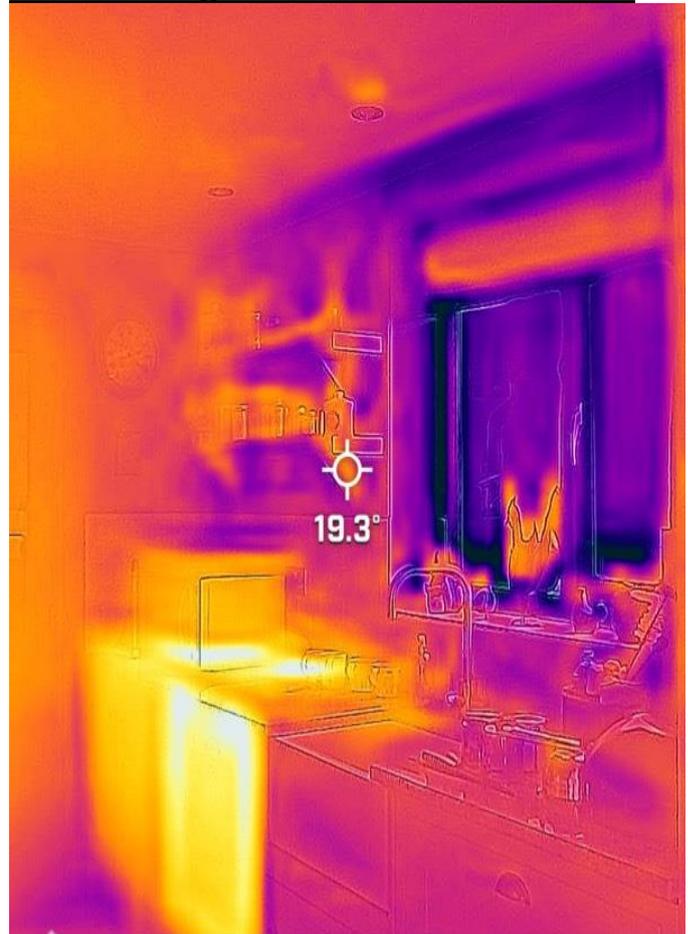
Image From Within The Kitchen.

Thermal Image From Within The Kitchen.

- The inspection of the hallway found there to be moderate heat loss throughout the fabric of the building which is indicated from the darker spots of the thermal image and there is a cold bridge around the window frames which is resulting in negative temperature variations within the space. The external inspection found that the render had been formed up to the frame which provided a clear pathway for cold bridging through the window frame.

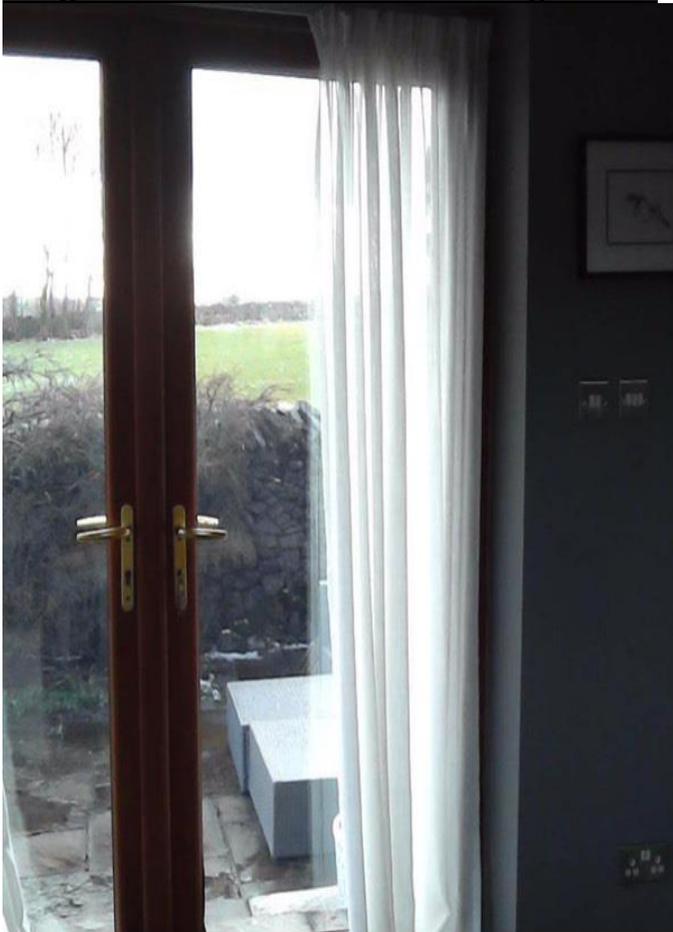
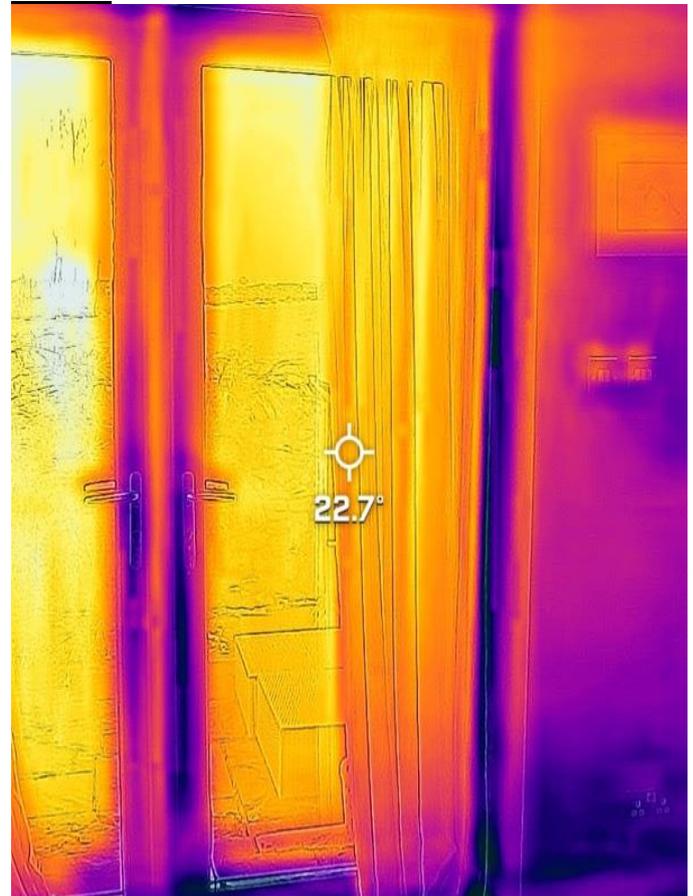
Image From Within The Rear Sitting Room.

Thermal Image Front Within The Rear Sitting Room.

- The inspection of the rear sitting room found there to be moderate heat loss through the fabric of the building which is indicated from the darker spots of the thermal image and there is a cold bridge around the window frames which is resulting in negative temperature variations within the space. The external inspection found that the render had been formed up to the frame which provided a clear pathway for cold bridging through the window frame.

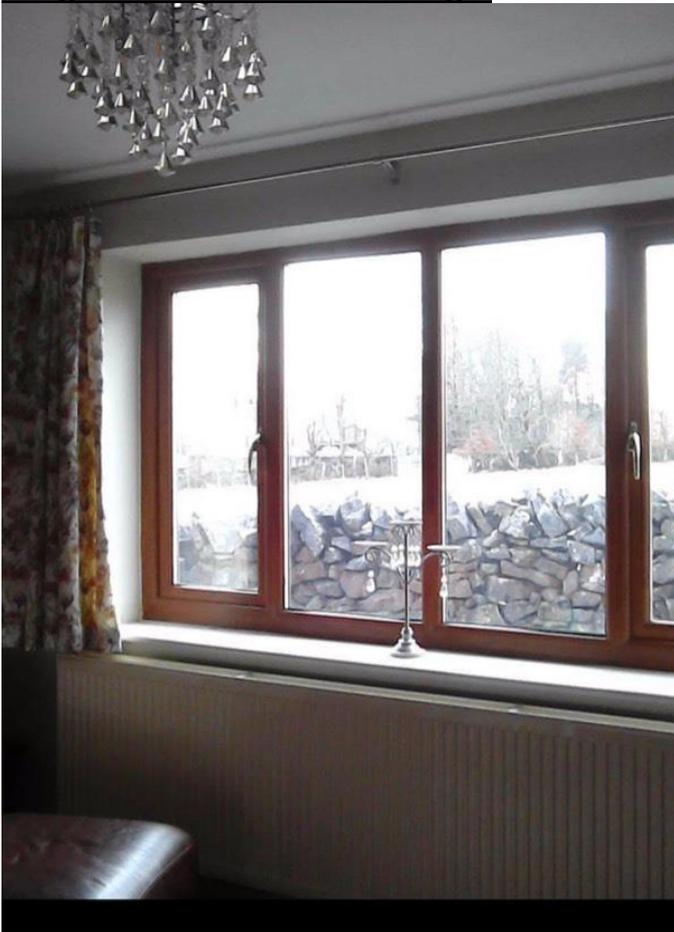
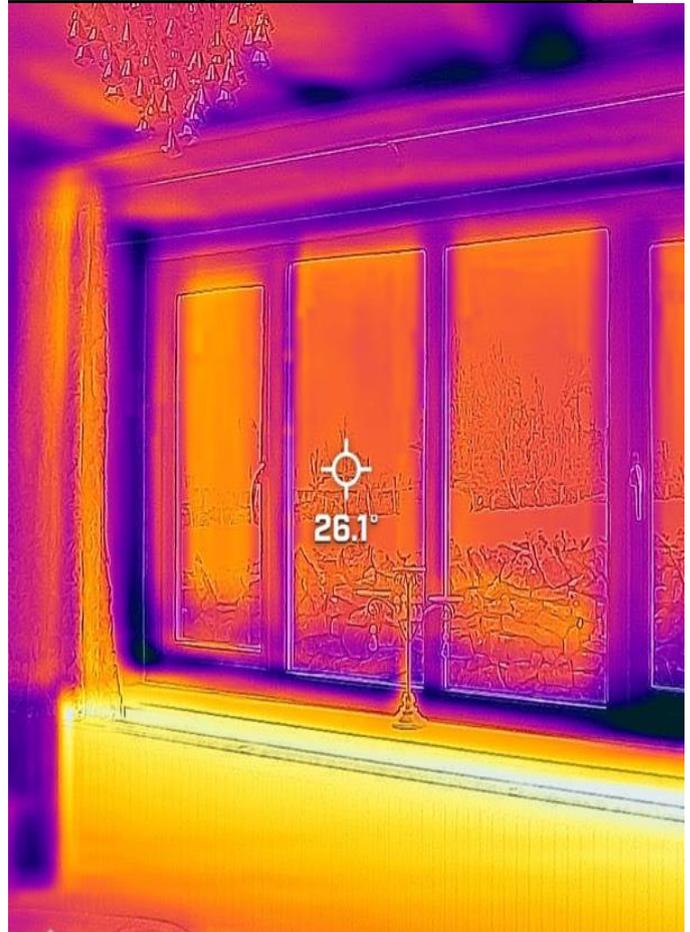
Image From Within The Lounge.

Thermal Image From Within The Lounge.

- The inspection of the lounge found there to be moderate heat loss through the fabric of the building which is indicated from the darker spots of the thermal image and there is a cold bridge around the window frames which is resulting in negative temperature variations within the space. The external inspection found that the render had been formed up to the frame which provided a clear pathway for cold bridging through the window frame.

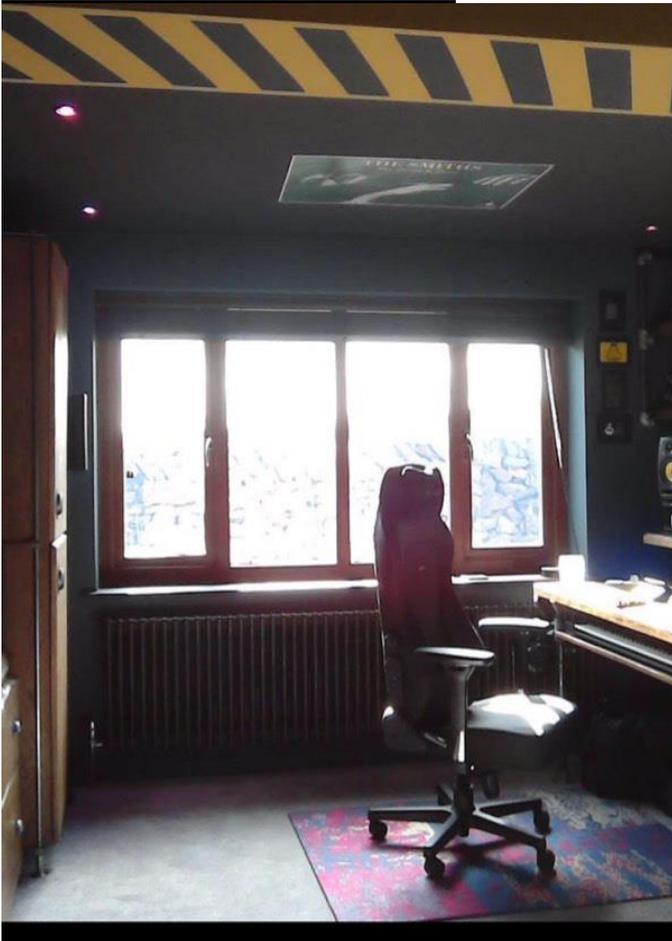
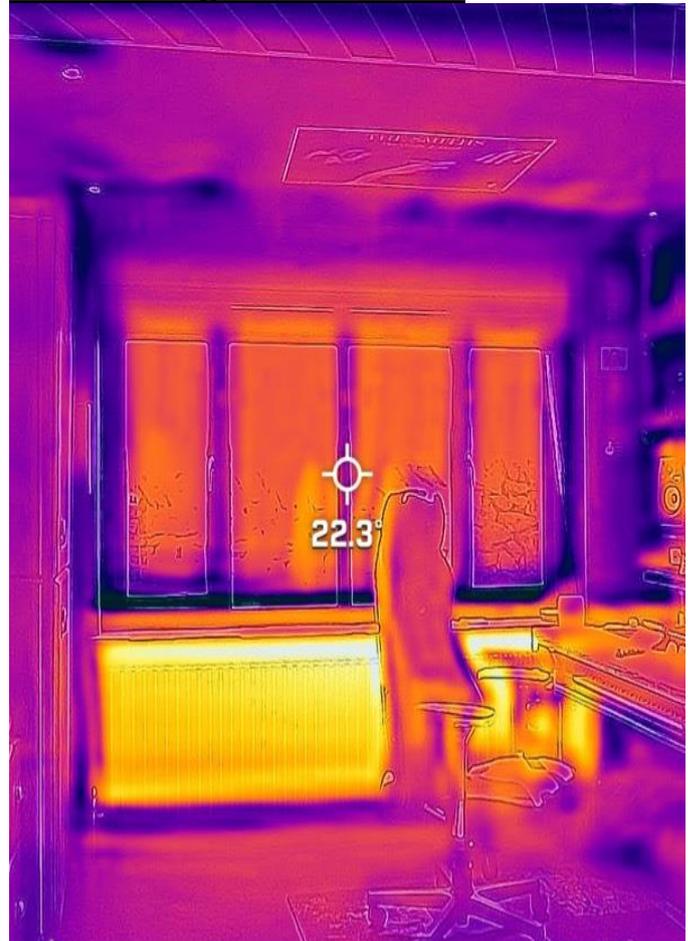
View From Within The Studio.

Thermal Image Of The Studio.

- The inspection of studio found there to be moderate heat loss through the fabric of the building which is indicated from the darker spots of the thermal image and there is a cold bridge around the window frames which is resulting in negative temperature variations within the space. The external inspection found that the render had been formed up to the frame which provided a clear pathway for cold bridging through the window frame.

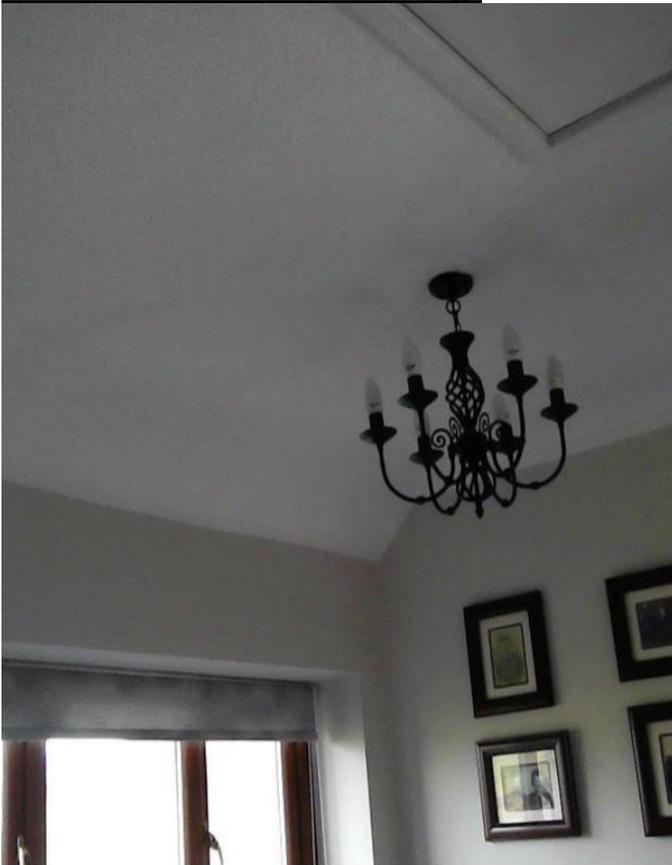
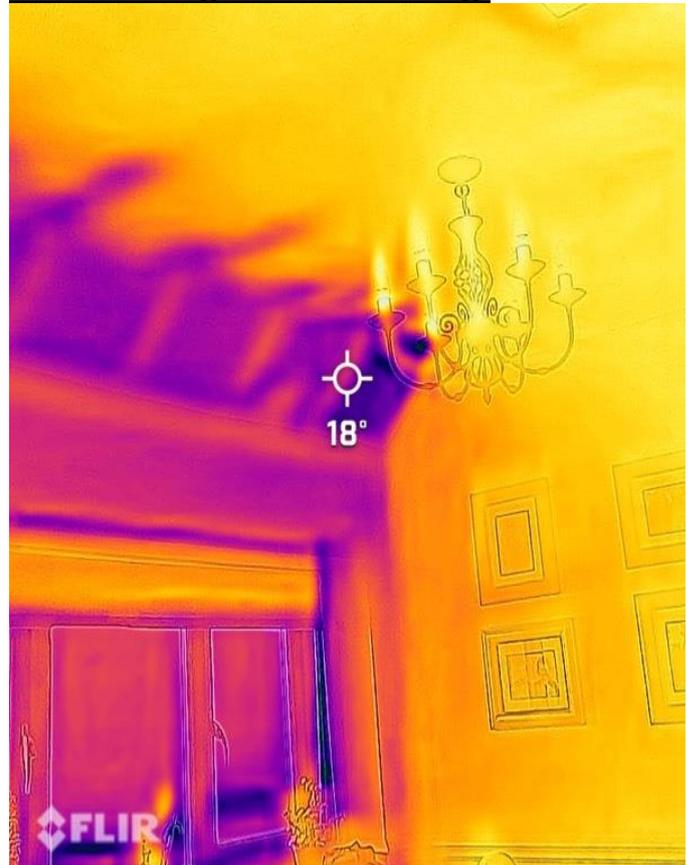
View From Within The Landing.

Thermal Image Of The Landing.

- The inspection of landing found there to be moderate heat loss through the fabric of the building, and into the loft space which is indicated from the darker spots of the thermal image. There is also a cold bridge around the window frames which is resulting in negative temperature variations within the space. The external inspection found that the render had been formed up to the frame which provided a clear pathway for cold bridging through the window frame. Inspection from within the loft space found that the insulation has not been installed to the clipped eaves which is resulting in excessive heat loss into the loft space.

- The main cause for concern is the lack of insulation to the clipped eaves which correlates with the client comments that the upper rooms are colder than the rear two of the building and is uncomfortable.

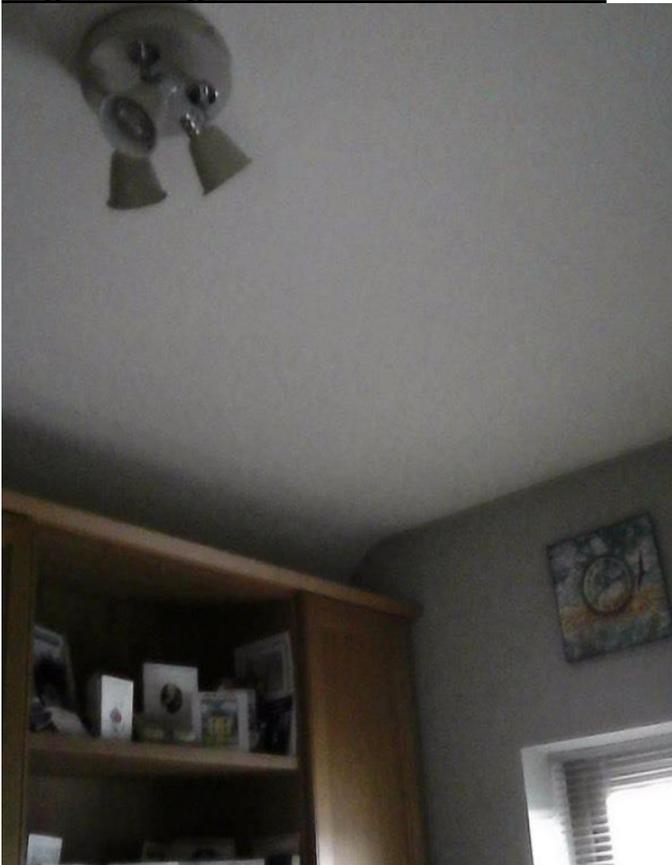
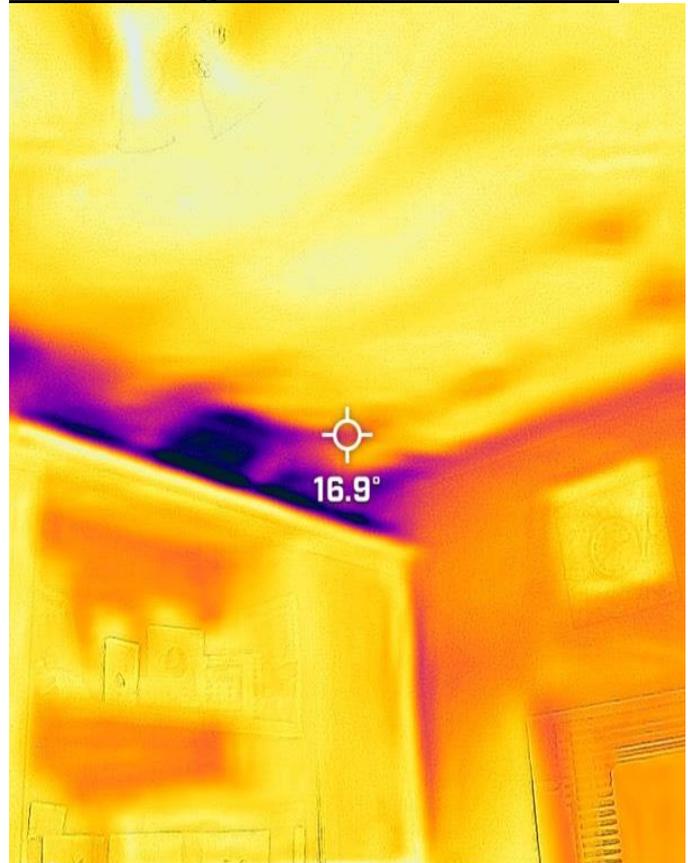
Regular Image From Within Bedroom 1.

Thermal Image From Within Bedroom 1.

- The inspection of bedroom 1 found there to be moderate heat loss through the fabric of the building, and into the loft space which is indicated from the darker spots of the thermal image. There is also a cold bridge around the window frames which is resulting in negative temperature variations within the space. The external inspection found that the render had been formed up to the frame which provided a clear pathway for cold bridging through the window frame. Inspection from within the loft space found that the insulation has not been installed to the clipped eaves which is resulting in excessive heat loss into the loft space.

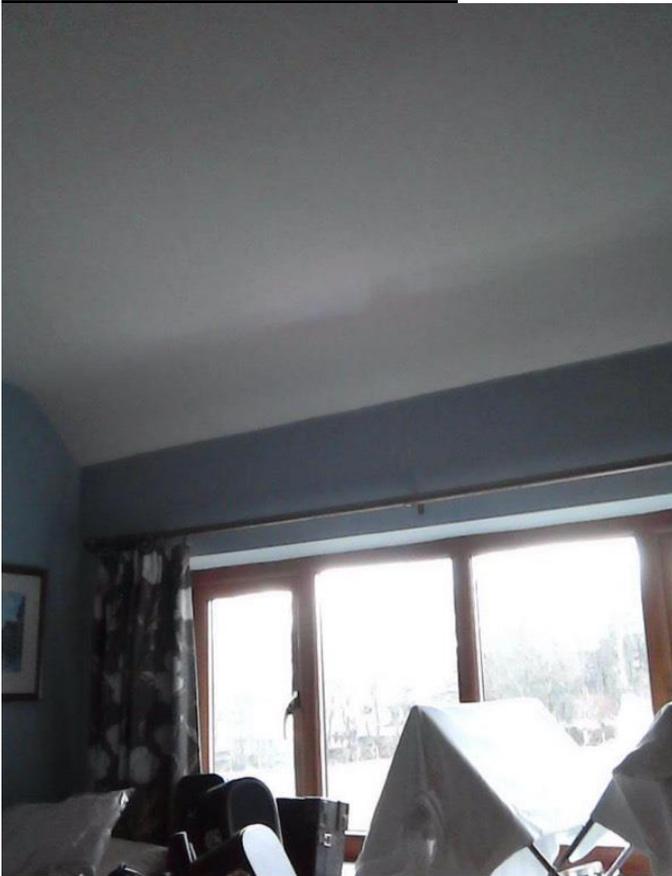
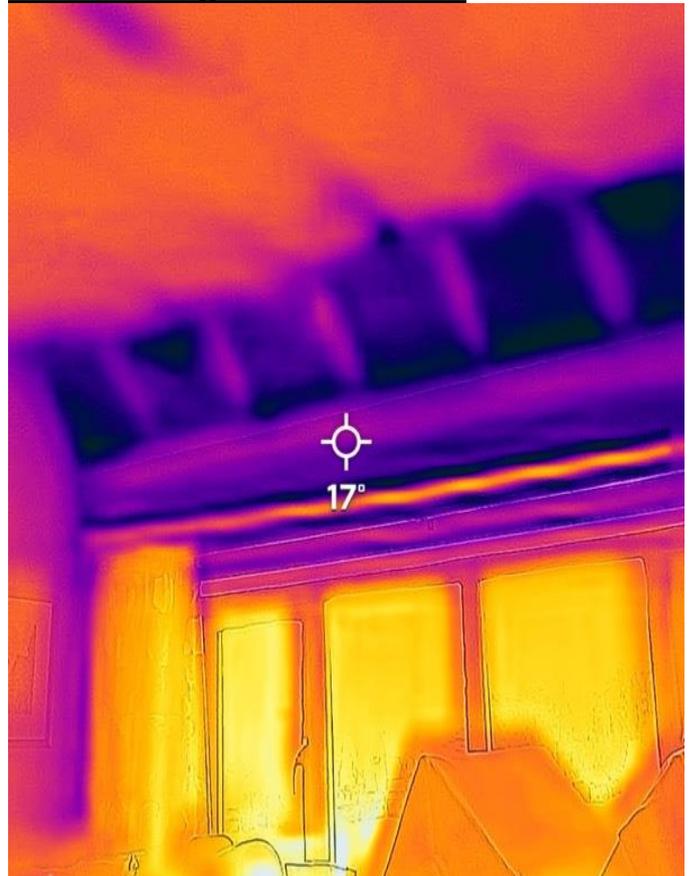
View From Within Bedroom 2.

Thermal Image Of Bedroom 2.

- The inspection of bedroom 2 found there to be moderate heat loss through the fabric of the building, and into the loft space which is indicated from the darker spots of the thermal image. There is also a cold bridge around the window frames which is resulting in negative temperature variations within the space. The external inspection found that the render had been formed up to the frame which provided a clear pathway for cold bridging through the window frame. Inspection from within the loft space found that the insulation has not been installed to the clipped eaves which is resulting in excessive heat loss into the loft space.

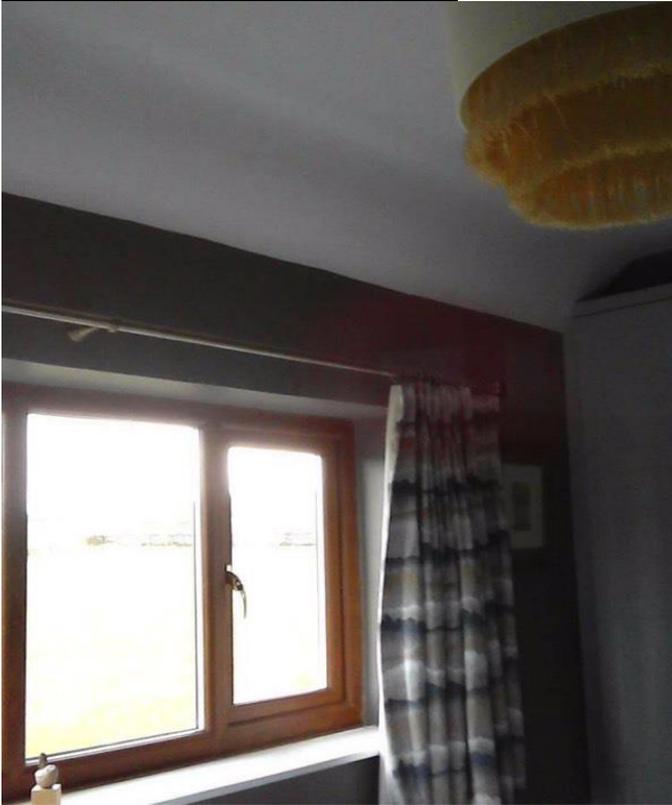
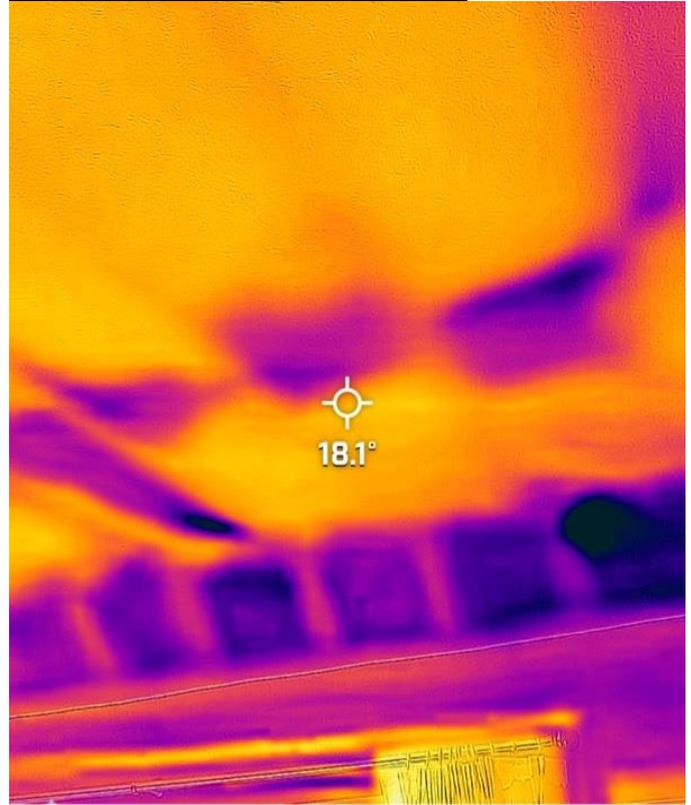
View From Within Bedroom 3.

Thermal Image Of Bedroom 3.

- The inspection of bedroom 3 found there to be moderate heat loss through the fabric of the building, and into the loft space which is indicated from the darker spots of the thermal image. There is also a cold bridge around the window frames which is resulting in negative temperature variations within the space. The external inspection found that the render had been formed up to the frame which provided a clear pathway for cold bridging through the window frame. Inspection from within the loft space found that the insulation has not been installed to the clipped eaves which is resulting in excessive heat loss into the loft space. Water ingress from the roof has also been detected to the ceiling as seen in the thermal image and this is as a result of driving rain from the recent storms.
