Client Name: XXX XXXXXXXXXX
Address: X XXX XXXXX
XXXXXXXX
XXXXX
XXX XXXX
Purpose of Report: STRUCTURAL BUILDING SURVEY
Report Reference: SBS|XXX|XXXX
Inspection Date: 0X MXX 20XX
Surveyor Name: XX XXXXX XXXXX BSc Hons, MCIQB, CSRT, CSSW, DipDEA, UKAS-P402/P405
Building Surveyor Engineer Name: XXXX XXXXXXXX BSc (Hons) C Build E, MCABE.

State of repair: Poor Condition

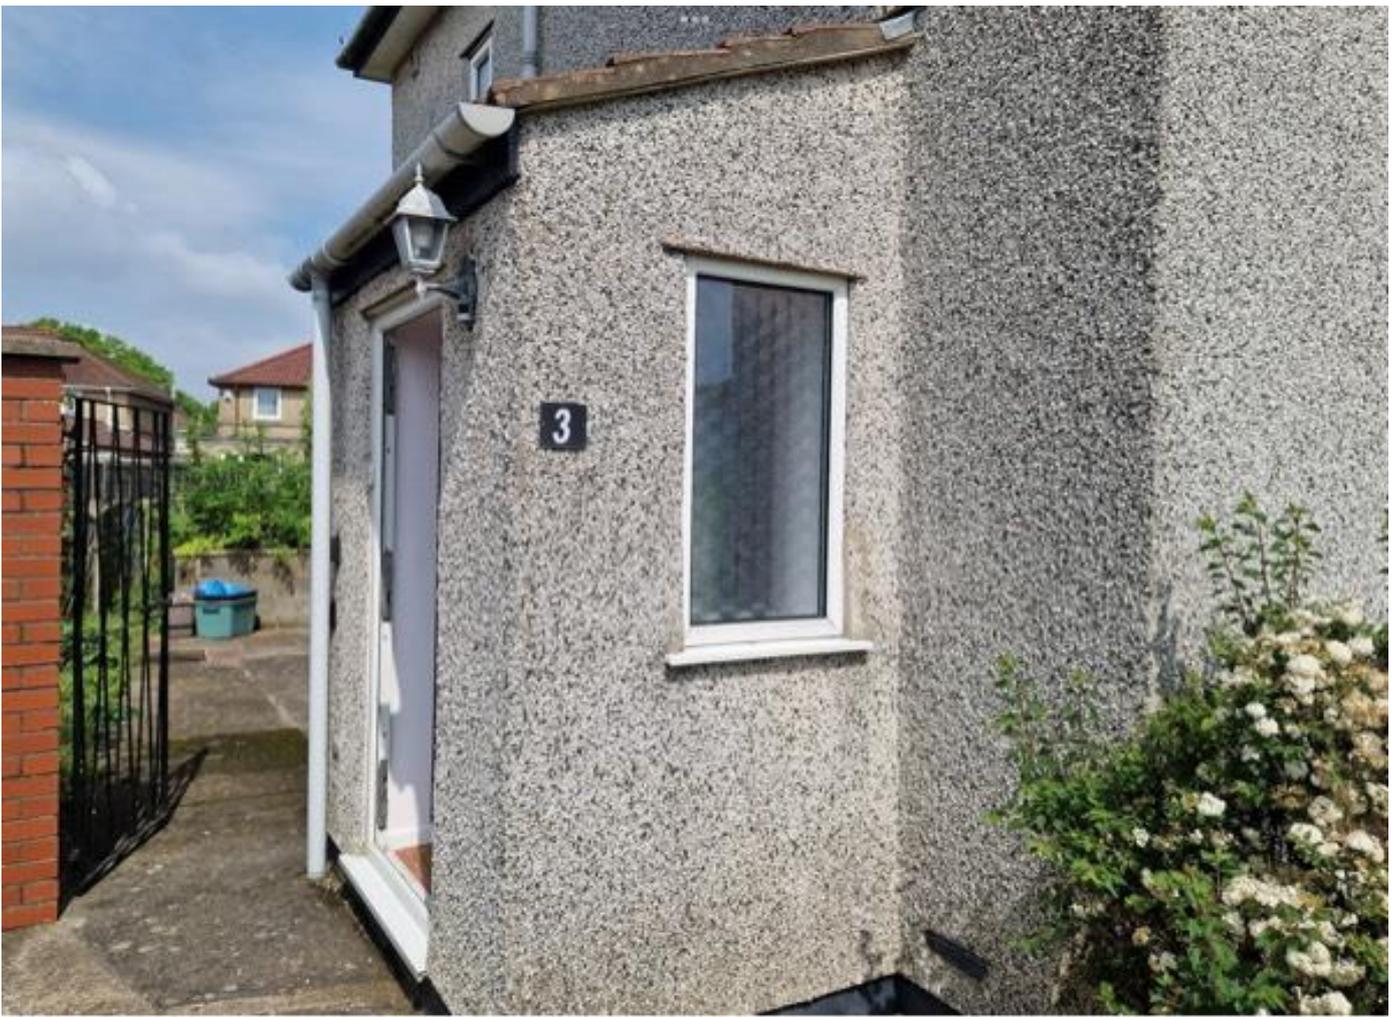
Secondary Roof

- There is a secondary cut timber roof to the ground floor porch. This is a mono pitched roof with gabled finish with the same concrete interlocked roof coverings as the main roof.
- The roof was noted to be in satisfactory condition with no evidence internally to suggest issues with the waterproof values of the structure or 'know on' effects flowing slight spread of the main roof.
- Water is discharged from the roof via a PVCU gutter section rainwater system with outlet downpipes hold fast fixed to the external elevations.
- The gutter section rainwater system shows physical evidence of blockages with debris causing restrictions to the water flow leading to the rainwater outlets.
- Recommend these are cleared and repaired to prevent water penetration to the building.

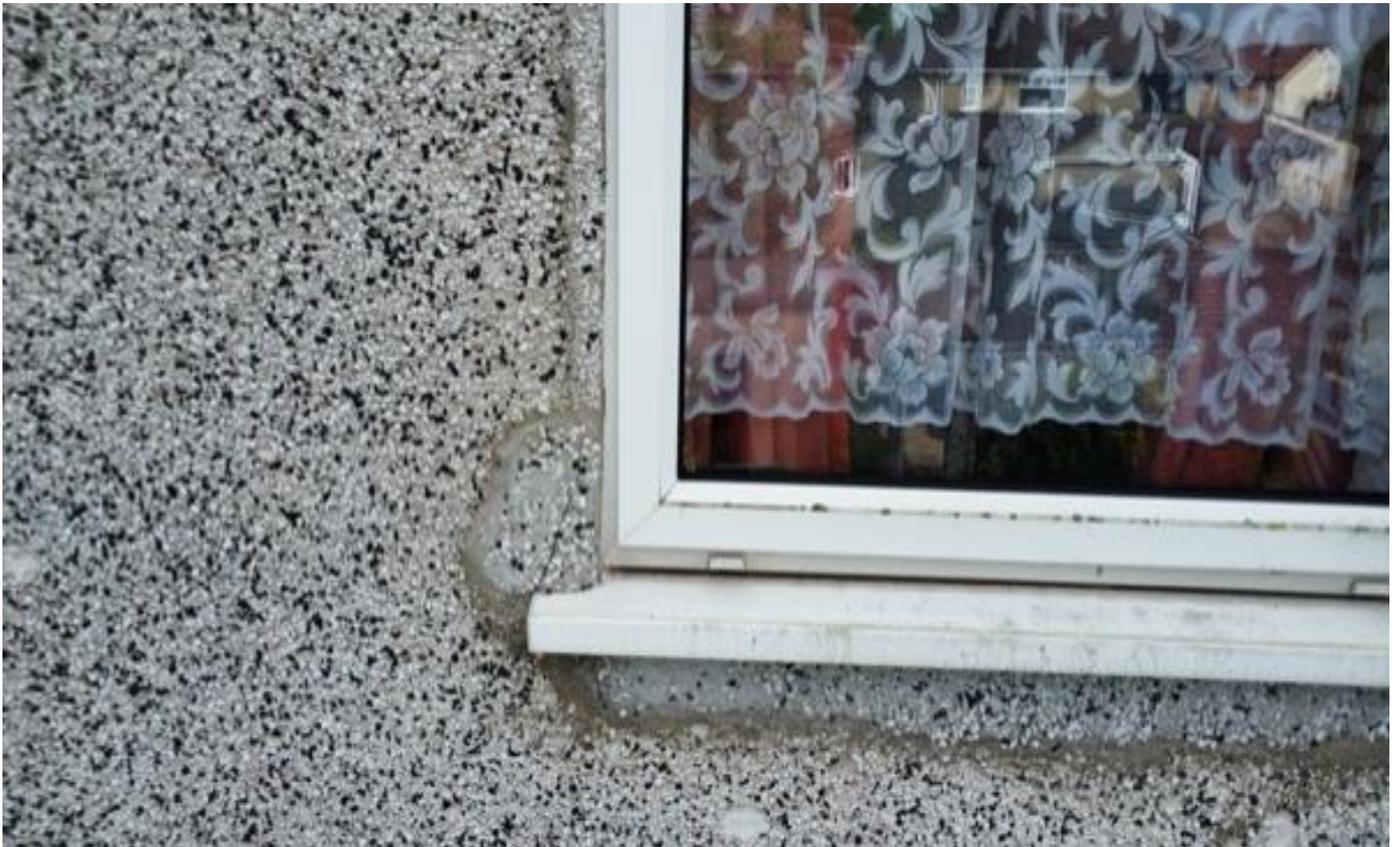
General condition of Render and Window Install.

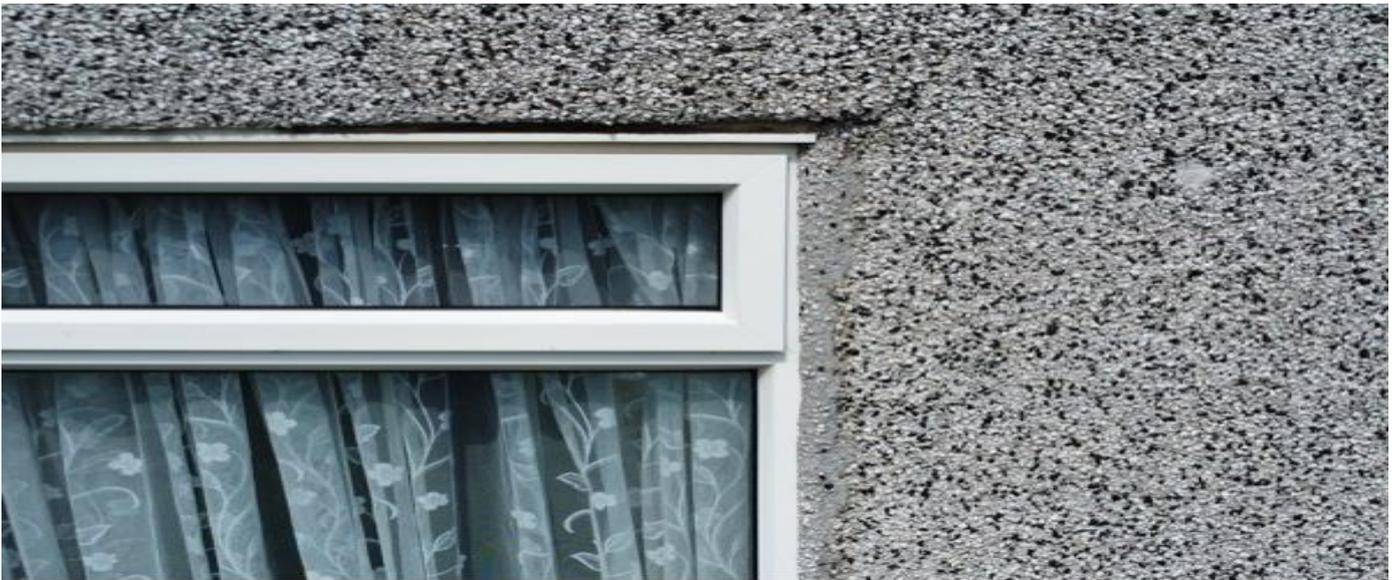
General condition of Render and Window Install/repairs

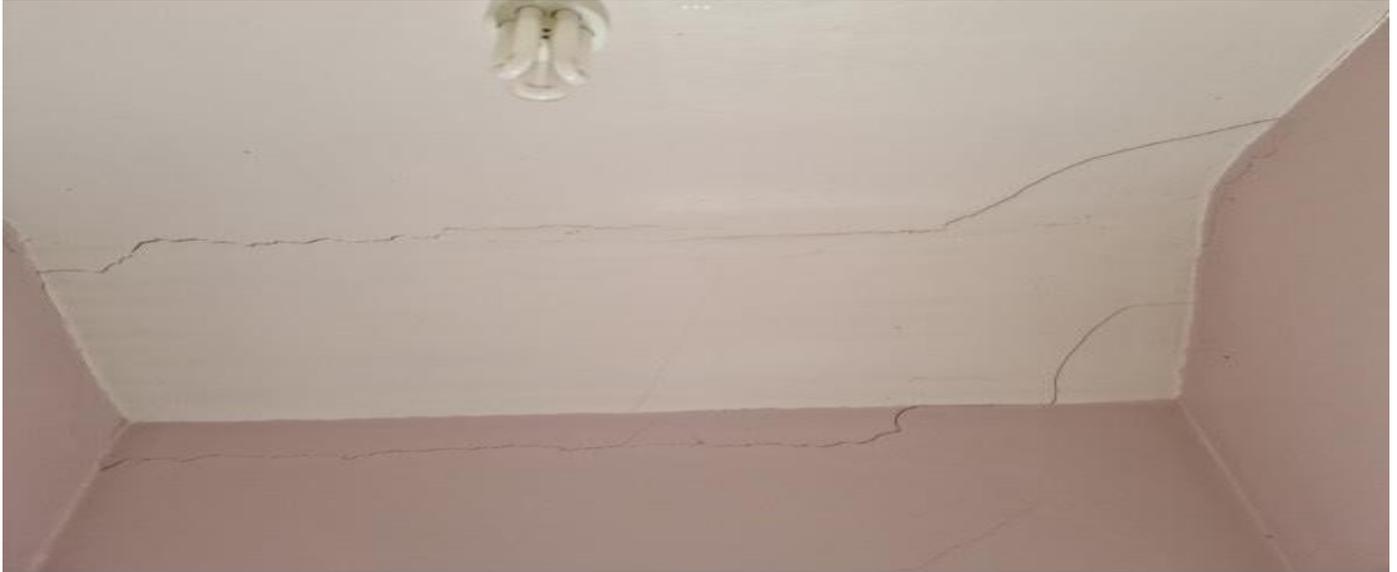
Internal Cracking to Ceiling & Wall Surfaces (consistent with roof spread)

- Recommend structural strengthening by way of timber web support propping and strapping of timber supporting roof structures, this to prevent any further spread and or sag occurring.

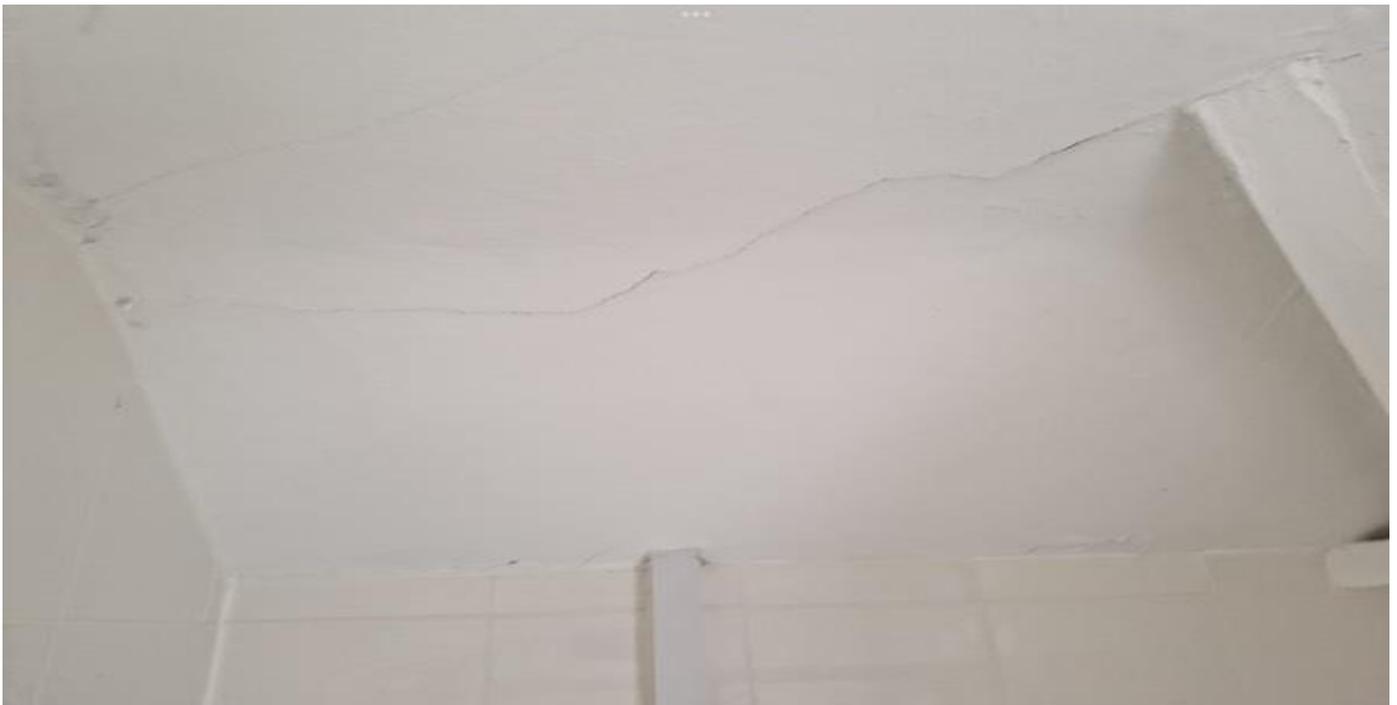
Internal Cracking to Ceiling & Wall Surfaces (consistent with roof spread)

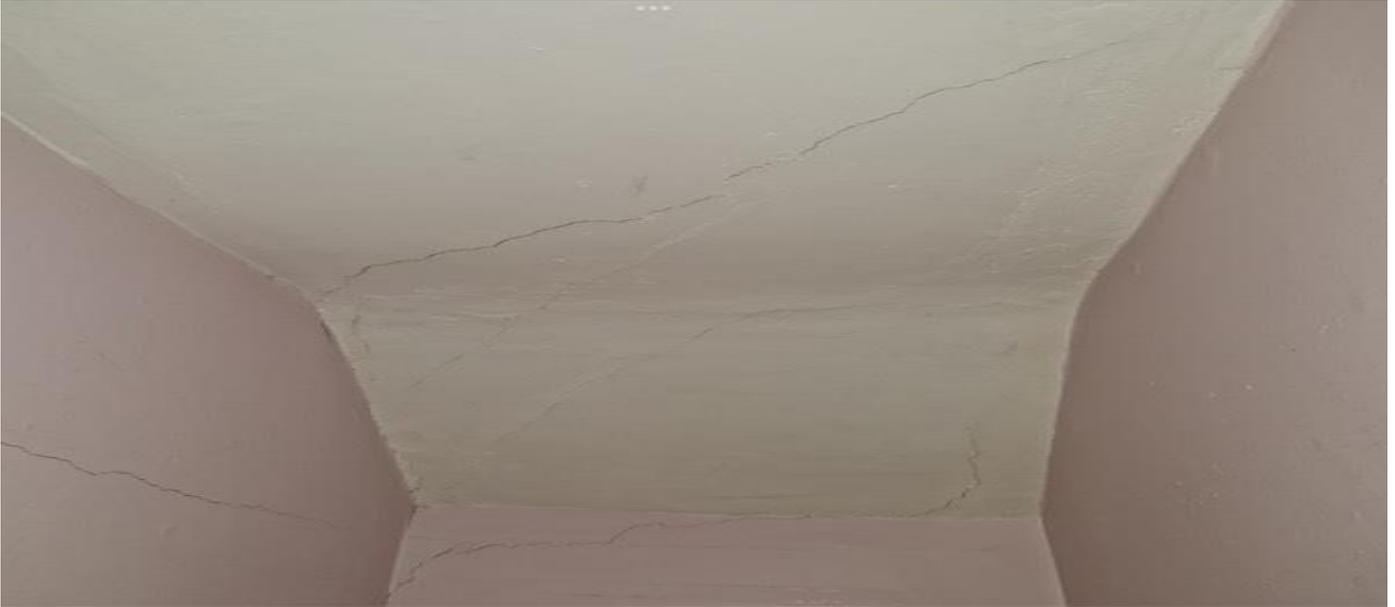
Internal Cracking to Ceiling & Wall Surfaces (consistent with roof spread)

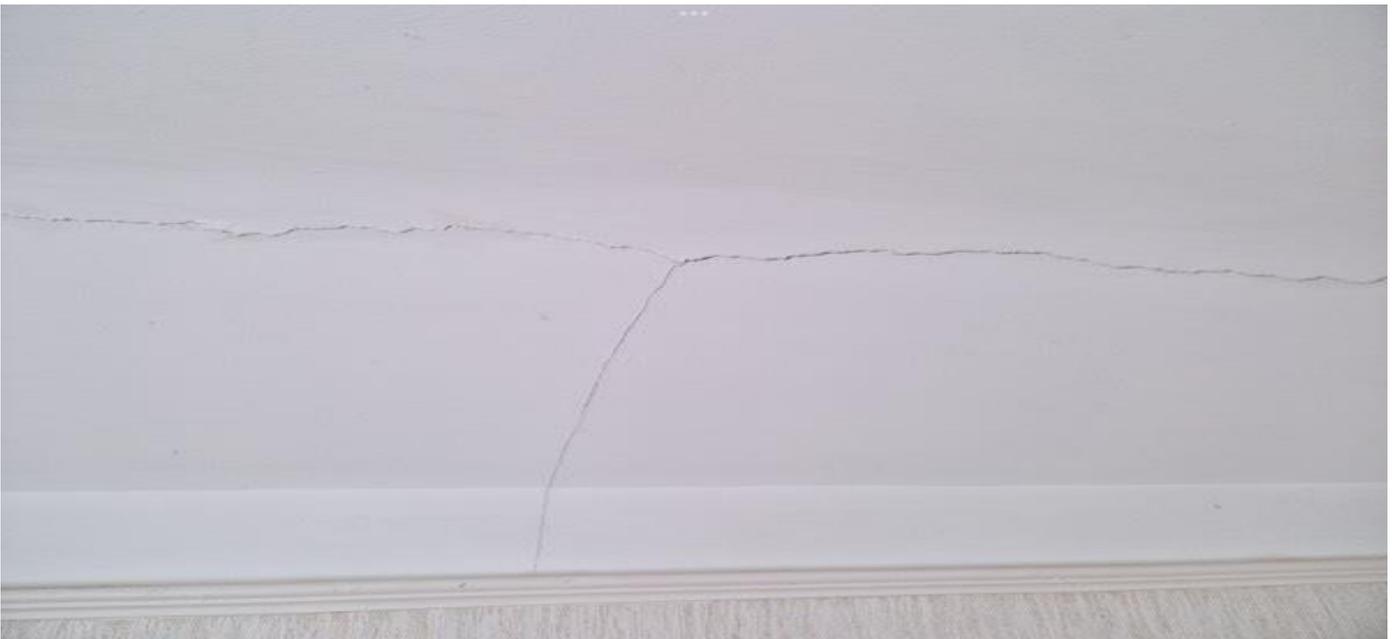
Internal Cracking to Ceiling & Wall Surfaces (consistent with roof spread)

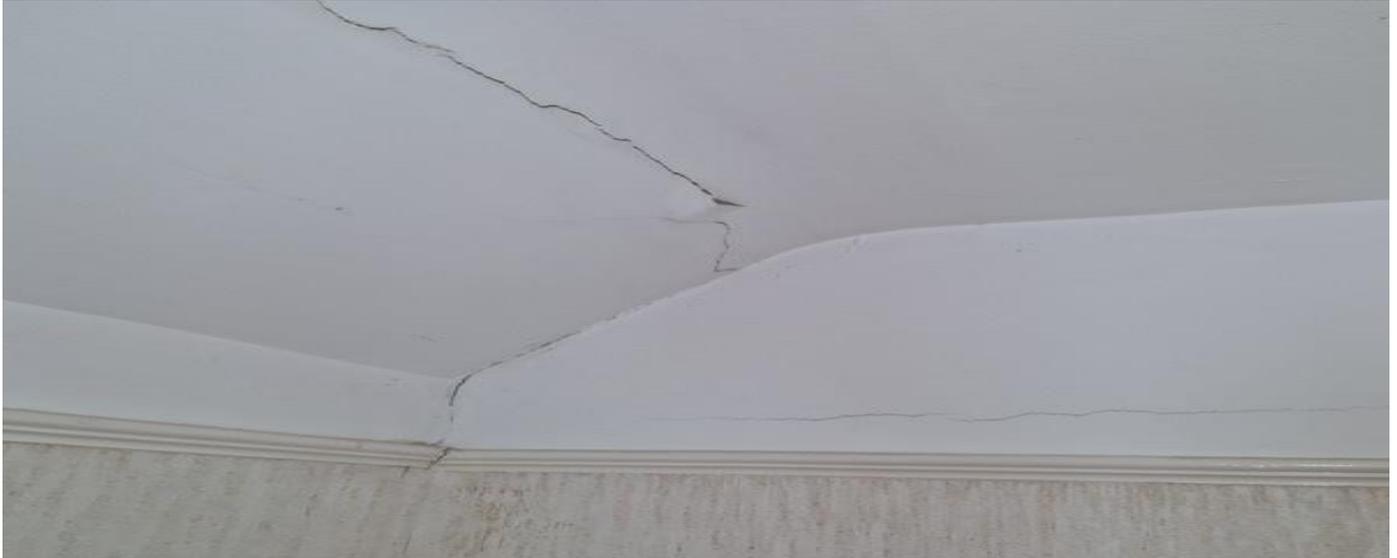
Internal Cracking to Ceiling & Wall Surfaces (consistent with roof spread)

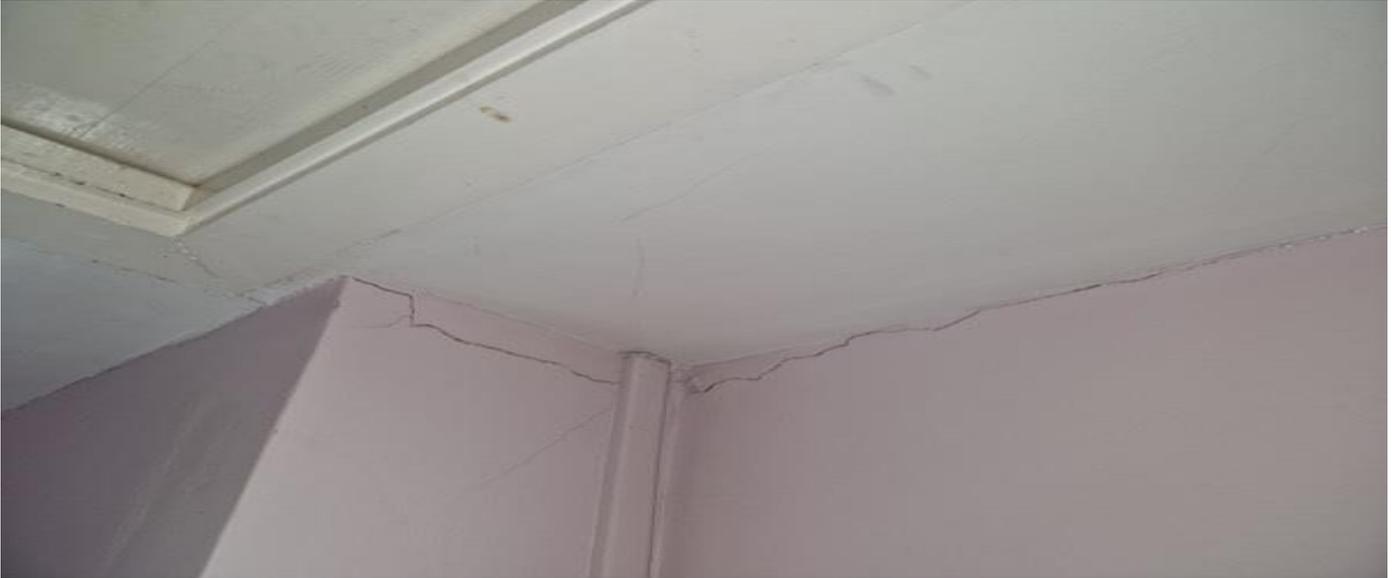
Internal Cracking to Ceiling & Wall Surfaces (consistent with roof spread)

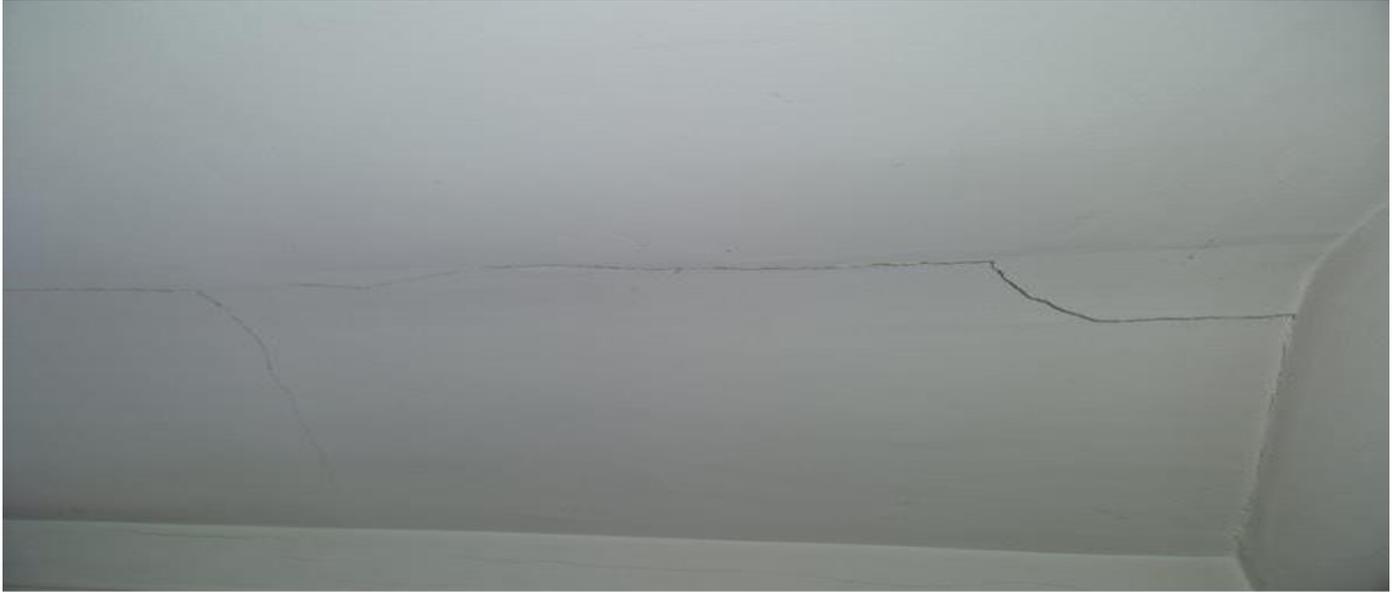
Internal Cracking to Ceiling & Wall Surfaces (consistent with roof spread)

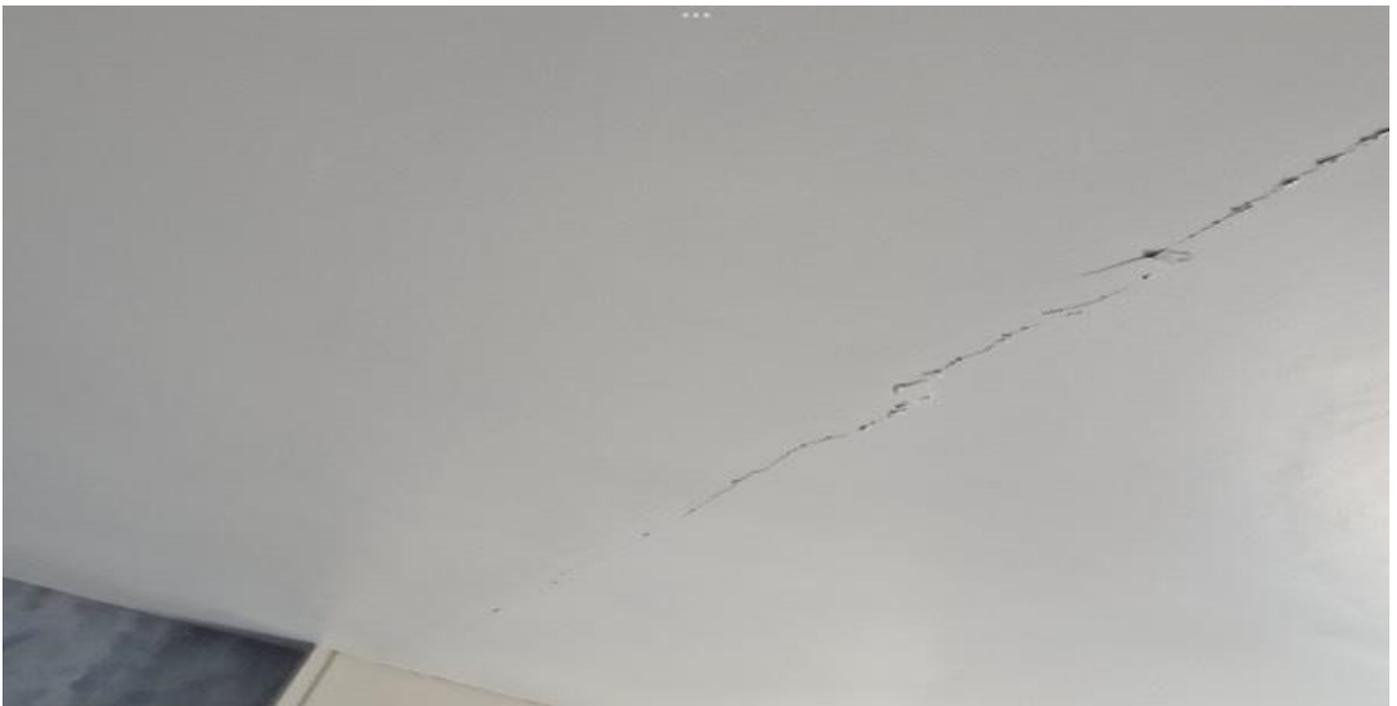
Internal Cracking to Ceiling & Wall Surfaces (consistent with roof spread)
