PROPERTY SURVEY

Client Name: XXX XXXXX XXXXX
Address: XX XXXXX XXXXXX
XXXXXX XXXXXX
XXXXXX
XX7 0XX
Purpose of Report: STRUCTURAL BUILDING SURVEY
Report Reference: SBS/XXX/2022
Inspection Date: 16 May 2022
Surveyor Name: XXXXX XXXXX BSc (Hons), ASSOC RICS, BCI, CII, BDMA
Building Surveyor Engineer Name: XXXX XXXX BSc (Hons) C Build E, MCABE.

- The property inspected was a farm located on a large plot of open fields of a country road and comprised of two main buildings to include a large stone-built building and a good-sized stone built detached bungalow within the grounds. The main building was found to comprise of a traditionally constructed stone-built structure which had a timber roof with a network of trusses and purlins and rafters supported on load-bearing walls. The roof has been covered with a natural slate roof covering and had a segmented decorative ridge tiles to the ridge line. There were several additions to the main building including a dormer projection at the front, a two-story extension at the front and a glazed conservatory at the rear.

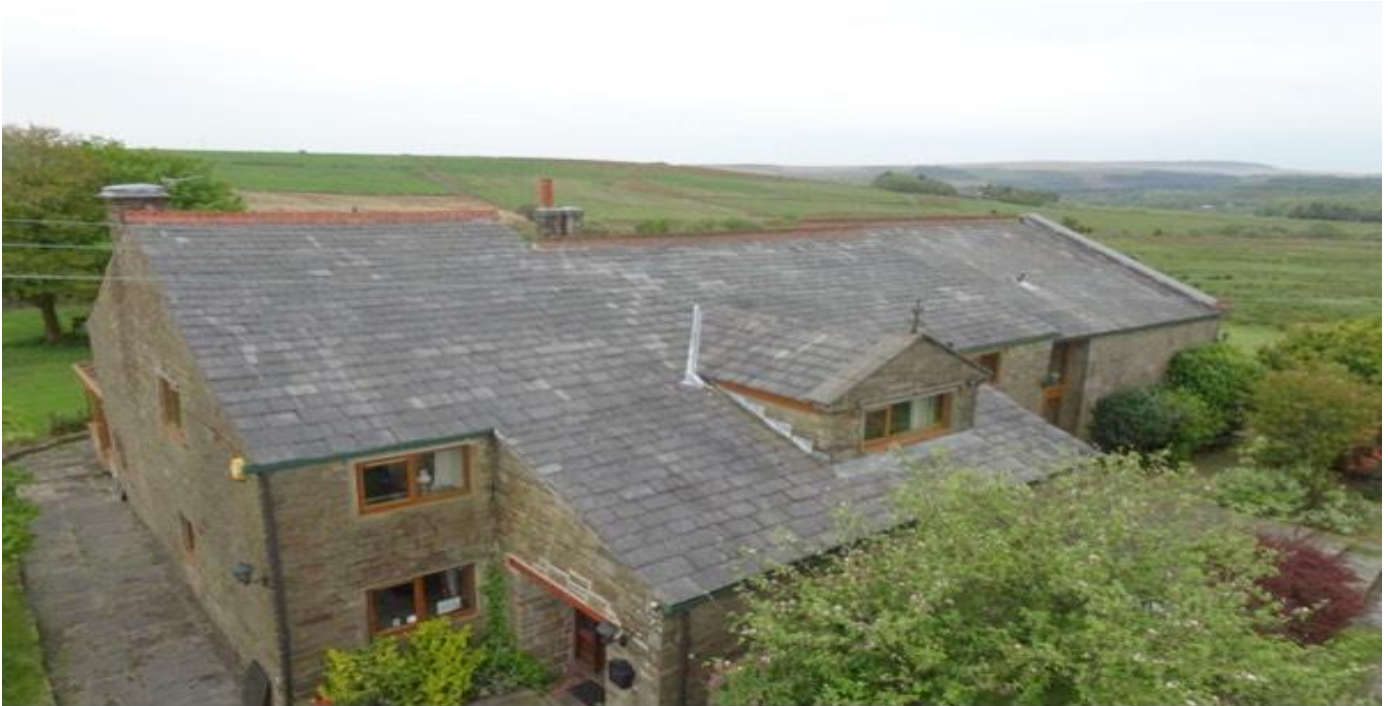
- The inspection of the main roof coverings across the natural slate services found these to be in poor condition with evidence of excessive historical repairs, lead tabs indicating nail fatigue, slipped and missing slates isolated areas, cracked slates in isolated areas, perished mortar flaunching and mortar pointing to the chimney with dated and deformed leading to the abutments and to the copings all of which would require renewal info to ensure water tightness of the roof structure.

Overview of the main roof and additions at the front.

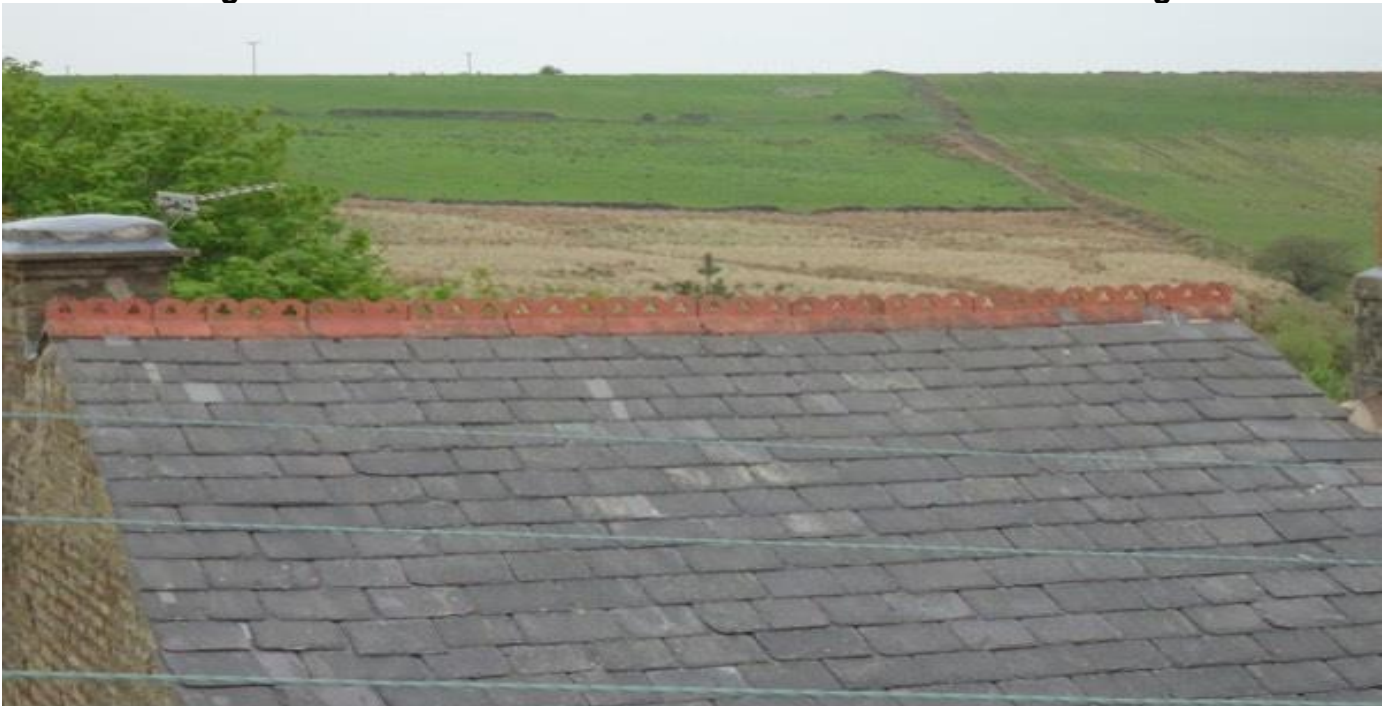
View of the ridge tiles at the left hand side from the front of the main building.

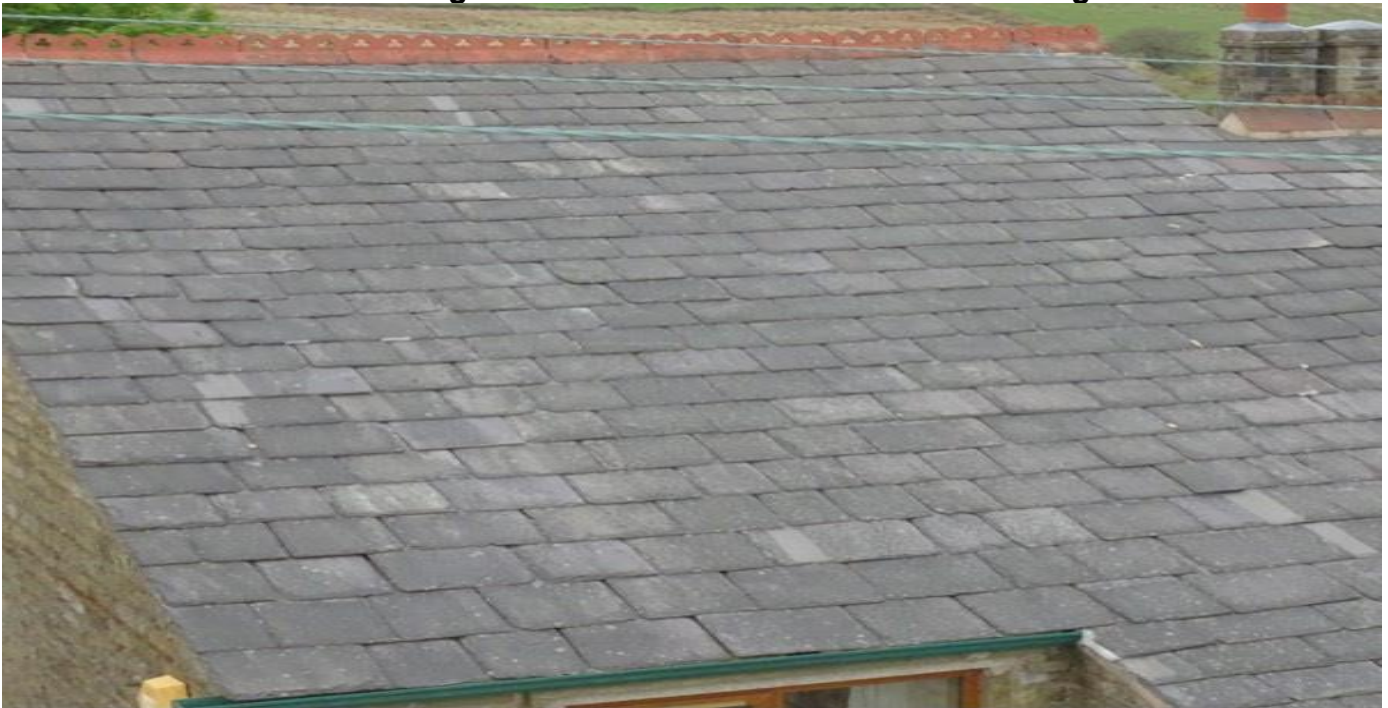
View of the main roof covering to the left hand side of the main building from the front.

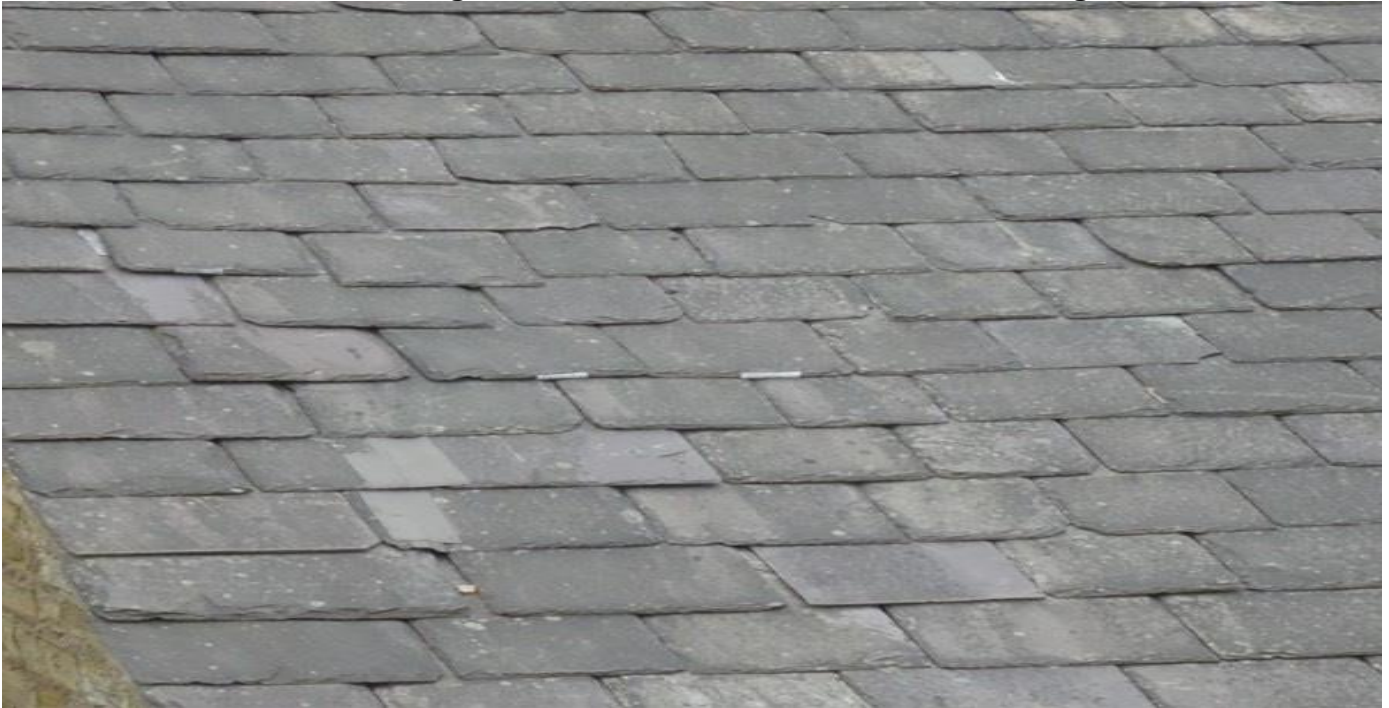
View of the main roof covering to the left hand side of the main building from the front.

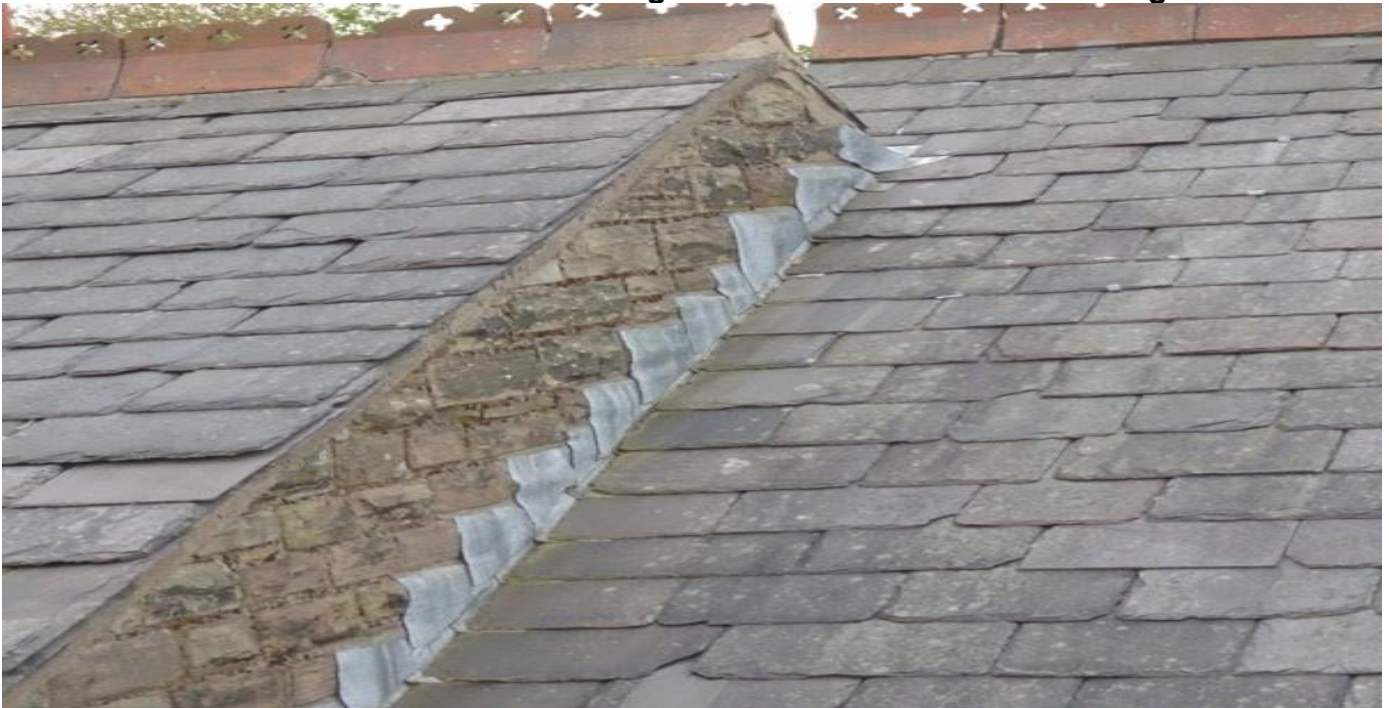
View of the leaded wall abutments to the right hand side of the main building from the front.

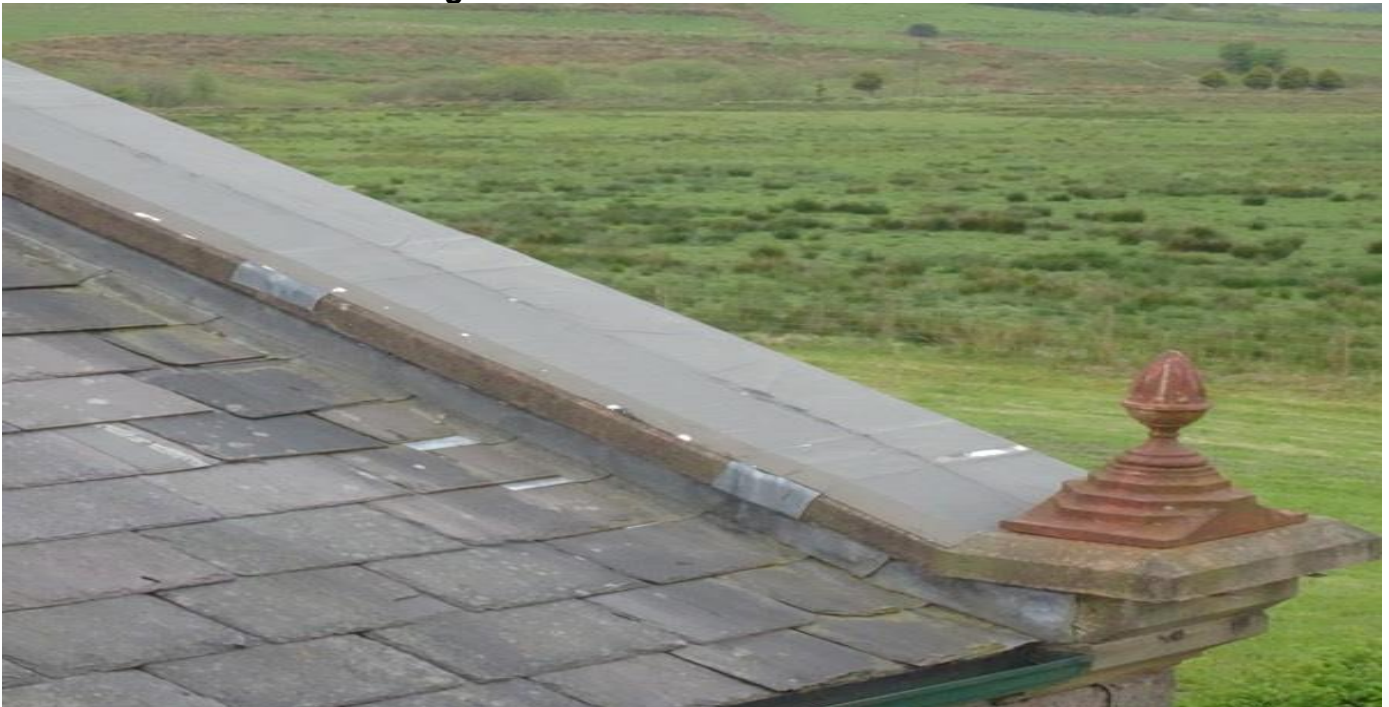
- There was evidence of whether sealant applied to the top of the chimneys and strip with the sealant to the top of the stone coping indicating that there is progressive deterioration of the materials in the area all of which will require full restorations to bring up to a acceptable and modern standard.

View of leaded abutments and the strip weather sealant to the stone coping at the right-hand side of the main building at the front.

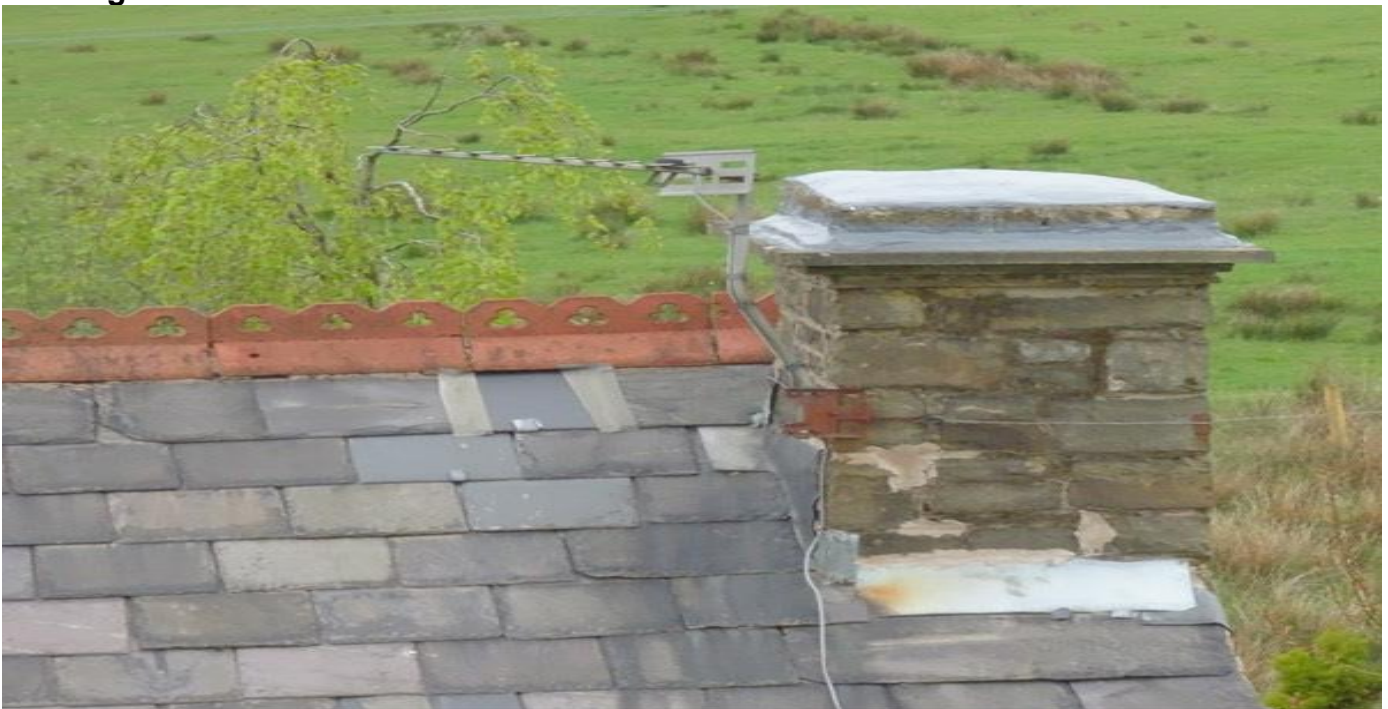
- The stone-built chimney to the left-hand side at the rear was found to be capped off and made redundant and had a rubberised acropol coating to the top.

View of the redundant stone built chimney and ridge tiles to the right hand side of the main building from the rear.

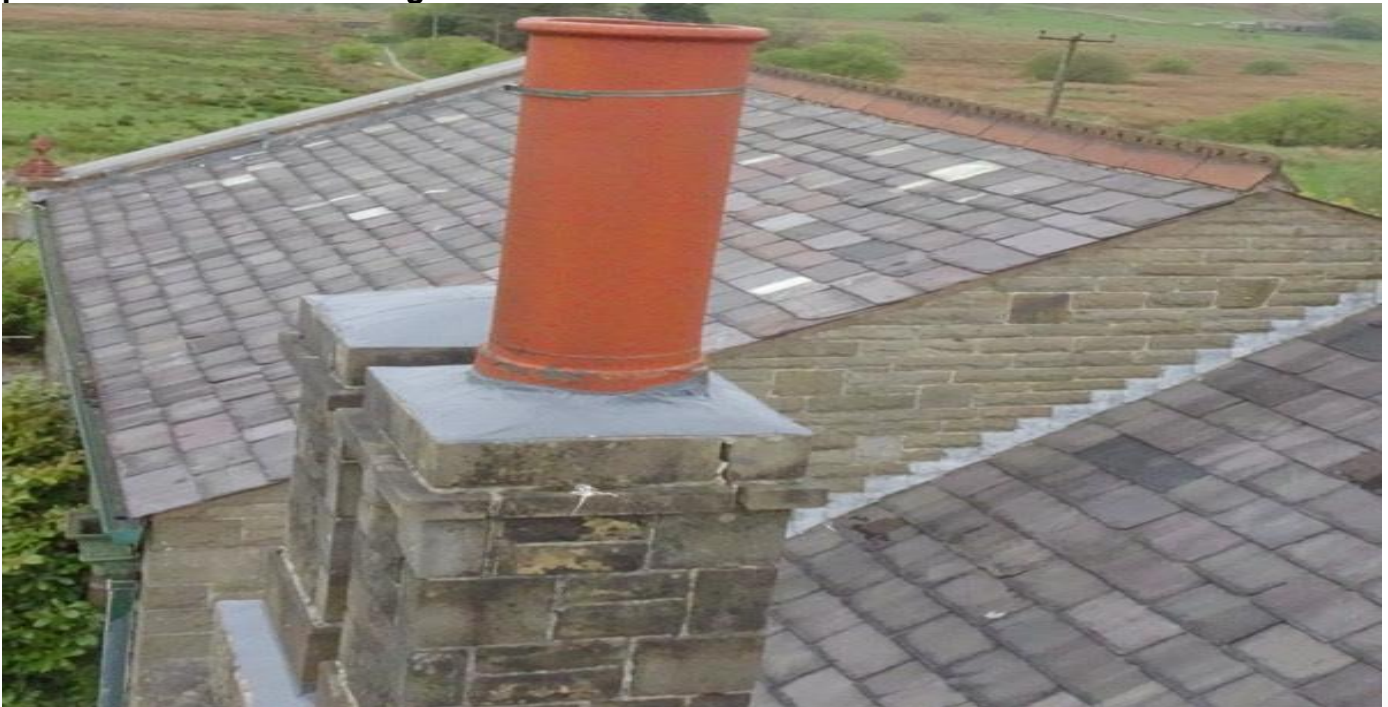
View of the chimney pots and mortar flaunching to the stone built chimney to the central portion of the main building at the rear.

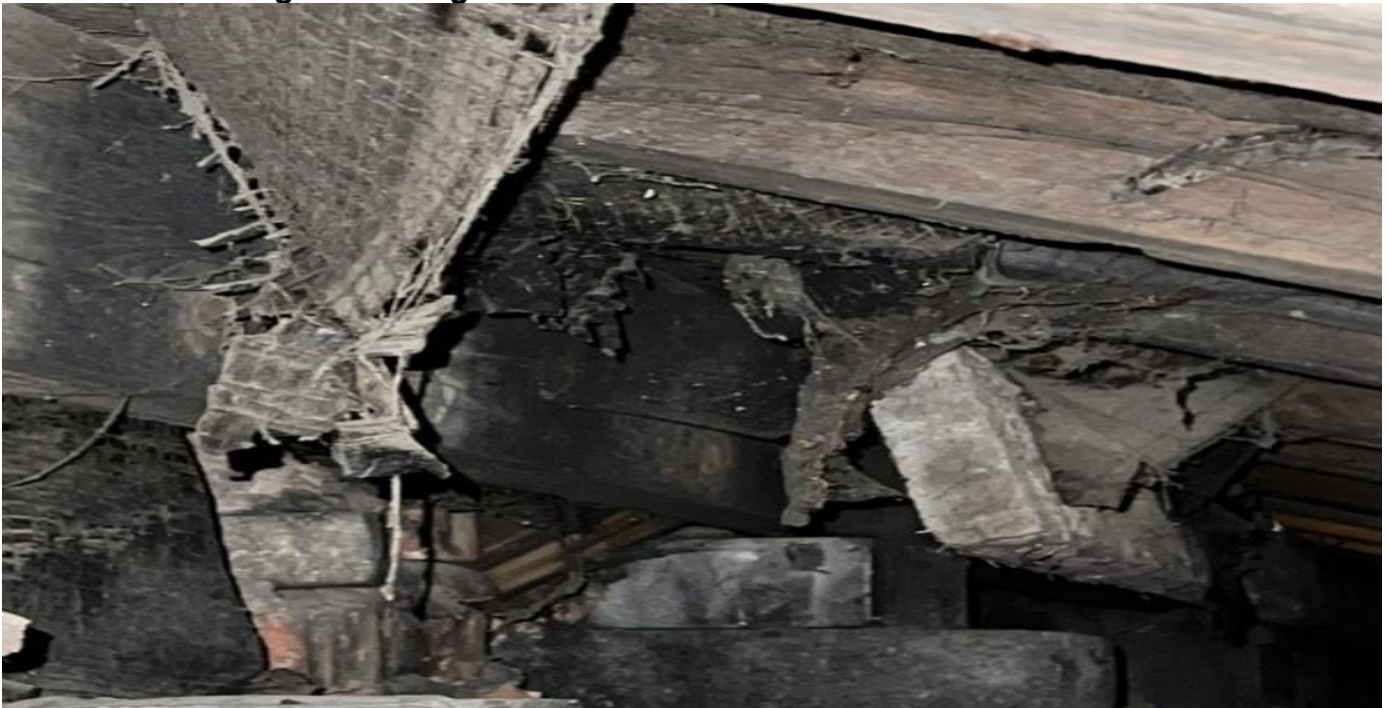
- The inspection also found there to be evidence of heavy wetting and rotting to isolated areas within the loft space and it is anticipated that when the roof covering is removed, timber repairs will be required required to the roof.

View of the sarking and rotting to the internal timber roof structure.

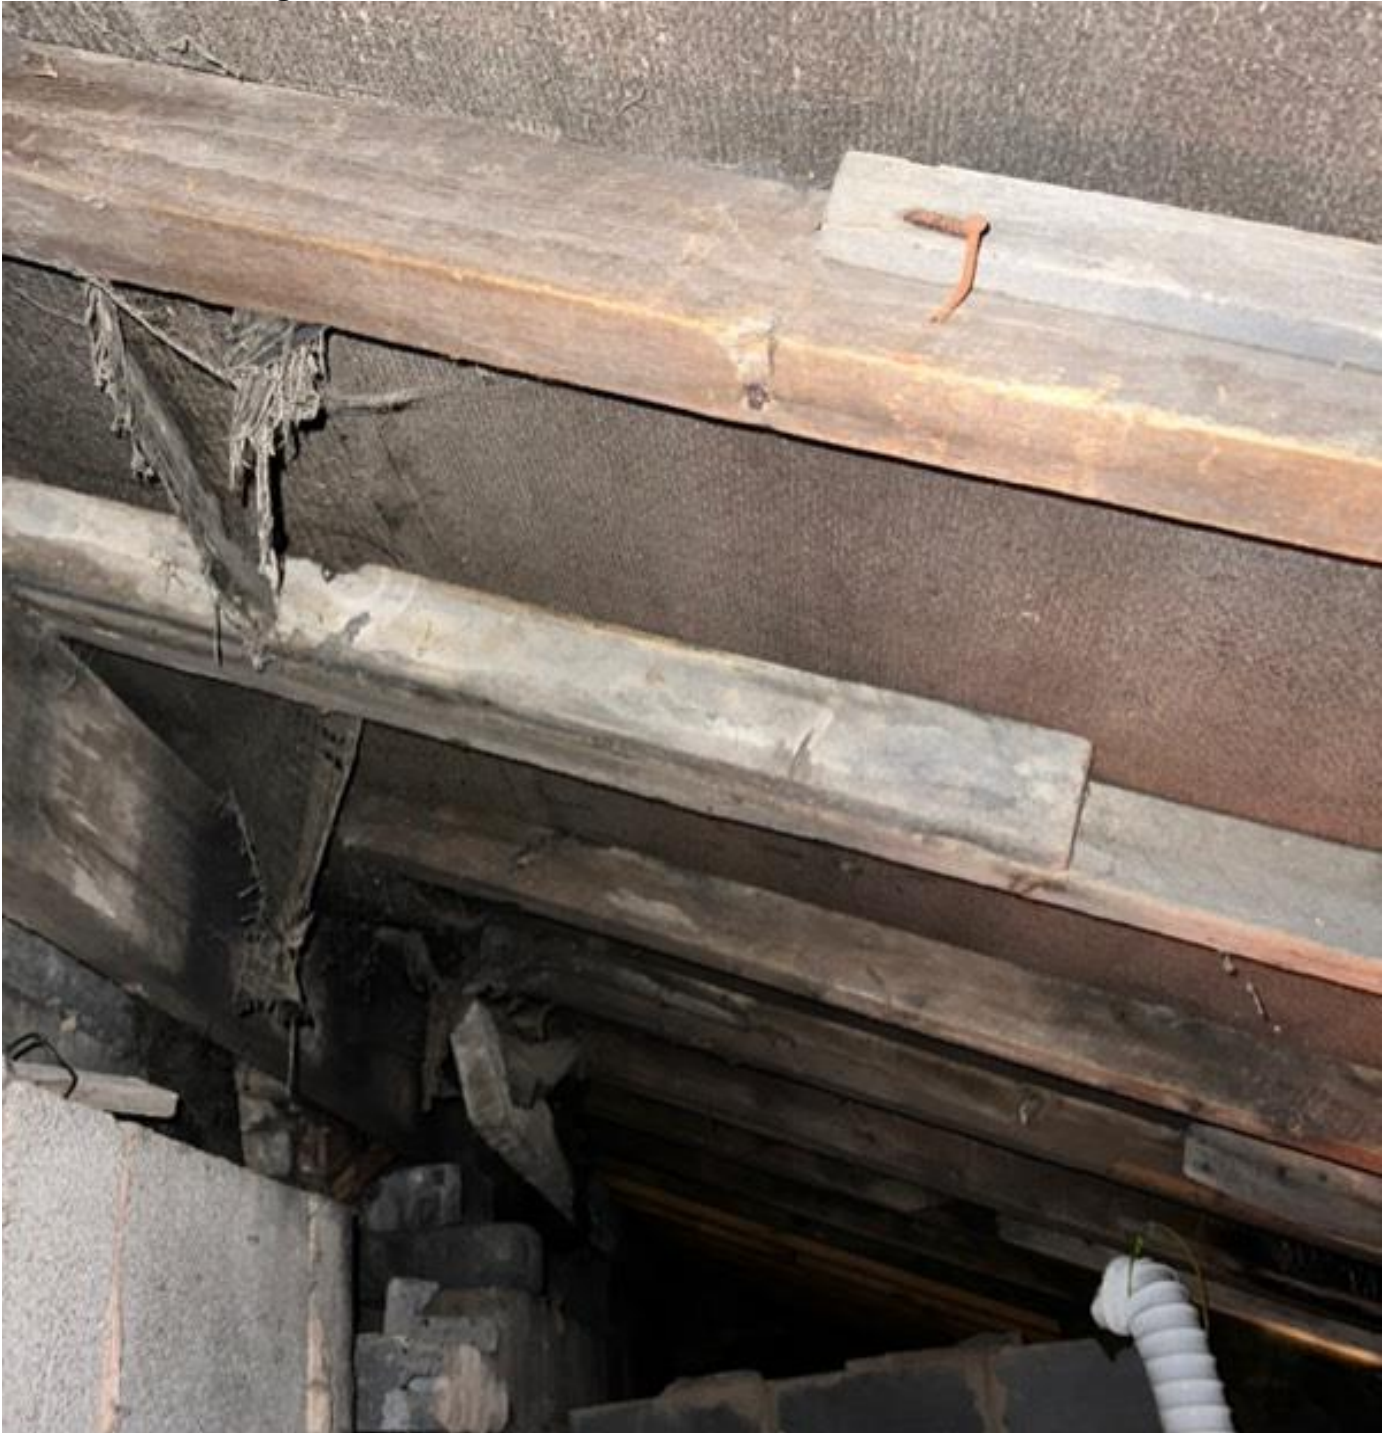
- The inspection of the timber roof structure from within the loft space found that there had been secondary supporting structures installed to the purlins and there has been alterations and repairs to the rafters.

View of the sarking and alterations to the internal timber roof structure.

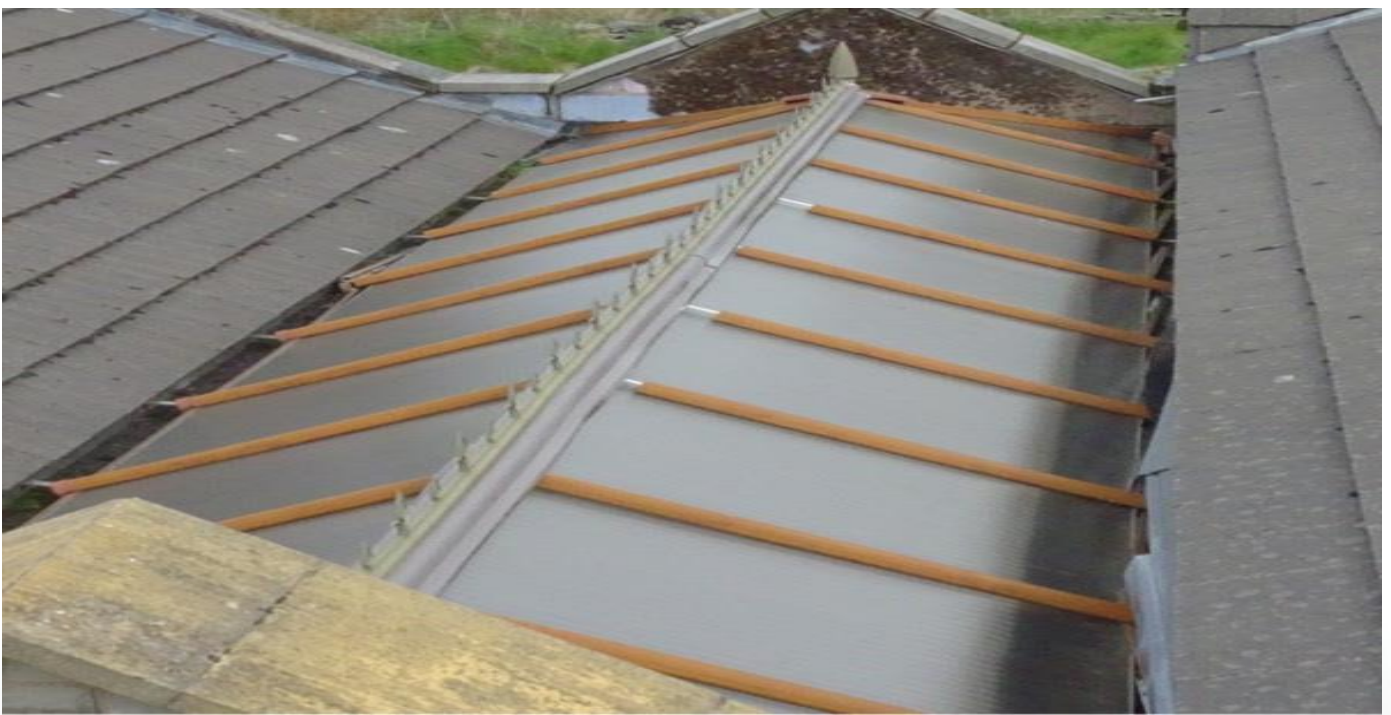
- The inspection of the central polycarbonate roof covering above the garage found this to be in poor condition with evidence of age-related decay suffering from a natural breakdown of materials over the time.

View of the polycarbonate roof to the detached bungalow.

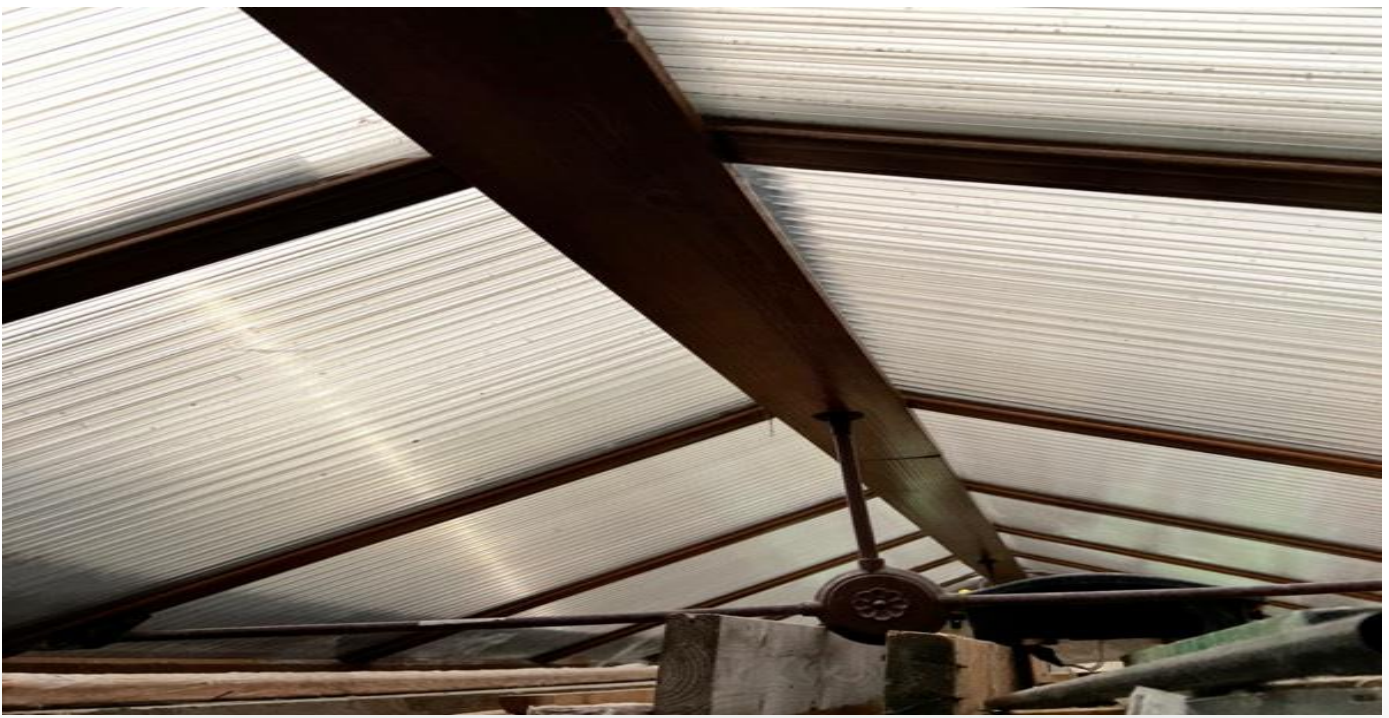
- The roof structure to the polycarbonate roof above the garage was found to be suffering from movements and had internal support due to deterioration of materials because of water ingress through the blocked box gutters and full renewal of the roof will be required to make an effective repair.

View of the internal supports to the polycarbonate roof to the garages of the detached bungalow.

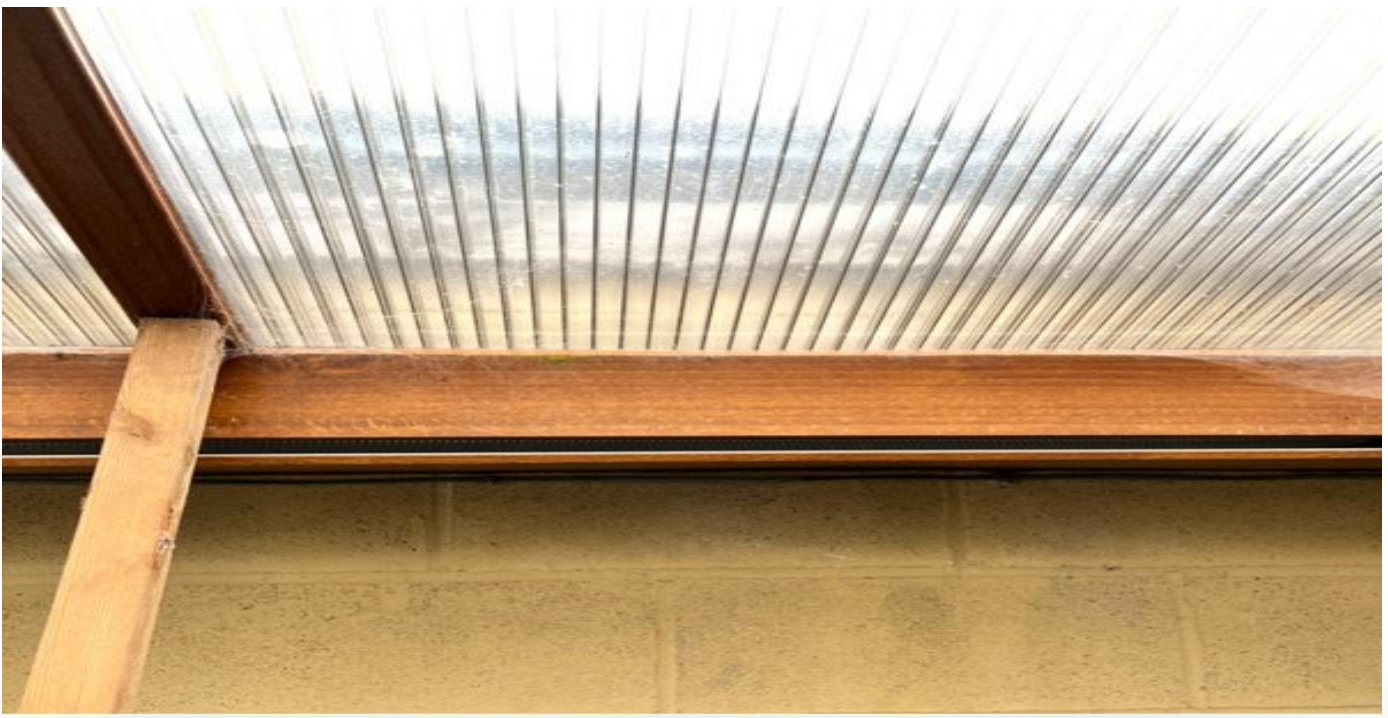
View of the internal supports to the polycarbonate roof to the garages of the detached bungalow.

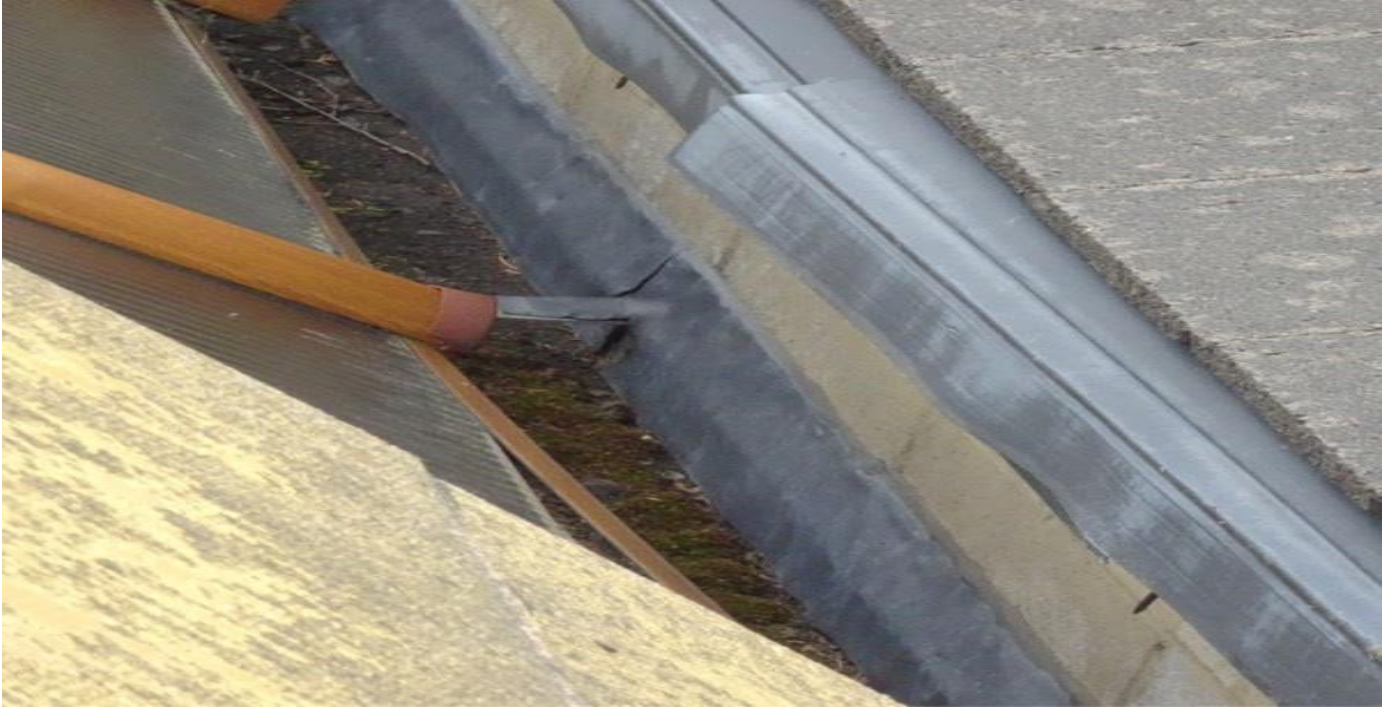
- Inspection of the box gutter to the polycarbonate roof found this to be in poor condition with evidence of blockages and rainwater ingress which is causing damage to the timber structure resulting in the requirement for internal supports pending full refurbishment of the roof.

View of lead line box gutter to the polycarbonate roof above the garage.

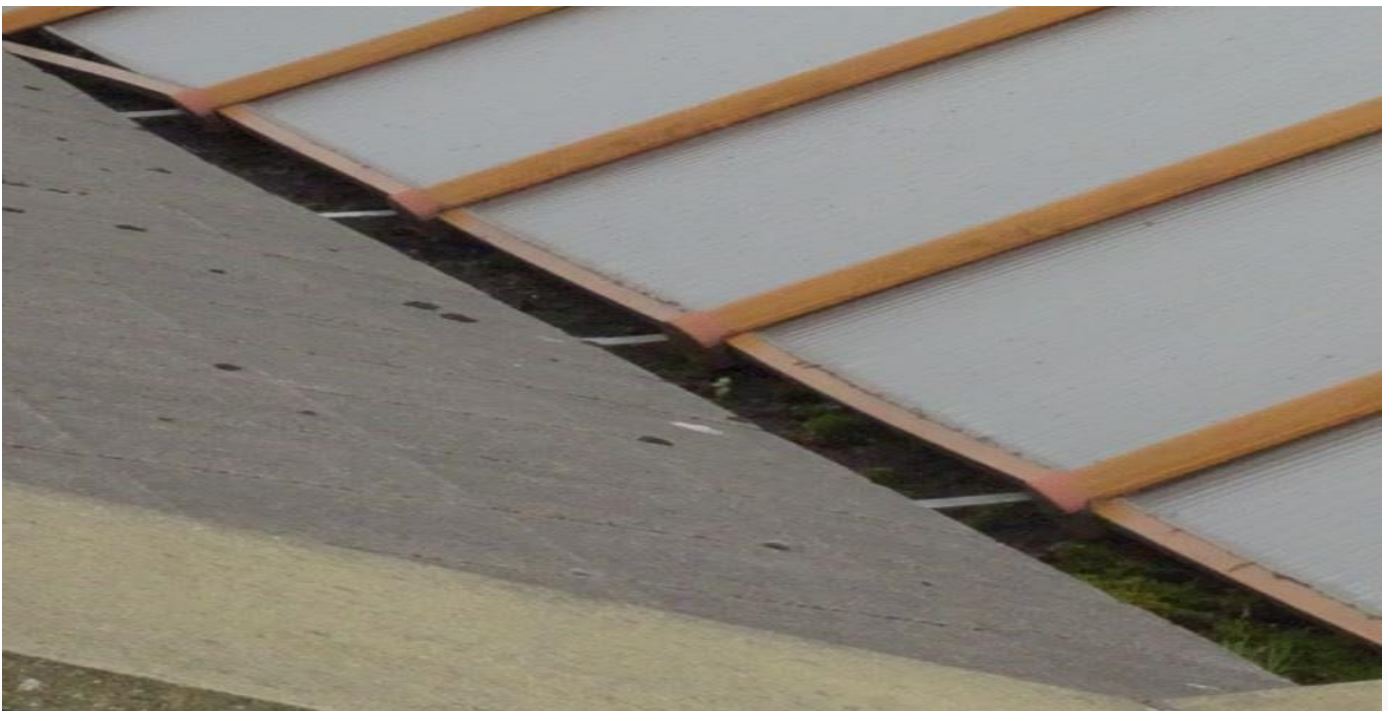
View of lead line box gutter to the polycarbonate roof above the garage.
