Roof Survey

Client Name: XXXXX XXXXXXXX
Address: XX XXXXX XXXXXXX
XXXXXXXXXX
XXX XXX
Purpose of Report: ROOF CONDITION SURVEY (Part 35 Compliant)
Report Reference: RCS/XXX/20XX
Inspection Date: 0X May 20XX
Surveyor Name: XXXXX XXXXXXX BSc, (Hons) MCIQB, CSRT, CSSW, DipDEA, UKAS-P402/P405

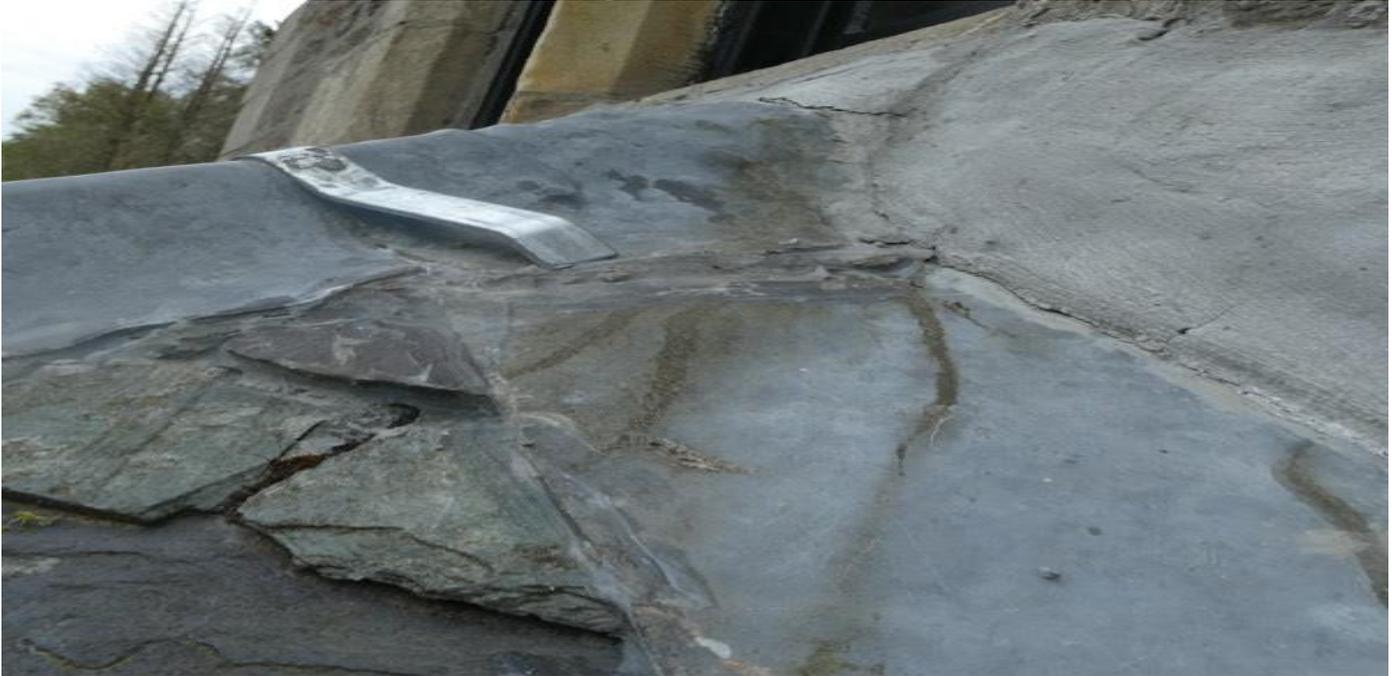
- Further inspection revealed poor quality slate repairs noted to have been secured in situ with silicon due to the incorrect cut size of the slates resulting in open and incomplete roof areas that inevitably is enabling water penetration.

Silicon seal applications detected to the bay window roof slates and lead flashing

- Recommend that the roof area is stripped and reslated with now formed code 5 lead abutments installed and mortar finished to the stone construction, consideration should also be given to the replacement of the window frame seals located above the bay roof to ensure water tightness.

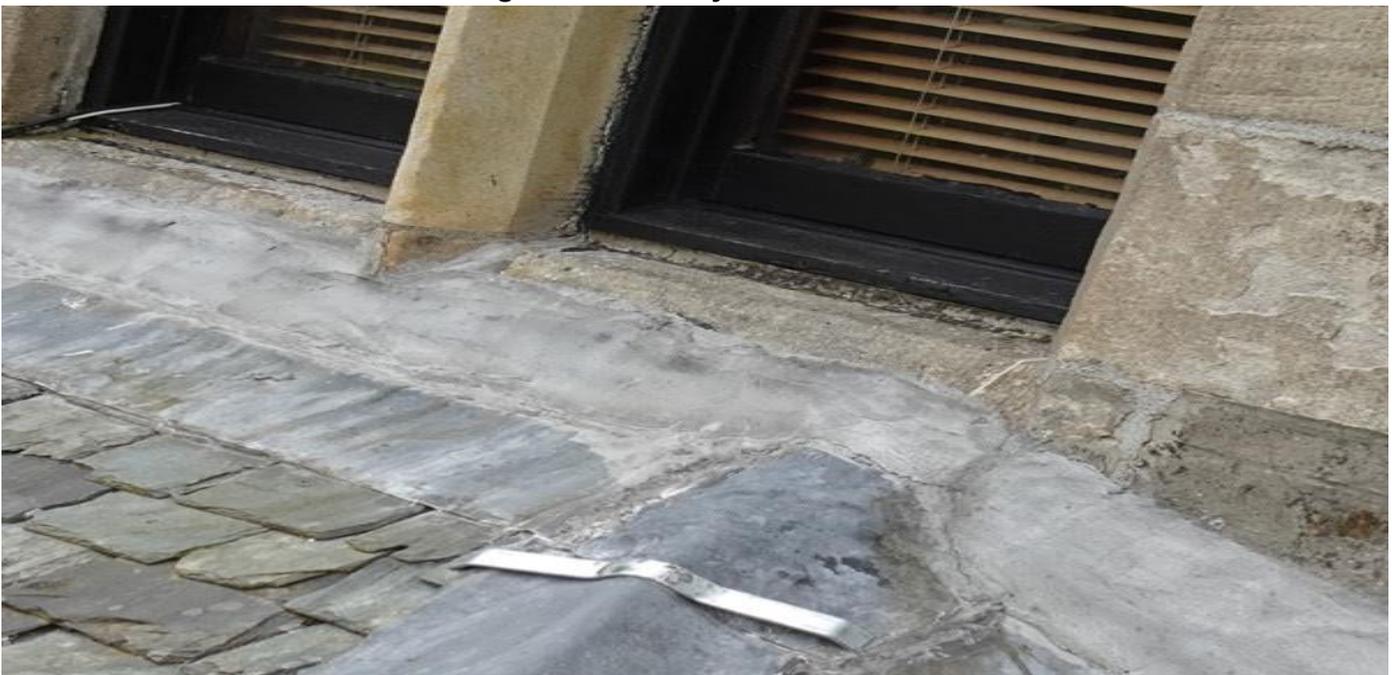
- An external inspection has highlighted cracking to the mortar roof abutments of the front bay window junctions consistent with Thermal and Differential movement, this is due to a combination of poor workmanship during previous repairs and water penetration through the window frame seals located above the roof, the cracks detected are consistent with expansion of the build materials with the combined effect of changes in the temperature and moisture content within the building.

Mortar abutment fillet cracks with age related decay also noted to window frame seals

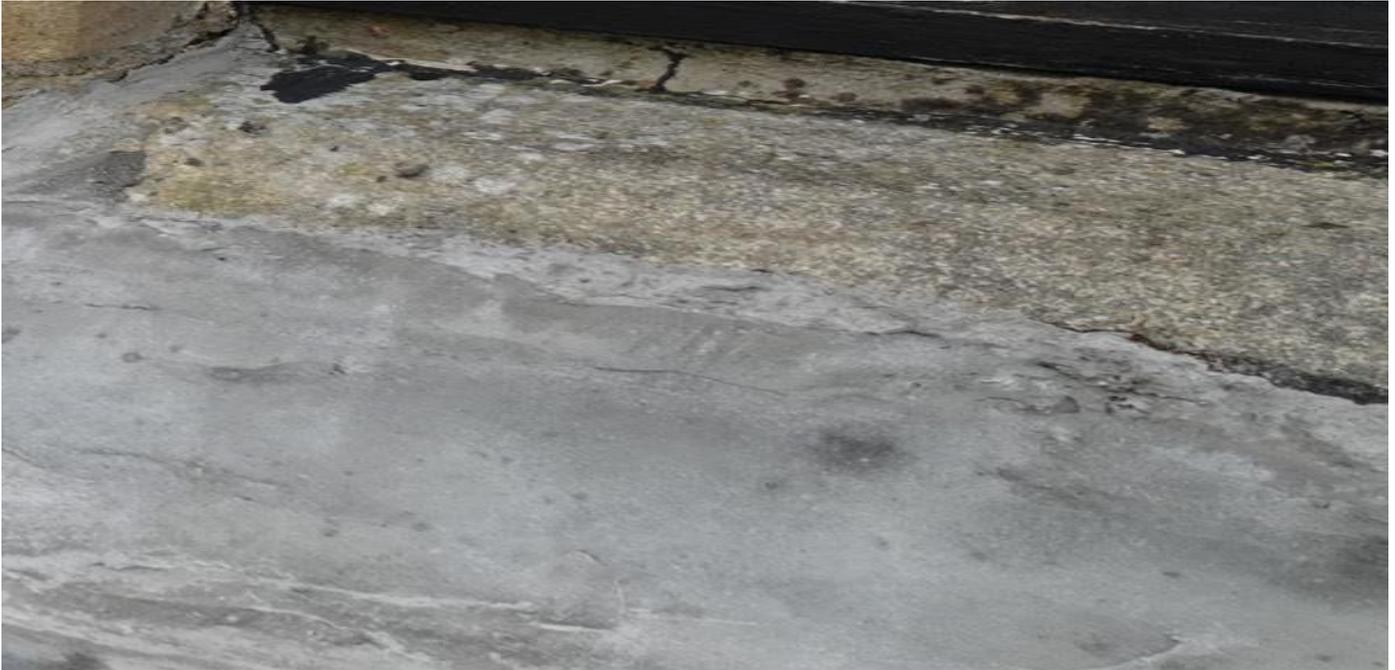
Mortar abutment fillet cracks with age related decay also noted to window frame seals

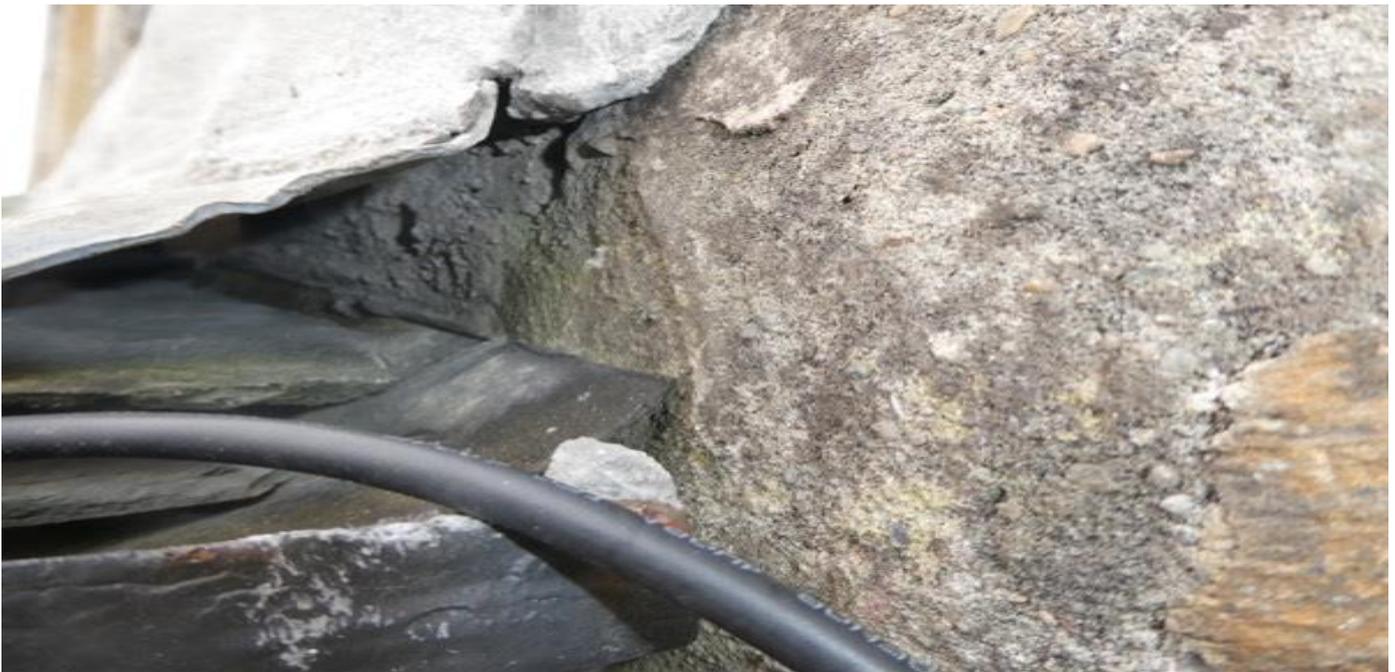
Lead abutment flashing in sufficiently dressed or rebate attached to masonry above bay window roof

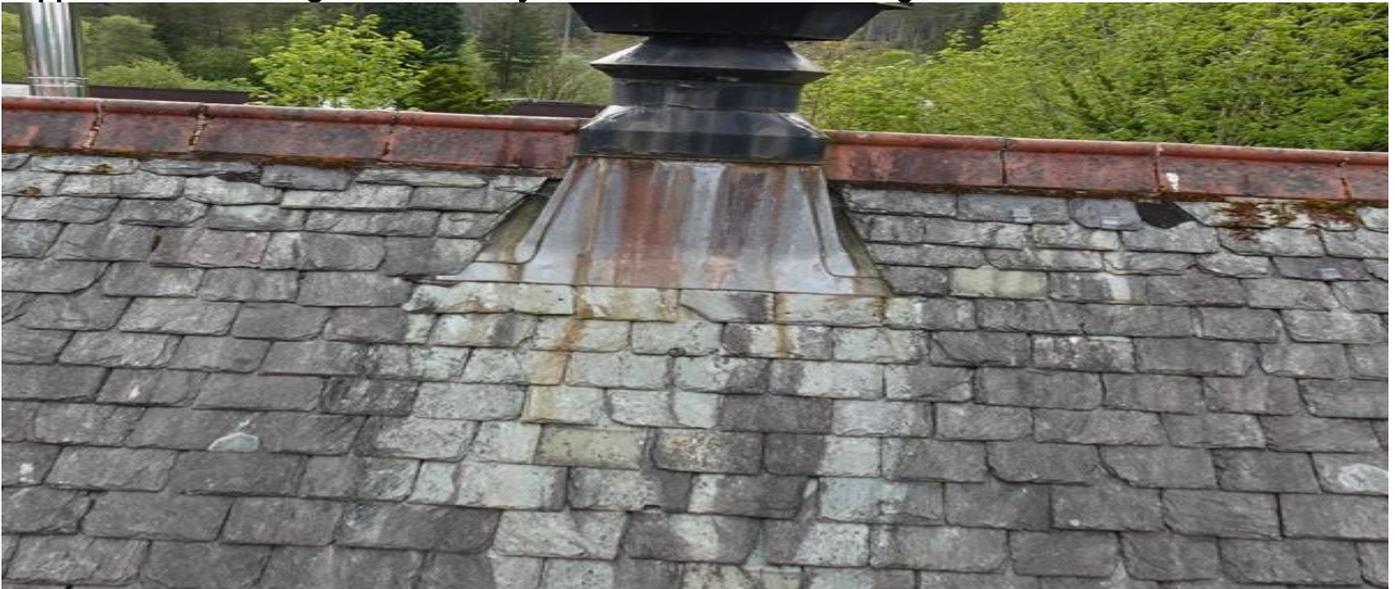
- The property has a pitched slate roof (natural slate) this appears to be in good condition but requires maintenance to the mortar areas with missing and damaged slates detected in isolated areas.
- The abutments and ridge tiles require of maintenance where cracking/missing mortar is evident and common problem with a property of this age.
- Recommend damaged slates are replaced to maintain the water proof values of the roof coverings.

Slipped slates and ridge mortar decay detected to the east facing main roof

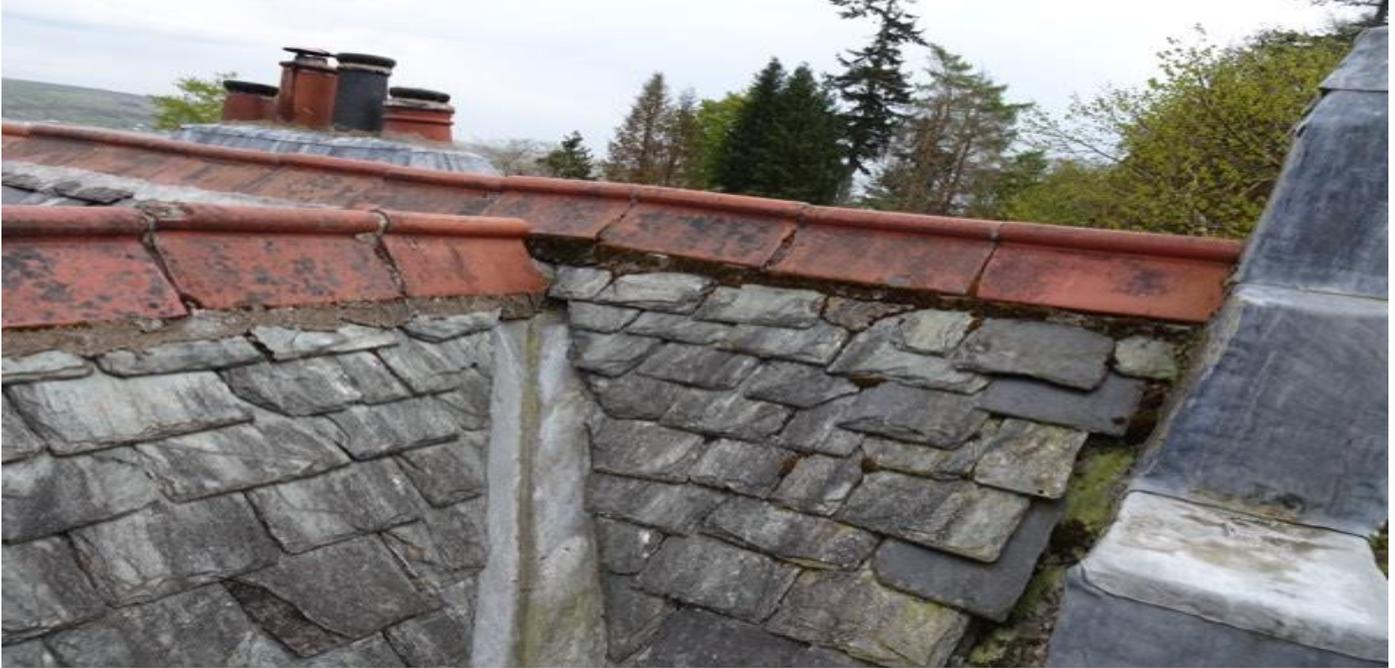
Missing and slipped slates detected to the west facing main roof

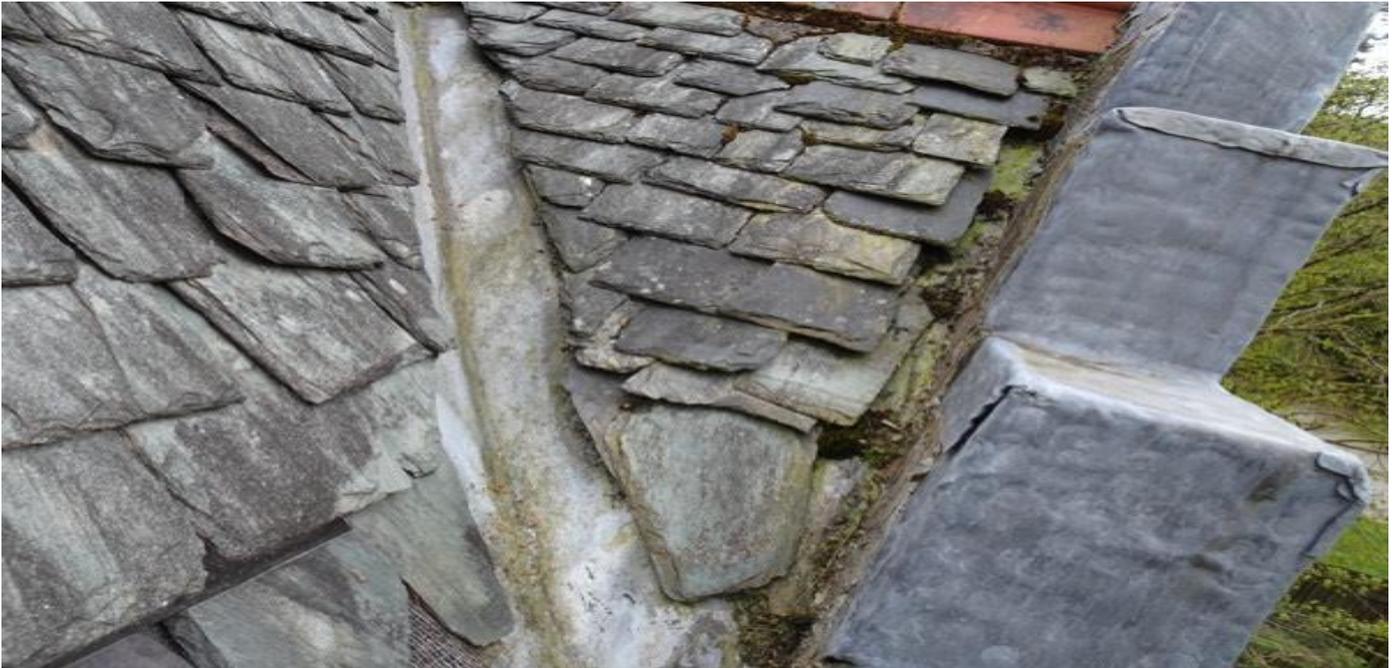
Missing and slipped slates detected to the west facing main roof

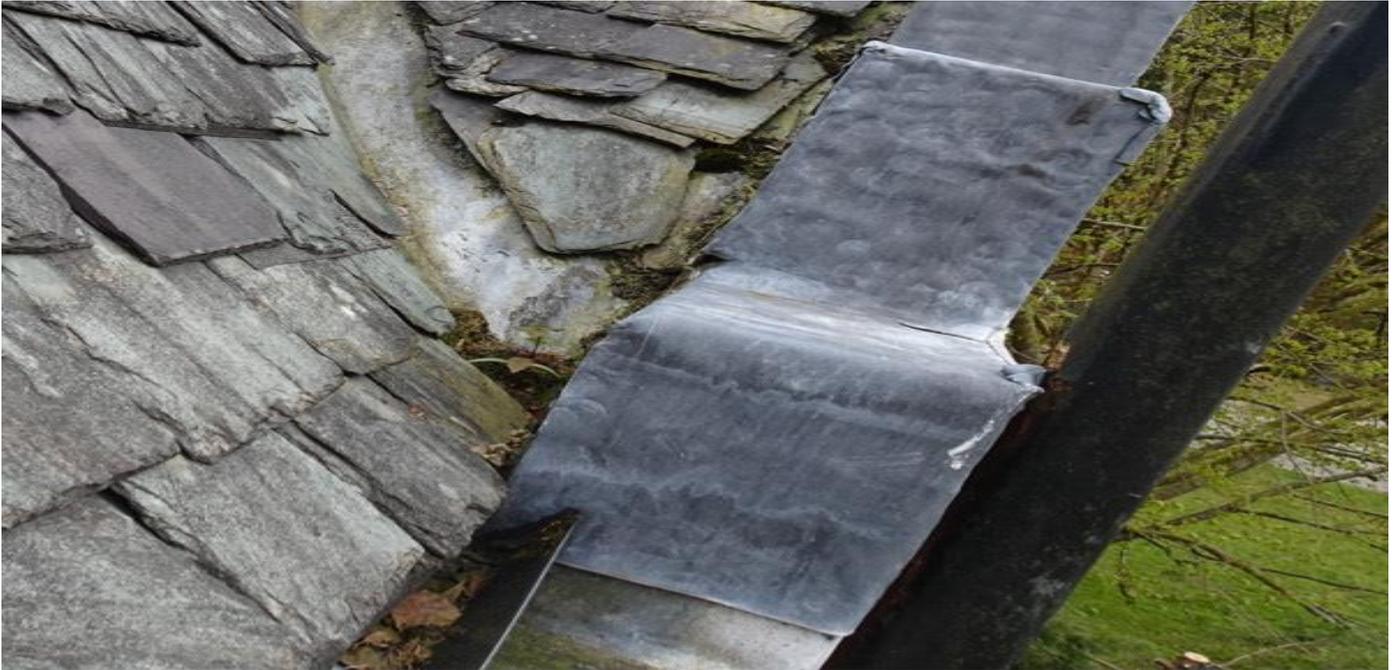
Missing and slipped slates detected to the west facing main roof

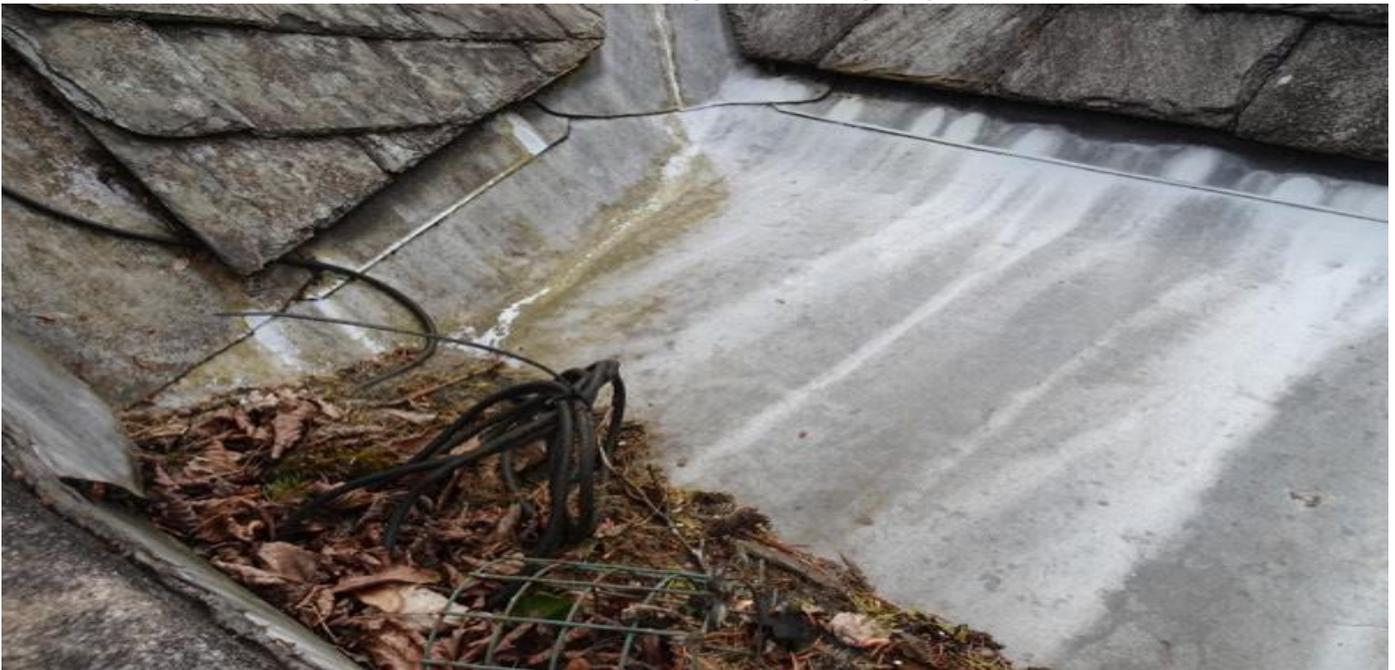
Several debris build up detected to the east facing main roof gulley

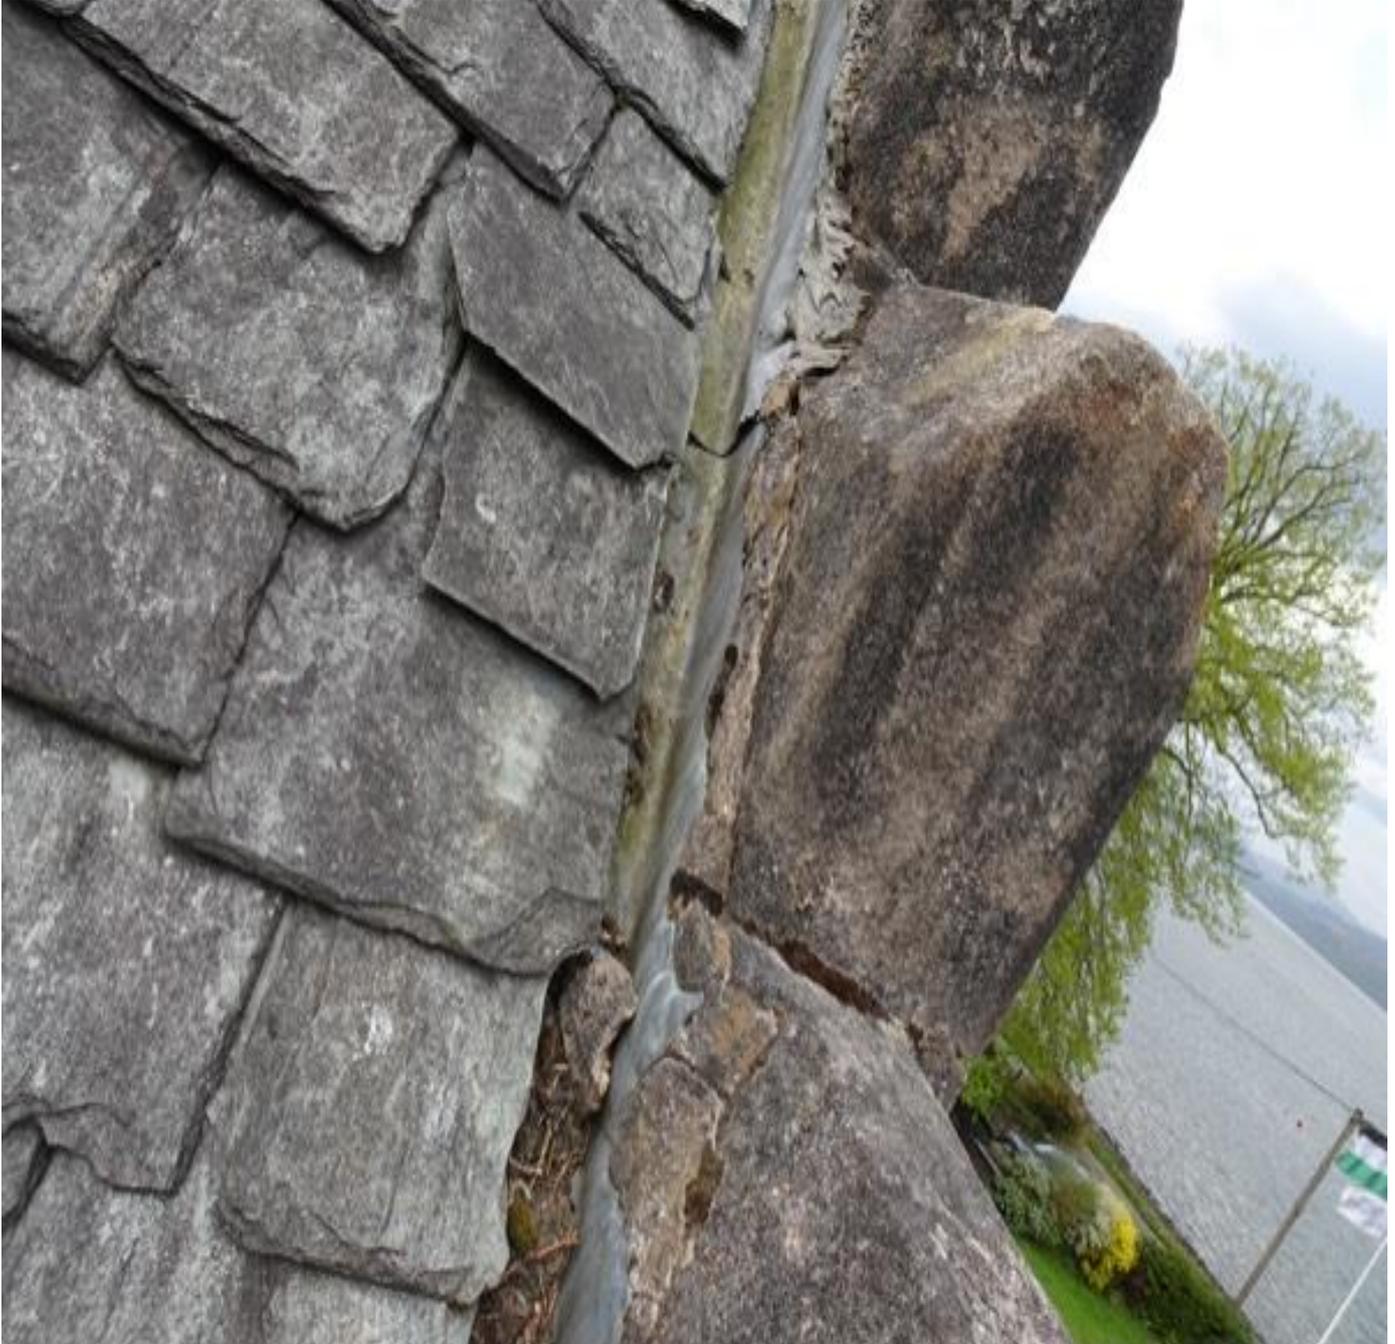
Severe mortar decay detected to the east facing masonry at roof line finish

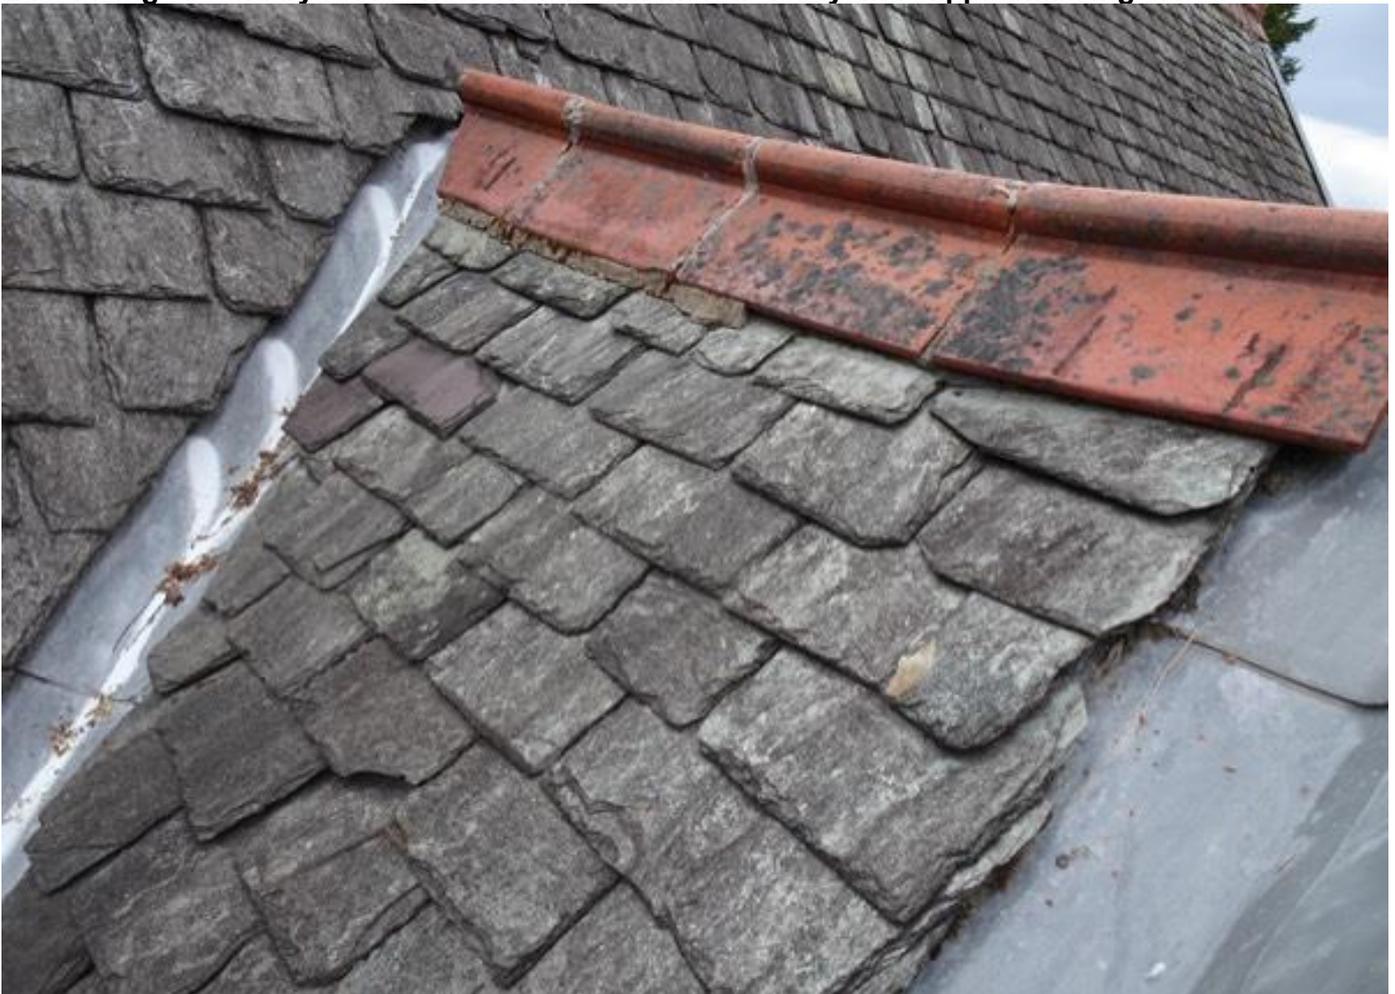
- The property has west and east facing secondary pitched slate roofs (natural slate) these appears to be in good condition but require maintenance to the mortar areas with missing and damaged slates detected in isolated areas around the valleys.
- The mortar abutments and ridge tiles require maintenance where cracking/missing mortar is evident and common problem with a property of this age.
- Recommend damaged slates are replaced and mortar areas are improved to maintain the water proof values of the roof coverings.

East facing secondary roofs show evidence of mortar decay and slipped/missing slates

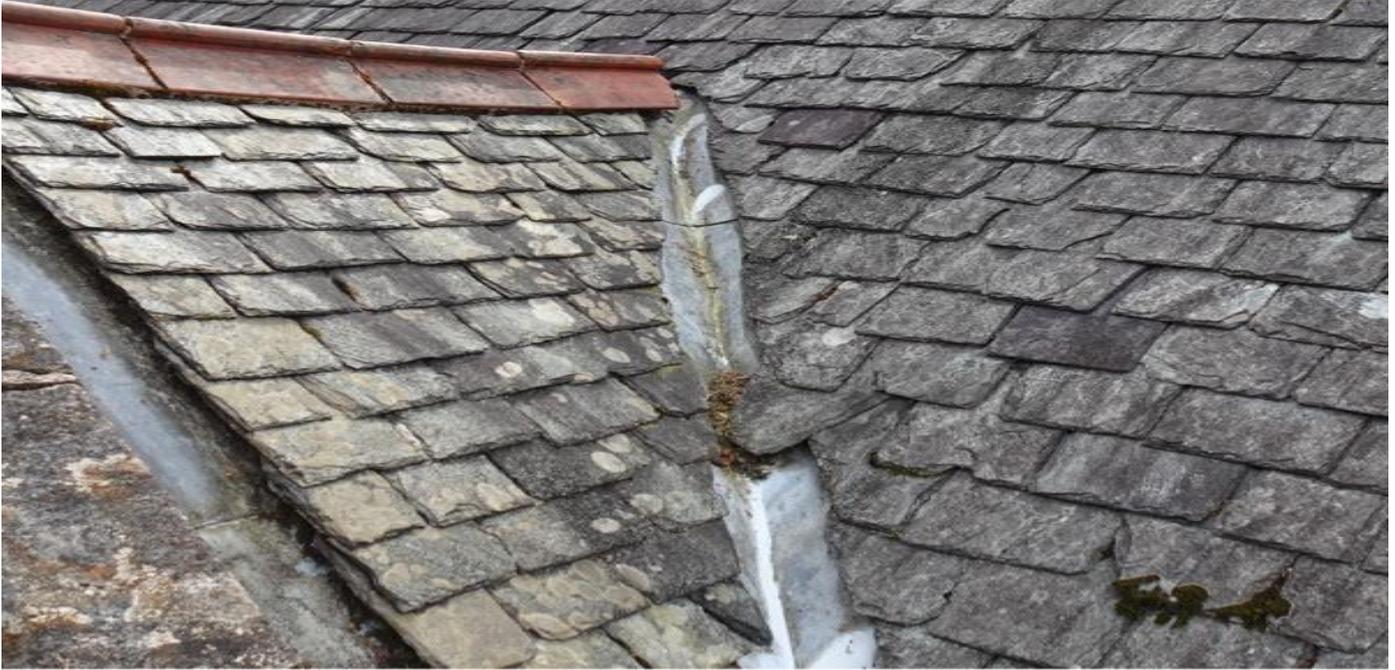
Ridge mortar decay and slipped valley slates detected to the east facing secondary roof

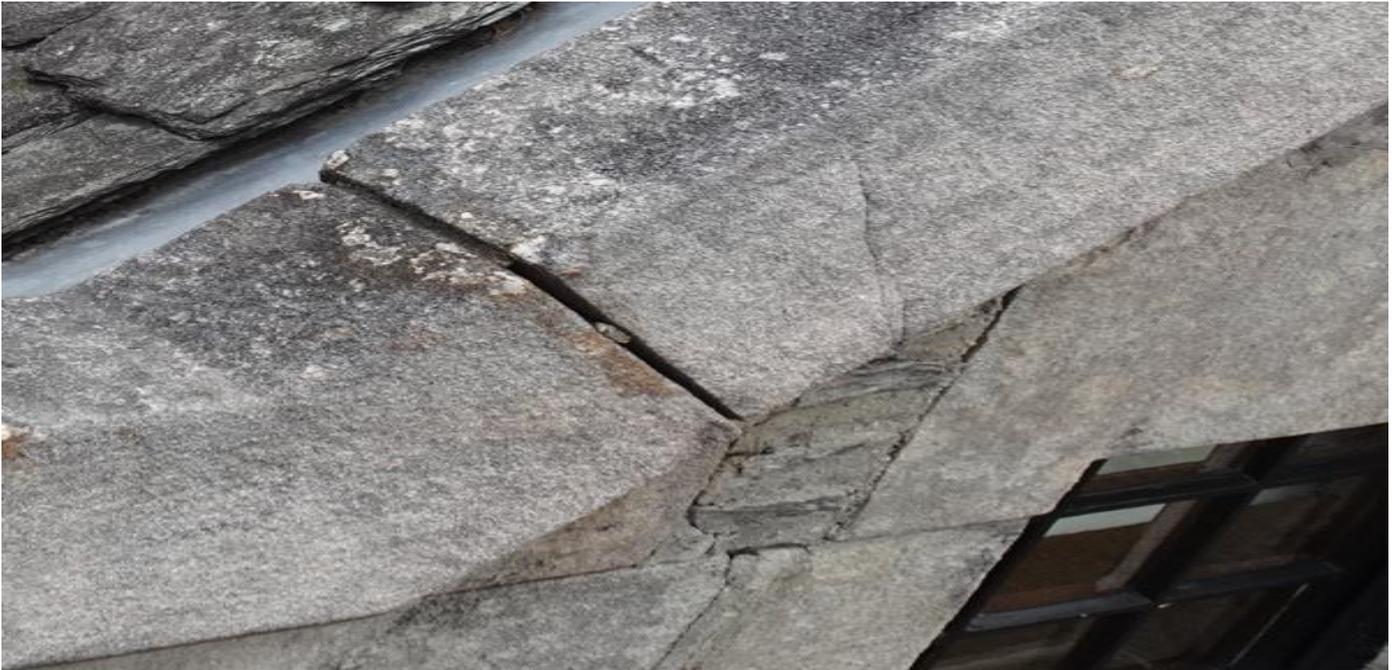
Mortar decay and erosion detected to the secondary roof stone tabling

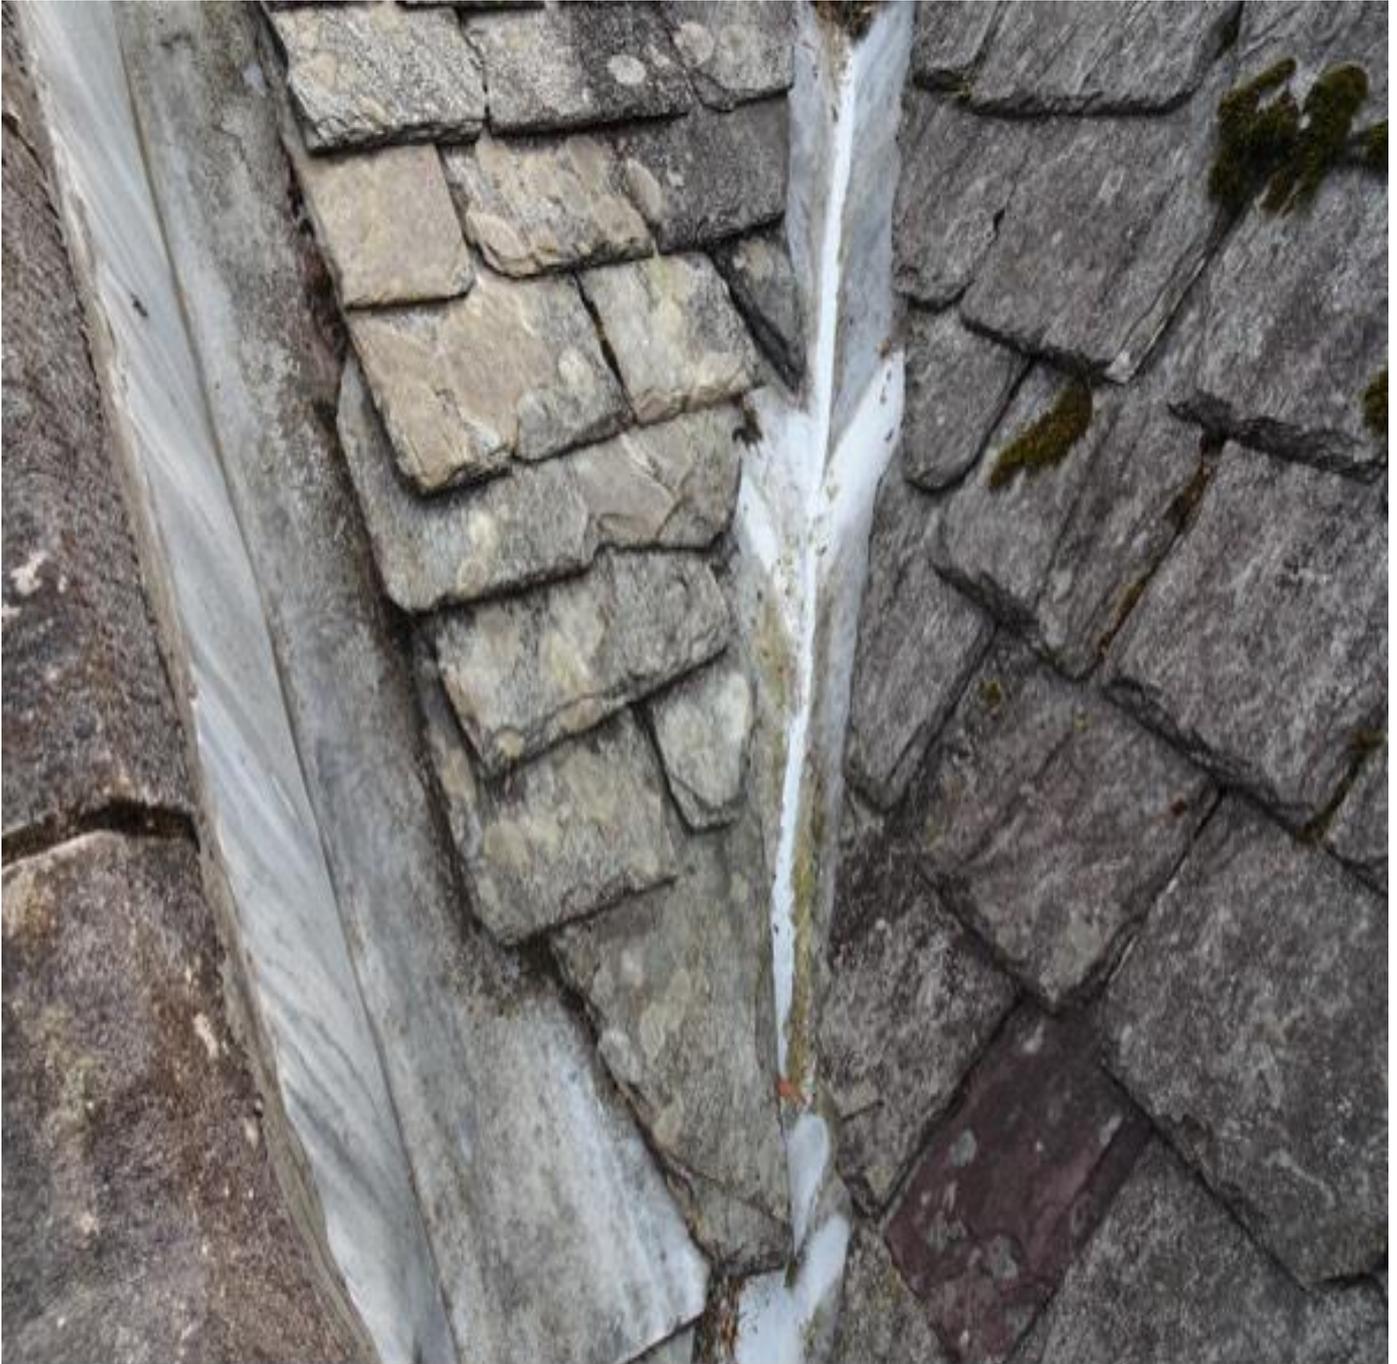
Slipped and insecure slates with noted mortar erosion detected to the stone tabling on the east facing secondary windows

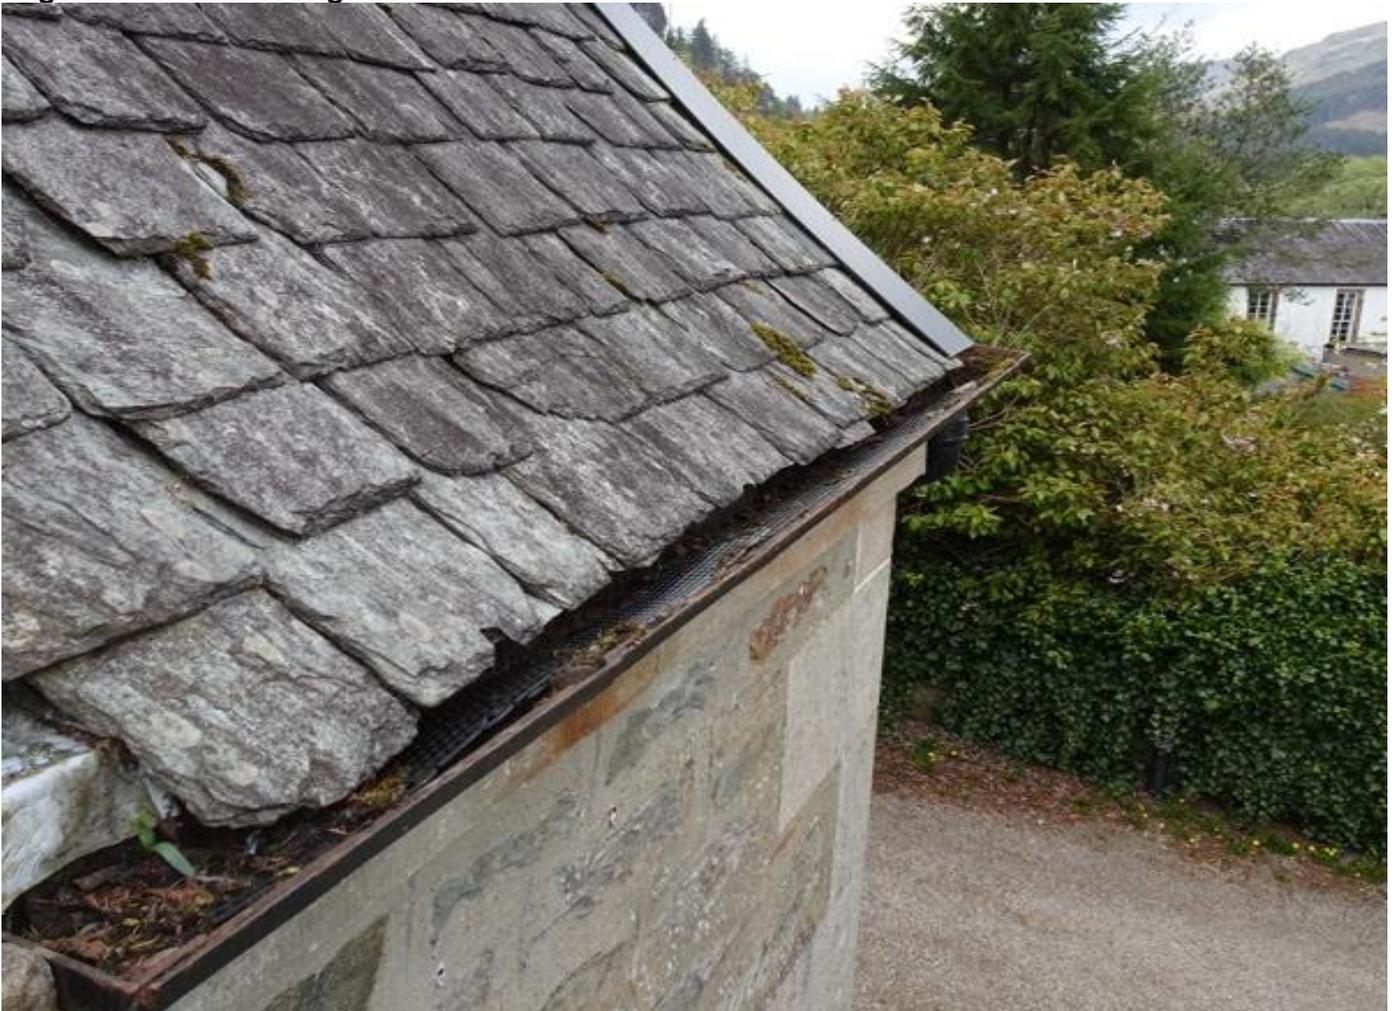
- Water is discharged from the roof via a Mixed Material gutter section rainwater system with outlet downpipes hold fast fixed to the external elevations.
- The gutter section rainwater system shows physical evidence of blockages with debris causing restrictions to the water flow leading to the rainwater outlets.
- Recommend these are cleared and repaired to prevent water penetration to the building.

Vegetation detected to gutter section

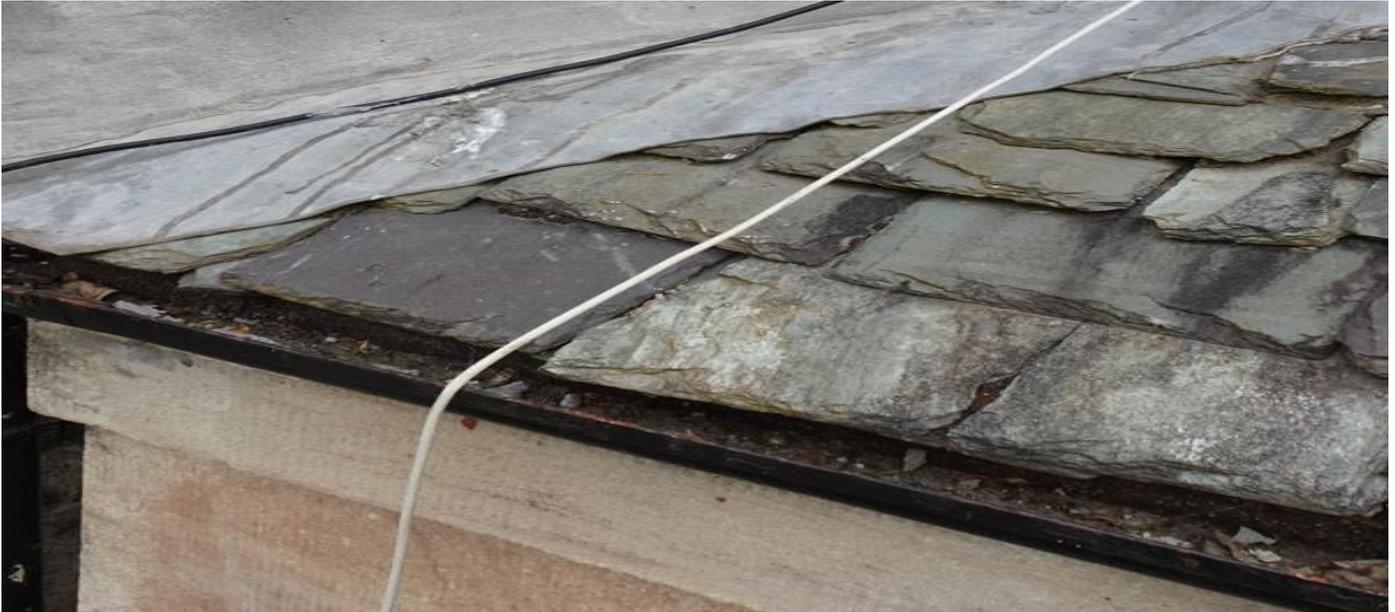
Debris build up detected to bay window

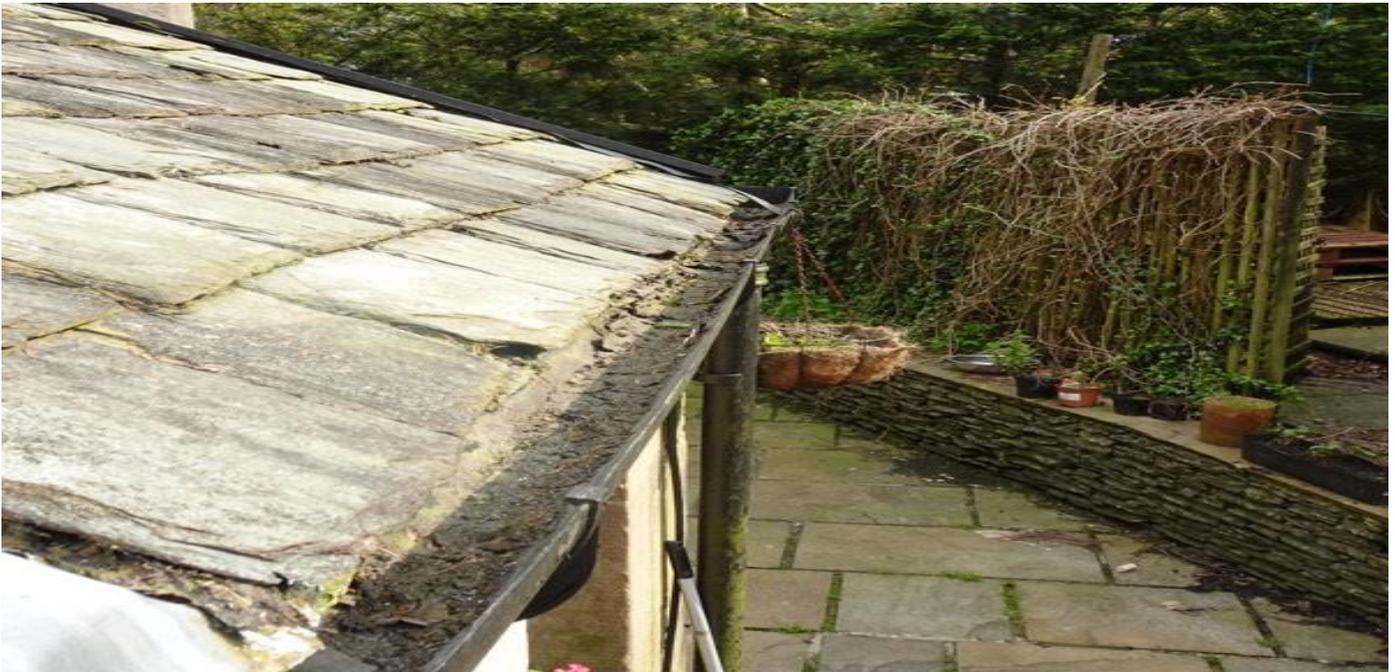
Debris detected to west facing sloping roof gutter section

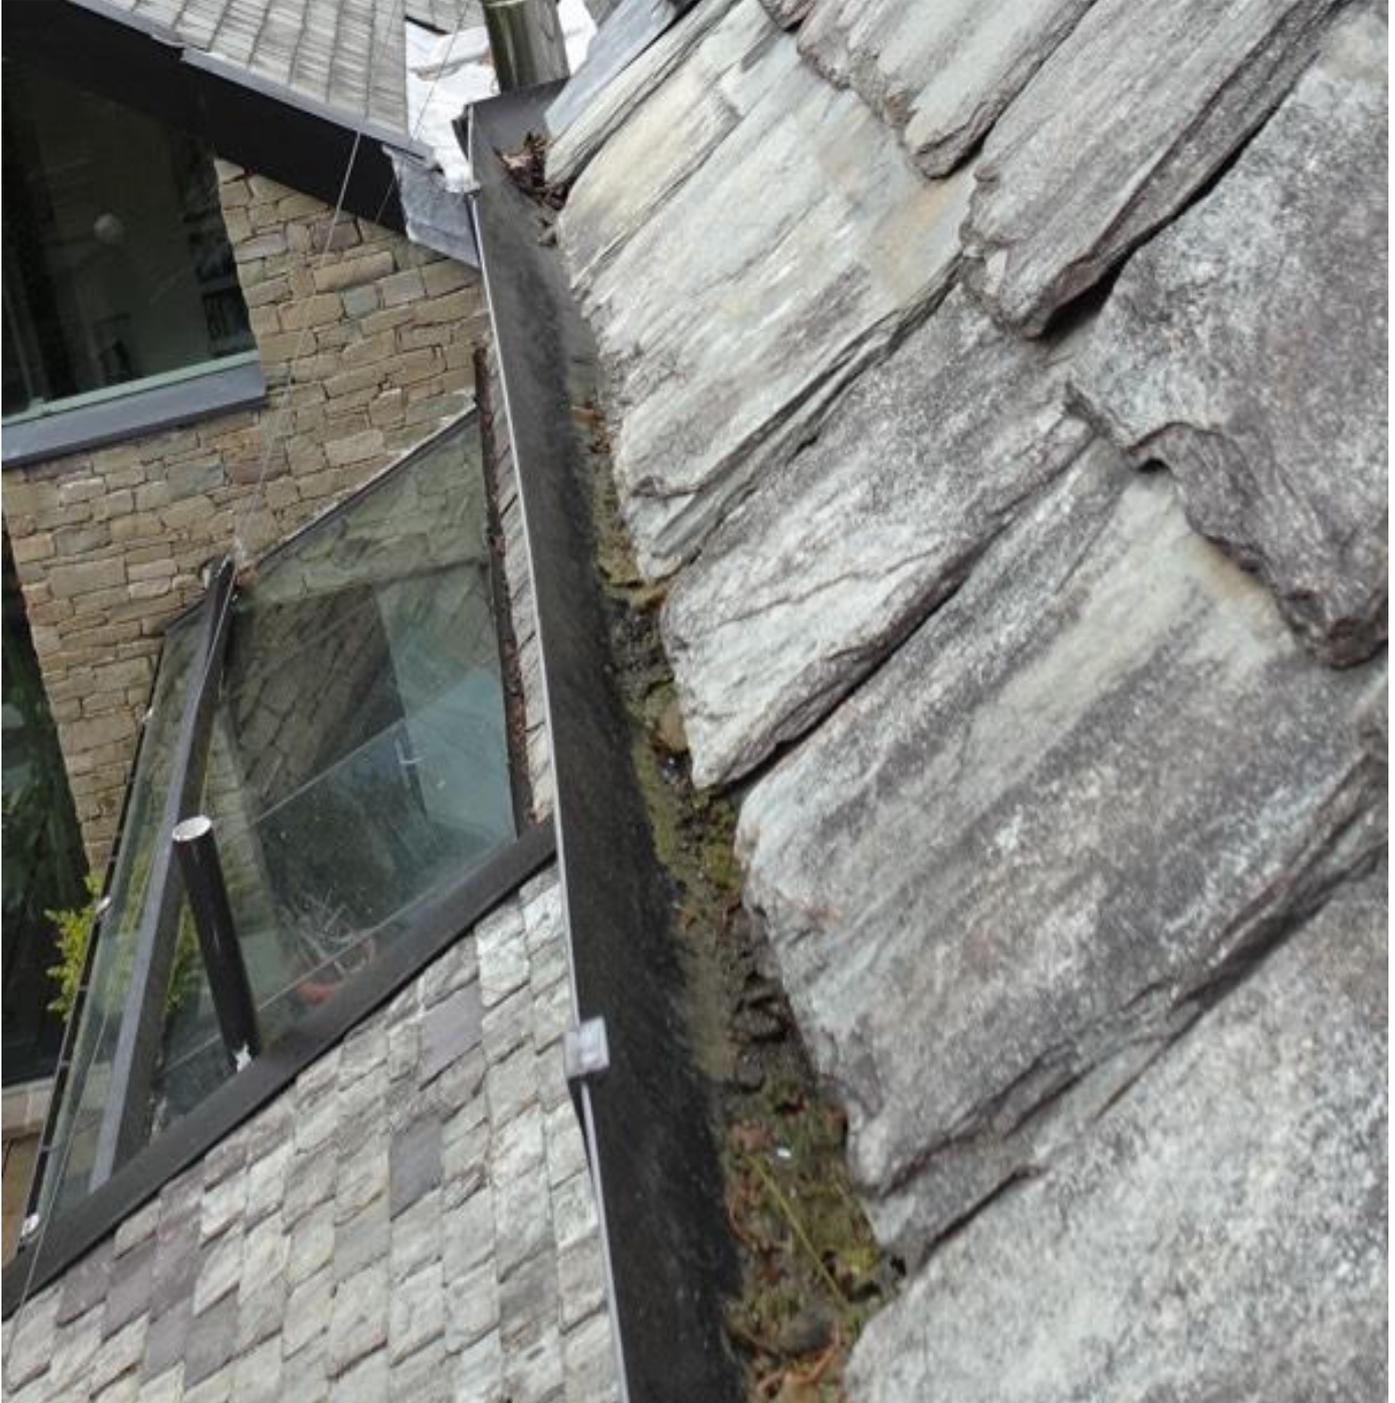
Minor debris build up detected to the west facing main roof

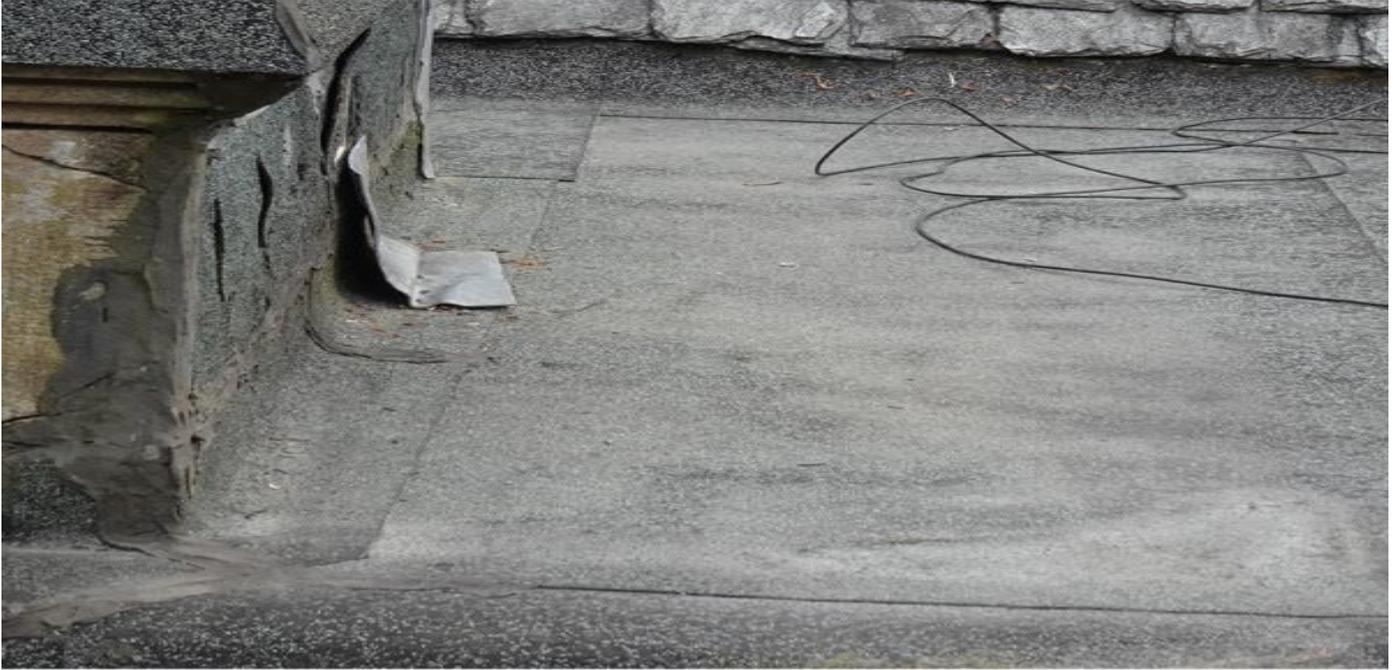
- The felt flat roof areas showed no physical defects adversely affecting the water proof values of the roof coverings at the time of the inspection, inspection did reveal that a section of abutment flashing appeared loose or insecure fixed which may lead to a degree of water penetration.
- Recommend the flashings are repaired in the short term with consideration given to the replacement of all the perimeter flashings in the long term.

Slight de bonding of the abutment flashing with a loose section of un related lead section detected
