Roof Survey

Client Name: XXXXX XXXXXXXX
Address: XX XXXXX XXXXXXX
XXXXXXXXXX
XXX XXX
Purpose of Report: ROOF CONDITION SURVEY (Part 35 Compliant)
Report Reference: RCS/XXX/20XX
Inspection Date: 0X May 20XX
Surveyor Name: XXXXX XXXXXXX BSc, (Hons) MCIQB, CSRT, CSSW, DipDEA, UKAS-P402/P405

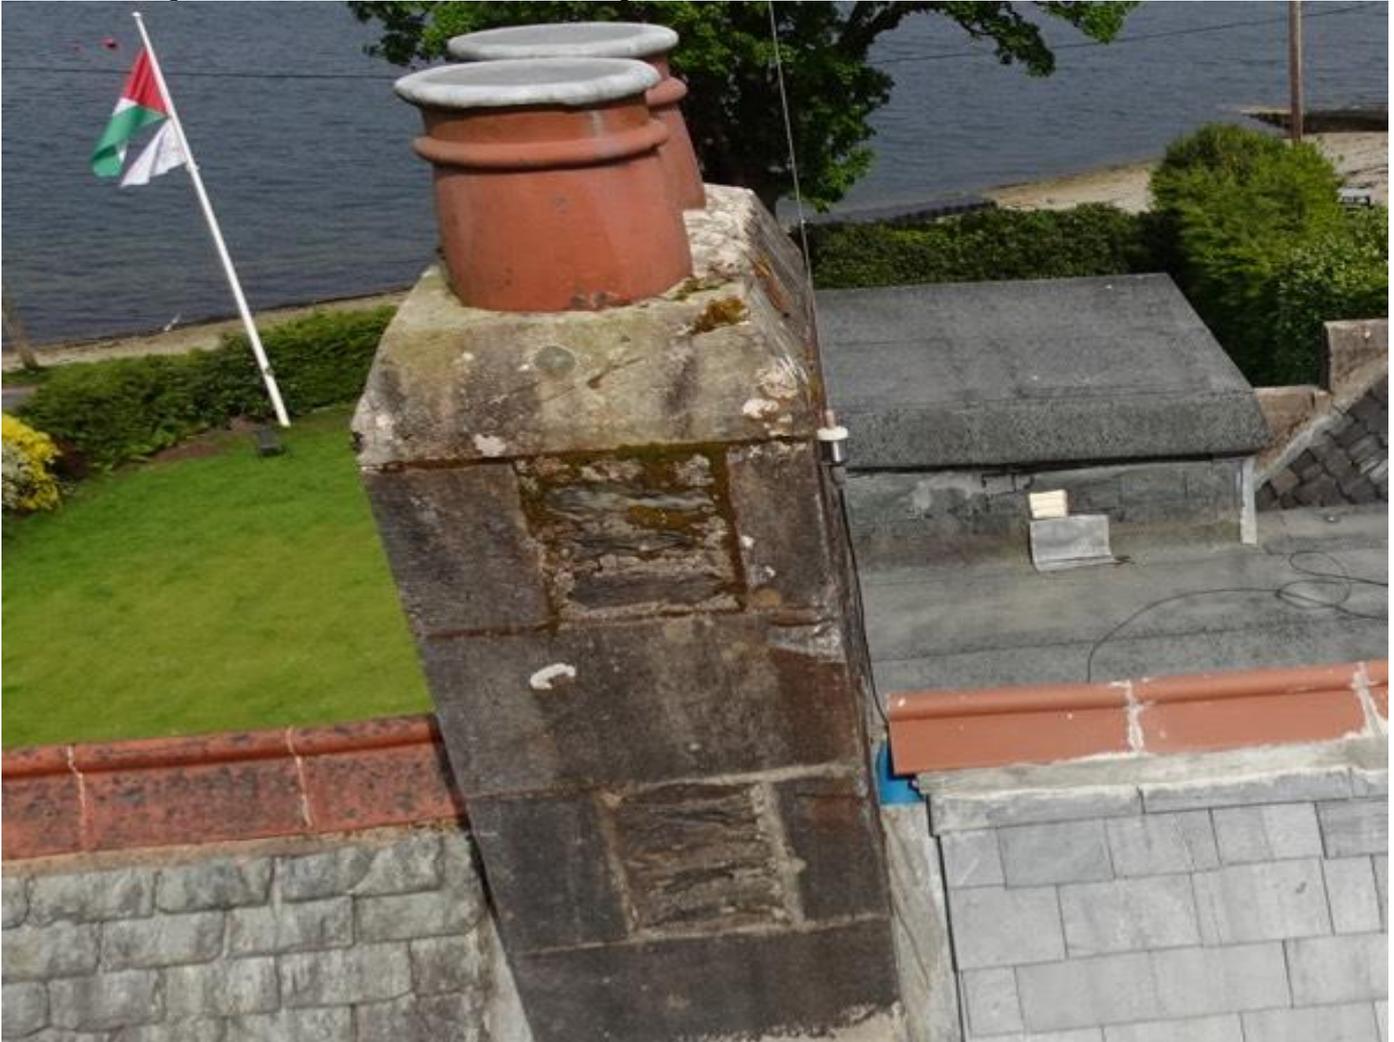
- The roof had a Stone Built chimney stacks with chimney pots, mortar flaunching and leaded abutments to the main roof covering.
- Inspection revealed evidence of decay and deterioration at the time of the inspection therefore refurbishments will be required to maintain conditions and prevent water penetration going forward.

Mortar decay detected to the central chimney stack

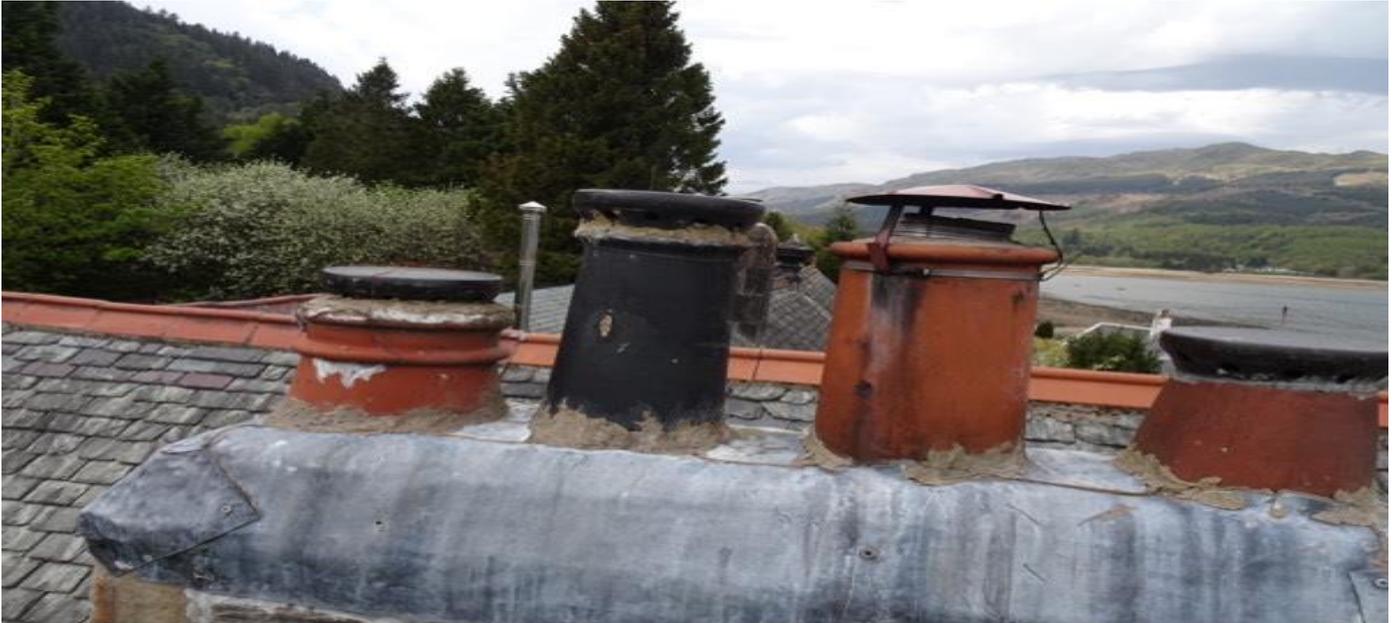
Gable end lead capping is noted to be insecure fixed with open unsealed areas

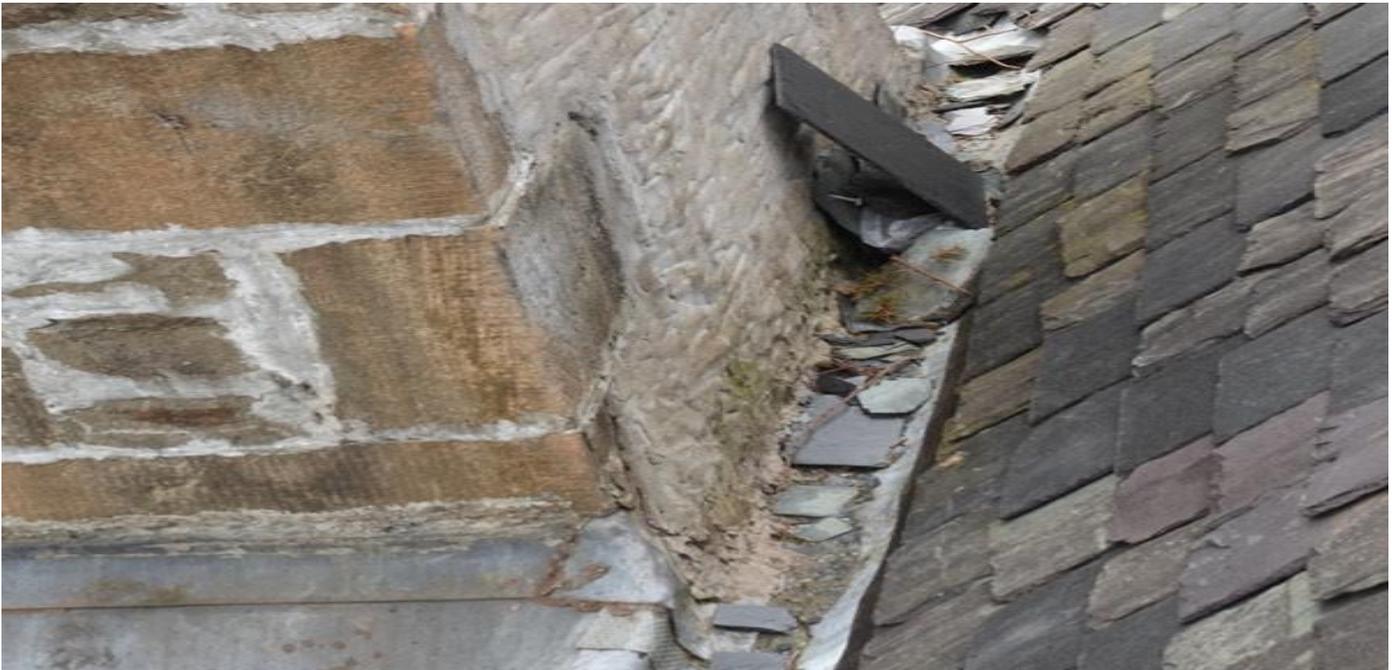
Debris build up detected to chimney stack back gutter

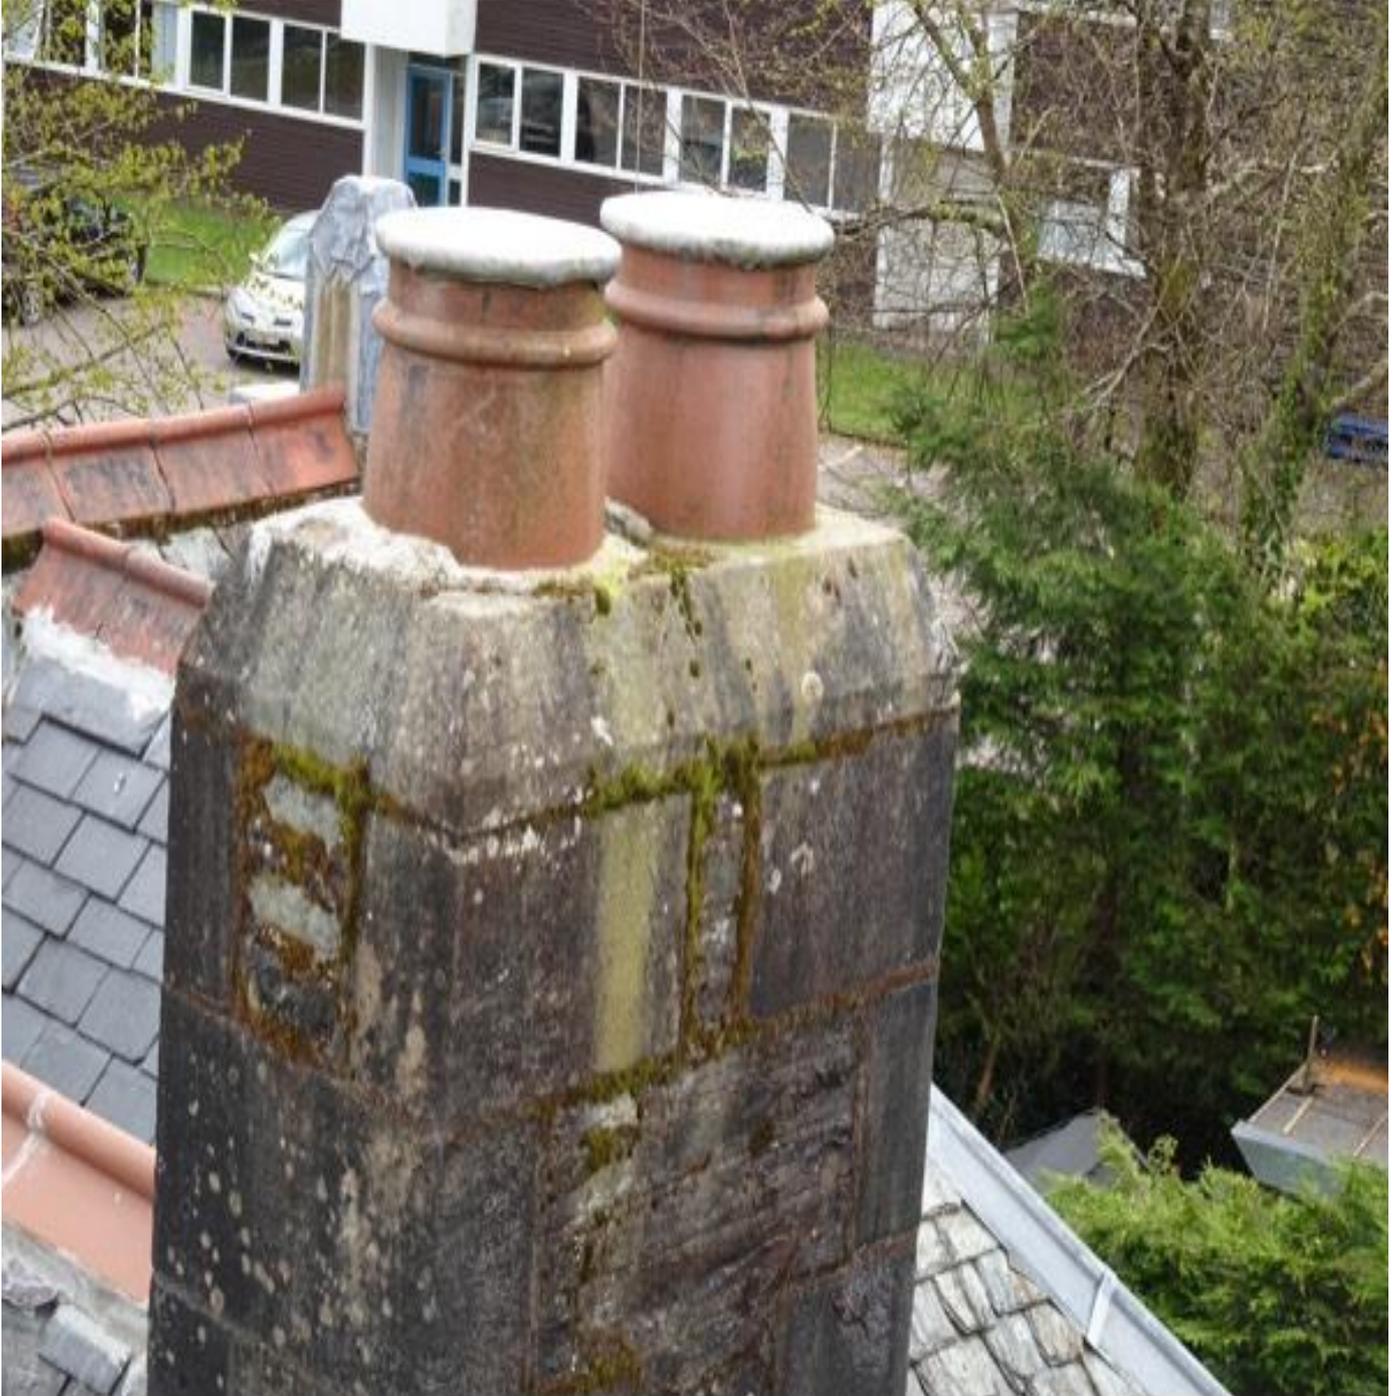
Age related decay detected to the central chimney stack

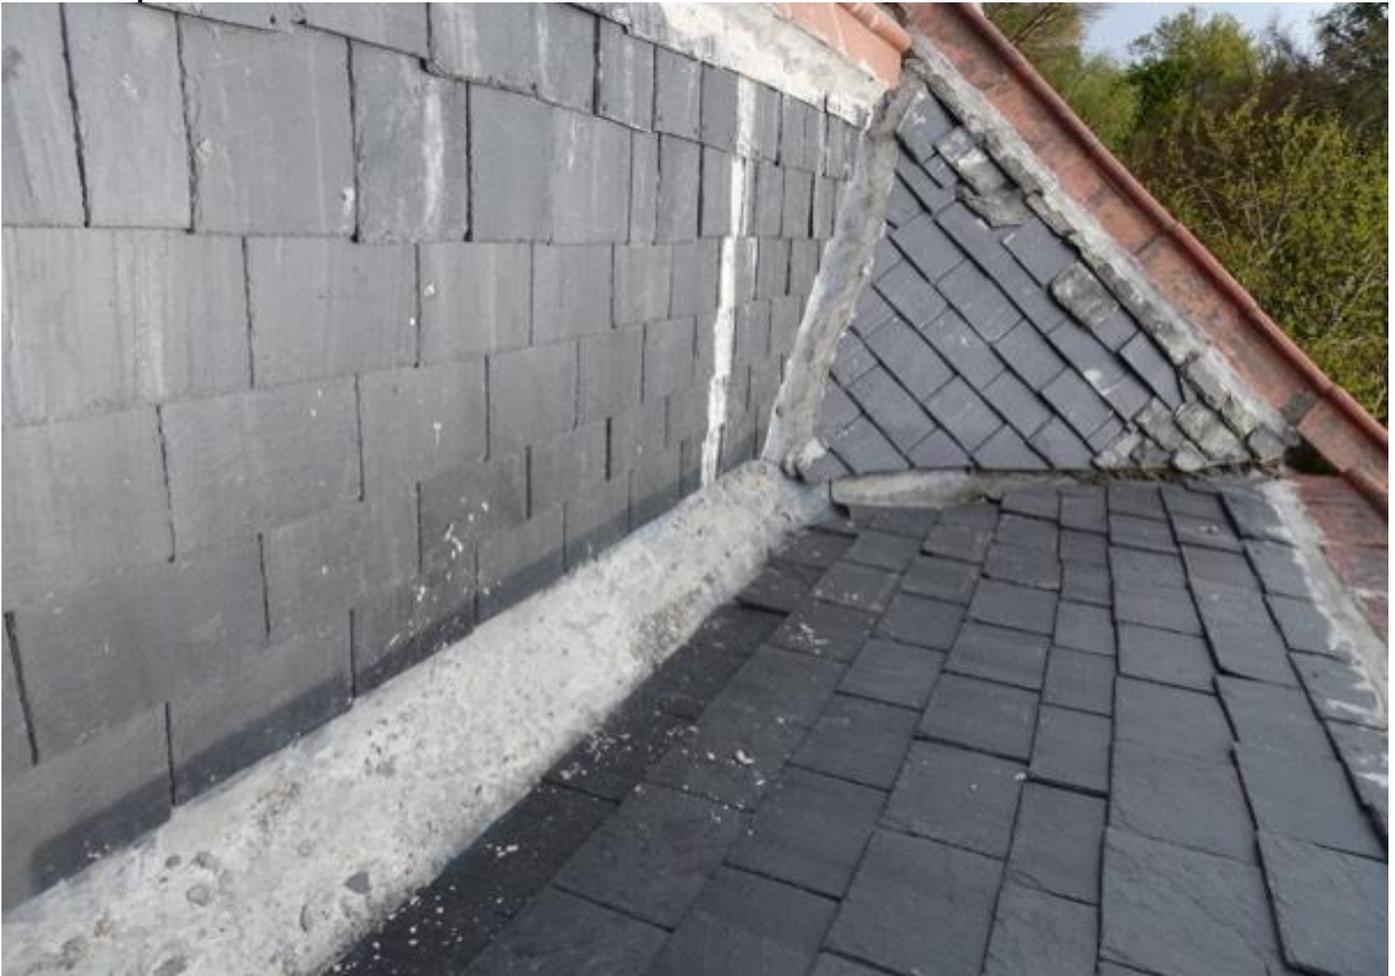
- The property has undergone some recent repairs to a section of pitched slate main roof (natural slate) this was found to be in poor condition and requires maintenance to the mortar areas with missing and damaged and incorrectly fixed slates.
- The ridge tiles require of maintenance where cracking/missing mortar is evident and should have been repaired correctly at the time of the repair.
- Recommend the slates are removed and replaced to maintain the water proof values of the roof coverings.

Recent repairs

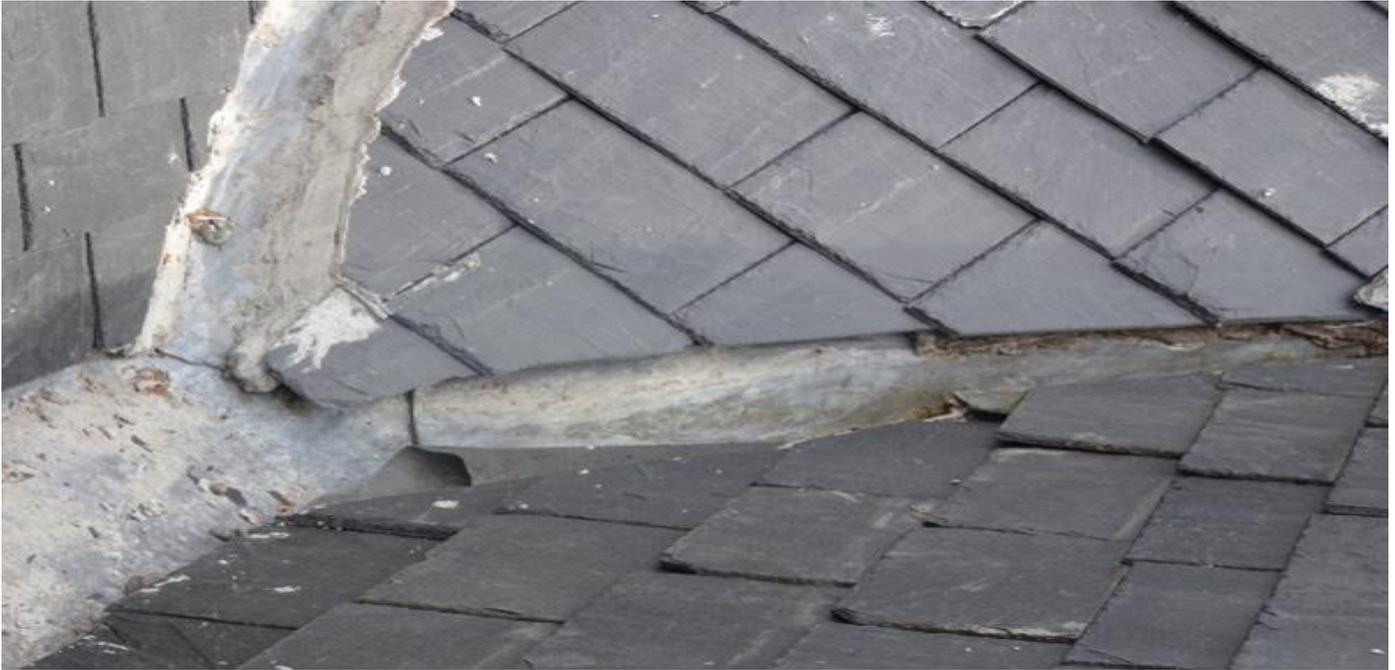
Poor quality workmanship

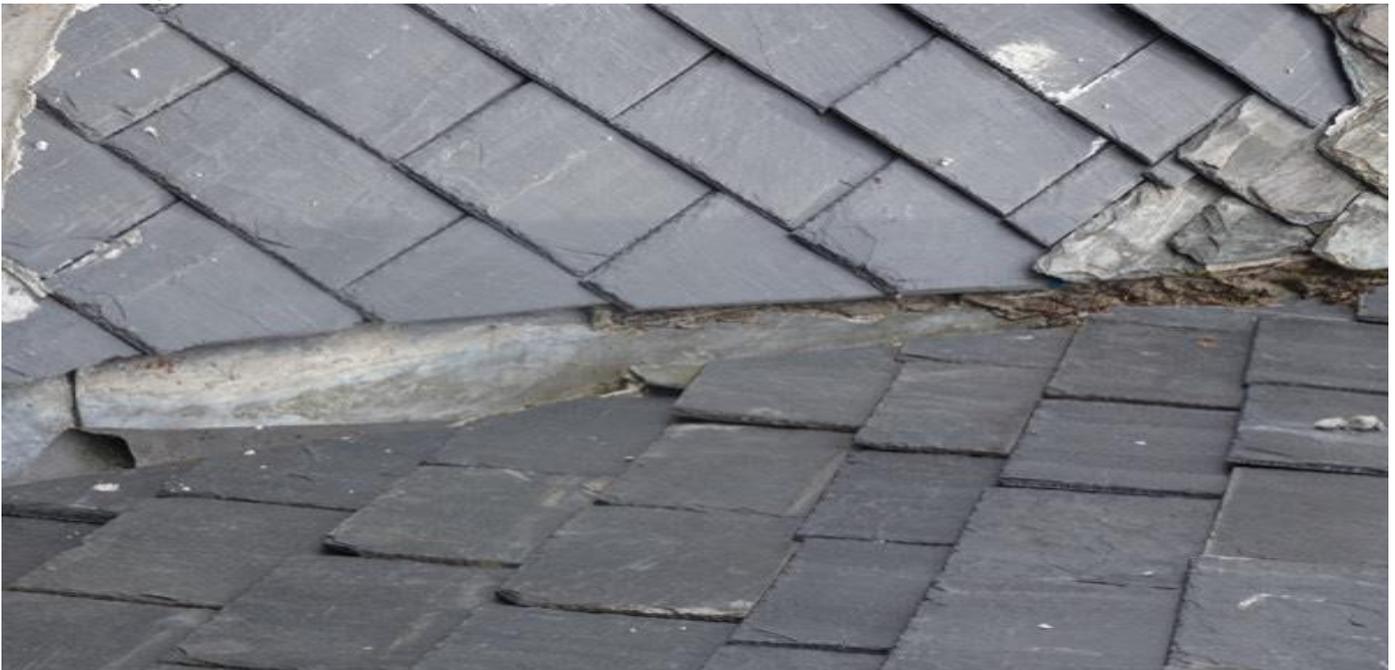
Poor quality workmanship

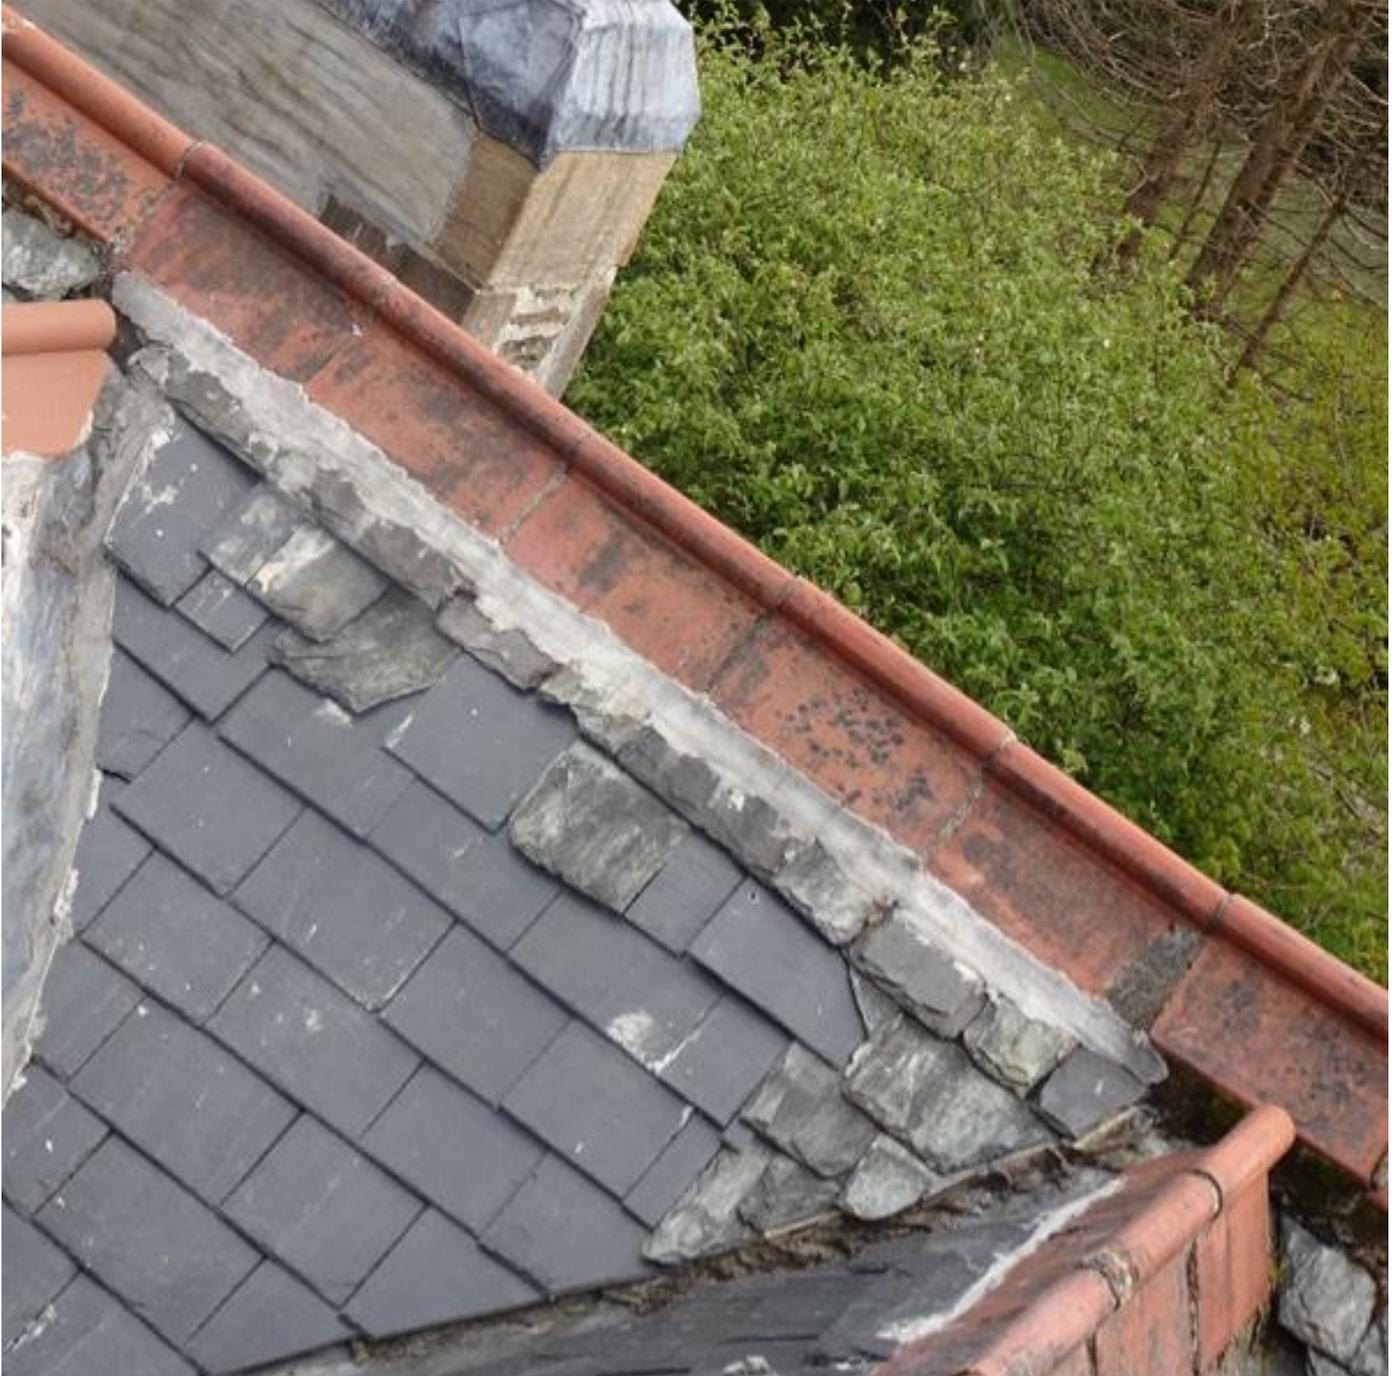
Poor quality workmanship

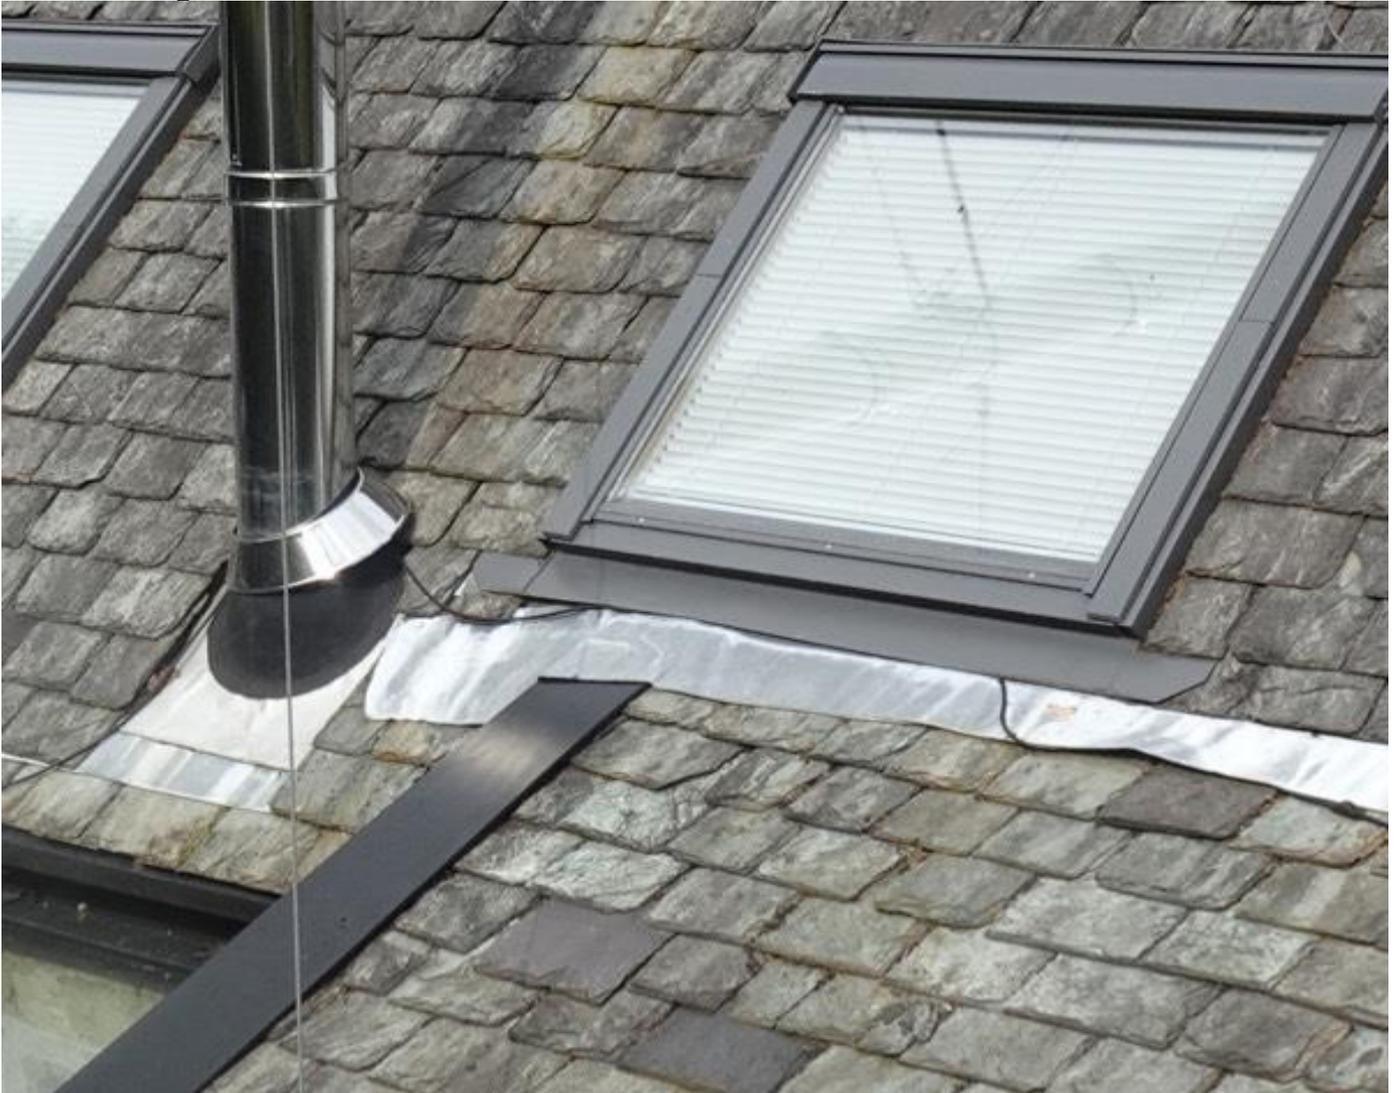
- The property has a west facing pitched slate roof (natural slate) this appears to be in good condition but requires maintenance to the lead flashing joint
- Inspection revealed that the lead flashing jointing piece was insecure fixed and slipped from situ exposing the roof joint
- Recommend damaged the lead flashing is replaced to maintain the water proof values of the roof coverings.

Lead flashing

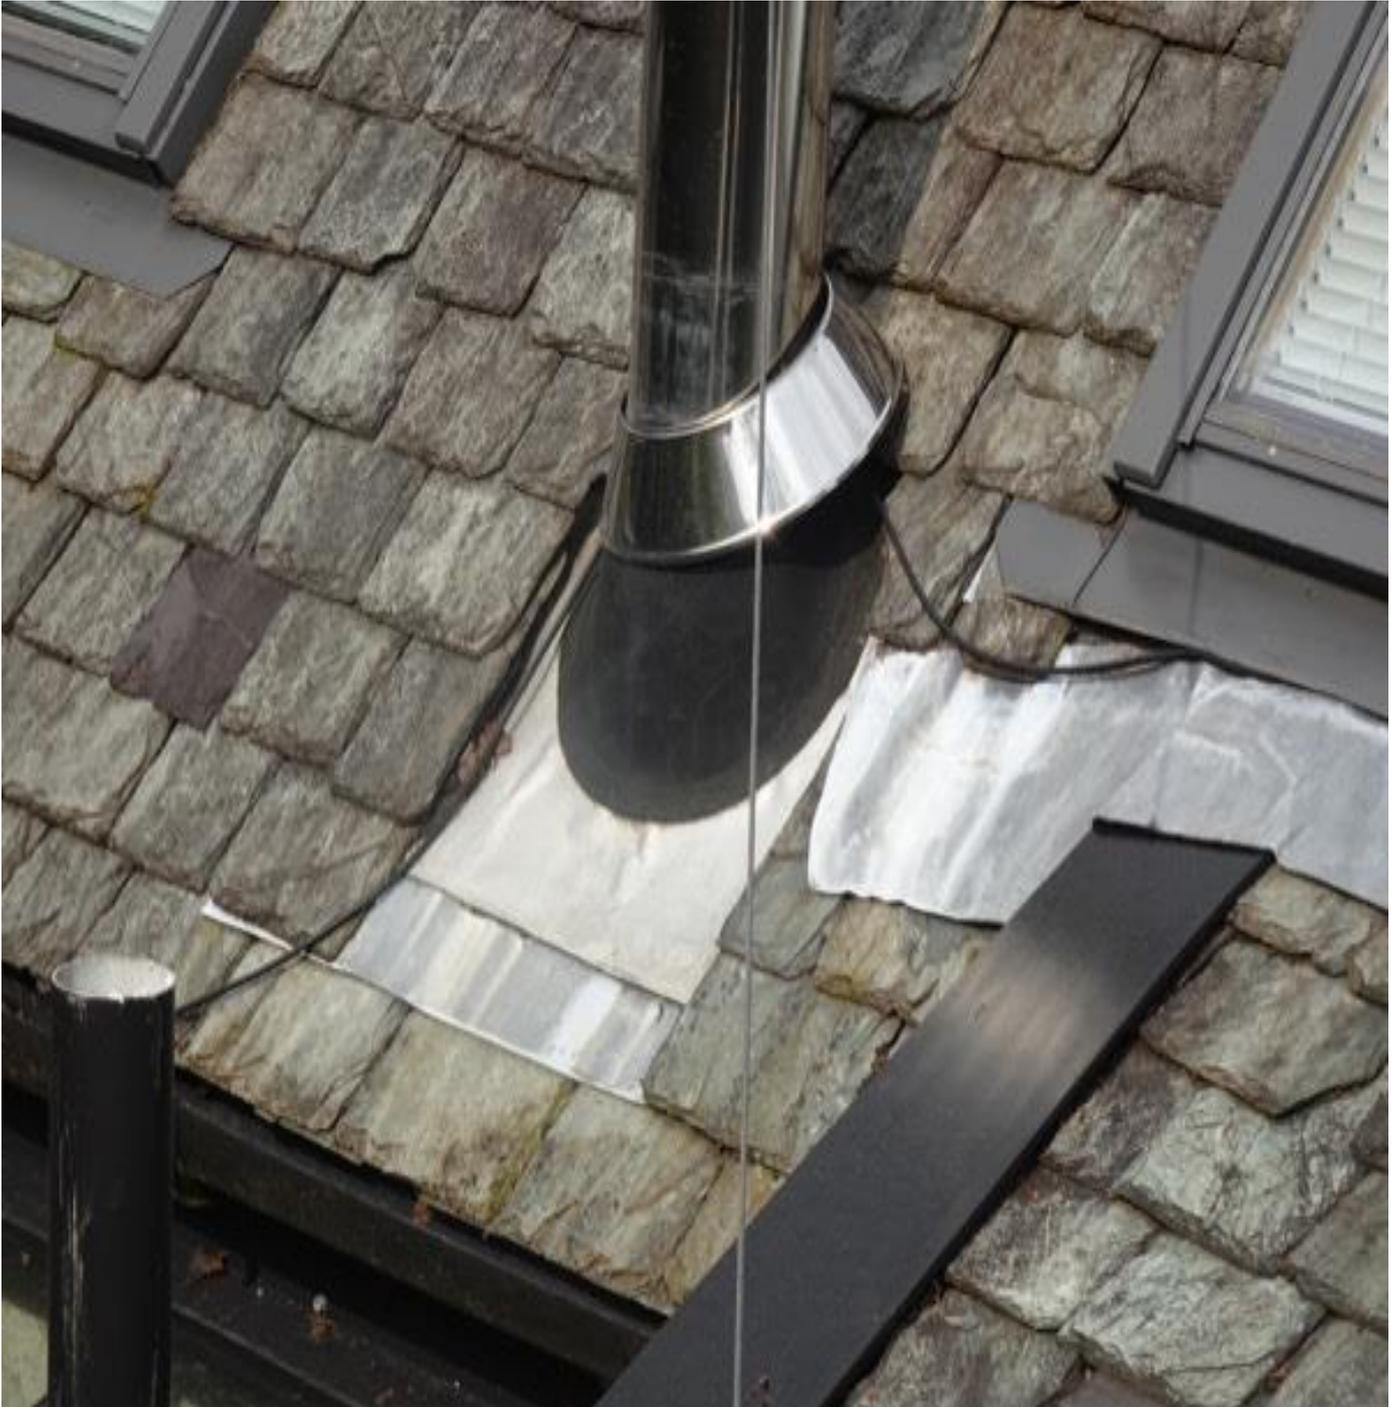
Slipped lead flashing
