Snagging Survey

Client Name: XXXX XXXXX
Address: XX XXXX XXXXXX XXXXX
XXXX
XXX XXXX
Purpose of Report: NEW BUILD SNAGGING
Report Reference: SS/XXX/2022
Inspection Date: 2Xth Jan 20XX
Surveyor Name: XXXXX XXXXXX BCI, CII, BDMA, ISO 18436-7 & BINDT CM/GEN
Building Surveyor Engineer Name: XXXX XXXXXX BSc (Hons) C Build E, MCABE.

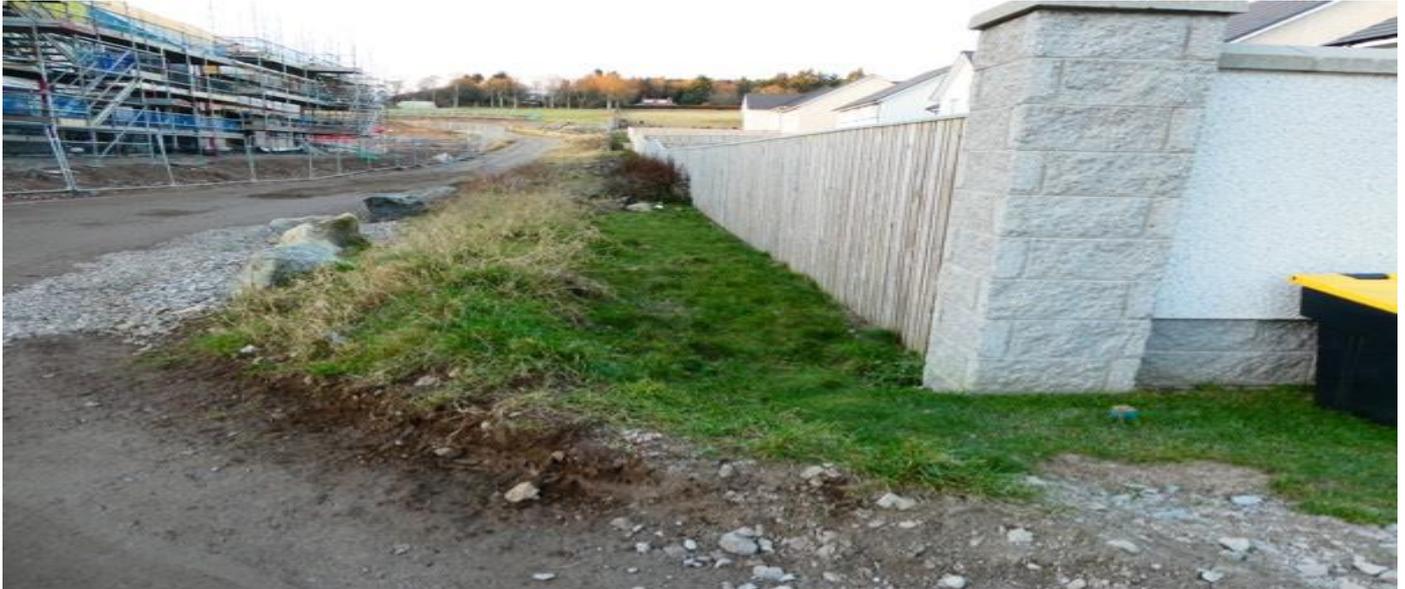
Elevated ground level detected beyond rear boundary fence

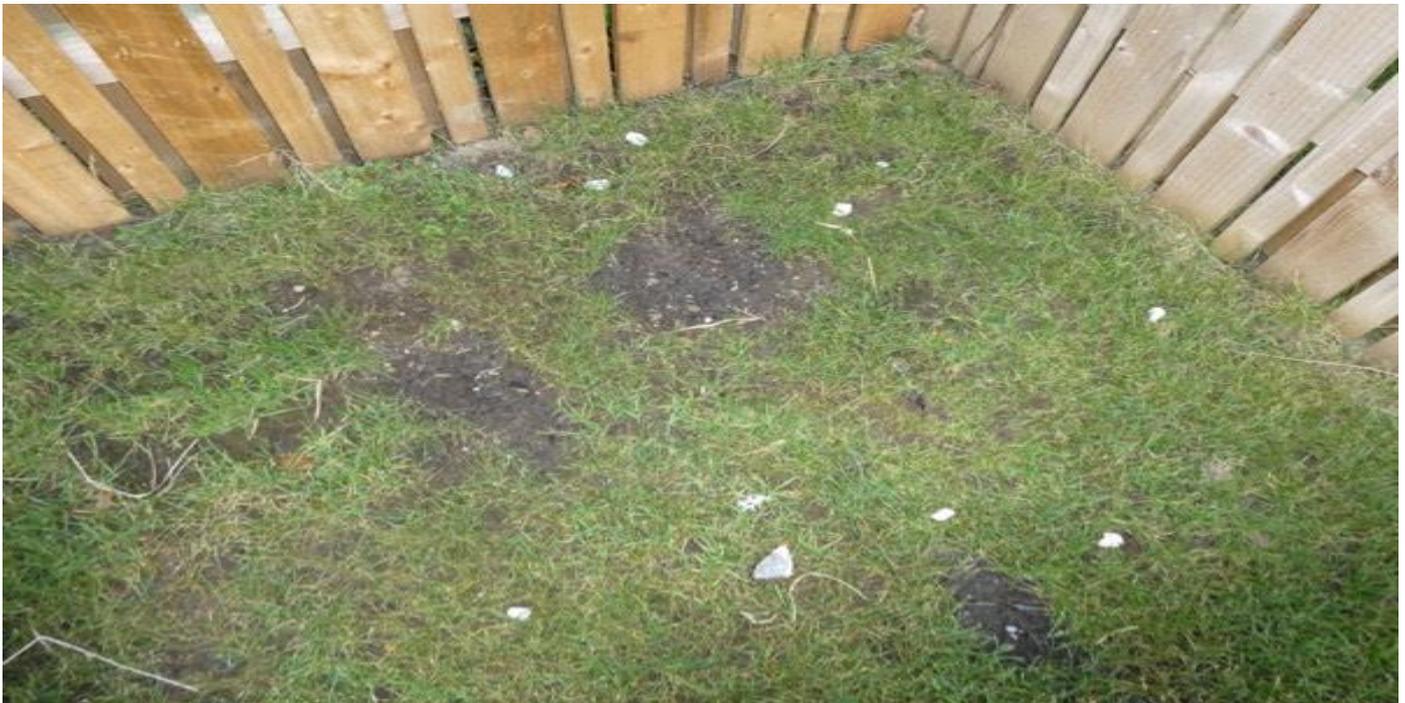
Rear elevation lawn laid over loos building material with insufficient top soil

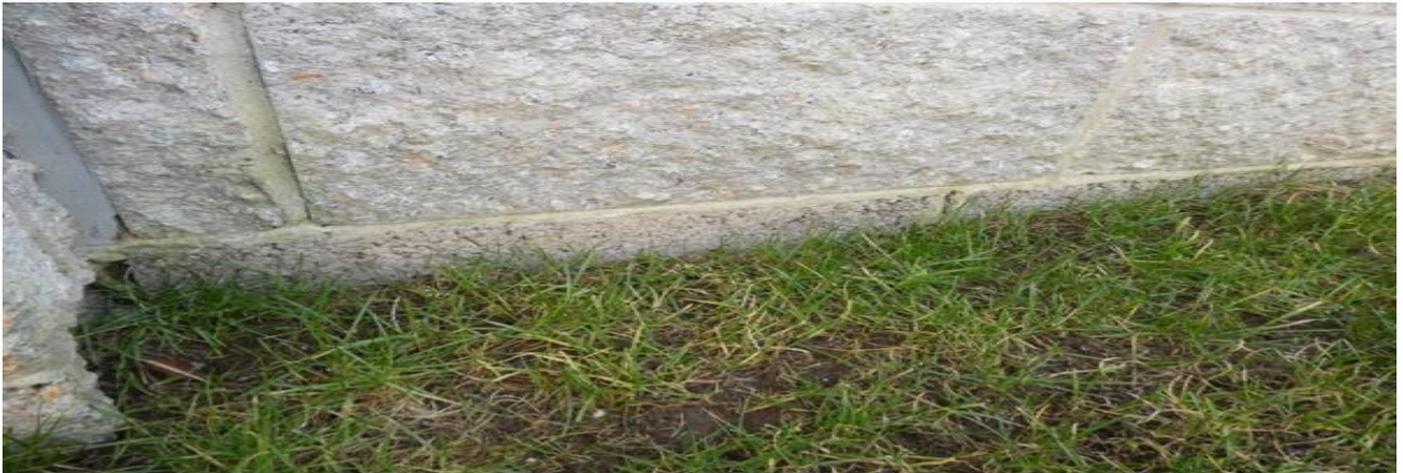
Ground saturation pockets to the rear elevation lawn area consistent with insufficient ground drainage exacerbated by the elevated ground level outside the perimeter boundary structures

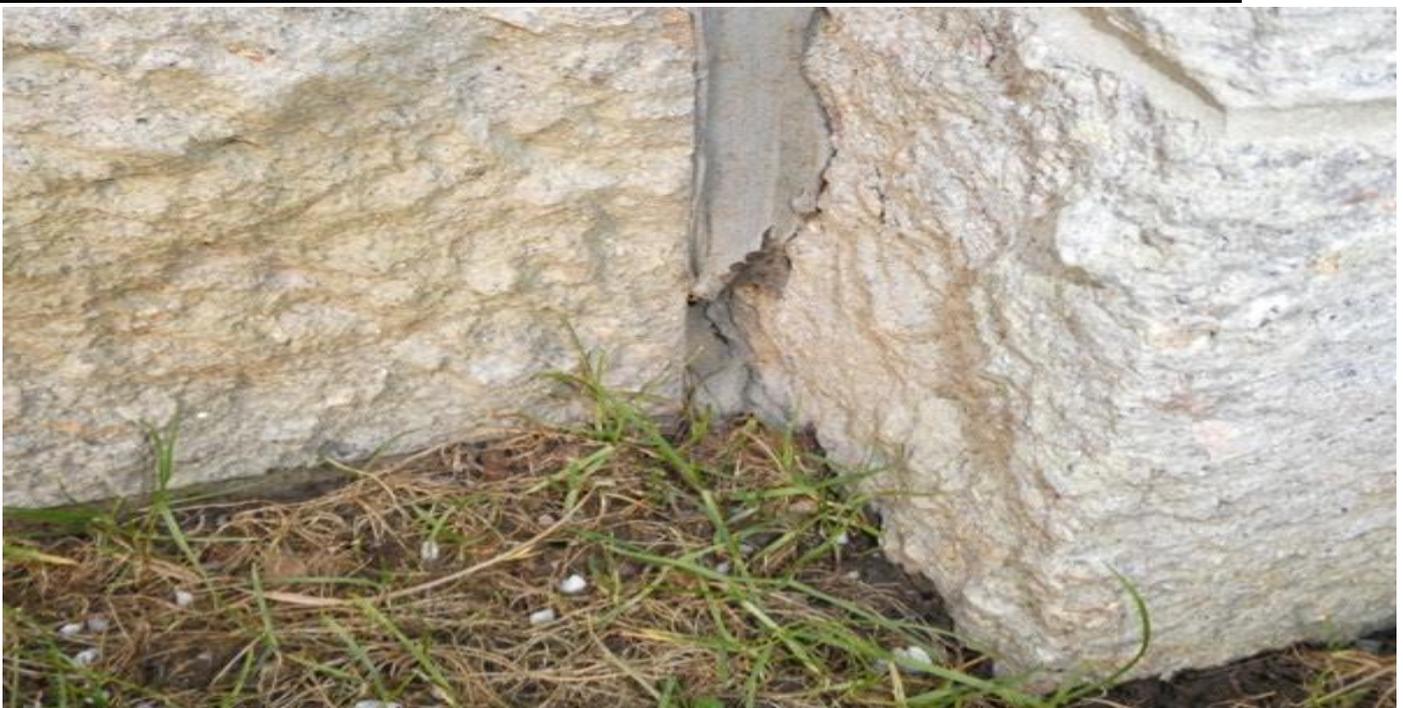
Holed incomplete boundary wall junction seal at base of wall pillar, this enable s water to enter freely from the elevated ground through the defective joint into the lower level lawn area.

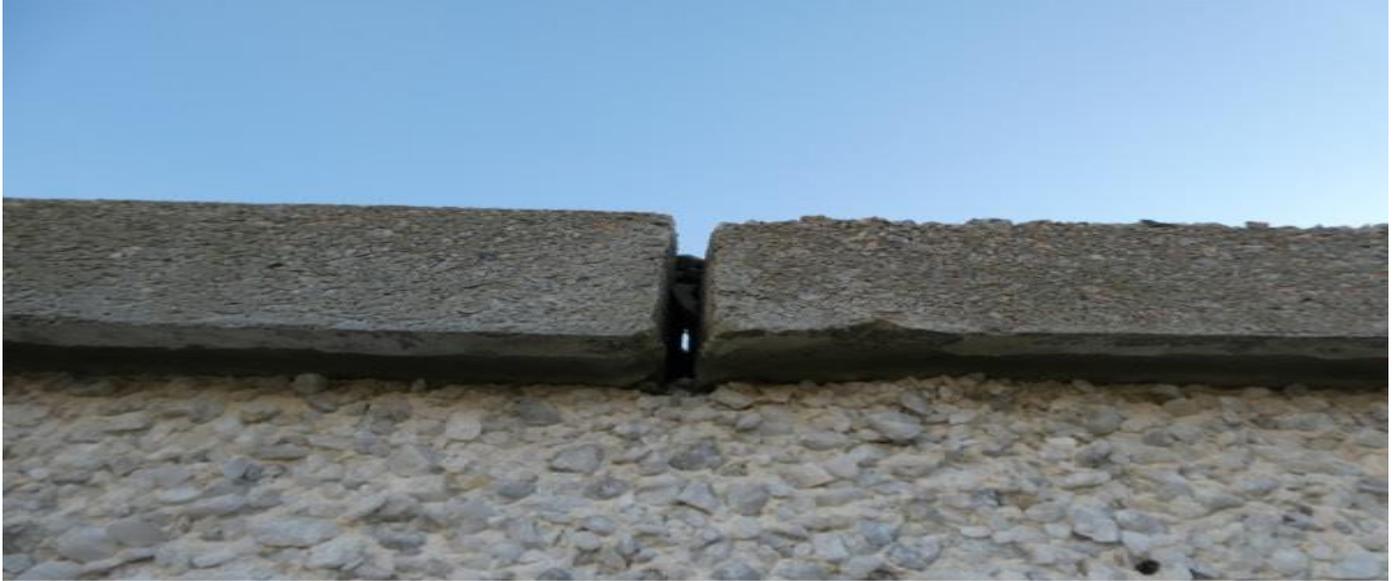
Incomplete mortar joints detected to the boundary wall cope stones

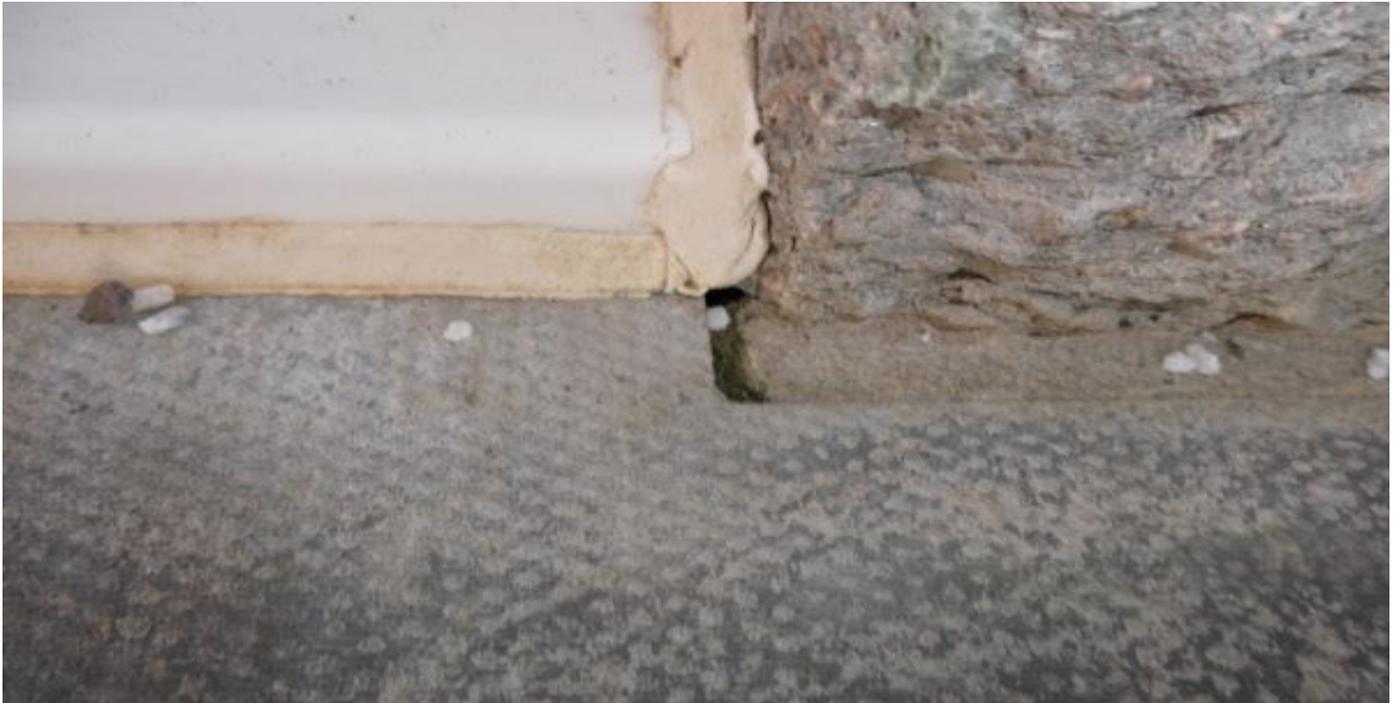
Incomplete mortar detected to the door step right location

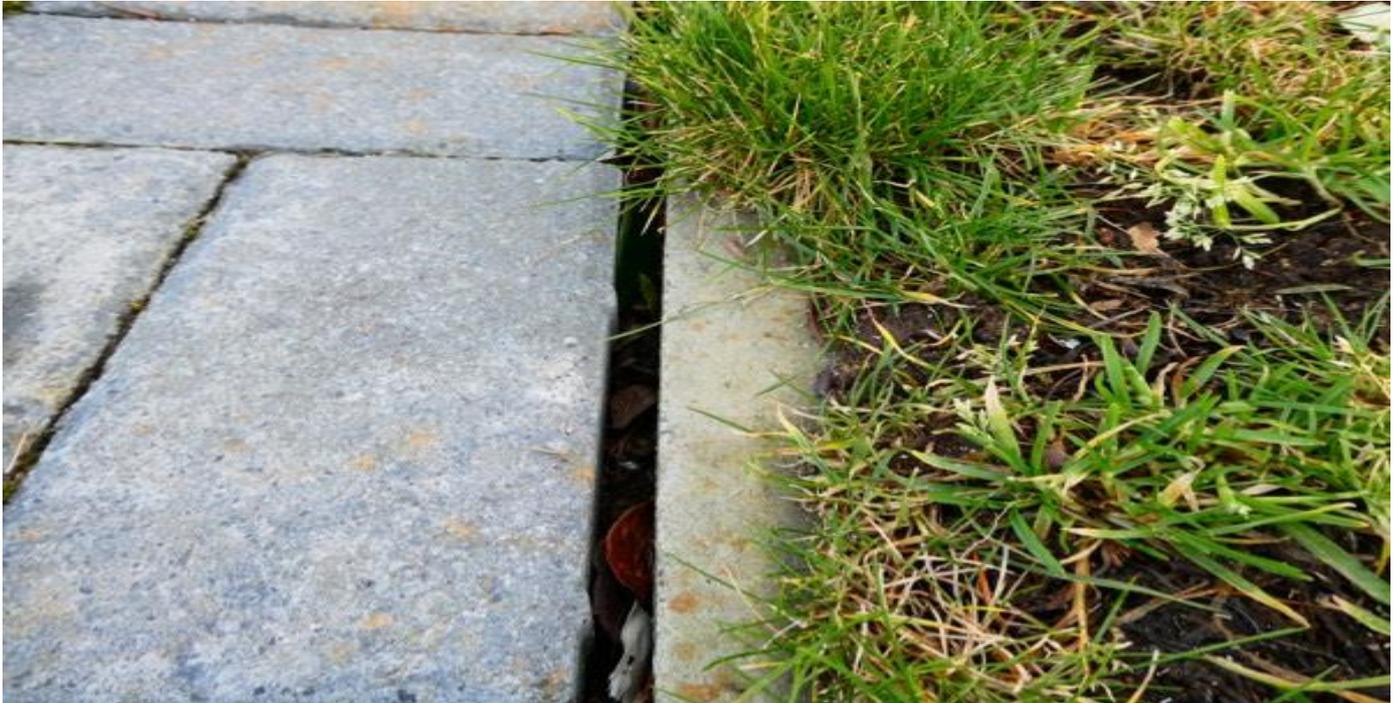
Insufficient dry mix detected to open perimeter concrete edging, mono block spread is inevitable

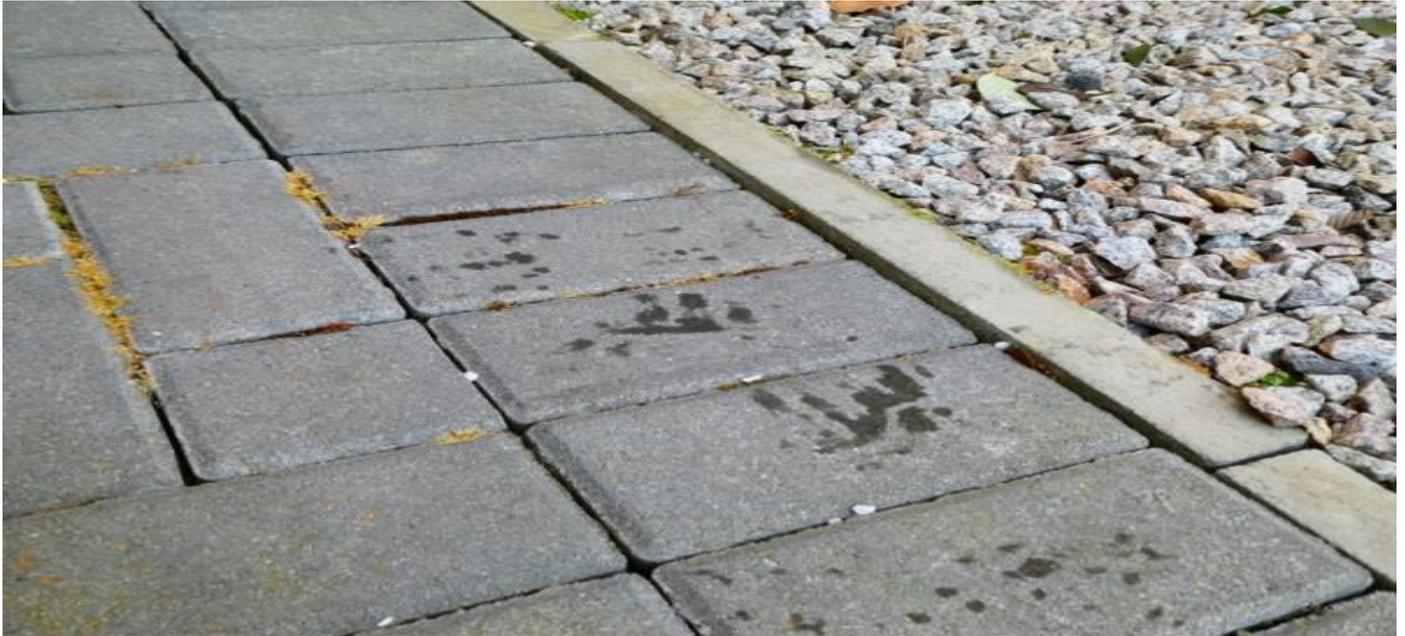
The mono block pathway to the side entrance has dropped in areas due to insufficient sub base

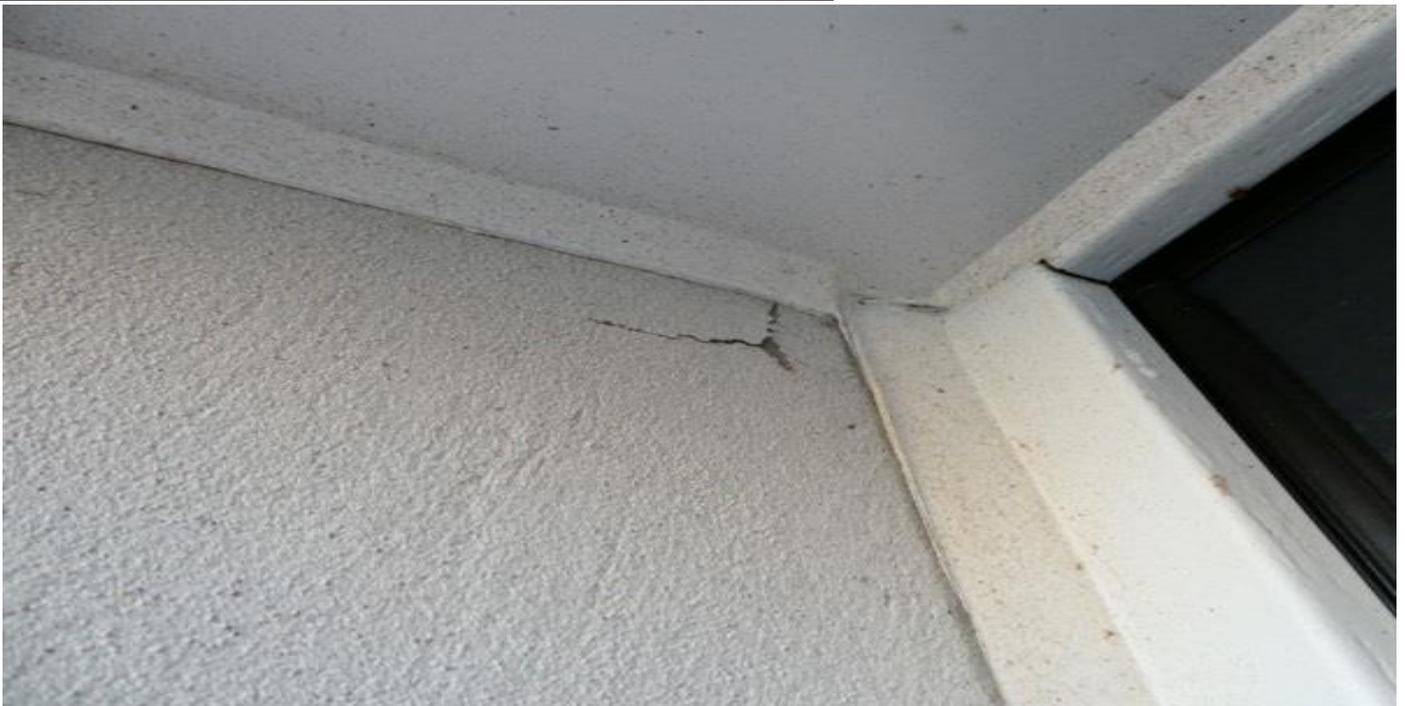
Render cracks detected to the left upper garage door reveal

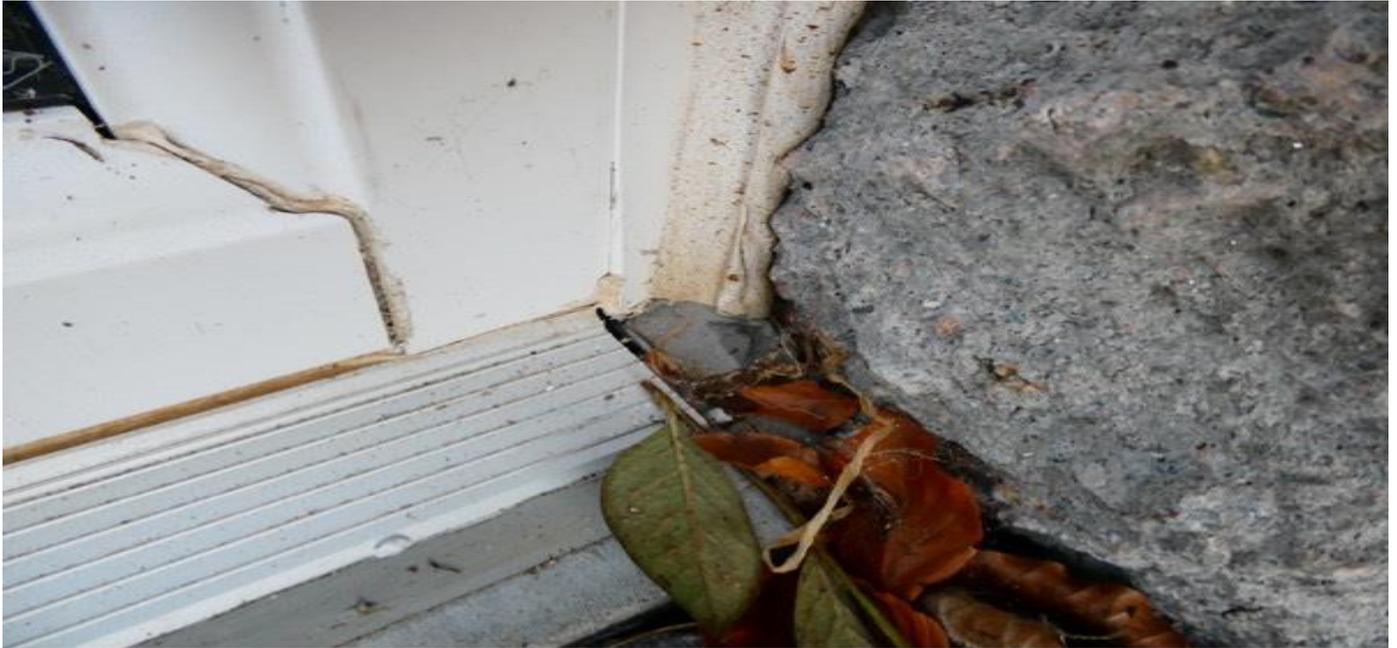
Holed and incomplete door frame seal detected to the front entrance door right

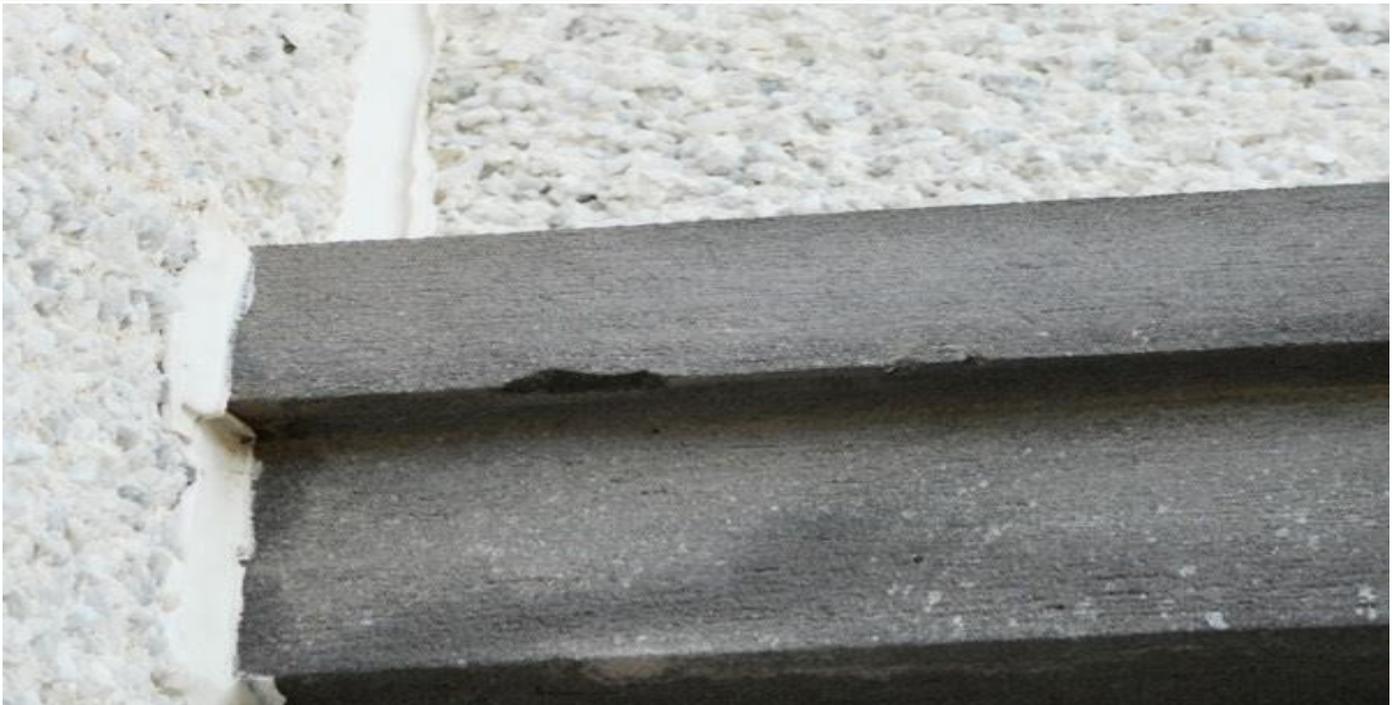
Chip damage detected in isolated areas to the stone overhang course

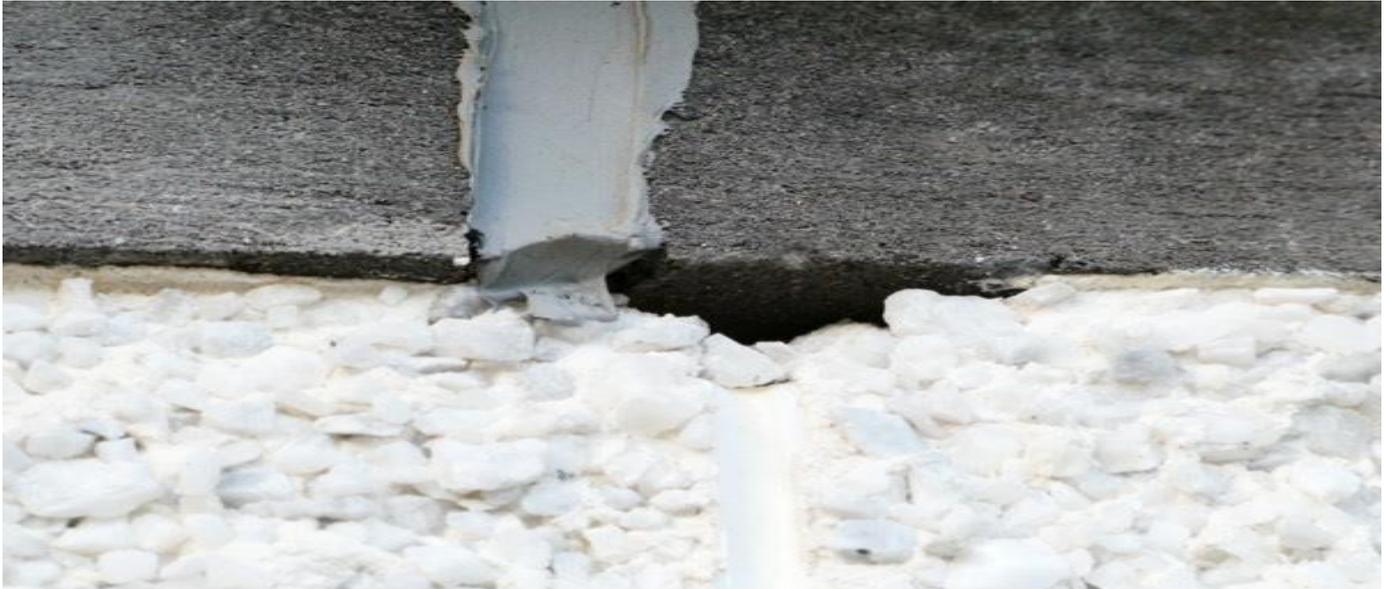
Areas of holed and incomplete render detected in isolated areas to the stone overhang course

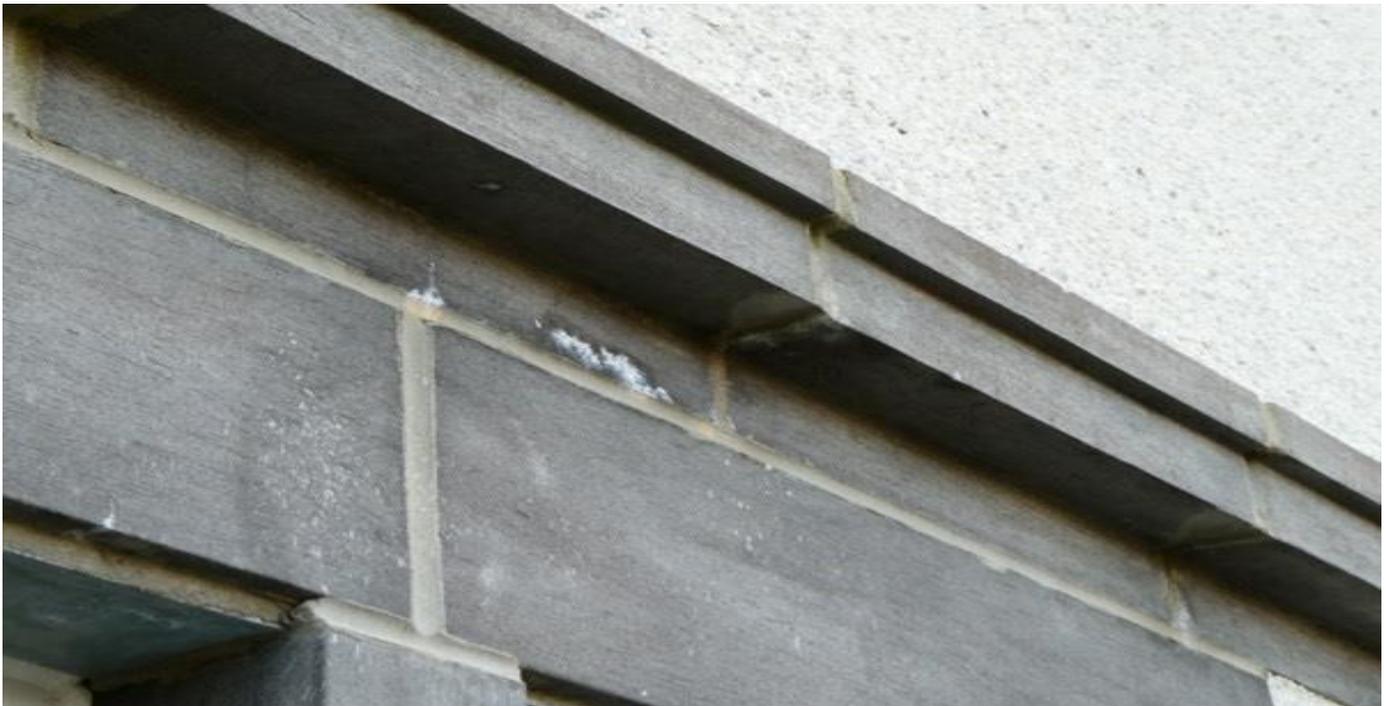
Evidence of efflorescence detected to isolated areas of the stone mullions, lintels and sills

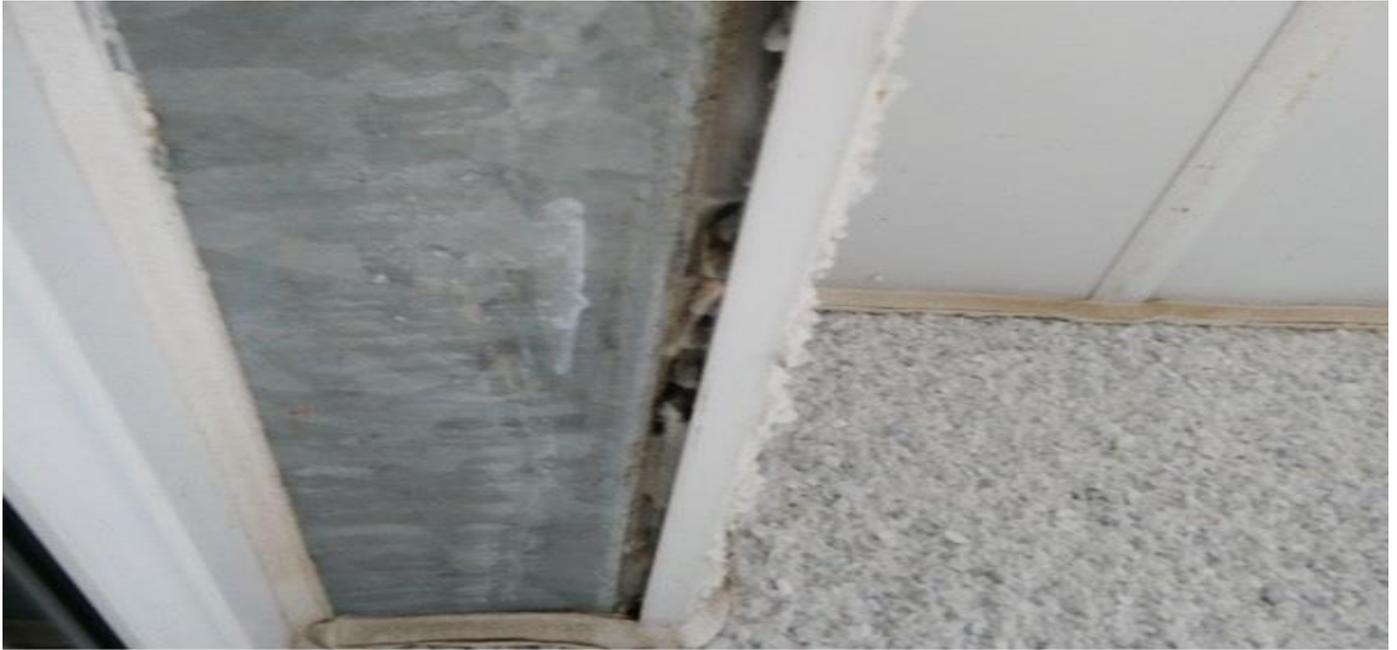
Incomplete render bead seal detected to a number of the window openings at lintel detail

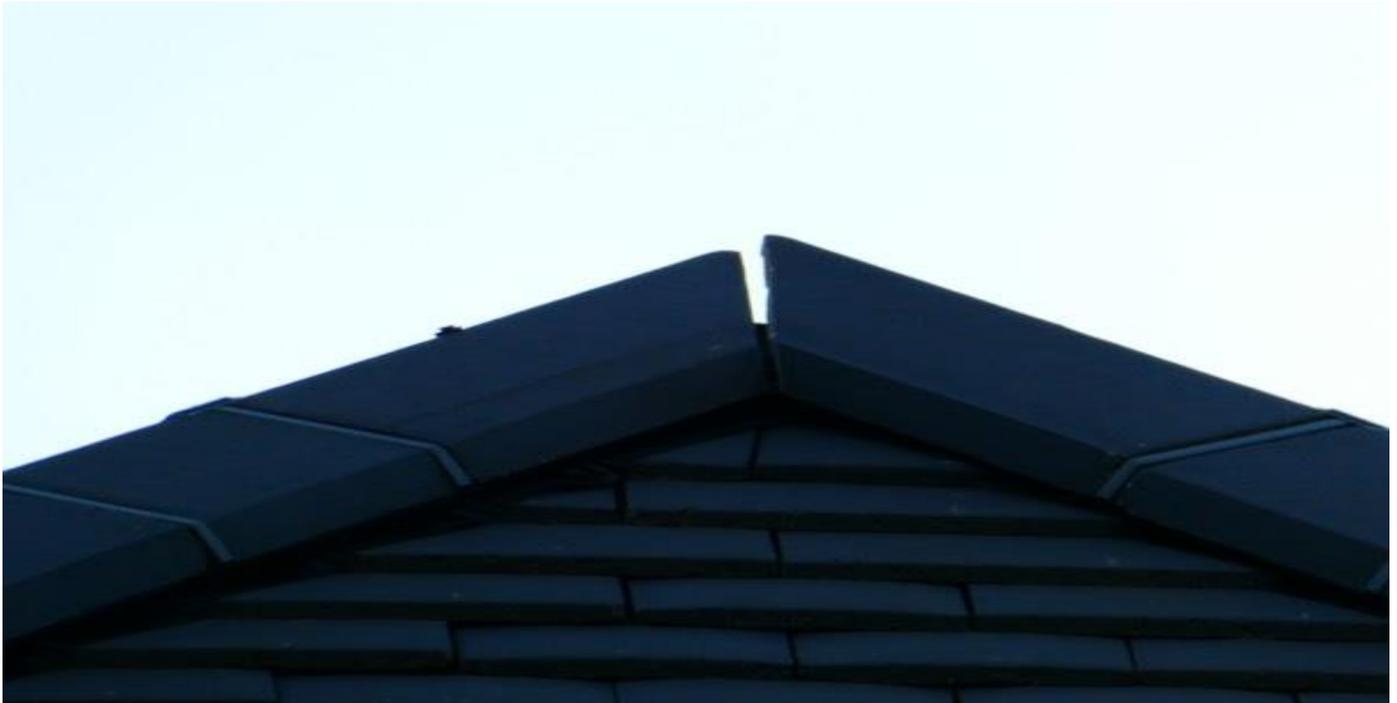
Dormer roof projection to the front elevation shows open and incomplete ridge mitre joint

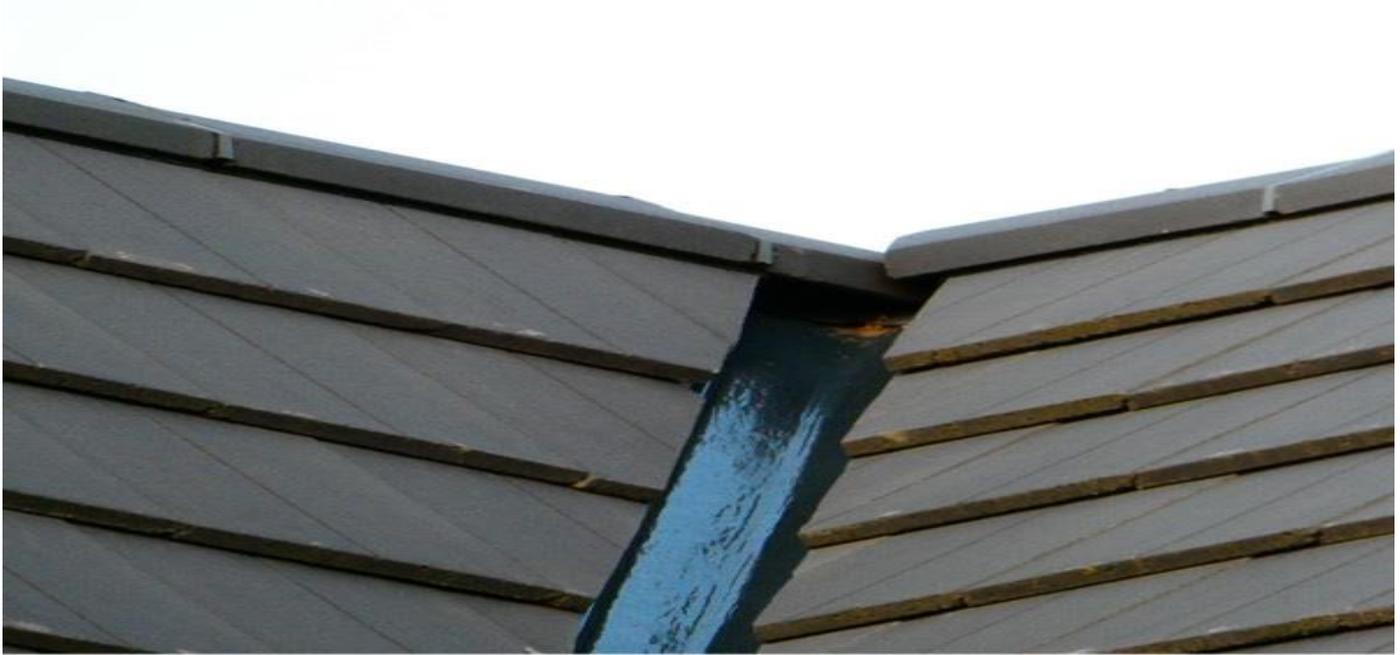
Missing lead cover flashing detected to maintain roof valley ridge

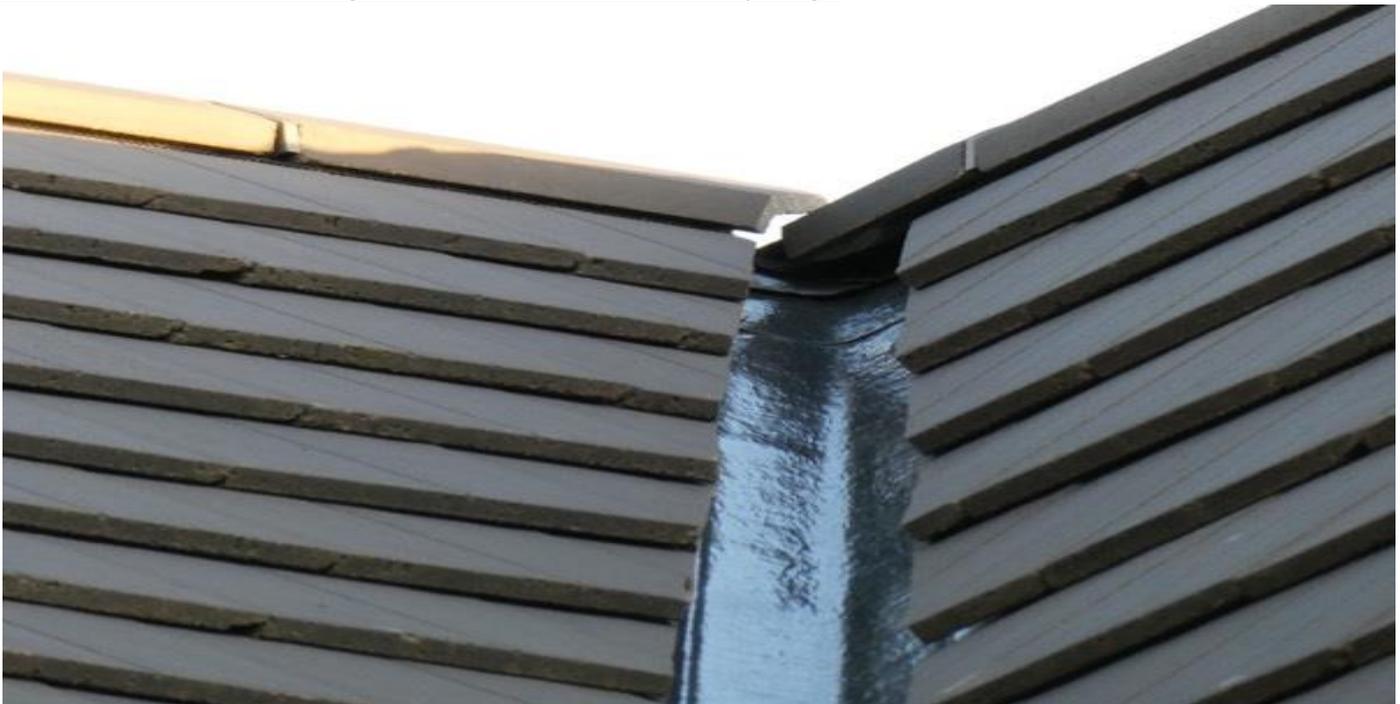
Insufficient cover flashing detected to main roof valley ridge

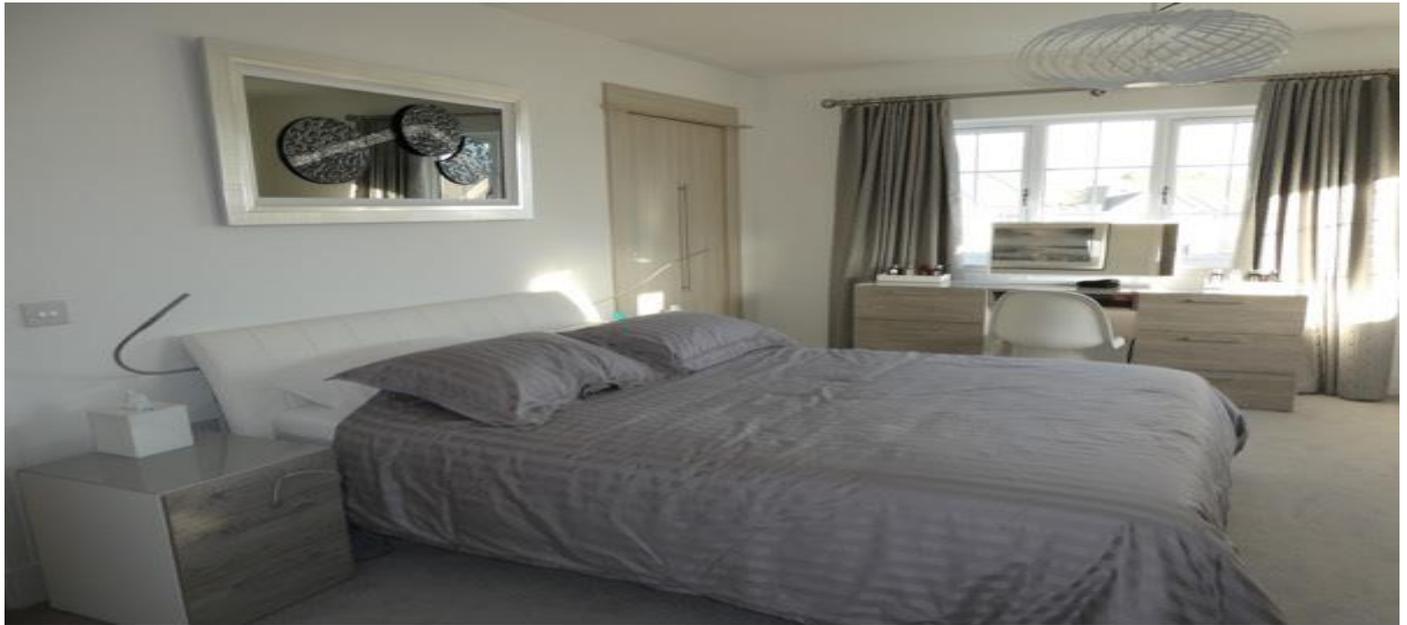
Master Bedroom 1

- Entrance door loose at keeper
- Nail pops to ceiling and wall above door entry
- Nail pops above wardrobes
- Wall plaster joint prominent behind tv location
- Wardrobe doors to right of bed set off plumb with tight close
- Skirting wall seal cracked in isolated areas
- Window sill and frame seal cracked
- Internal window sills marked
- En-suit entrance door mitres open
- Ceiling wall junction waves and uneven above bed

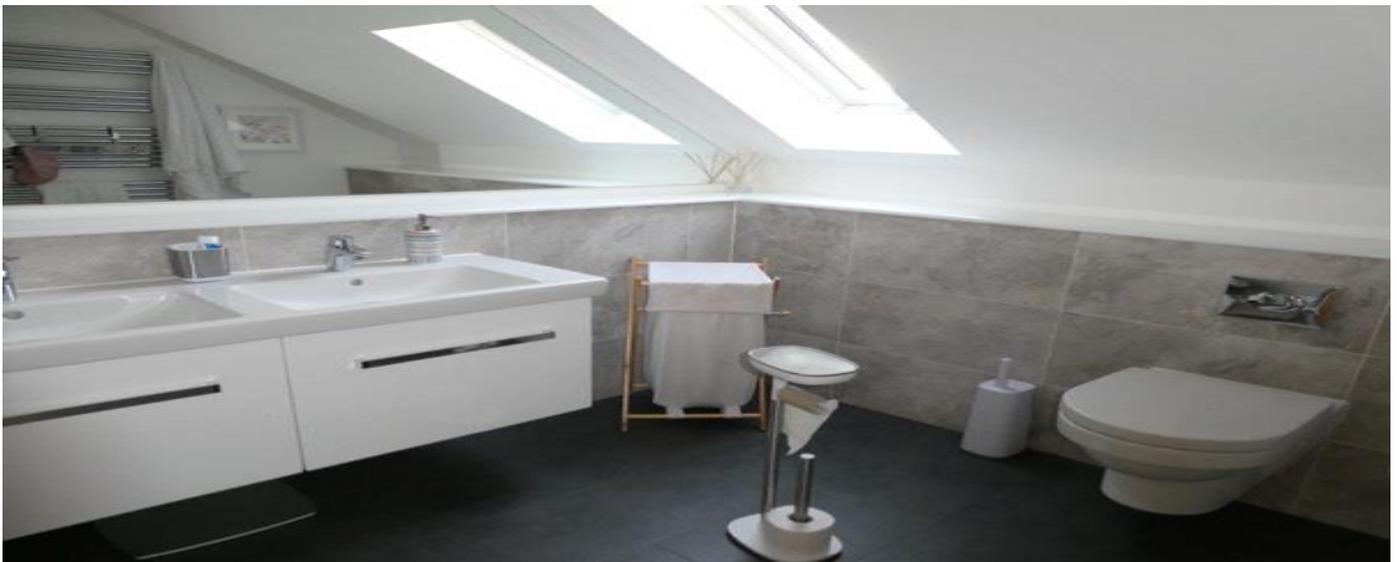
En Suite

- Following inspection it was noted that the ceiling had an emulsion smooth plaster finish with painted architraves, wood panel door with chrome furniture, Velux Window, Twin Basin's, Bulkhead/Vanity Units, WC, shower glass enclosure, Ceramic wall tiles, down lights, extractor/vent wall mounted heated towel rail.
- En-suit door opening not uniform
- Entrance door architraves mitres open
- Entrance door loose at keeper
- Heated towel rail secured to wall off plumb
- Flush plate to WC loose insecure fixed
- Ceiling plaster cracked above shower head with further cracking to ceiling wall junctions detected
- Shower head dropping from Siri
- Nail pops to ceiling above mirror
- Ceiling wall junction also cracked
- Twin basin taps loose insecure fixed
- Right hand waste plug jams when depressed
- Skirting tile seal incomplete at left of tray

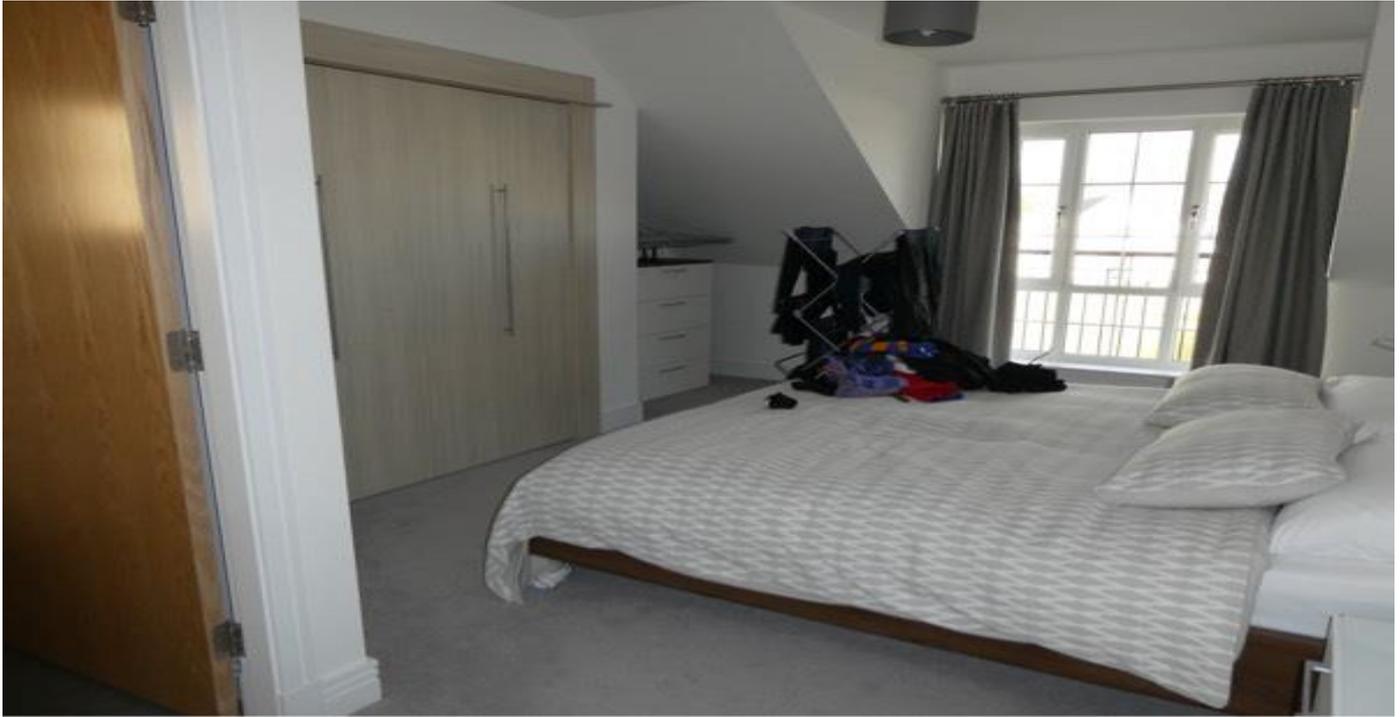
Bedroom 2

- Following inspection it was noted that the ceiling and walls had an emulsion smooth plaster finish with painted architraves, skirting, wood panel door with chrome furniture and window sill. PVCU windows, lights, double sockets, light switches, extractor isolation switch, TV/Phone point, wall mounted radiator.
- Entrance door not uniform
- Entrance door loose at keeper
- Ceiling wall junctions cracked
- Nail pops detected to wall right of en-suite
- Radiator secured to wall off level
- Left wardrobe door handle loose
- Skirting wall seal cracked in isolated areas
- Nail pops detected to wall reveals at window opening
- Window sill and frame seal cracked

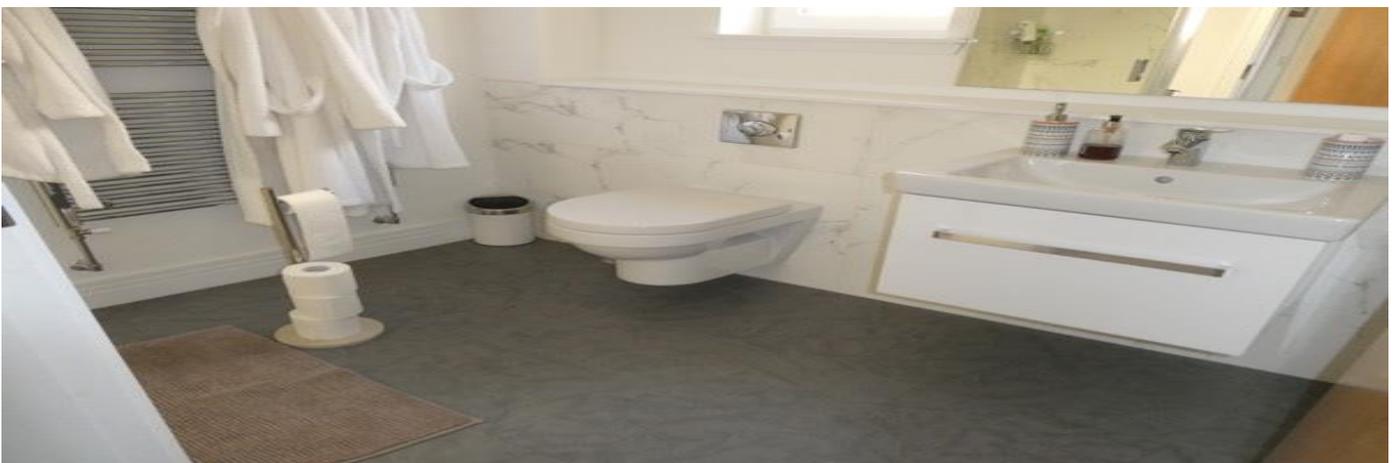
En Suite

- Following inspection it was noted that the ceiling had an emulsion smooth plaster finish with painted architraves, wood panel door with chrome furniture, PVCU window, Basin, Vanity Unit, WC, shower glass enclosure, Ceramic wall tiles, down lights, extractor/vent wall mounted heated towel rail.
- External door face marked around handle
- Entrance door loose at keeper
- Entrance door opening not uniform
- Door lock slightly stiff during use
- Wall ceiling junctions cracked in isolated areas
- WC flush panel loose insecure fixed
- Basin tap loose
- Basin plug jams in the downward setting
- Extractor secure in situ off square
- Heated towel rail off plumb
- Skirting tile seal missing from right and left
- Shower door cap to top right frame loose insecure fixed
- Window sill frame seal cracked.

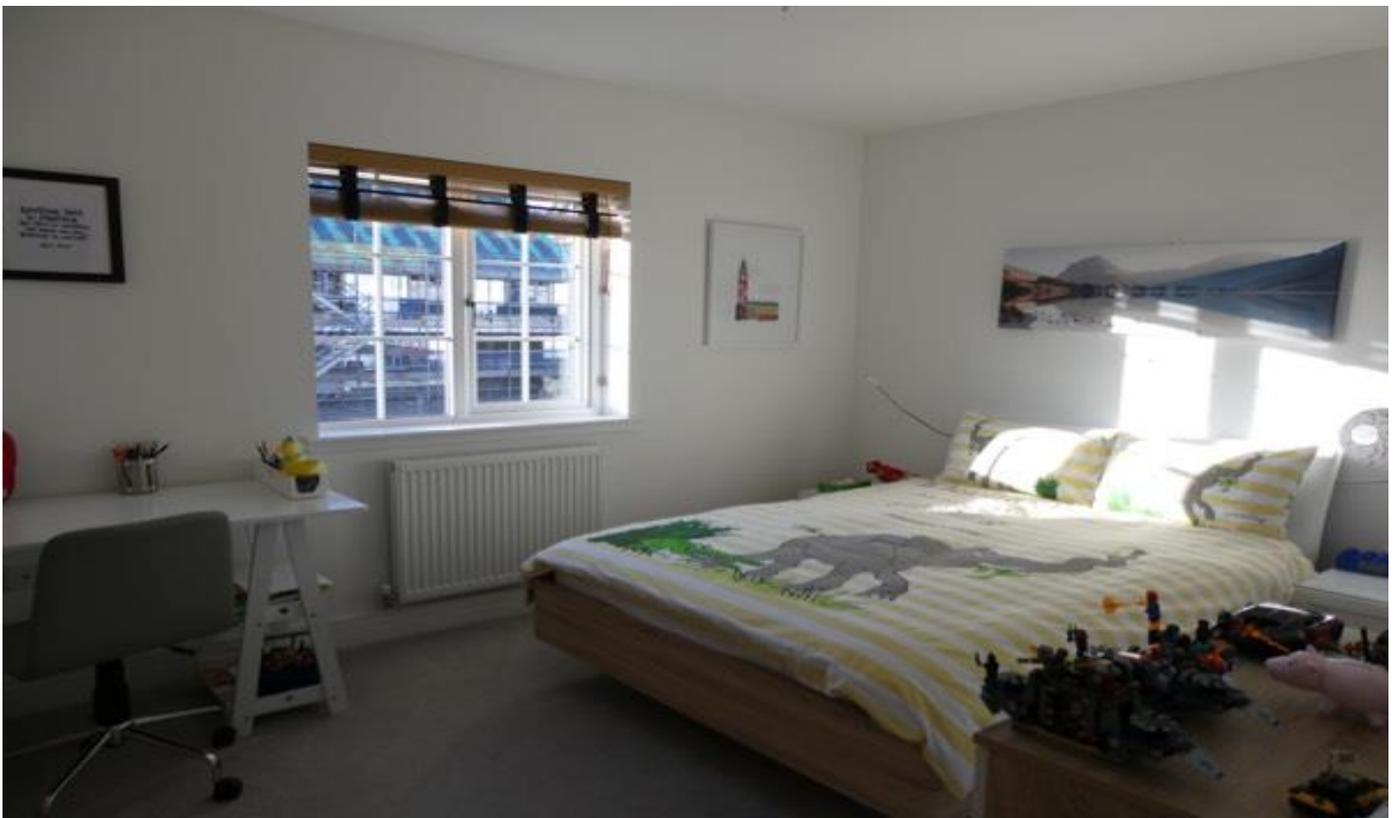
Bedroom 3

- Following inspection it was noted that the ceiling and walls had an emulsion smooth plaster finish with painted architraves, skirting, wood panel door with chrome furniture and window sill. PVCU windows, lights, double sockets, light switches, wall mounted radiator.
- Entrance door handle loose
- Entrance door opening not uniform
- Entrance door facing wall seal cracked to right side
- Ceiling wall junctions cracked in isolated areas
- Wardrobe door opening not uniform
- Window sill and frame seal cracked
- Sash opener grinds at bottom hinge during use

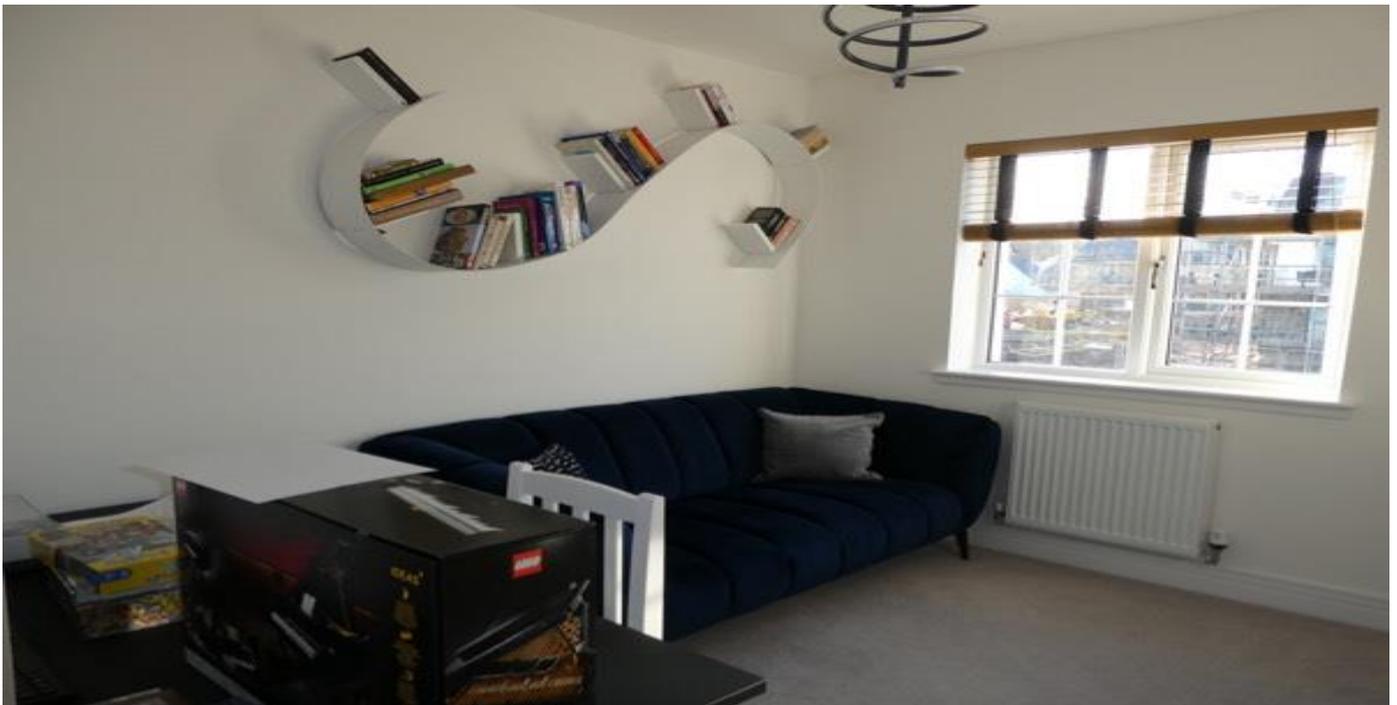
Bedroom 4 / Study

- Following inspection it was noted that the ceiling and walls had an emulsion smooth plaster finish with painted architraves, skirting, wood panel door with chrome furniture and window sill. PVCU window, lights, double sockets, light switches, wall mounted radiator.
- Entrance door loose at keeper
- Entrance door opening not in uniform
- Ceiling wall junctions cracked in isolated areas
- Light switch secured in situ off level
- Window sill drops to left and is set off level
- Window sill and frame seal cracked
- Sash opening catches on frame during use
- Wardrobe door loose at keeper
- Door opening not in uniform.
