Snagging Survey

Client Name: XXXX XXXXX
Address: XX XXXX XXXXXX XXXXX
XXXX
XXX XXXX
Purpose of Report: NEW BUILD SNAGGING
Report Reference: SS/XXX/2022
Inspection Date: 2Xth Jan 20XX
Surveyor Name: XXXXX XXXXXX BCI, CII, BDMA, ISO 18436-7 & BINDT CM/GEN
Building Surveyor Engineer Name: XXXX XXXXXX BSc (Hons) C Build E, MCABE.

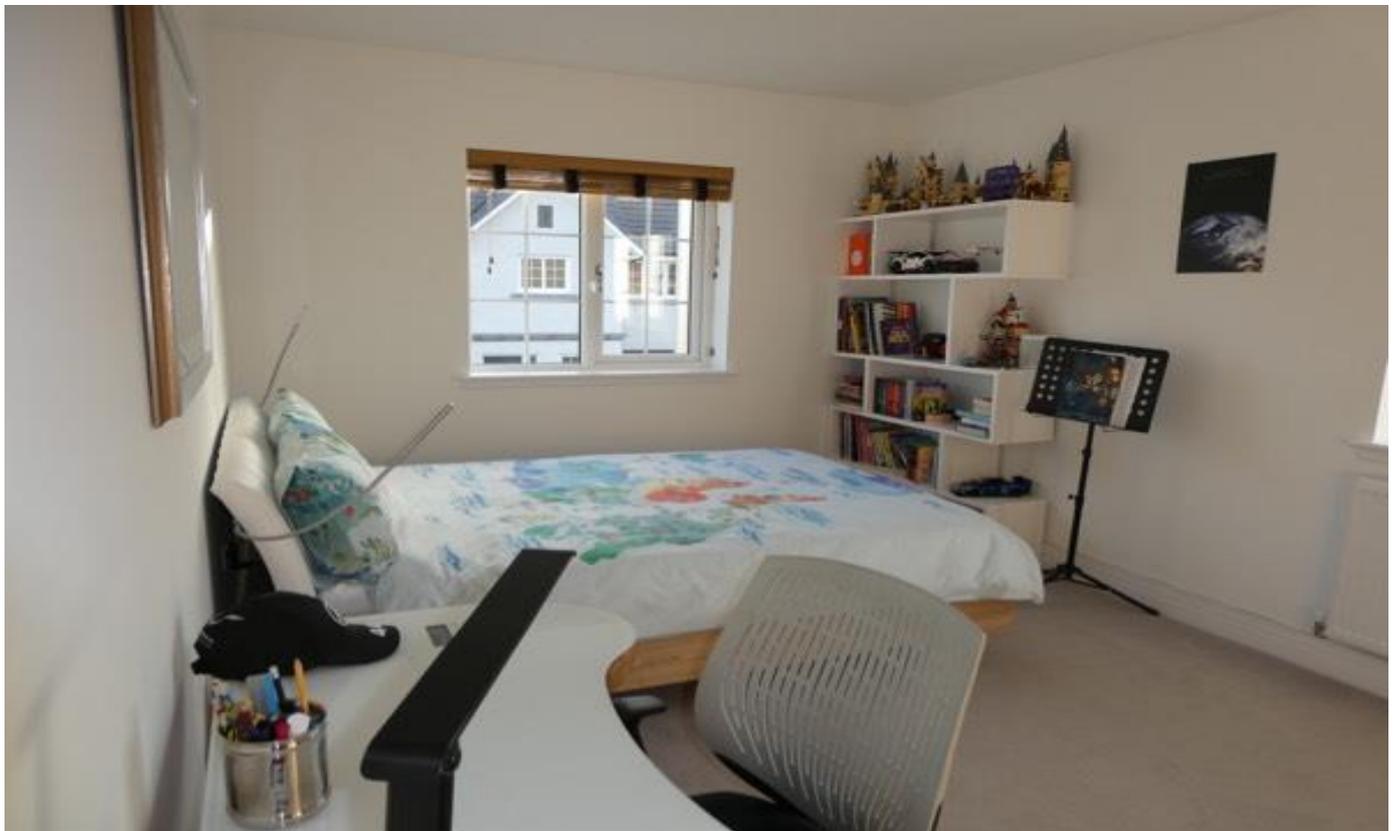
Bedroom 5

- Following inspection it was noted that the ceiling and walls had an emulsion smooth plaster finish with painted architraves, skirting, wood panel door with chrome furniture and window sill. PVCU windows, lights, double sockets, light switches, wall mounted radiator.
- Entrance door opening not uniform
- Wall ceiling junctions cracked in isolated areas
- Window sill and frame seals cracked in both windows
- Wardrobe door opening not inform
- Wardrobe left hand door handle loose
- Wardrobe architrave mitres open.

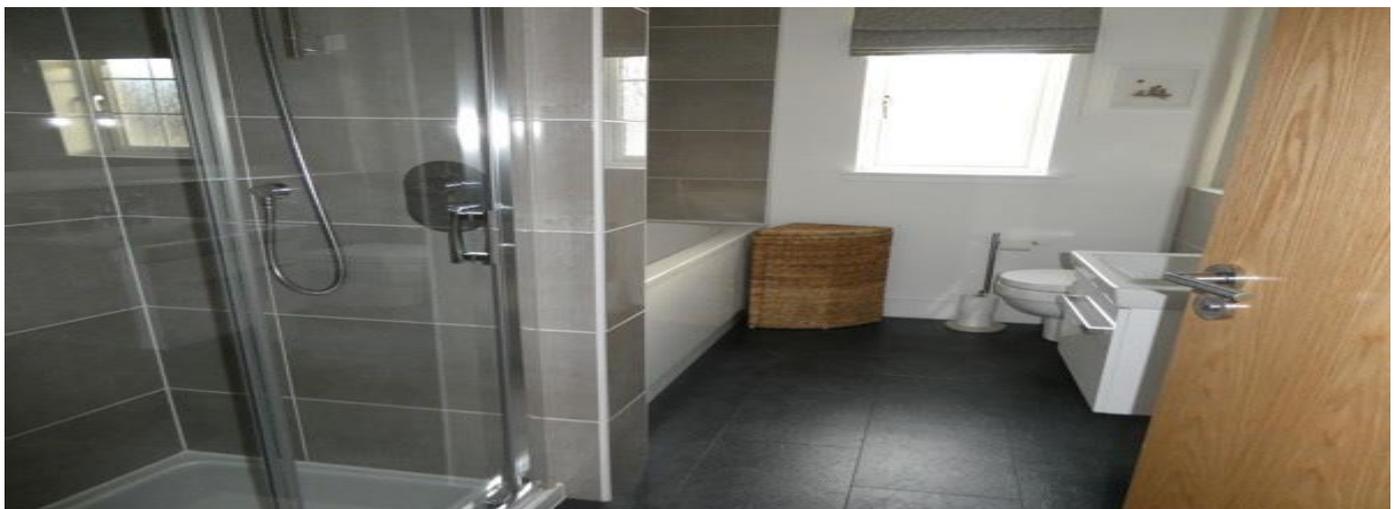
Bathroom

- Following inspection it was noted that the ceiling had an emulsion smooth plaster finish, painted architraves, ceramic wall tiles with wood panel door with chrome furniture, Obscure PVCU window, Basin/Vanity Unit, WC, Bath, Separate shower, Down lights, extractor/vent wall mounted heated towel rail.
- Entrance door marked internal face above handle
- Entrance door opening not uniform
- Entrance door lock stiff during operation
- Ceiling cracked above towel rail
- Wall ceiling junctions cracked in areas
- Basin plug sticks during operation
- WC flush panel loose
- Plaster crease detected to left pipe box
- Creased plaster at left edge tape reveal
- Cracked seal at sill frame
- Frame cap missing to shower at right of door frame
- Left cap loose insecure fixed to door frame.

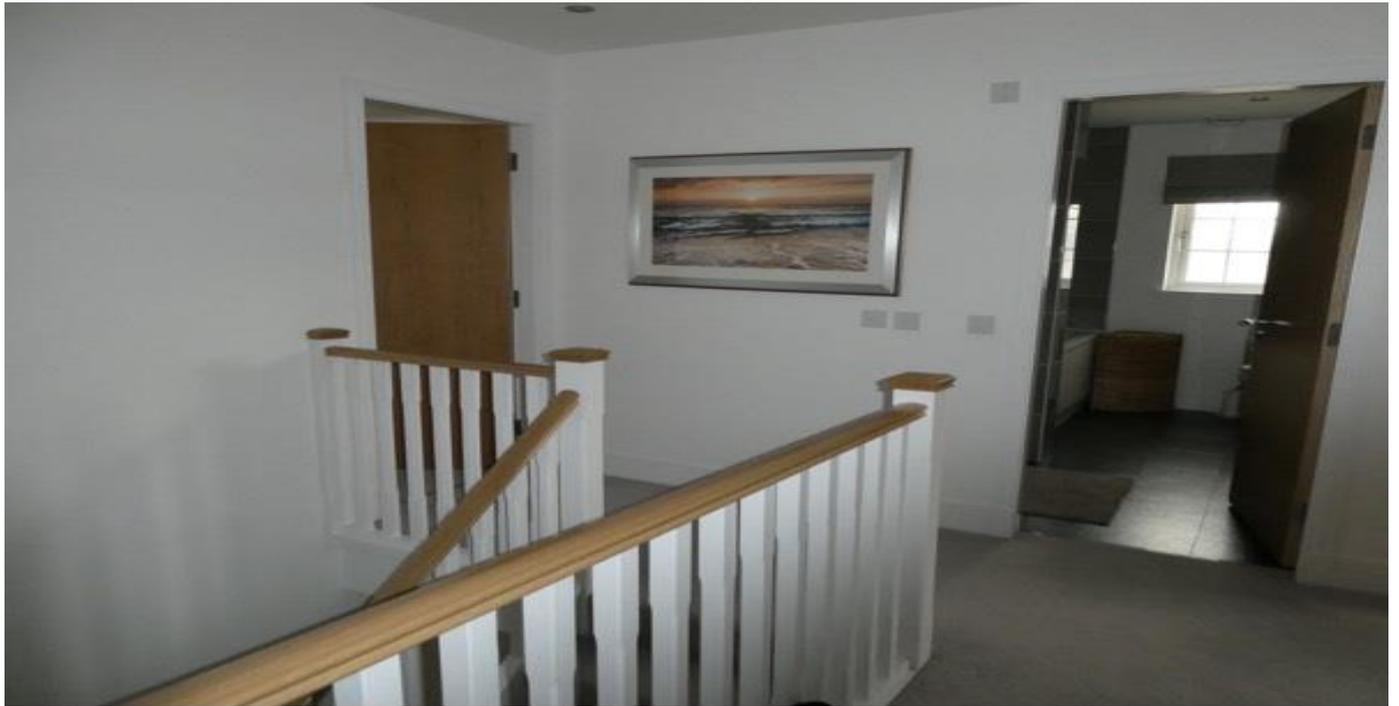
Upper hallway

- Following inspection it was noted that the ceiling and walls had an emulsion smooth plaster finish with painted architraves, skirting, wood handrail/balustrades, lights, double sockets, light switches, hard wired smoke detector, wall mounted radiator.
- Ceiling hatch jams during use
- Plaster uneven around light switches
- Newel post plugs not flush and prominent.
- Room entrance door way mitres open
- Cupboard door loose at keeper
- Cupboard door opening not uniform
- Base rail cracks to balustrade seal
- Cracking detected above left of master bedroom entry consistent with thermal movement.

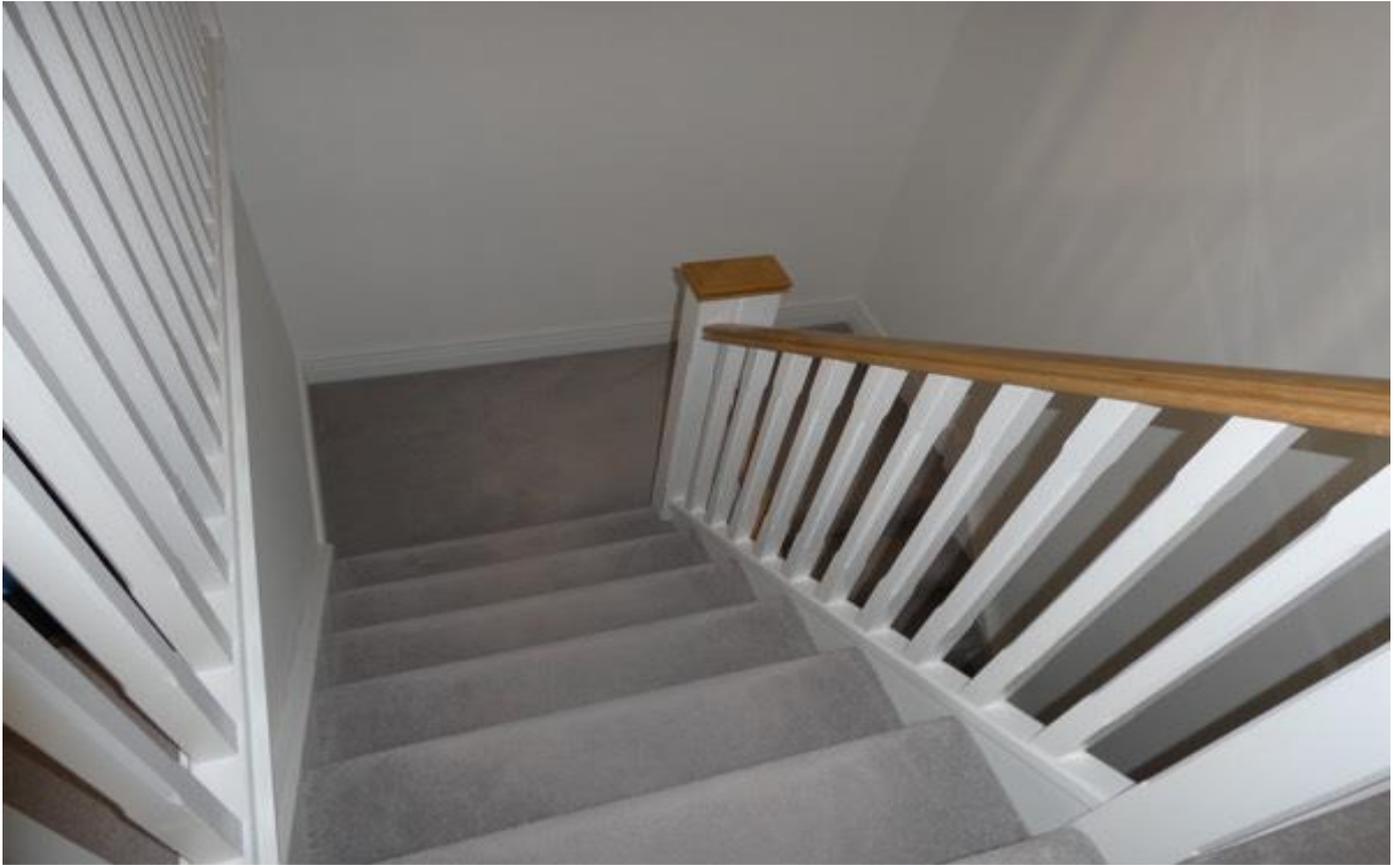
- Following inspection it was noted that the ceiling and walls had an emulsion smooth plaster finish with painted architraves, skirting, wood handrail/balustrades.
- Horizontal plaster crease detected at landing back wall.
- Cracked wall riser seal detected
- Cracked newel post wall joint
- Landing floor deck movement detected due to insecure fixing detected
- Balustrade and newel post noted to be indented in isolated areas.

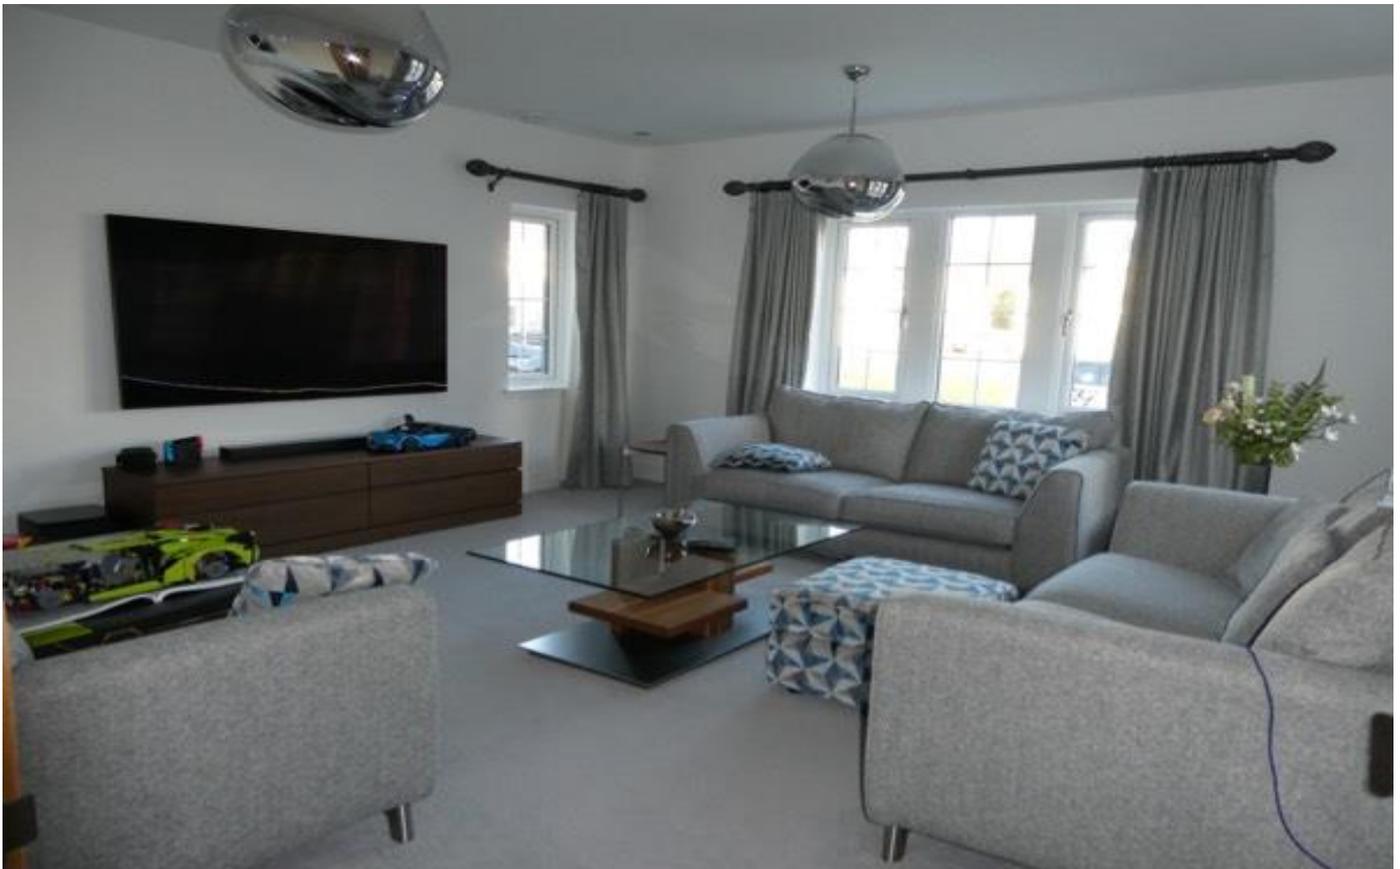
Lounge

- Following inspection it was noted that the ceiling and walls had an emulsion smooth plaster finish with painted architraves, skirting, Door with chrome furniture and window sil. PVCU windows, lights, double sockets, light switches, TV/Phone point, wall mounted radiator.
- Entrance door set right hand door upper dead bolt stiff
- Entrance doors not uniform
- Wall ceiling junctions cracked and uneven
- Window frame sill seal cracked
- East facing right window handle loose.

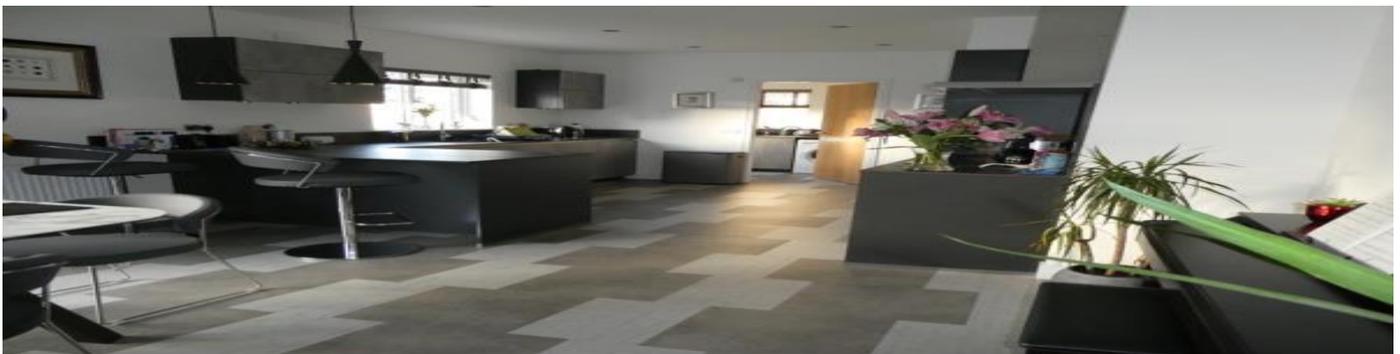
Kitchen

- Entrance door loose at keeper
- Entrance door opening not uniform
- Skirting wall seal cracked in isolated areas
- Ceiling pops detected above longer
- Window sill frame seal cracked

- Extractor tunnel loose insecure fixed
- Wall unit soft close do not fully close.
- Plinth vent grill below appliances loose
- Sink tap loose
- No base unit shelf

- Sink window sill frame seal cracked
- Cupboard door loose at keeper
- Cupboard door opening not uniform

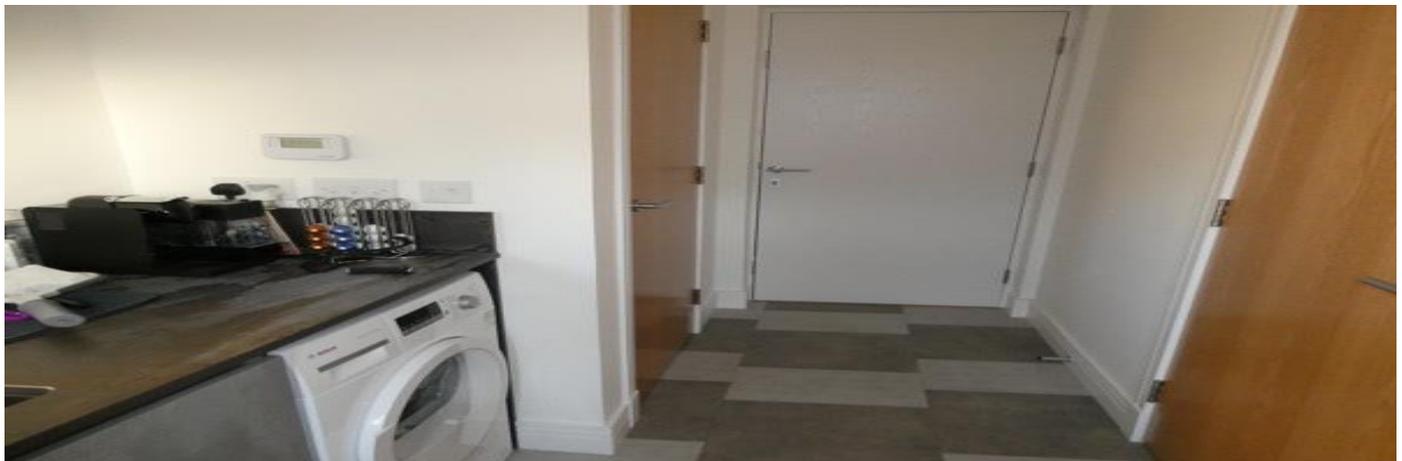
Utility Room

- Following inspection it was noted that the ceiling and walls had an emulsion smooth plaster finish with painted architraves, skirting, wood panel doors with chrome furniture and window sill and rear entry door, garage entry door, fitted units, lights, double sockets, light switches, wall mounted radiator.
- Entrance door loose at keeper
- Entrance door opening not uniform
- Wall nail pipes above garage entry
- Ceiling wall junctions cracked
- Sink tap loose
- No shelf detected within base unit
- Skirting wall seal cracked
- Window sill and frame seal cracked
- Back door opening not uniform
- Radiator secured to wall off level
- Nail pops to wall
- Garage door marked around handle
- Main rear entrance door opening not uniform
- Tank cupboard entrance door opening not uniform

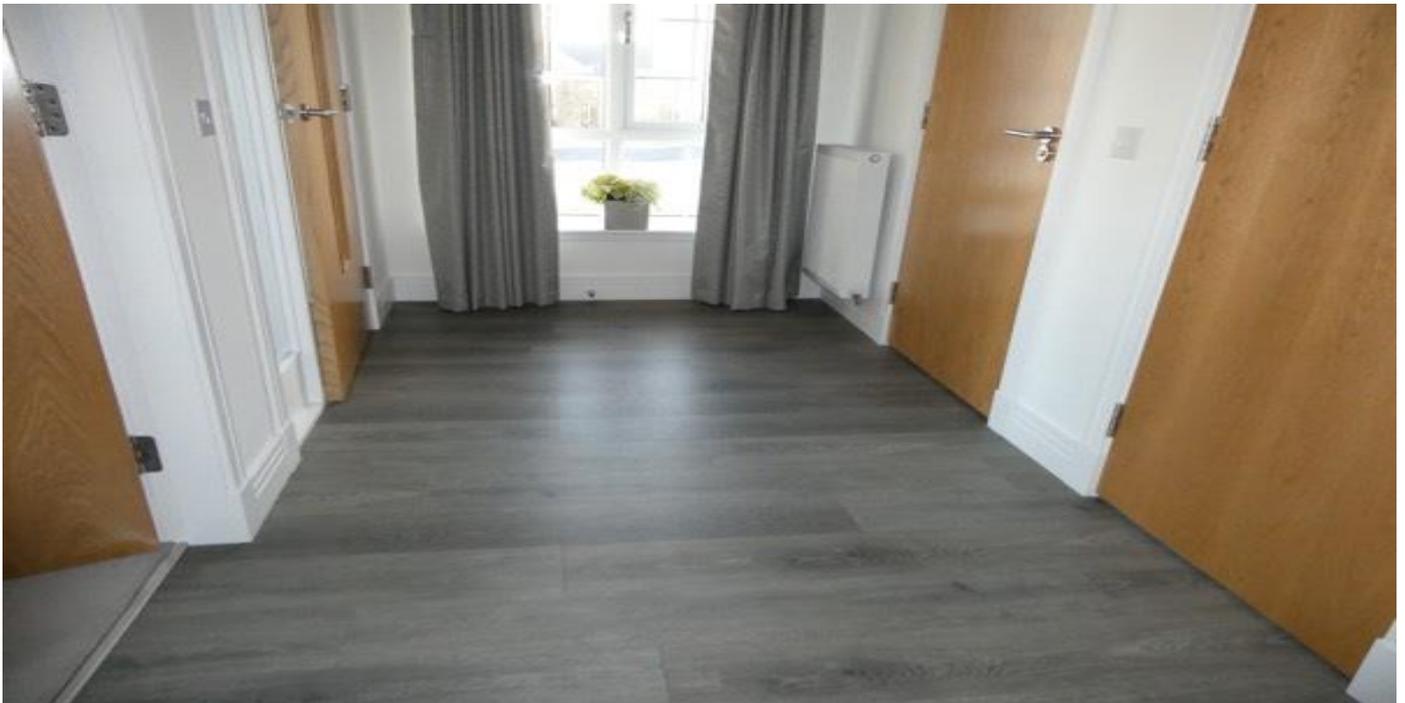
Hallway

- Following inspection it was noted that the ceiling and walls had an emulsion smooth plaster finish with painted architraves, skirting, wood handrail/balustrades, PVCU window, lights, double sockets, light switches, extractor isolation switch, hard wired smoke detector, wall mounted radiator.
- Wall nail pops detected above the lounge entry door
- Radiator secured to wall off level
- Vestibule door mitres open
- Ceiling wall junctions cracked
- Window sill frame seal cracked
- Cupboard door opening not in uniform
- Cupboard door loose at keeper.
- Under stair cupboard door opening not uniform

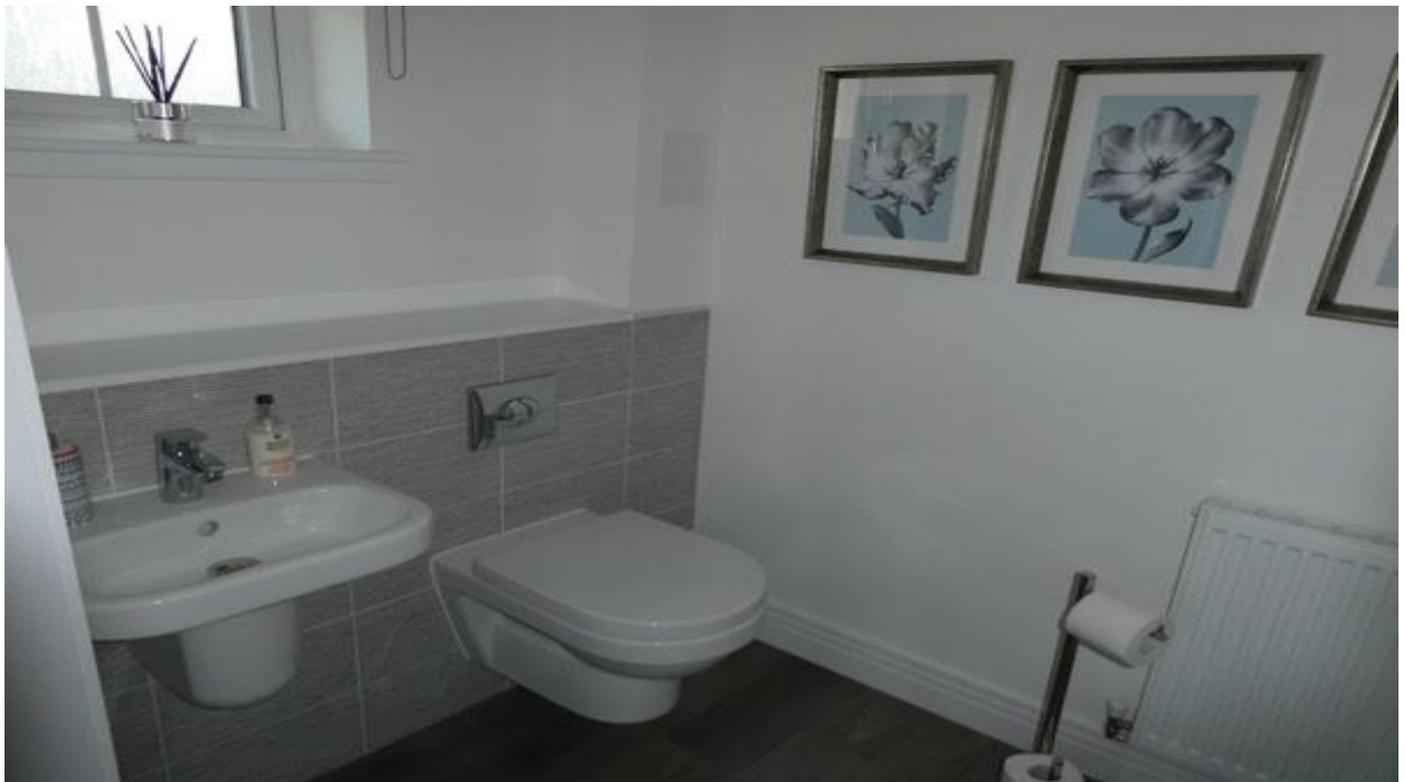
Toilet

- Following inspection it was noted that the ceiling and walls had an emulsion smooth plaster finish part ceramic tiled with painted architraves, PVCU window, wood panel door with chrome furniture, Basin, WC, extractor/vent wall mounted radiator.
- Entrance door loose at keeper
- Entrance door opening not uniform
- Entrance door lock stiff during operation
- WC flush panel loose
- Floor seal incomplete at bulkhead
- Window frame seal cracked
- Ceiling wall junctions cracked
- Nail pops detected above entry door

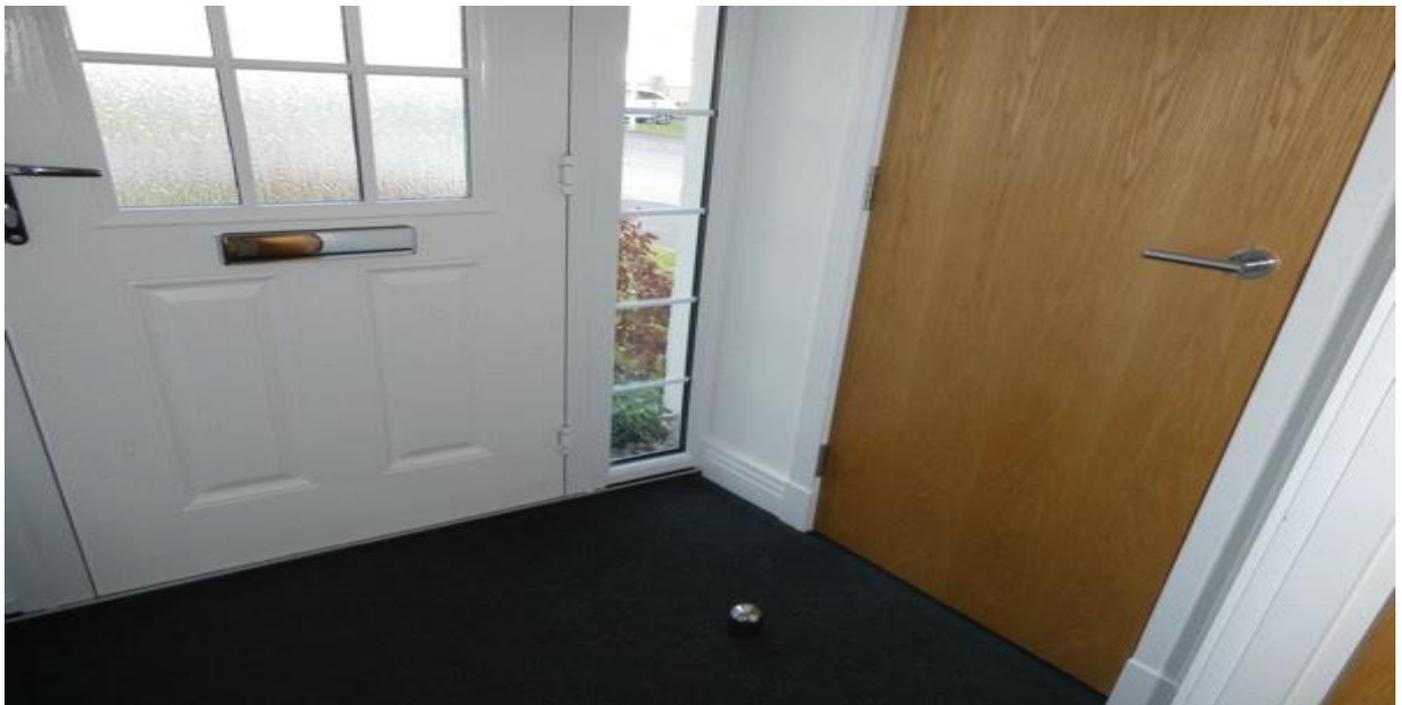
Vestibule

- Following inspection it was noted that the ceiling and walls had an emulsion smooth plaster finish with painted architraves, skirting, PVCU main entrance door, flush panel door, lights, double sockets, light switches, wall mounted radiator.
- Hall entrance door loose at keeper
- Hall entrance door opening not uniform
- Radiator secured to wall off level
- Entrance door seal damaged at base
- Entrance door frame seal cracked.
- Meter cupboard door not uniform
- Ceiling wall junctions cracked
- Skirting wall seal cracked
