Thermographic Survey

Client Name: XXXXX XXXXXXXX
Address: XXX XXXX XXXX
X XXXXX XXXXX
XXXXXXXXXX
XXXXXXXXXX
XXX XXX
Purpose of Report: BUILDING HEAT LOSS QUALITATIVE INFRARED ANALISYS
Report Reference: IAS/XXX/20XX
Inspection Date: 22 Jan 20XX
Surveyor Name: XXXXX XXXXX ISO 18436-7 & BINDT CM/GEN
Thermographer Name: XXXXX XXXXX ISO 18436-7 & BINDT CM/GEN
Average Ambient Temperature: 46.4 Fahrenheit
Imager Used: FLIR CX3

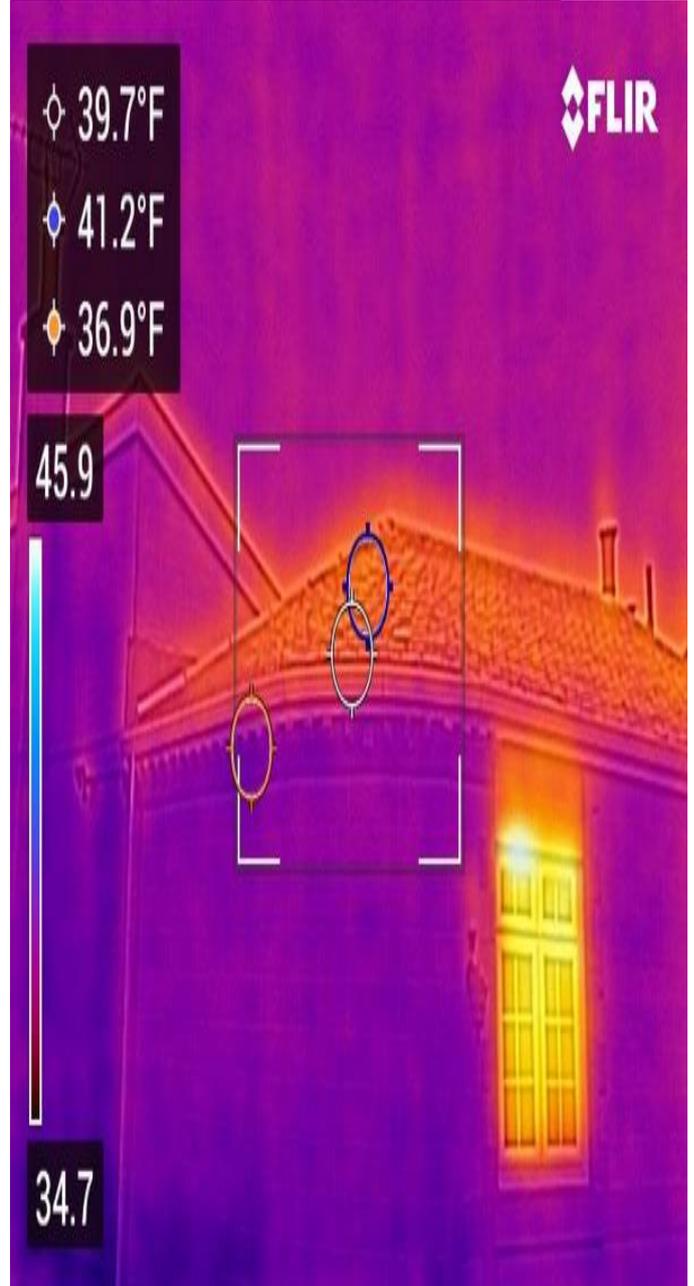
Thermal Image Shows High Levels Of Heat Loss Through Then Roof Coverings

- A Thermal image inspection of the roof covering revealed high levels of thermal heat loss emissivity to the roof area inspected suggesting missing or insufficient insulating materials, these will require improvement to meet with current building regulations.

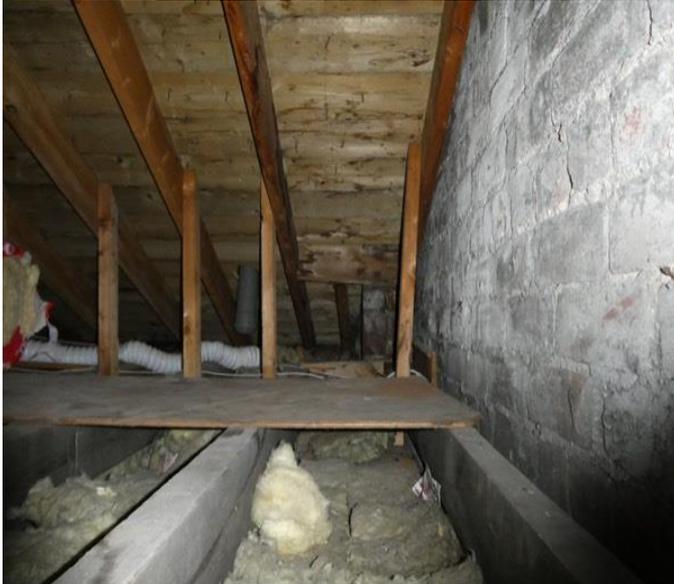
Insufficient Insulation Detected Within The Roof Void

- Inspection within the loft space has found thermal anomalies in loft space area at the time of survey, inspection revealed missing and insufficient insulation material within the ceiling ties resulting in significant heat loss through the room ceilings exiting through the roof coverings.

- Consideration should therefore be given to ensuring that the wool insulation material has an even distribution level of 300mm depth to meet with current building regulation standards.

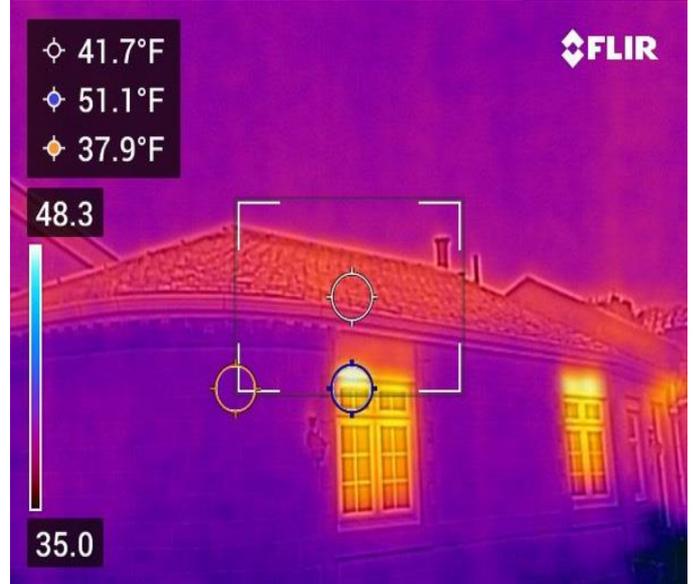
Thermal Image Shows High Levels Of Heat Loss Through The Roof Covering

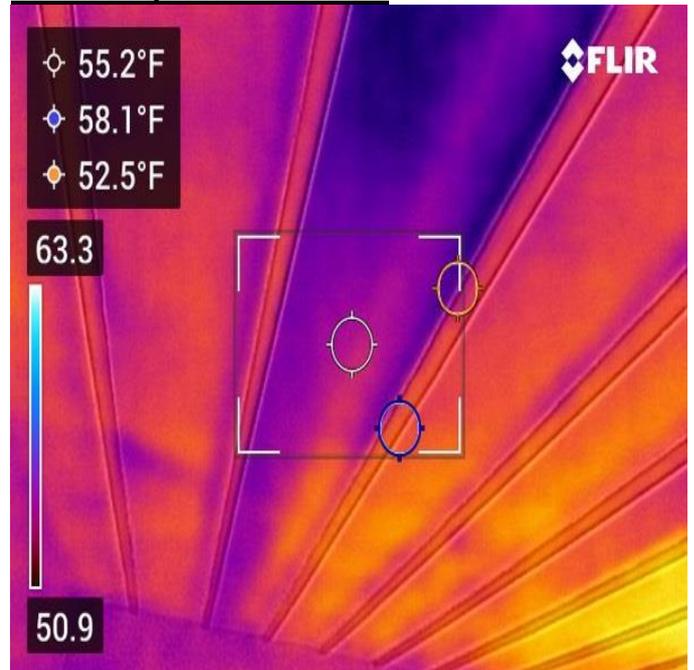
Vaulted Ceiling In Lounge Shows Missing Or Inadequate Insulation

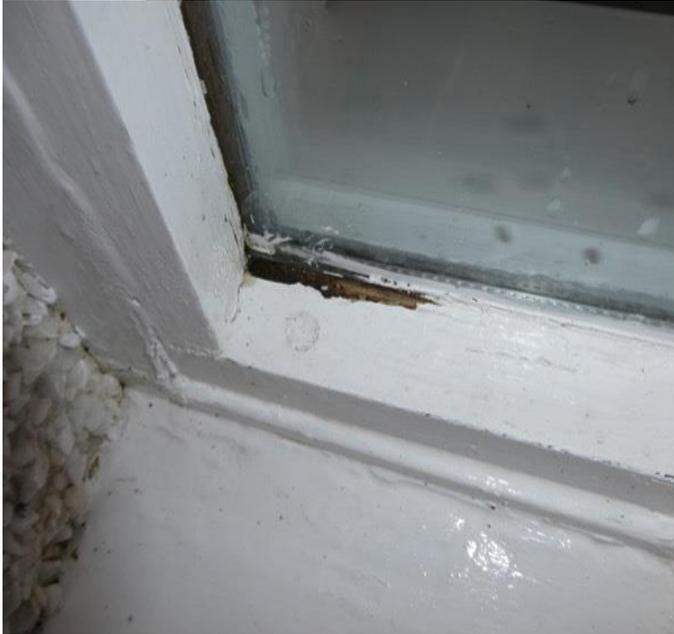
Severe Decay Detected To Lounge Timber Windows

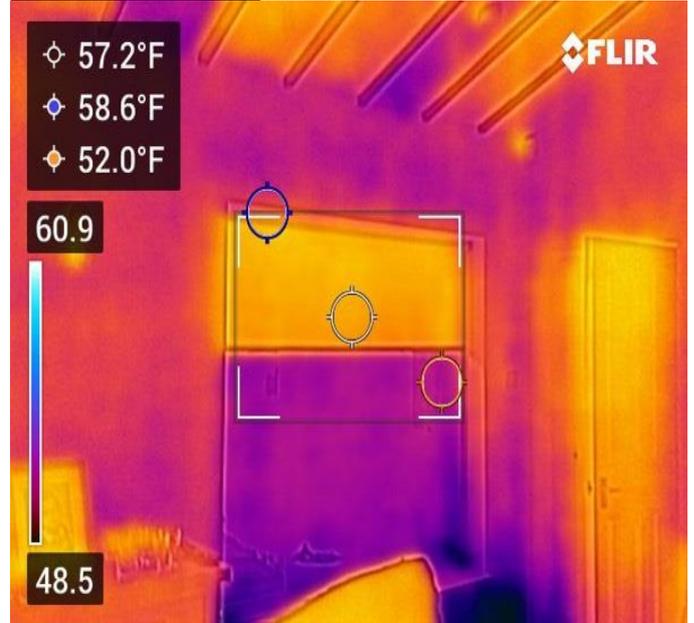
High Levels Of Heat Loss Detected To Lounge Window

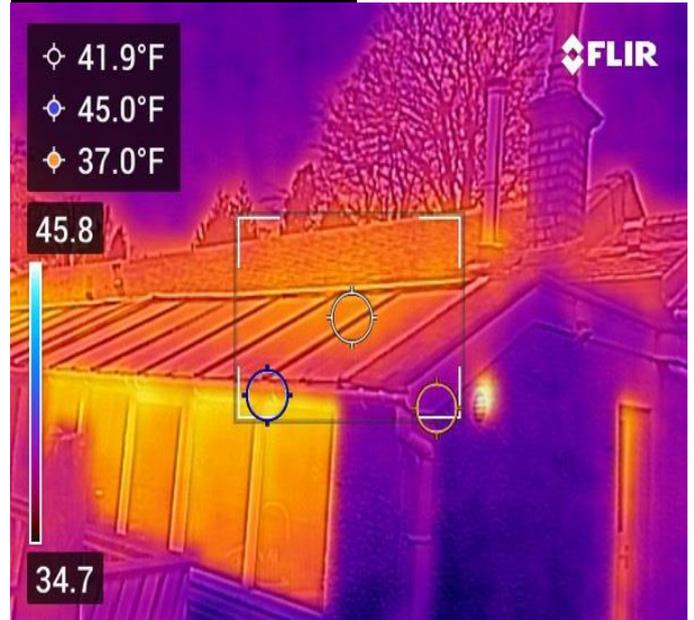
High Levels Of Heat Loss Detected To The Kitchen Glazed Panels

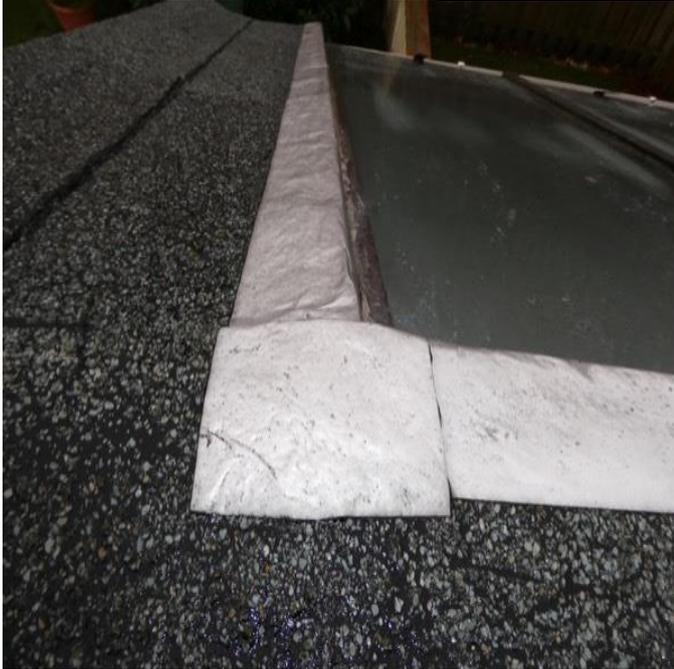
Aqua Seal Tape Detected To The Kitchen Glazed Panel Felt Roof Joint

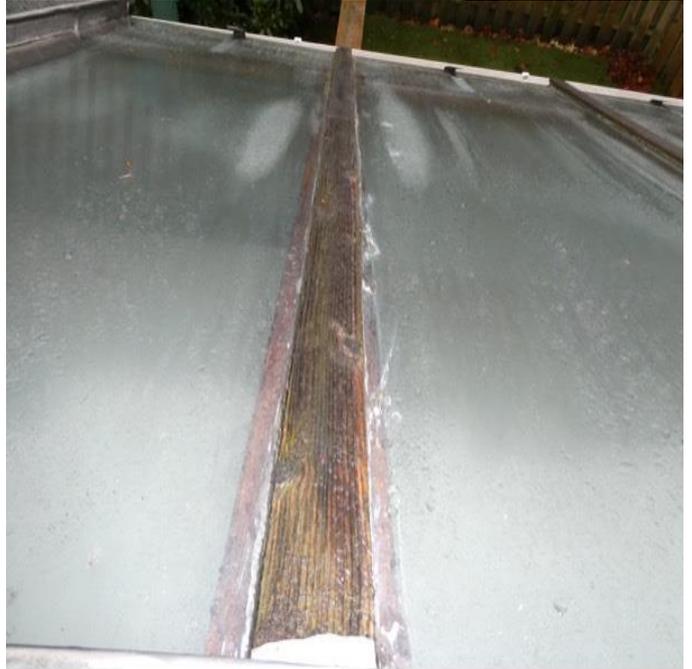
Exposed Timber Roof Bar Joints Detected To Kitchen Glazed Panel Roof

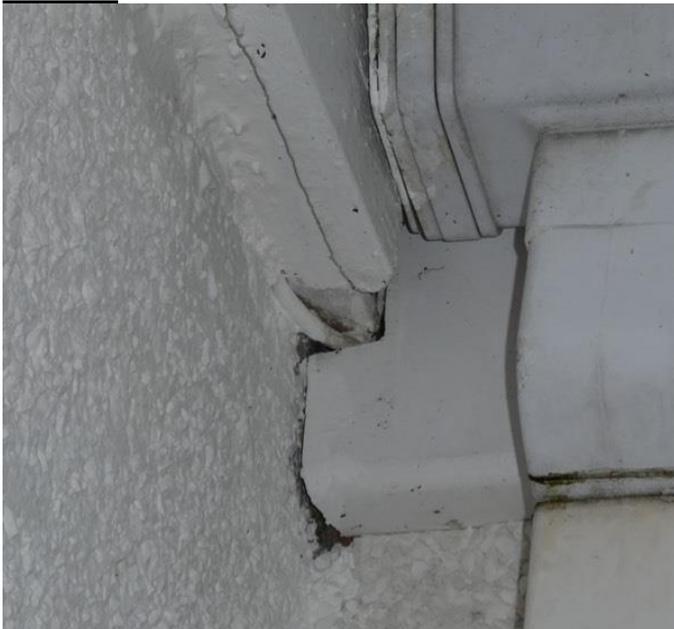
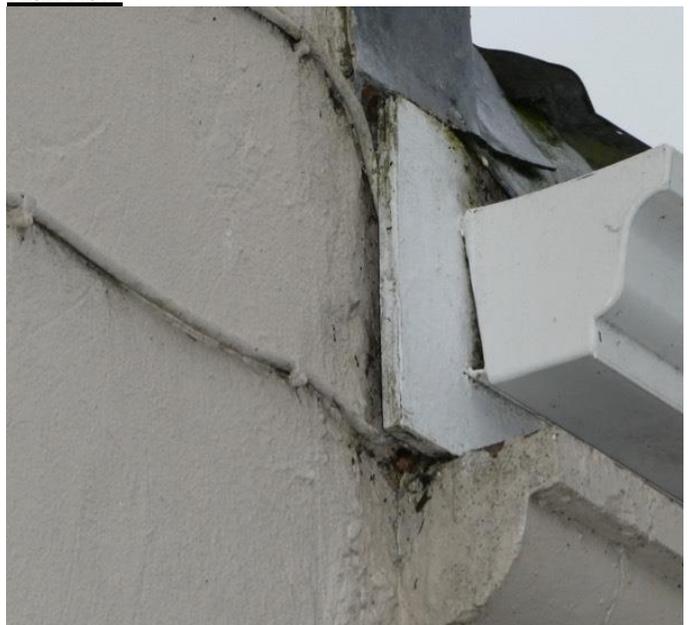
Unsealed And Open Facia Abutment Joint To Wall

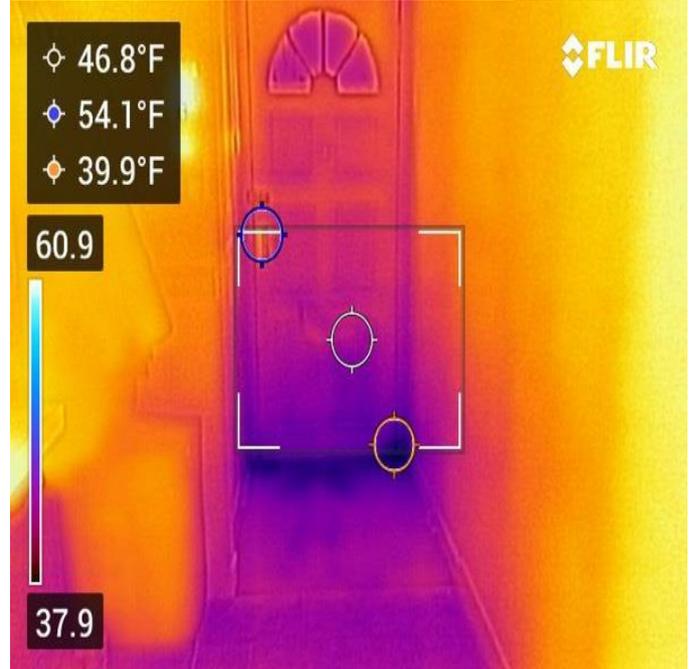
High Levels Of Air Filtration Detected To The Base Of The Door Threshold

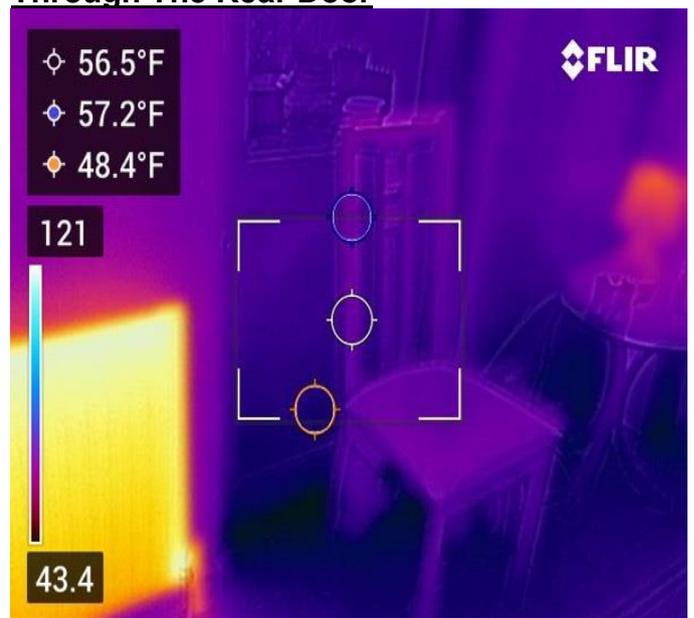
High Levels Of Air Filtration Detected Through The Rear Door

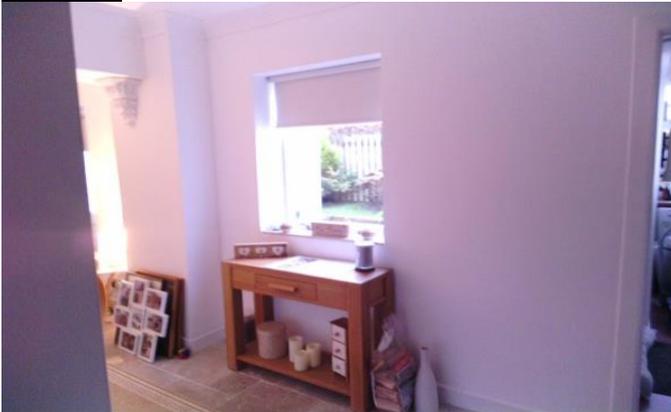
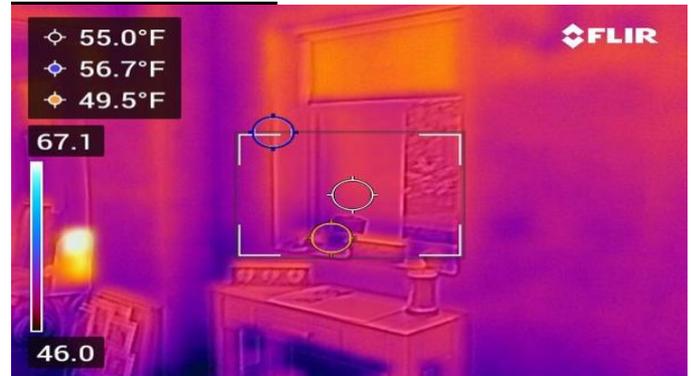
Hallway

High Levels Of Air Filtration Around The Window Location

- Inspection revealed excessive energy loss emissivity around the window and door openings, the dominant cause of break down is confirmed to be resultant from distortion of the window frame opening sashes, inefficient window seals with holed and missing mortar and mastic seal detected to the frame perimeters at the reveal abutment.

- Inspection of the door frames revealed decay and distortion to the timber construction door frames due to age.
- Recommend the window frames/seals are replacement or upgraded to a more thermally efficient grade with cam mechanism adjustments carried out mitigate the Heat Loss and create an enhanced compressed seal to all window and door opens to reduce excessive energy loss through the building envelope.

- Consideration should also be given to the replacement of the existing timber construction doors to a modern thermally efficient UPVC high performance secure locking system to enhance the energy efficiency of the building envelope.

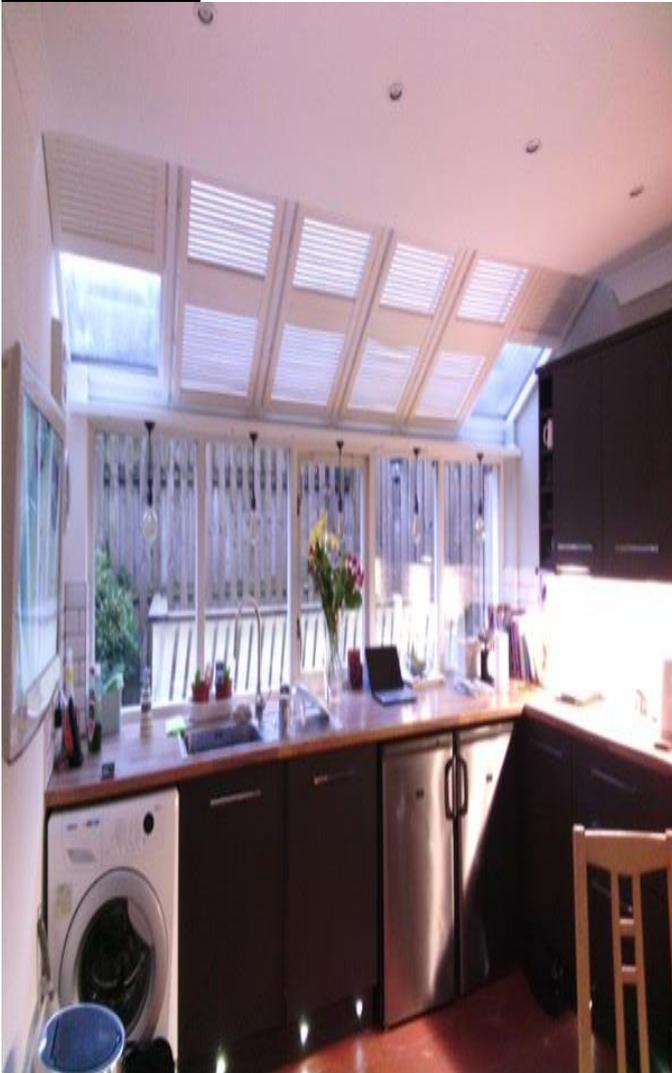
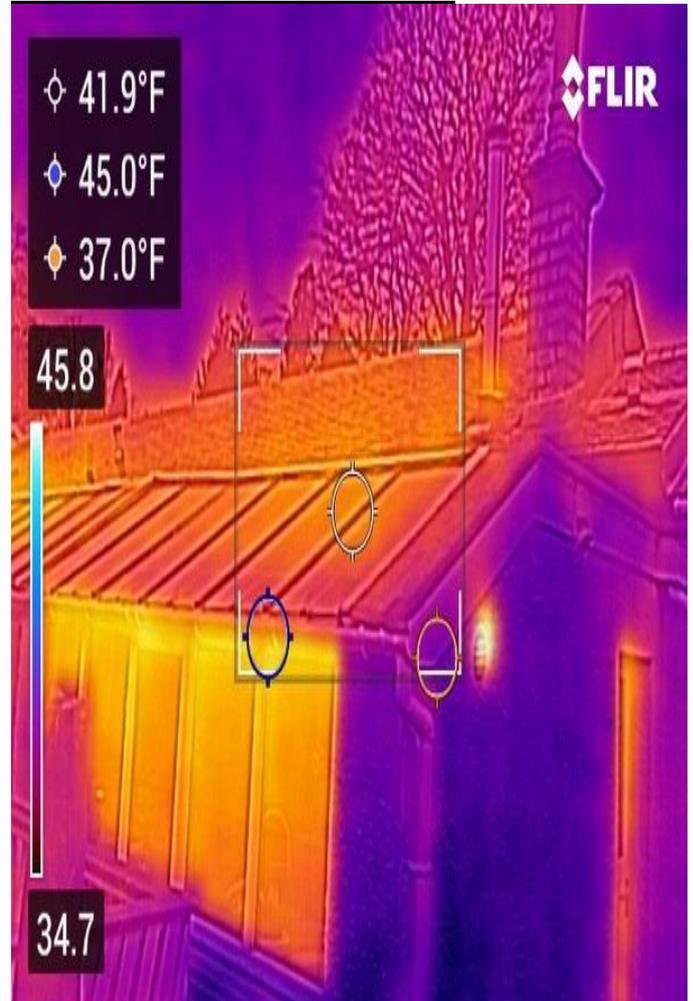
Kitchen Area

Heat Loss Detected To The Glazed Roof, Windows And Entrance Door

- Inspection revealed excessive energy loss emissivity around the vertical and sloping window and door openings.
 - Inspection of the door frames revealed decay and distortion to the timber construction door frames due to age.
 - Consideration should also be given to the replacement of the existing timber construction doors to a modern thermally efficient UPVC high performance secure locking system to enhance the energy efficiency of the building envelope.
 - Consideration should also be given to replacement of the felt flat roof due to age related decay, this would facilitate the introduction of additional Celotex insulating boards to further enhance the room energy efficiency reducing heat loss significantly
-

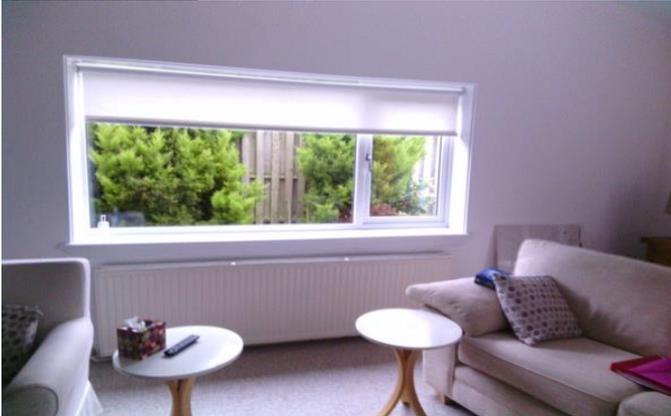
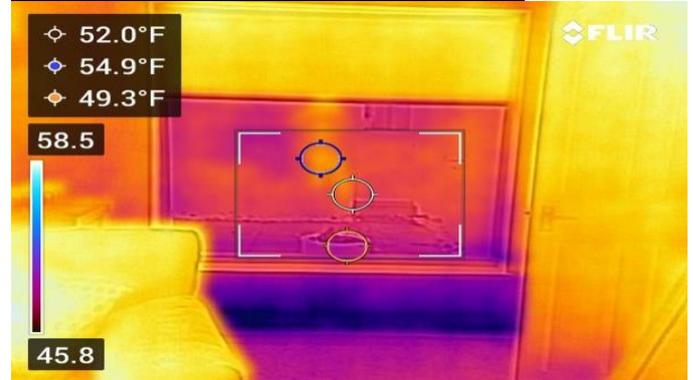
Lounge Area

Thermal Image Shows High Levels Of Heat Loss Around Windows And Walls

- Inspection revealed excessive energy loss emissivity around the window and door openings, the dominant cause of break down is confirmed to be resultant from distortion of the window frame opening sashes, inefficient window seals with holed and missing mortar and mastic seal detected to the frame perimeters at the reveal abutment.

- Inspection of the window frame revealed decay and distortion to the timber construction window frames due to age.
- Thermal images show missing or insufficient insulation to the vaulted ceiling area confirmed by large areas of cold spots detected, recommend that the ceiling is over boarded with the introduction of a 50-75mm Celotex insulation PIR board to enhance the room energy efficiency and increase warm air retention.

- Recommend the window frames/seals are replacement or upgraded to a more thermally efficient grade with cam mechanism adjustments carried out mitigate the Heat Loss and create an enhanced compressed seal to all window and door opens to reduce excessive energy loss through the building envelope.

- Consideration should also be given to the replacement of the existing timber construction window to a modern thermally efficient UPVC high performance secure locking system to enhance the energy efficiency of the building envelope.

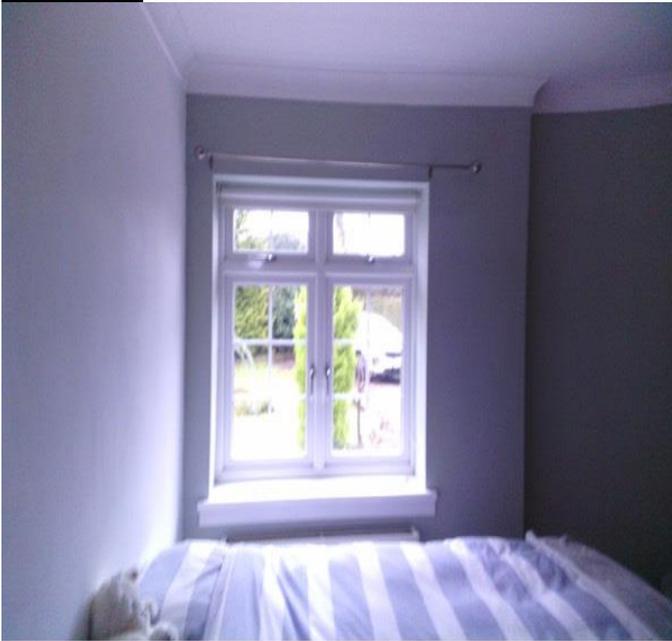
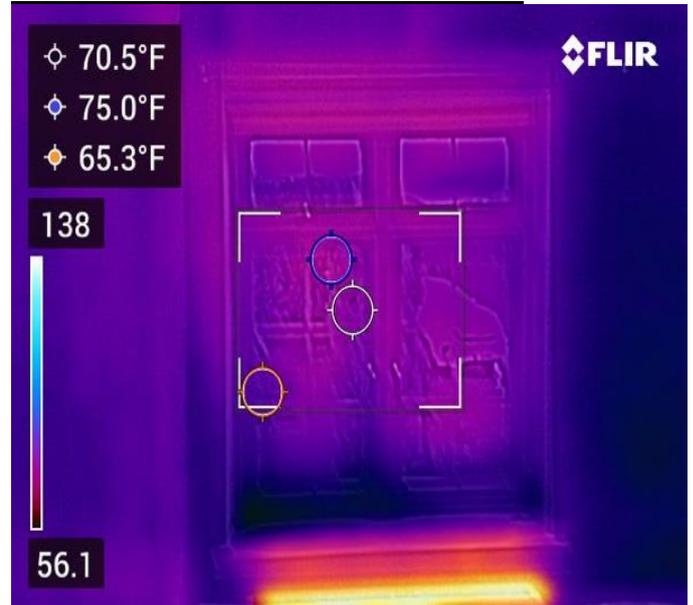
Bedroom

Thermal Image Shows High Levels Of Heat Loss And Excessive Air Filtration

- Inspection revealed excessive energy loss emissivity around the window and opening, the dominant cause of break down is confirmed to be resultant from distortion of the window frame opening sashes, inefficient window seals with holed and missing mortar and mastic seal detected to the frame perimeters at the reveal abutment.

- Thermal images show missing or insufficient insulation to the ceiling area confirmed by large areas of cold spots detected.
- Consideration should therefore be given to ensuring that the wool insulation material has an even distribution level of 300mm depth to meet with current building regulation standards.

- Recommend the window frames/seals are replacement or upgraded to a more thermally efficient grade with cam mechanism adjustments carried out mitigate the Heat Loss and create an enhanced compressed seal to the window sash to reduce excessive energy loss through the building envelope.

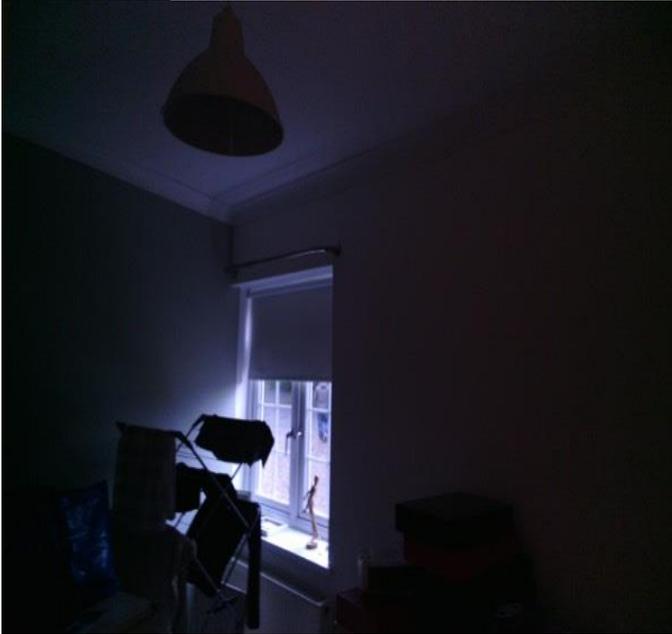
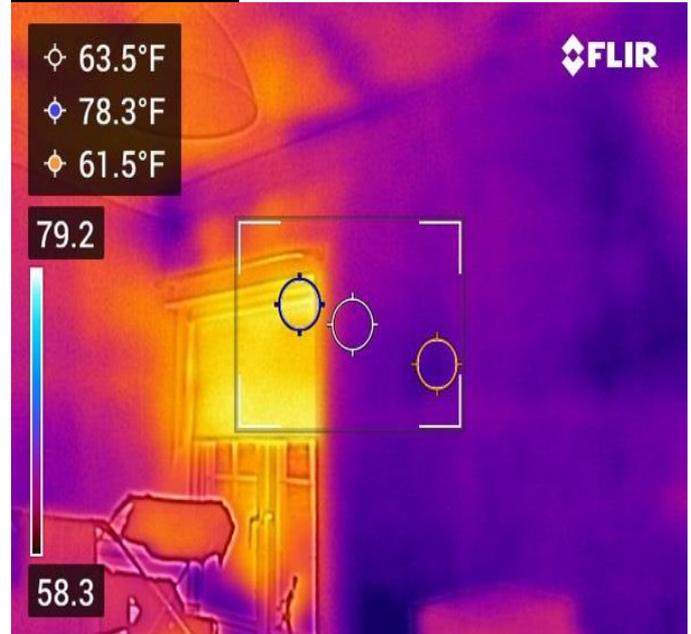
Bedroom 2

- Inspection revealed excessive energy loss emissivity around the window and opening, the dominant cause of break down is confirmed to be resultant from distortion of the window frame opening sashes, inefficient window seals with holed and missing mortar and mastic seal detected to the frame perimeters at the reveal abutment.

- Thermal images show missing or insufficient insulation to the ceiling area confirmed by large areas of cold spots detected.
- Consideration should therefore be given to ensuring that the wool insulation material has an even distribution level of 300mm depth to meet with current building regulation standards.

- Recommend the window frames/seals are replacement or upgraded to a more thermally efficient grade with cam mechanism adjustments carried out mitigate the Heat Loss and create an enhanced compressed seal to the window sash to reduce excessive energy loss through the building envelope.

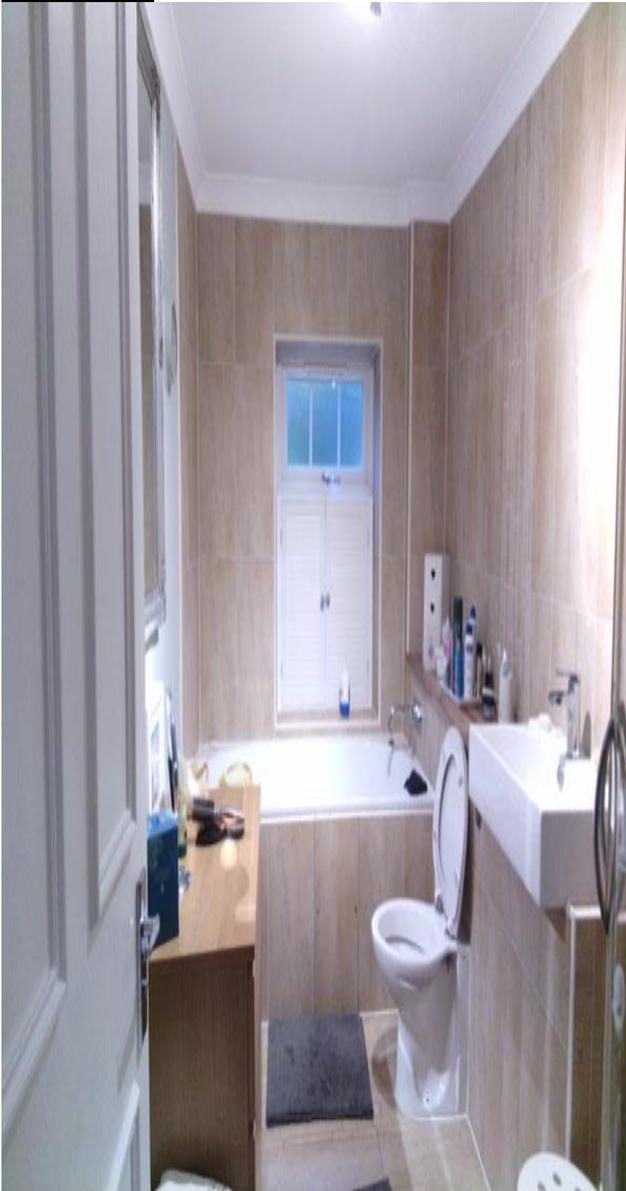
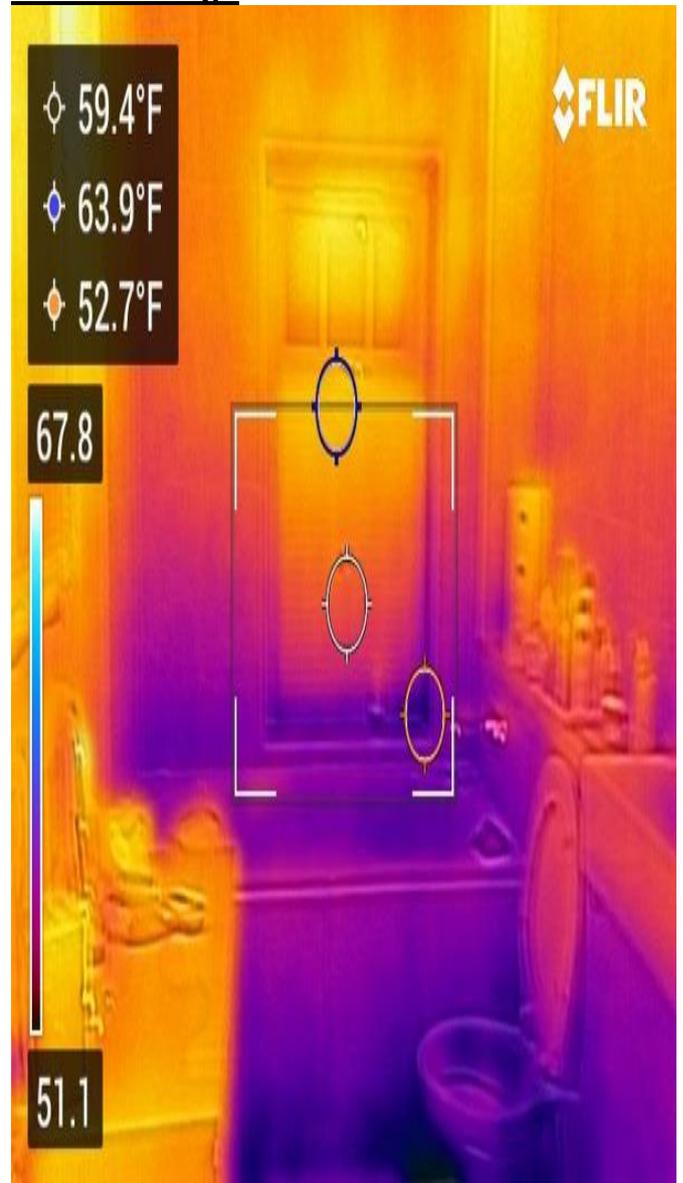
Bathroom

- Inspection revealed excessive energy loss emissivity around the window and opening, the dominant cause of break down is confirmed to be resultant from distortion of the window frame opening sashes, inefficient window seals with holed and missing mortar and mastic seal detected to the frame perimeters at the reveal abutment.

- Thermal images show missing or insufficient insulation to the ceiling area confirmed by large areas of cold spots detected.
- Consideration should therefore be given to ensuring that the wool insulation material has an even distribution level of 300mm depth to meet with current building regulation standards.

- Recommend the window frames/seals are replacement or upgraded to a more thermally efficient grade with cam mechanism adjustments carried out mitigate the Heat Loss and create an enhanced compressed seal to the window sash to reduce excessive energy loss through the building envelope.
