ROOF SURVEY

XXXXXX XXXXXXXX
XXXX XXXXXX
XXXXXX
XXXX XXXX XXXXXX
GXX 8XX
ROOF CONDITION SURVEY
RCS/XXX/2022
21st Jan 2022
XXXXX XXXXXX BCI, CII, BDMA, MIOR

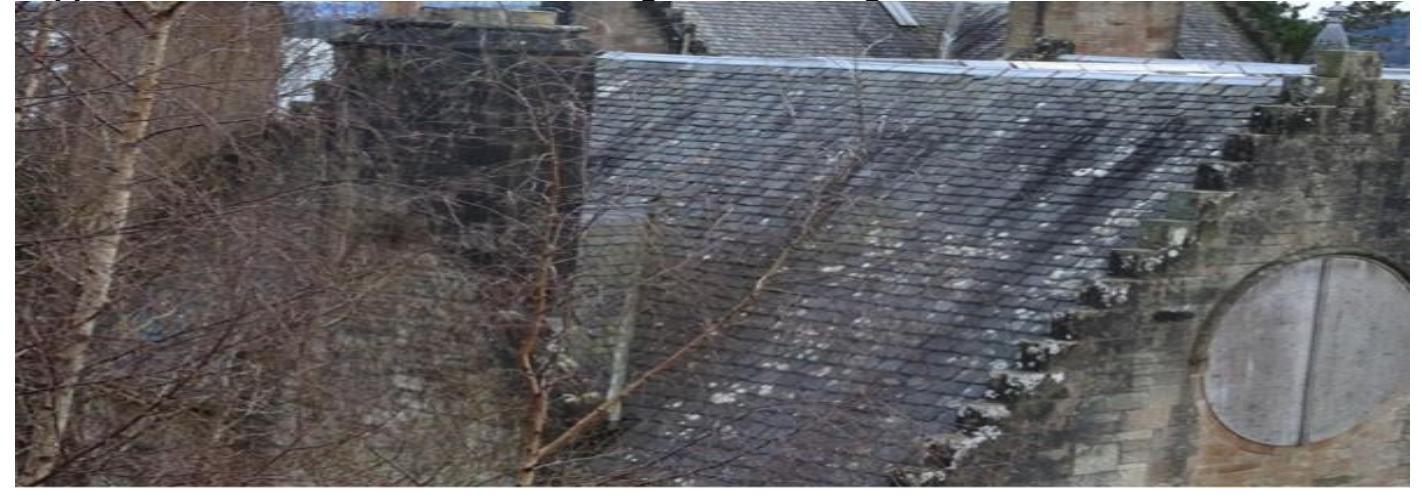
Slipped slates detected at the north facing main roof ridge line

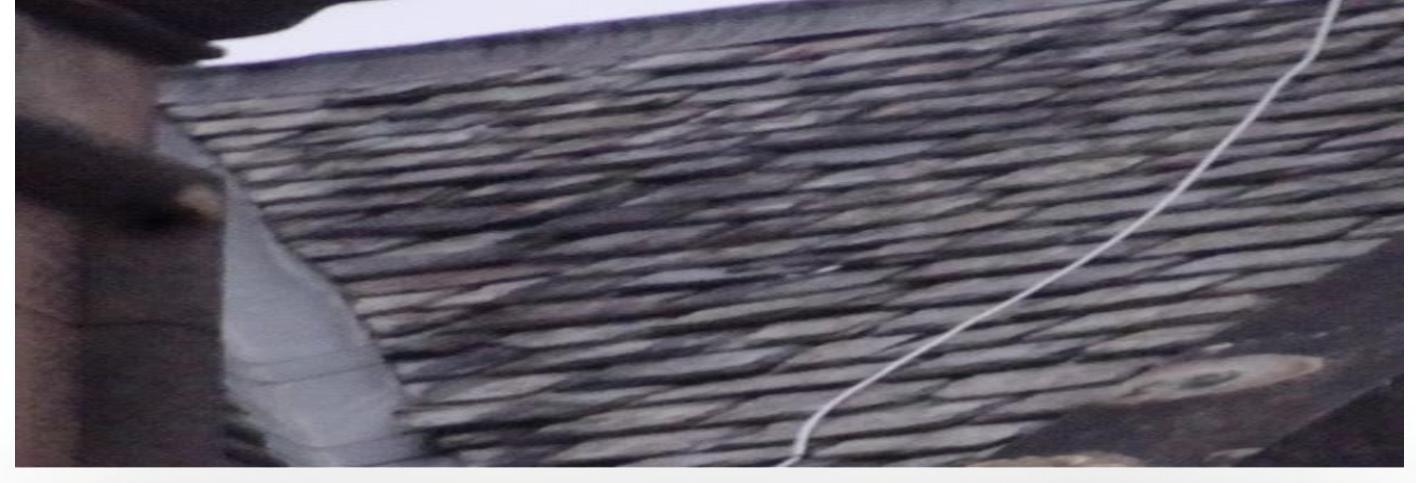
Slipped and missing slates detected to the south east main roof slope

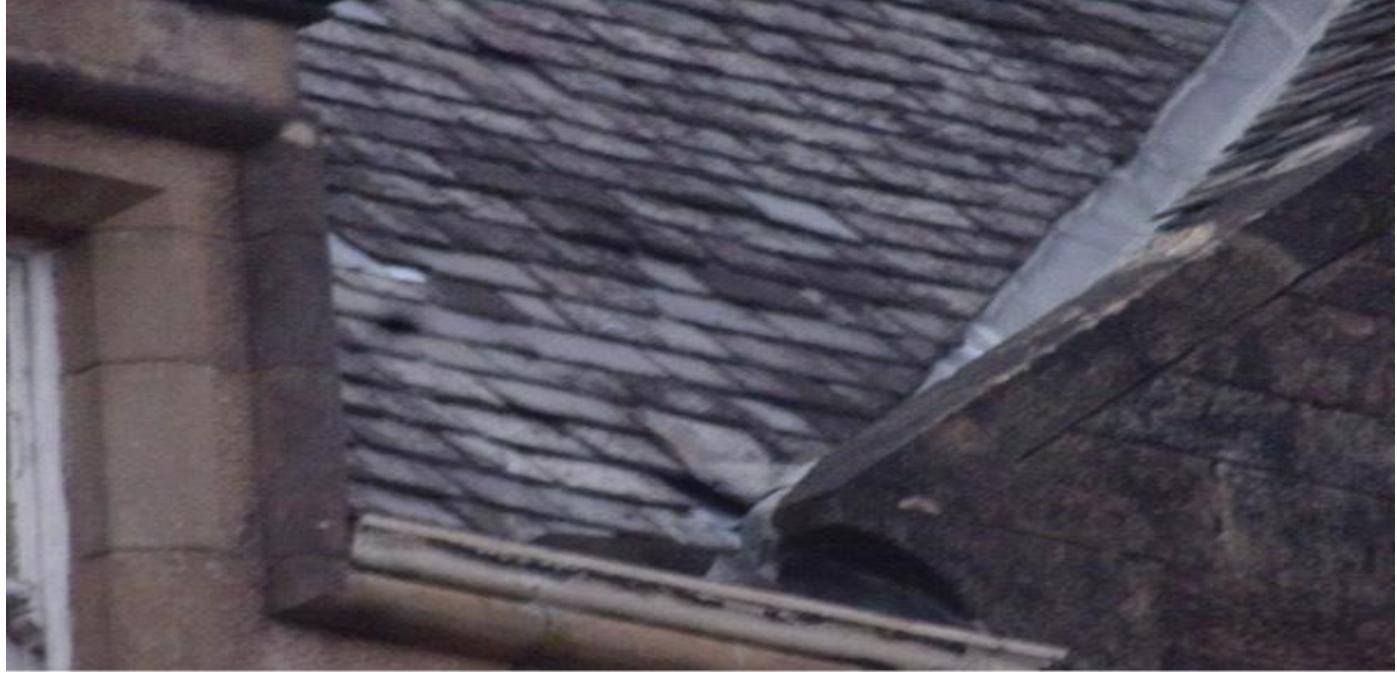
Slipped and missing slates detected to the south east main roof slope at the main valley area

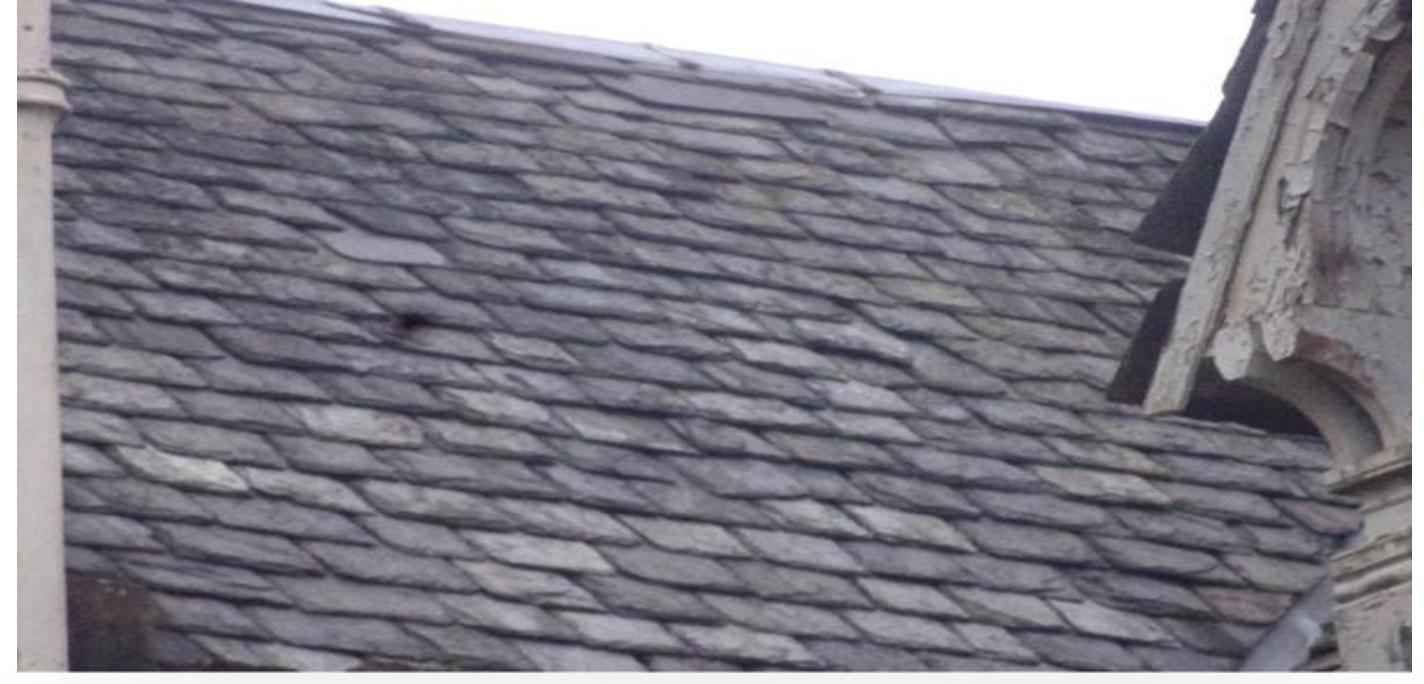
Slipped and missing slates detected to the north west main roof slope at the ridge line

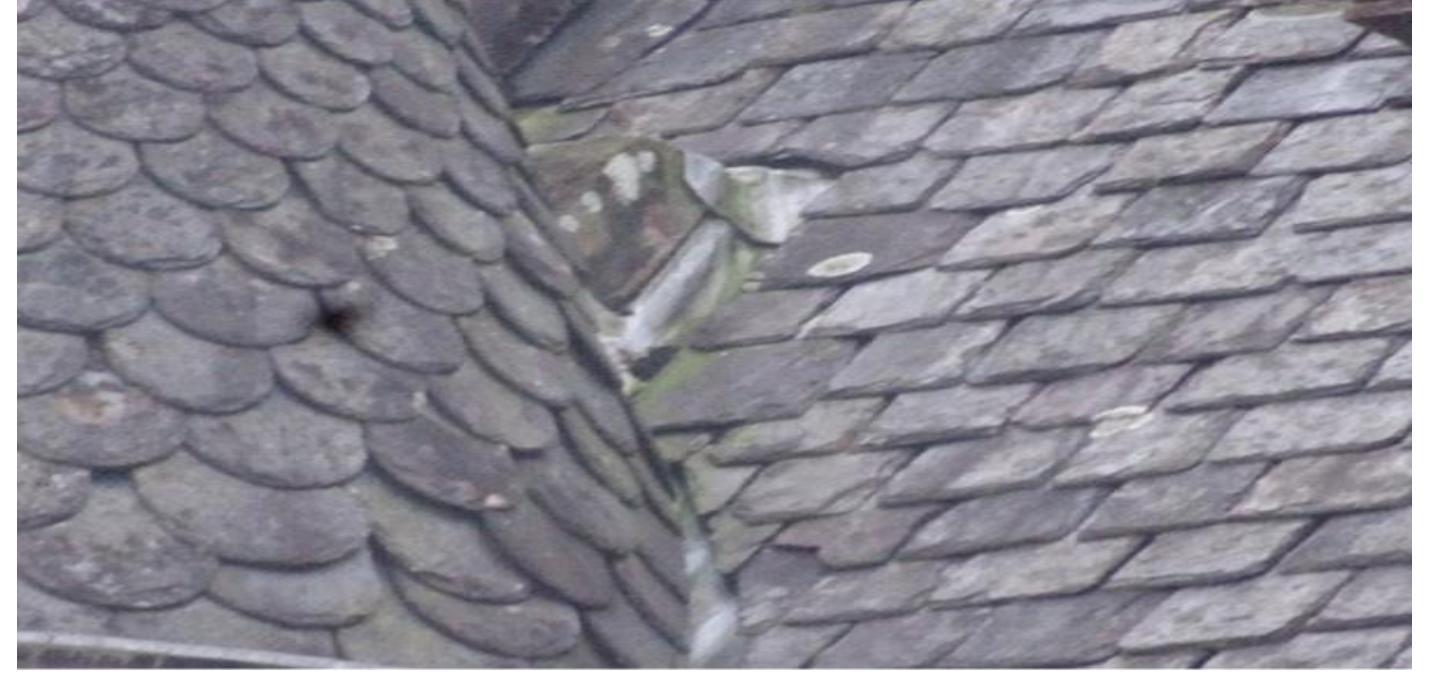
Missing and slipped slates detected to the torrent back gutter and east main roof slope

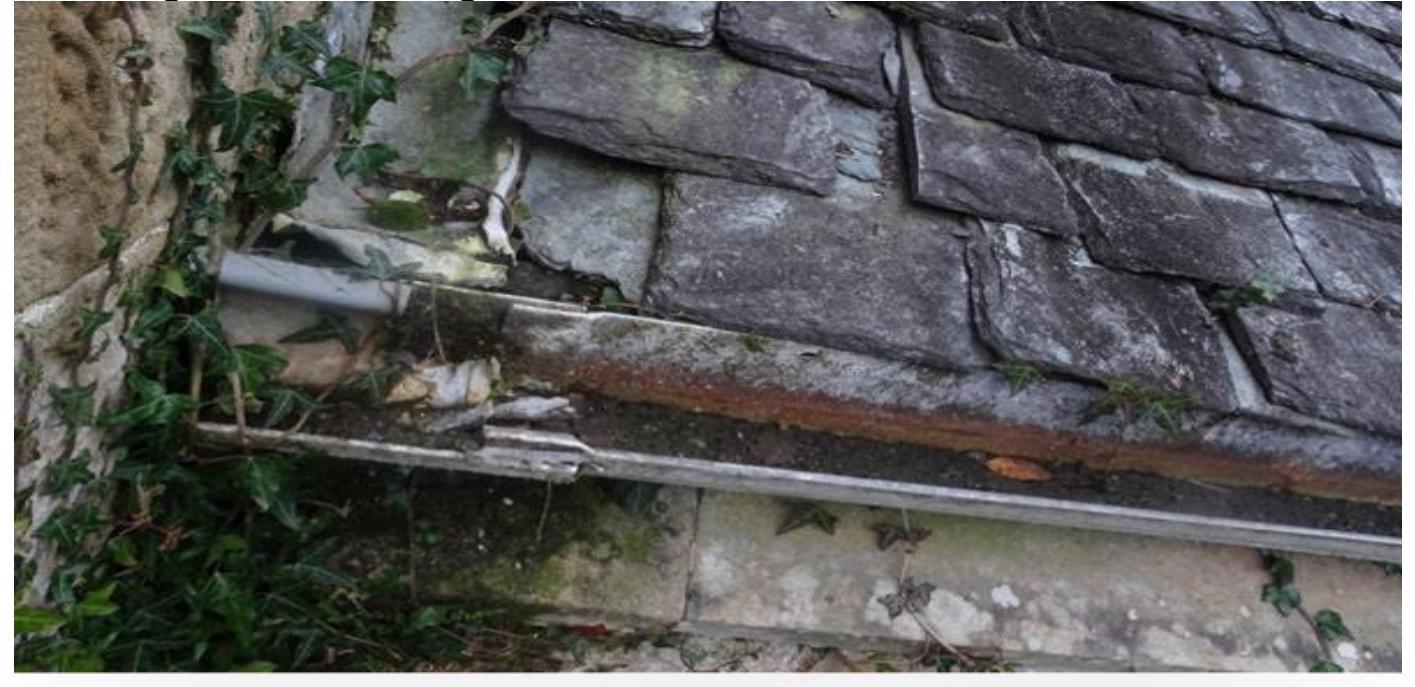
Mortar skew decay with slipped and missing and detected OG gutters detected to the rear east facing main roof covering

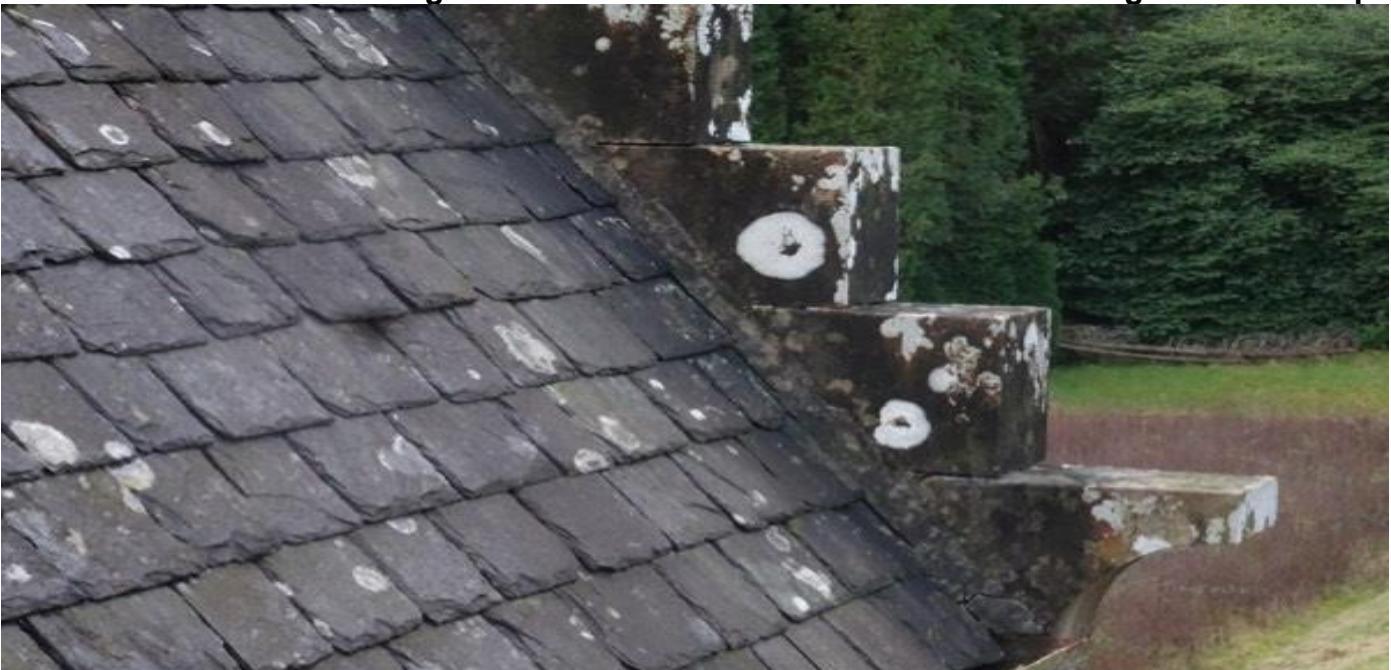
Severe mortar skew cracking and deterioration detected to the north facing main roof slope

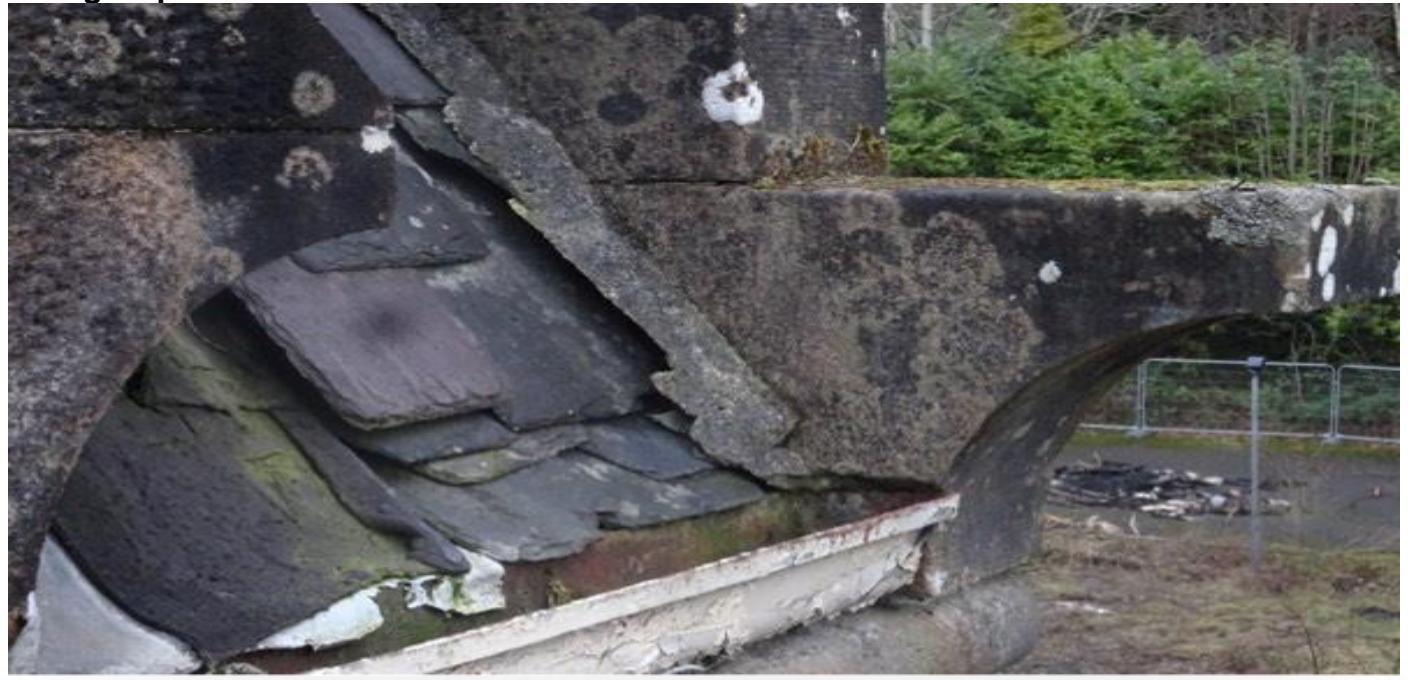
Severe open holed areas detected to the main roof slope and skew are at the north east facing slope

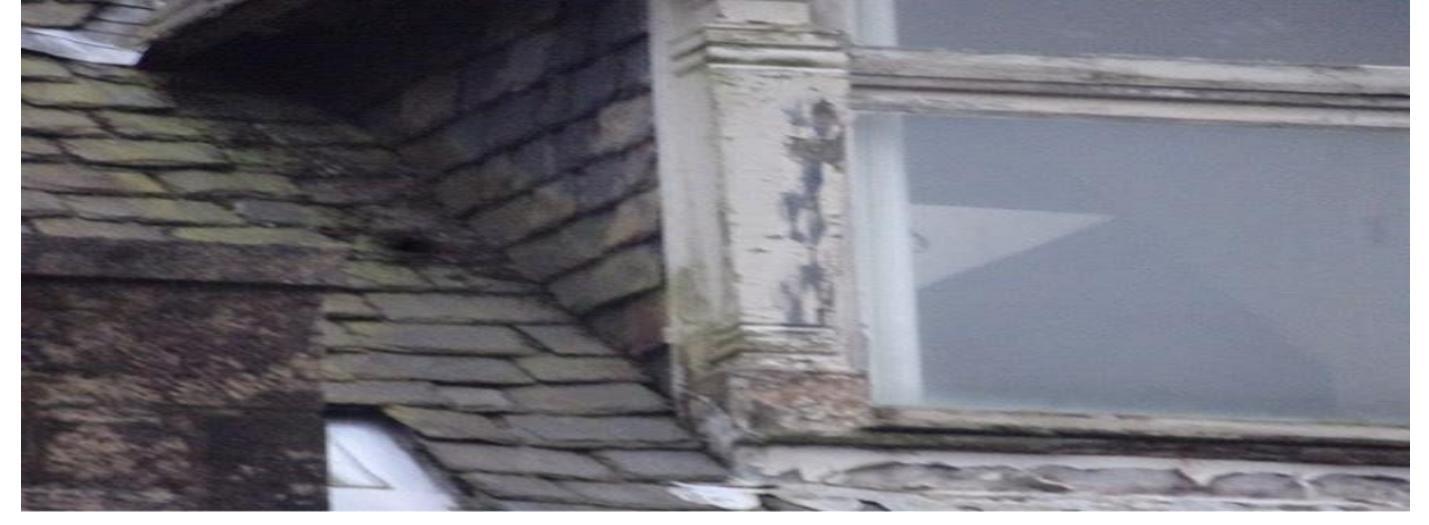
Age related decay and weathering detected to the west facing dormer window wood work

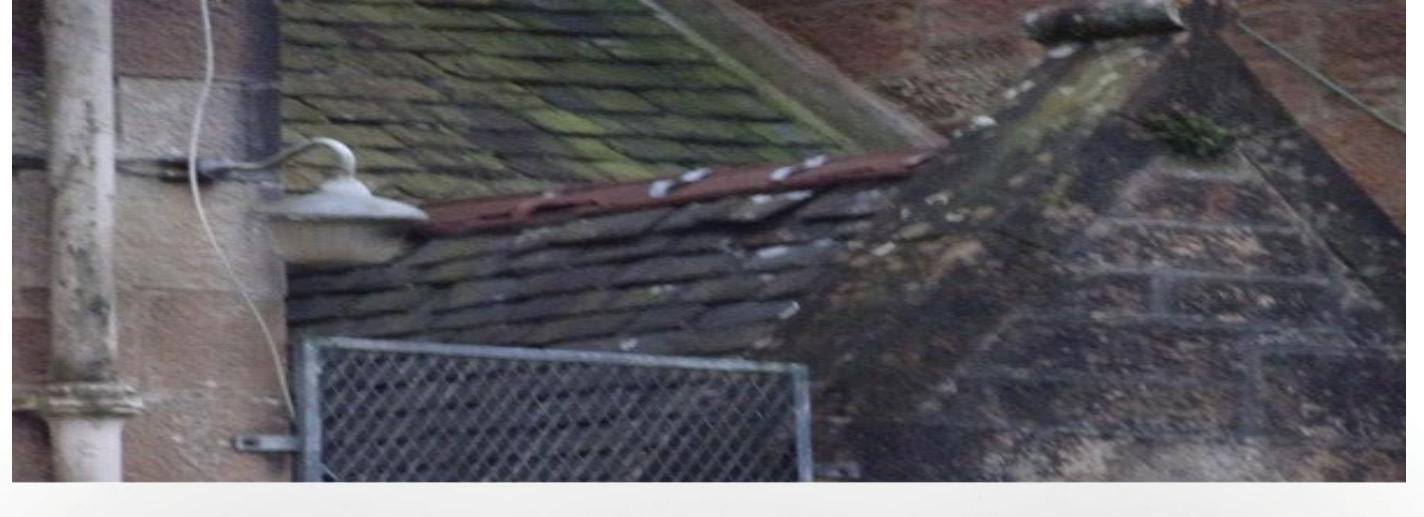
Loose and insecure slates with missing mortar detected to the west facing low level dormer

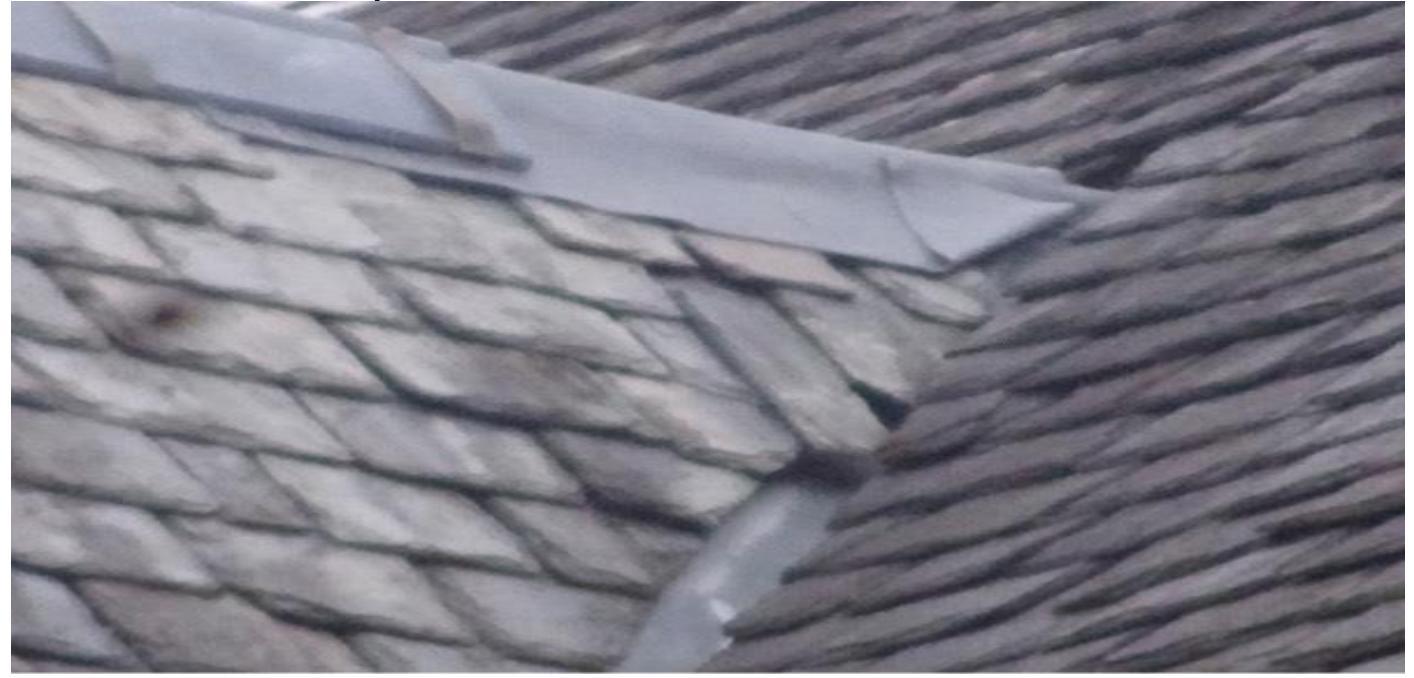
Sever nail sickness detected with loose and insecure slates detected to the south facing dormer window roof slopes

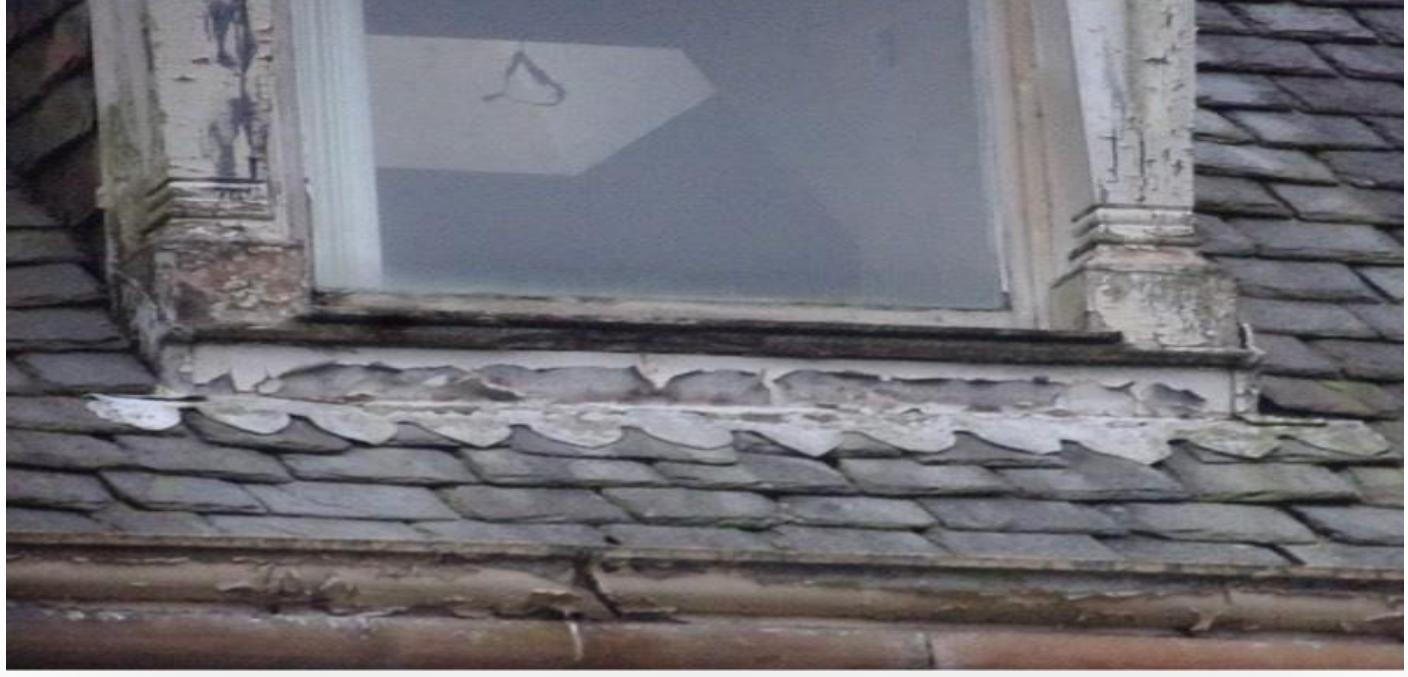
Age related decay detected to the scalloped lead dormer flashings to the west facing dormers

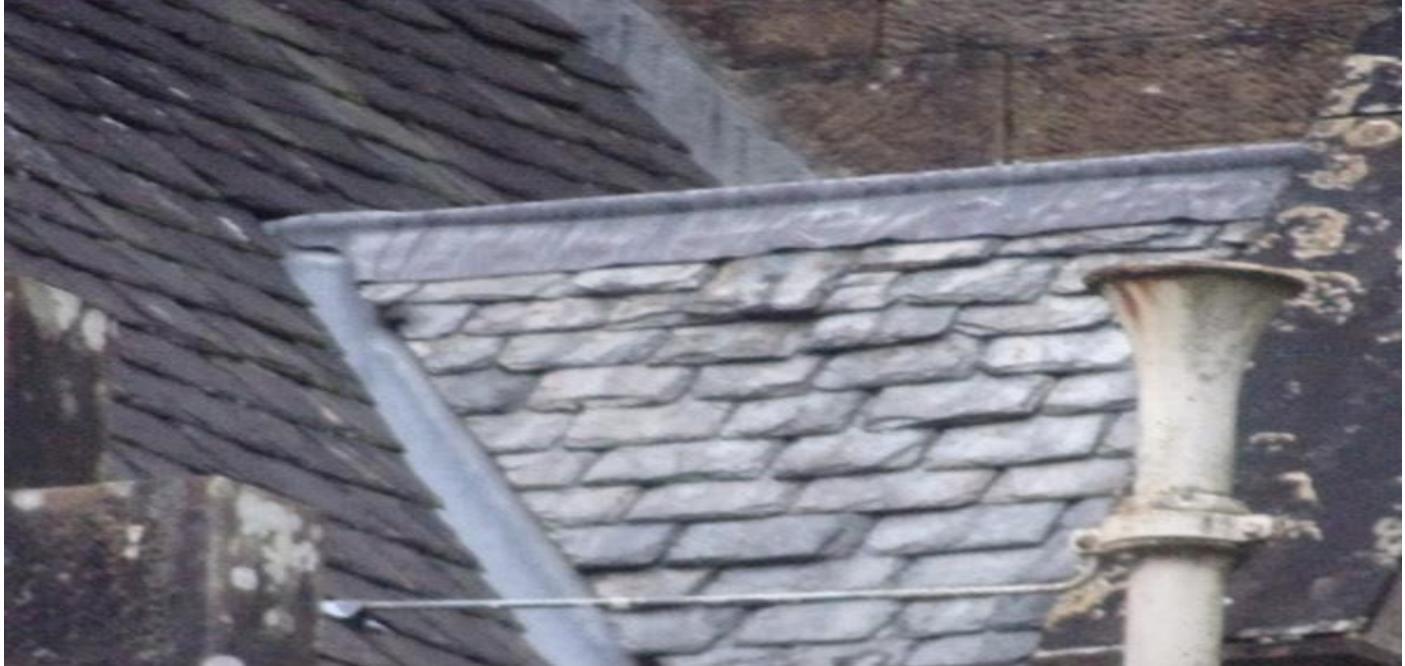
Isolated slipped slates detected to the east facing dormer roof slope at the ridge line

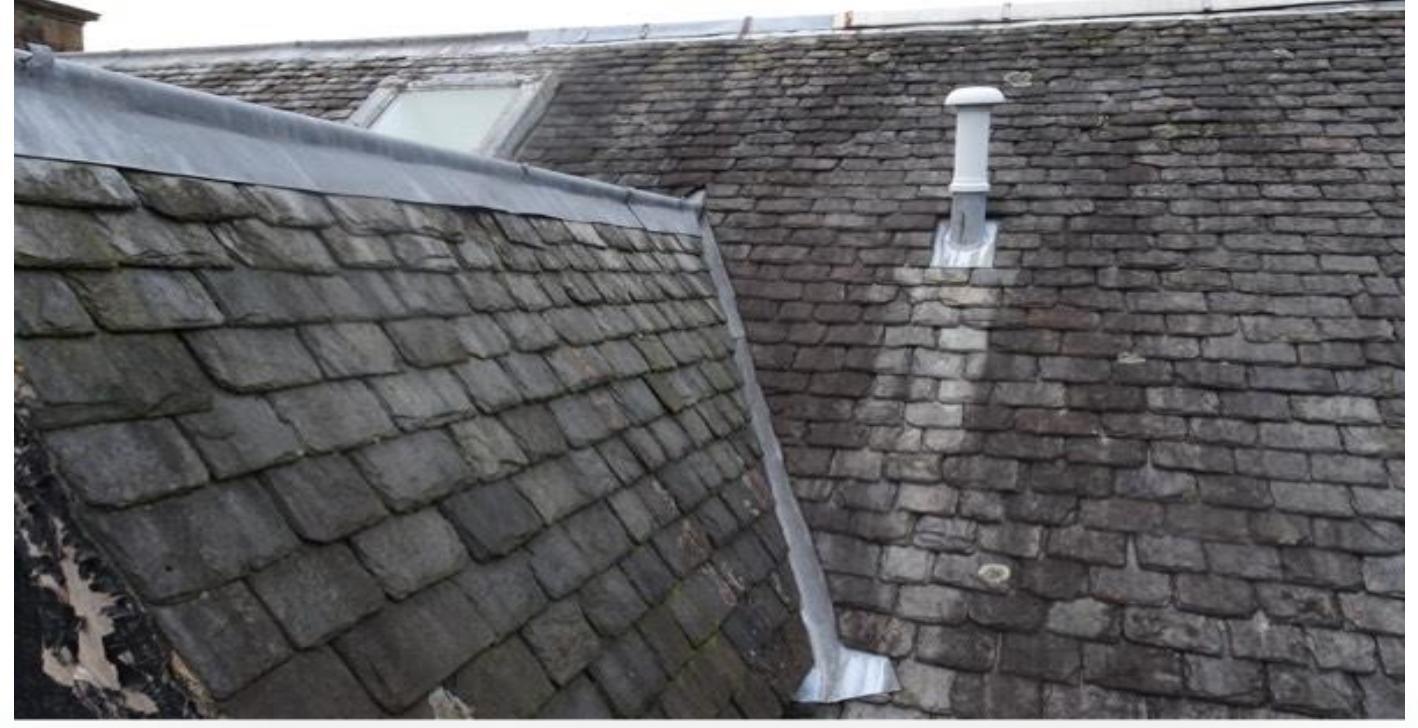
Isolated slipped slates detected to the north facing dormer roof slope at the ridge line

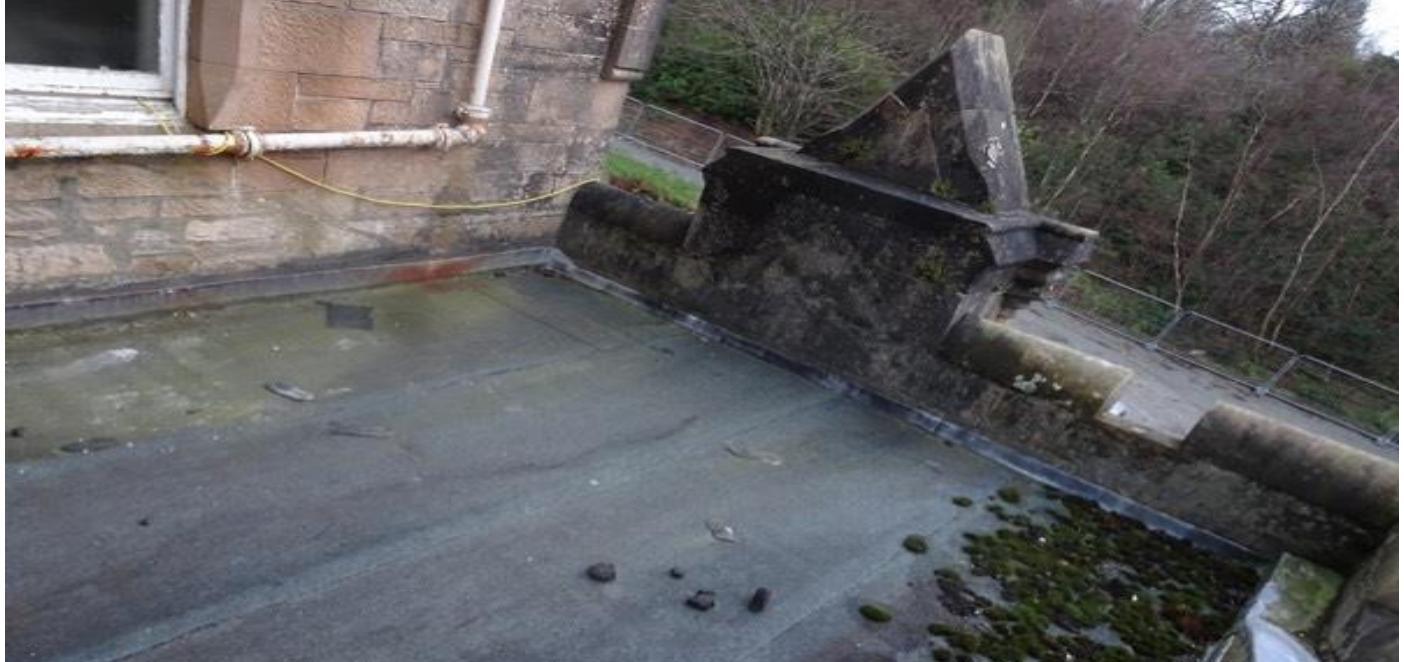
Cracked render detected above the lead abutment flashing to the stone parapet wall of the south east flat roof above the main entrance

- <u>Recommend these are replaced to prevent water penetration.</u>
- The felt flat roof to the north facing single storey extension area shows physical evidence of thermal movement and deterioration, these appear to be leaking and will now require replacement where cracking/splitting is evident resulting in water penetration.

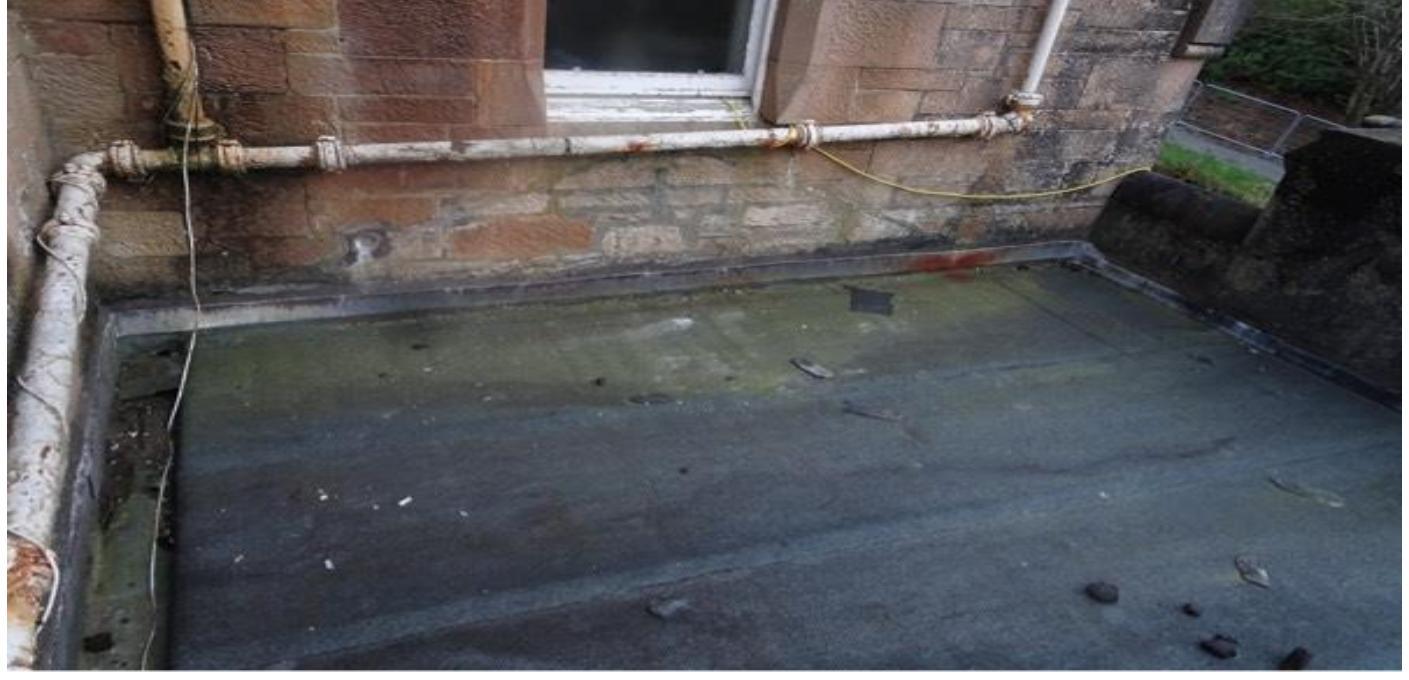
Holed and cracked mortar fillet noted above the rear lead abutment flashing to the south west flat roof above the main entrance

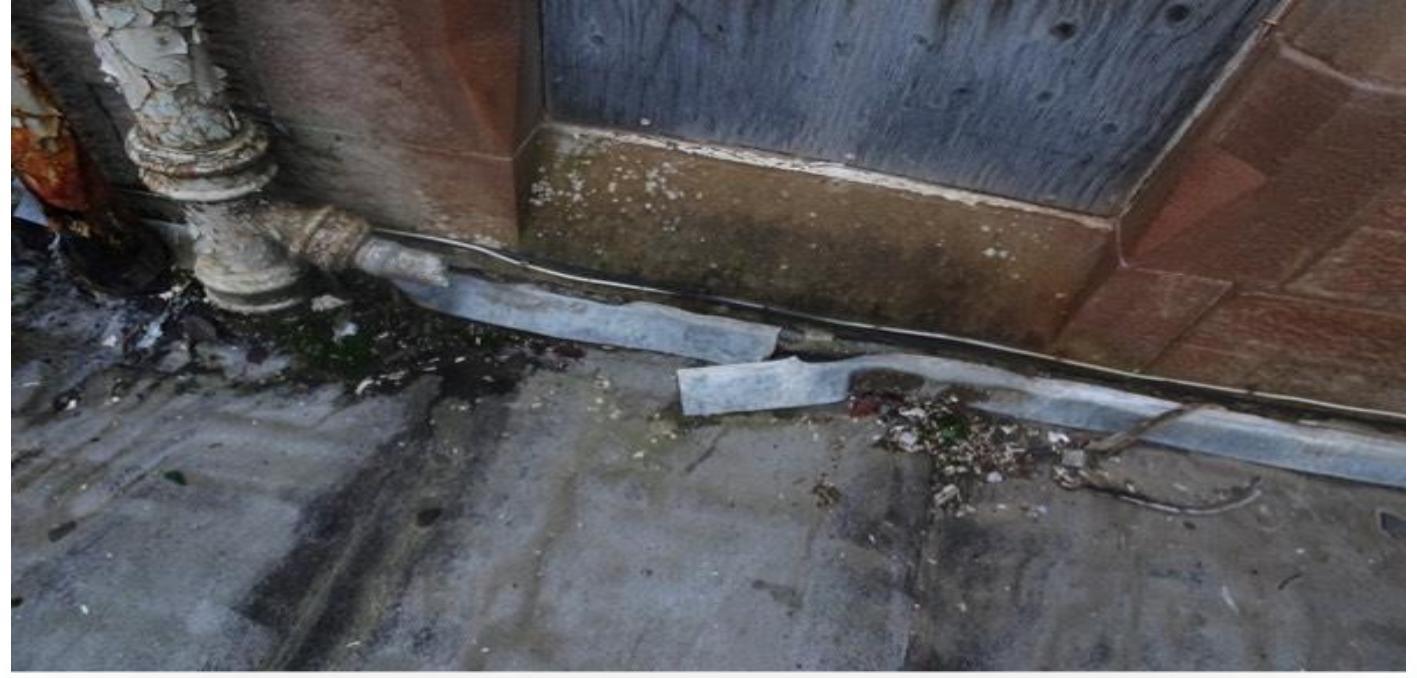
Detached perimeter lead abutment detected to the north facing rear elevation flat roof

- Further inspection revealed lead abutment detached areas exposing the roof to water penetration.
- <u>Recommend replacement with a modern EPDM or built up felt system.</u>

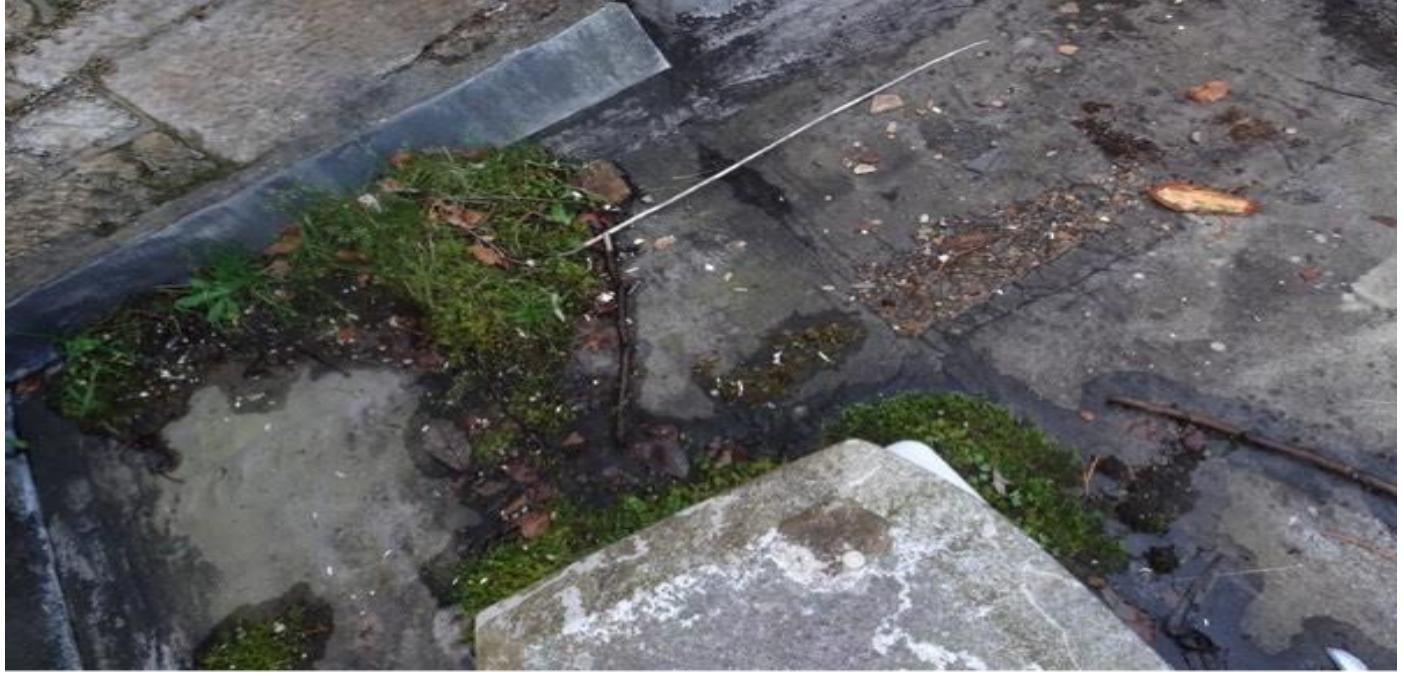
Sagging deck area with stress cracked felt detected to the rear elevation north elevation flat roof

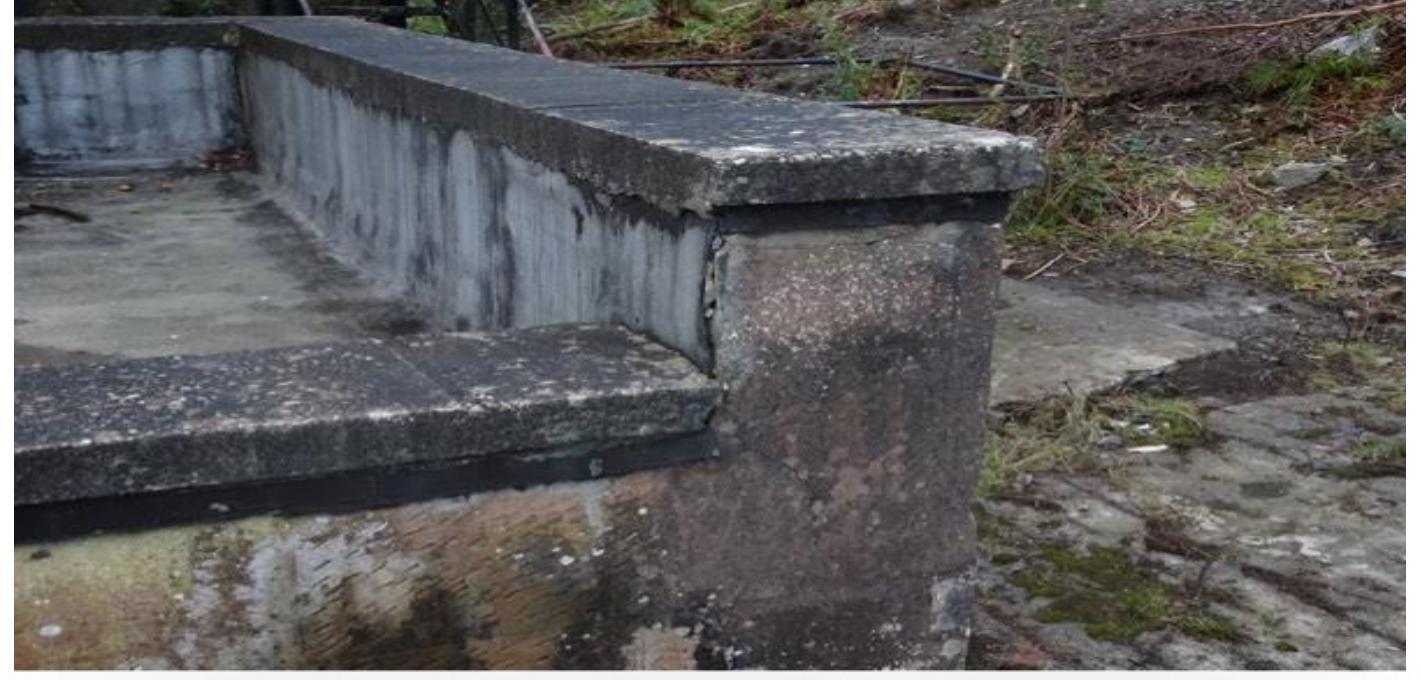
De bonding felt detected to the perimeter parapet wall to the north facing flat roof extension

- <u>Recommend replacement with a modern EPDM or built up felt system.</u>

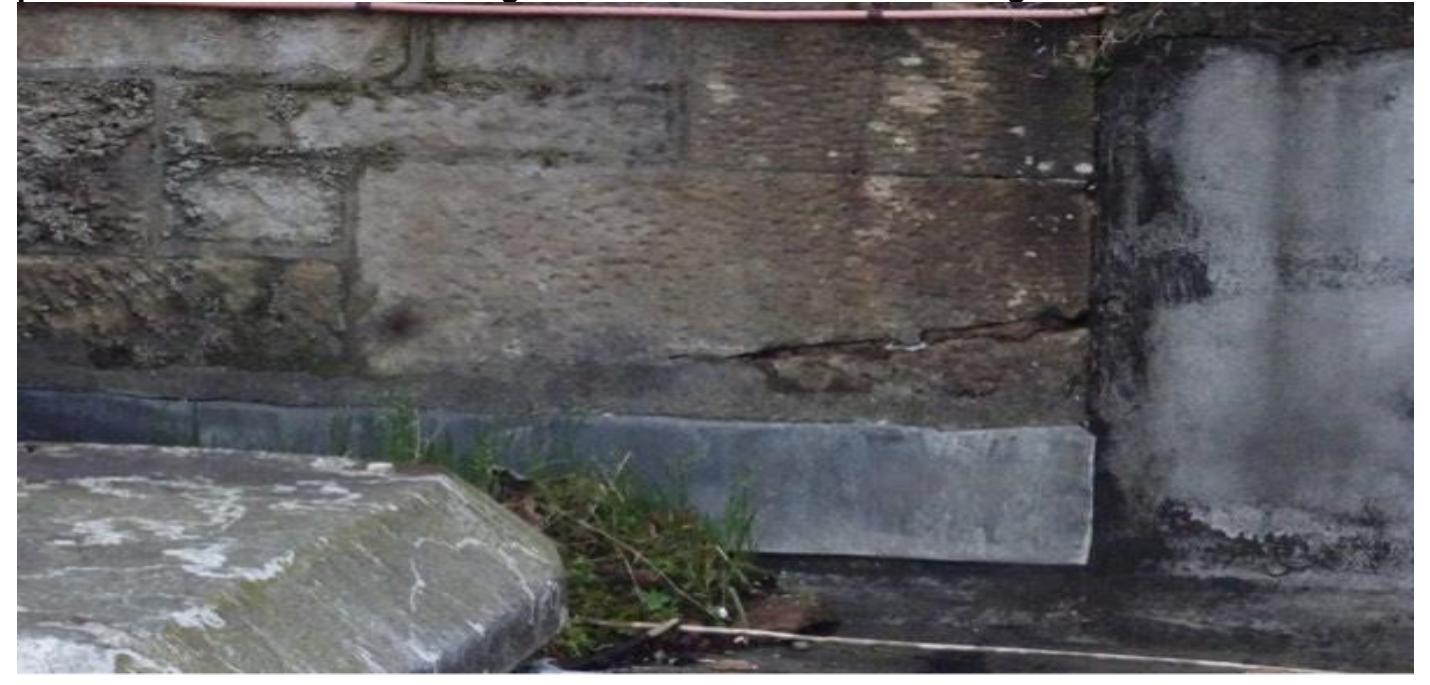
Open and cracked mortar detected to a historical stone wall crack located above the perimeter lead abutment flashing to the rear elevation north facing flat roof

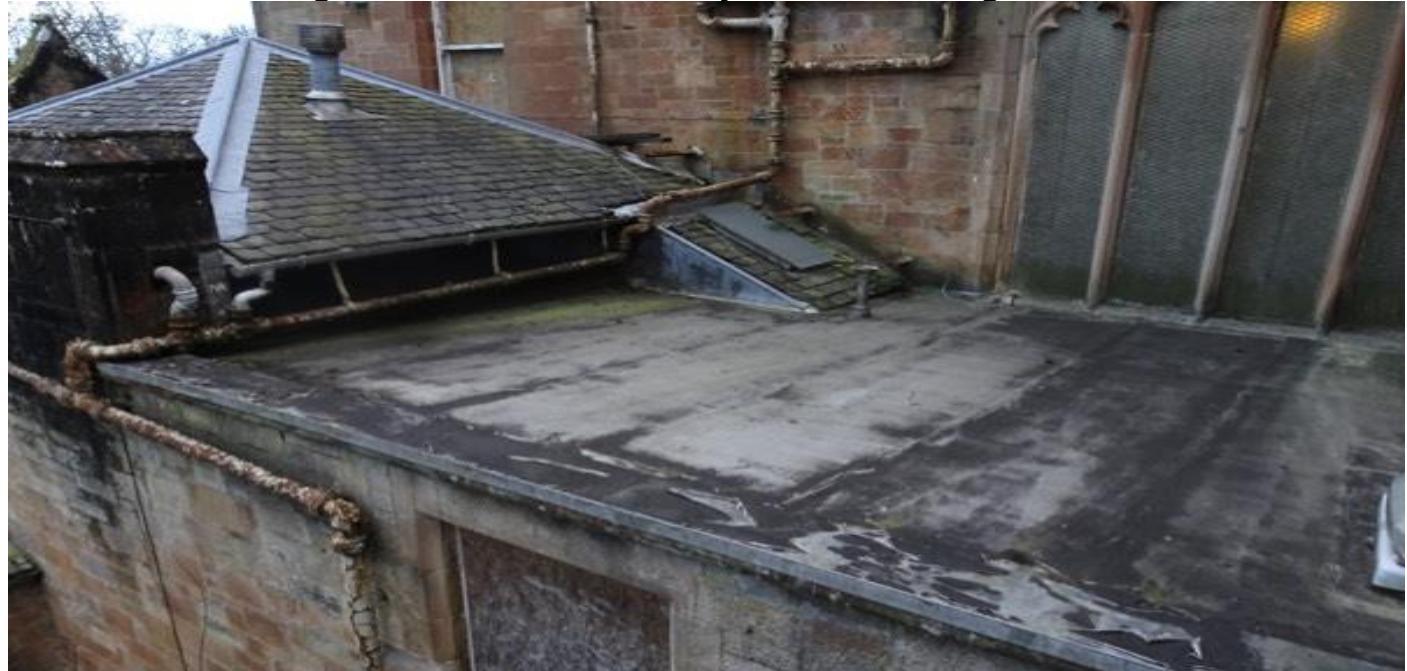
Surface delaminating detected to the secondary rear north facing flat roof area

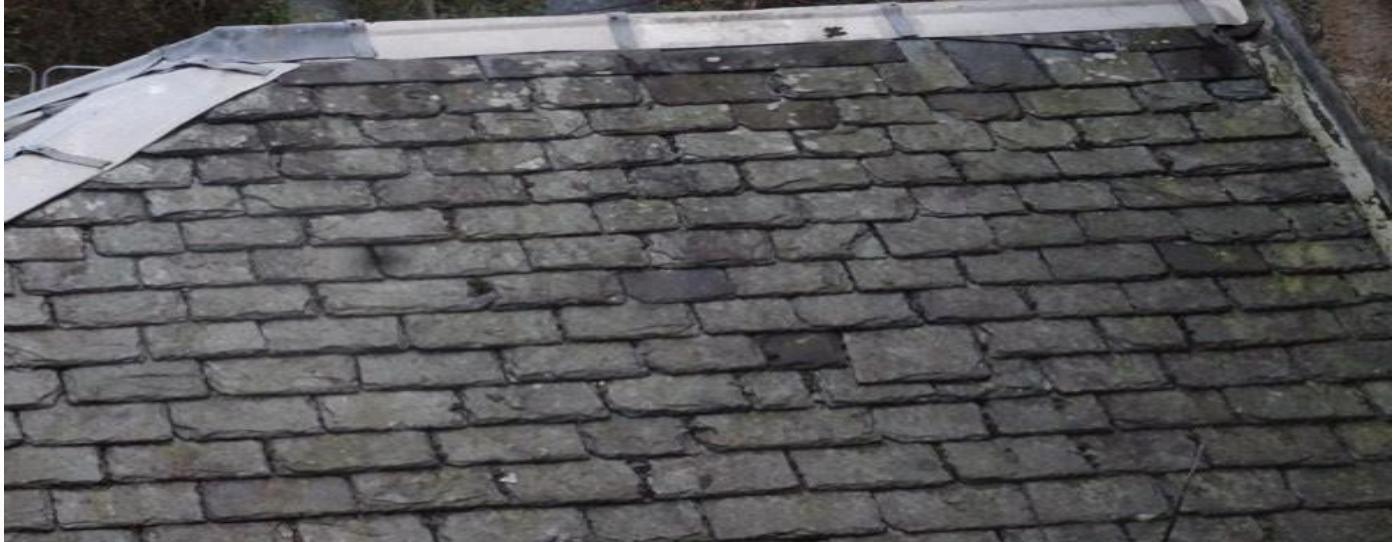
Slipped slates detected to the rear elevation extension roof

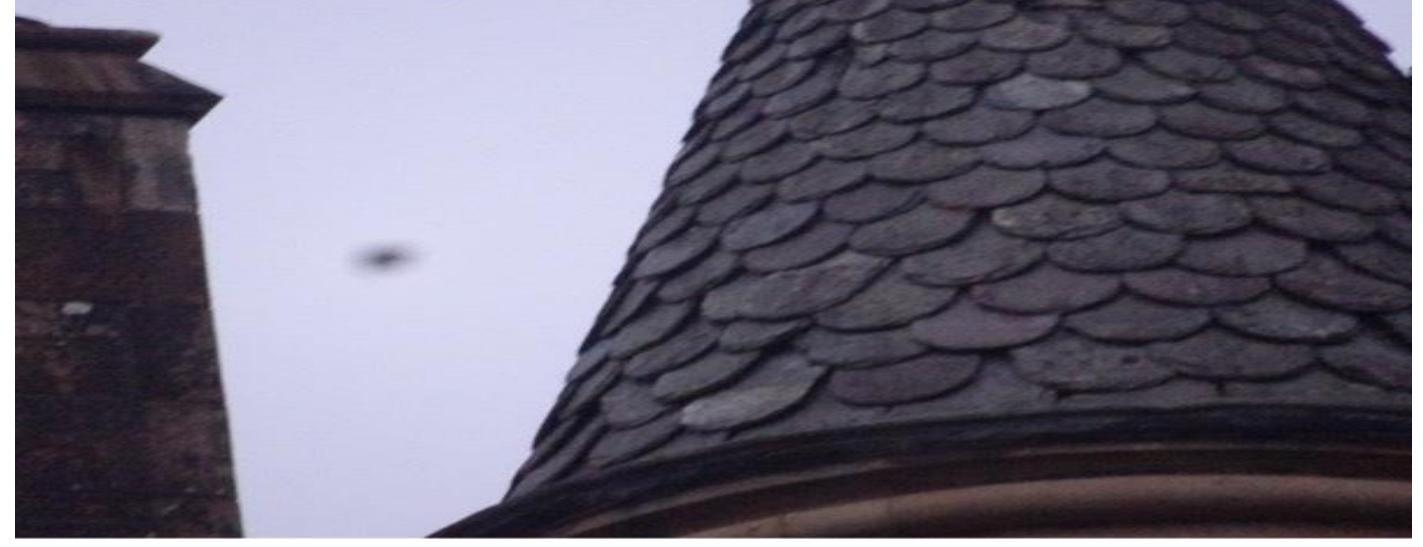
Slipped scalloped slates detected to the south facing turret roof

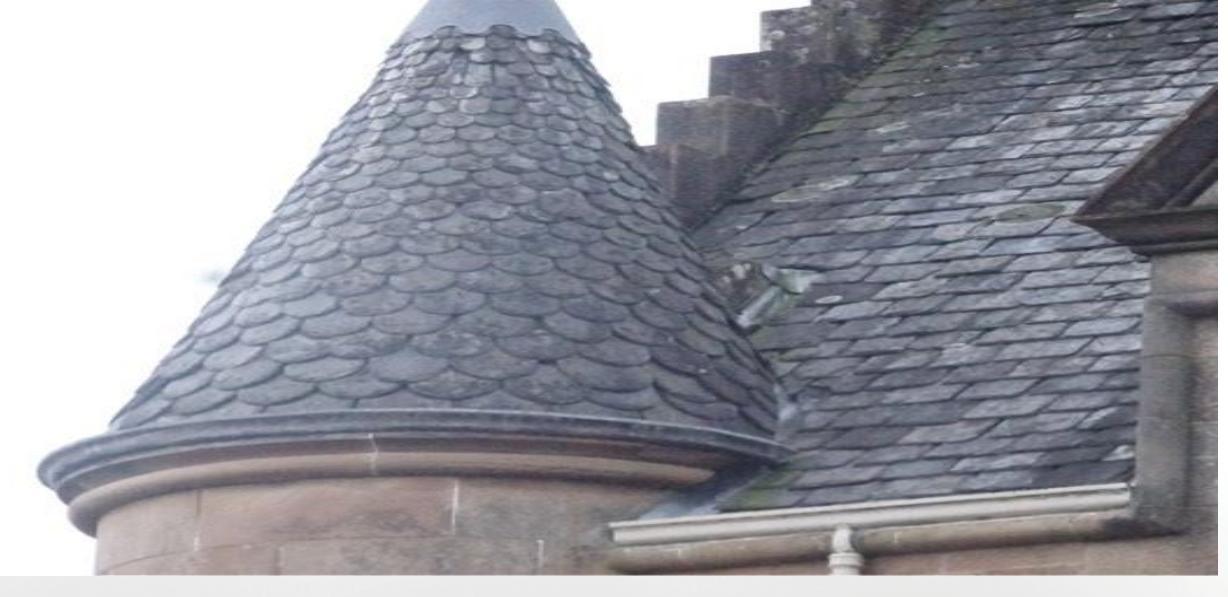
Slipped and missing slates close to the ridge detected to the south right turret

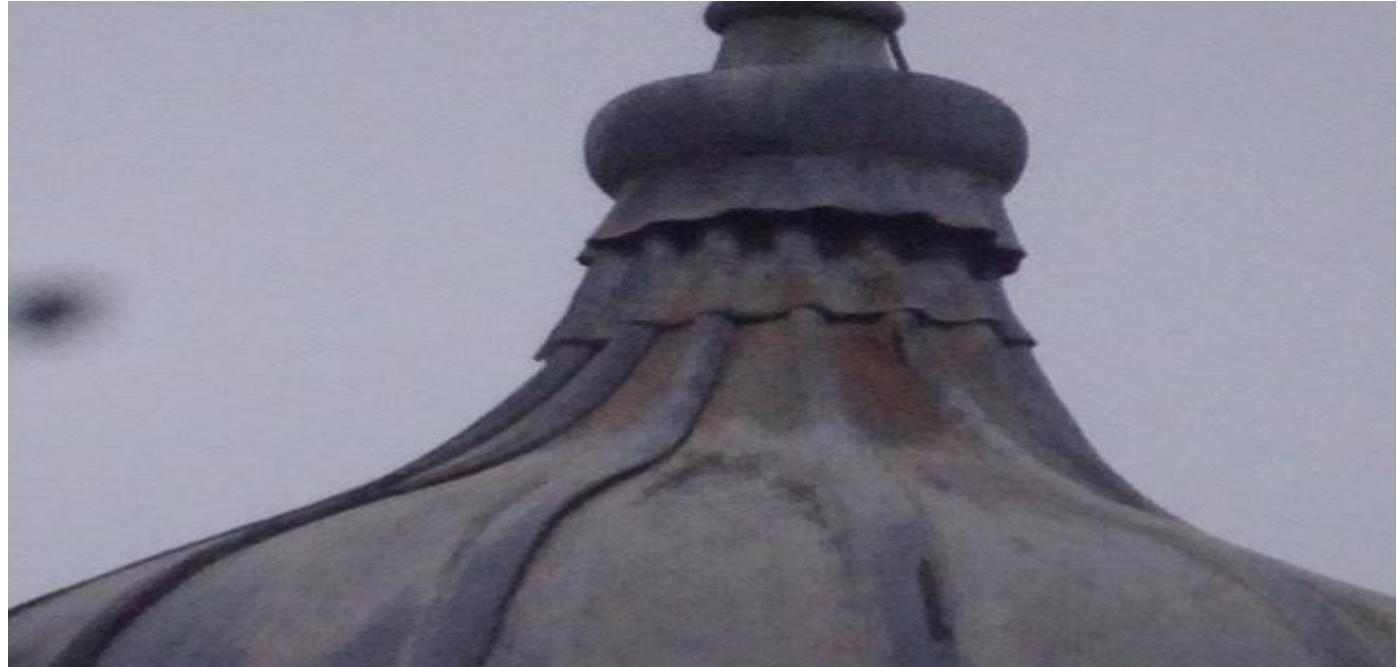
Central turret roof lead finial insecure set in situ
