ROOF SURVEY

XXXXXX XXXXXXXX
XXXX XXXXXX
XXXXXX
XXXX XXXX XXXXXX
GXX 8XX
ROOF CONDITION SURVEY
RCS/XXX/2022
21st Jan 2022
XXXXX XXXXXX BCI, CII, BDMA, MIOR

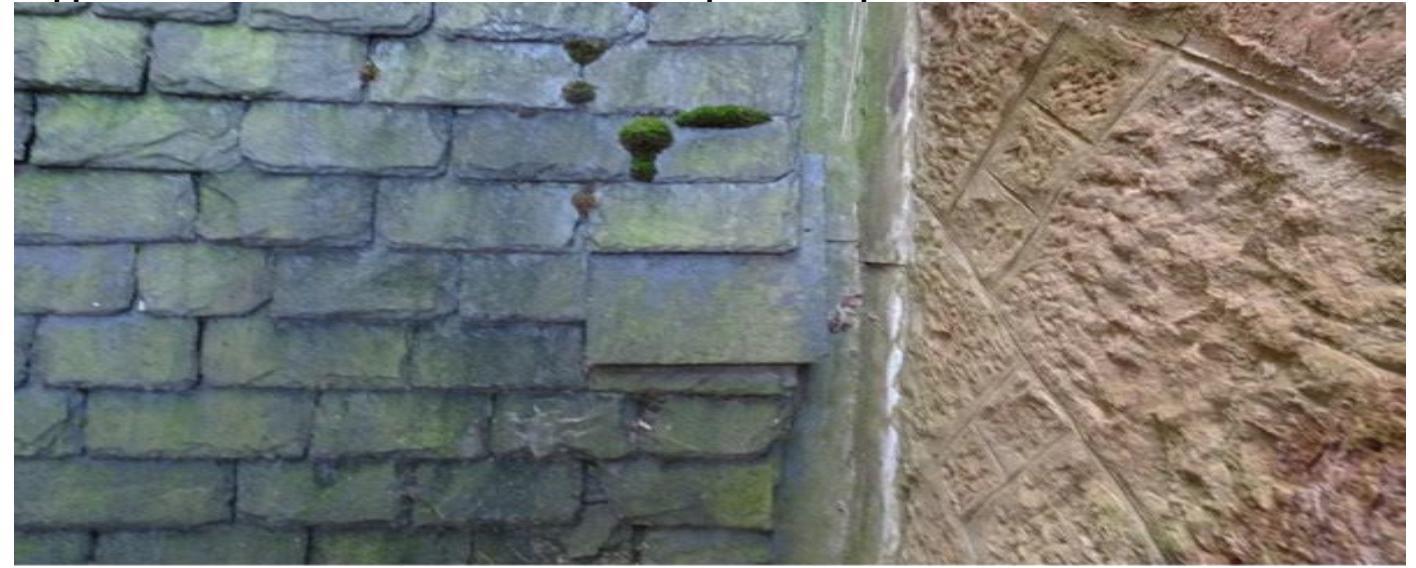
Slipped slates detected to the central roof slope side slip area

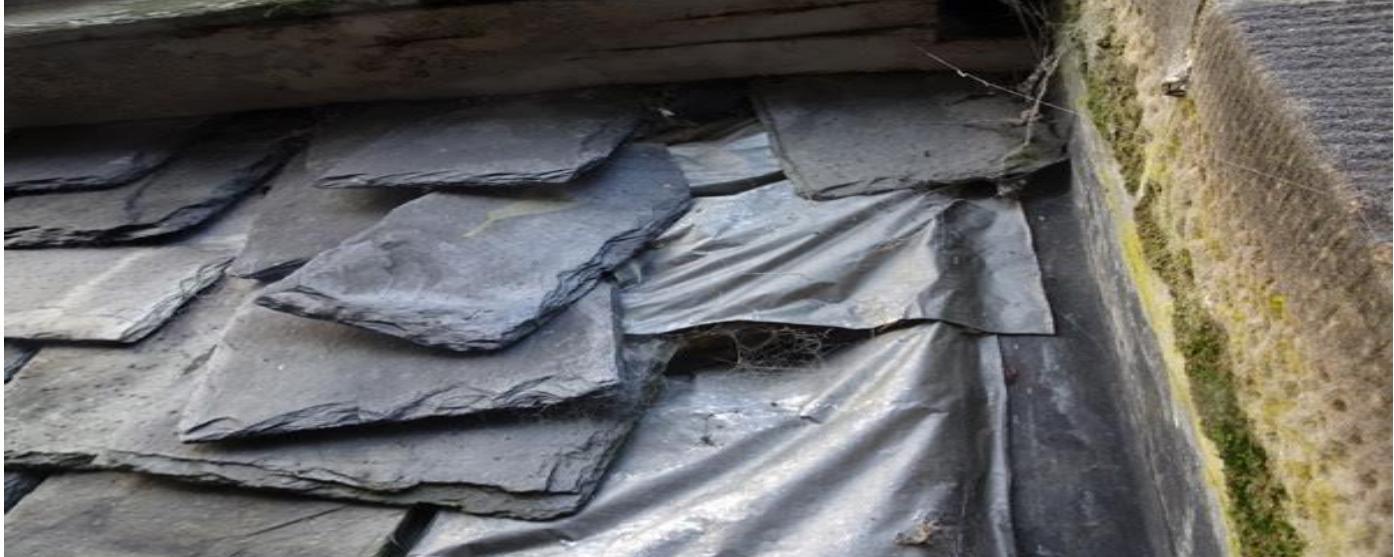
Slipped and missing slates with temporary bitumen tape seal detected to the central roof slope
