Client Name: XXXXX XXXXXX
Address: XXXXX XXXXX XXXX
XXXX X XXXXX
XXXX XXXX XXXX
XXXXXXXX XXXXX
XXXXXXXXXX
XXXXXX
CF3 XXX
Purpose of Report: ASBESTOS MANAGEMENT SURVEY
Report Reference: AMS|XXX|20XX
Inspection Date: 0X May 20XX
Surveyor Name: XXXX XXXXXX BSc Hons, MCIQB, CSRT, CSSW, DipDEA, UKAS-P402/P405
Building Surveyor Engineer Name: XXXX XXXXXX BSc (Hons) C Build E, MCABE.

Property Image

INTRODUCTION

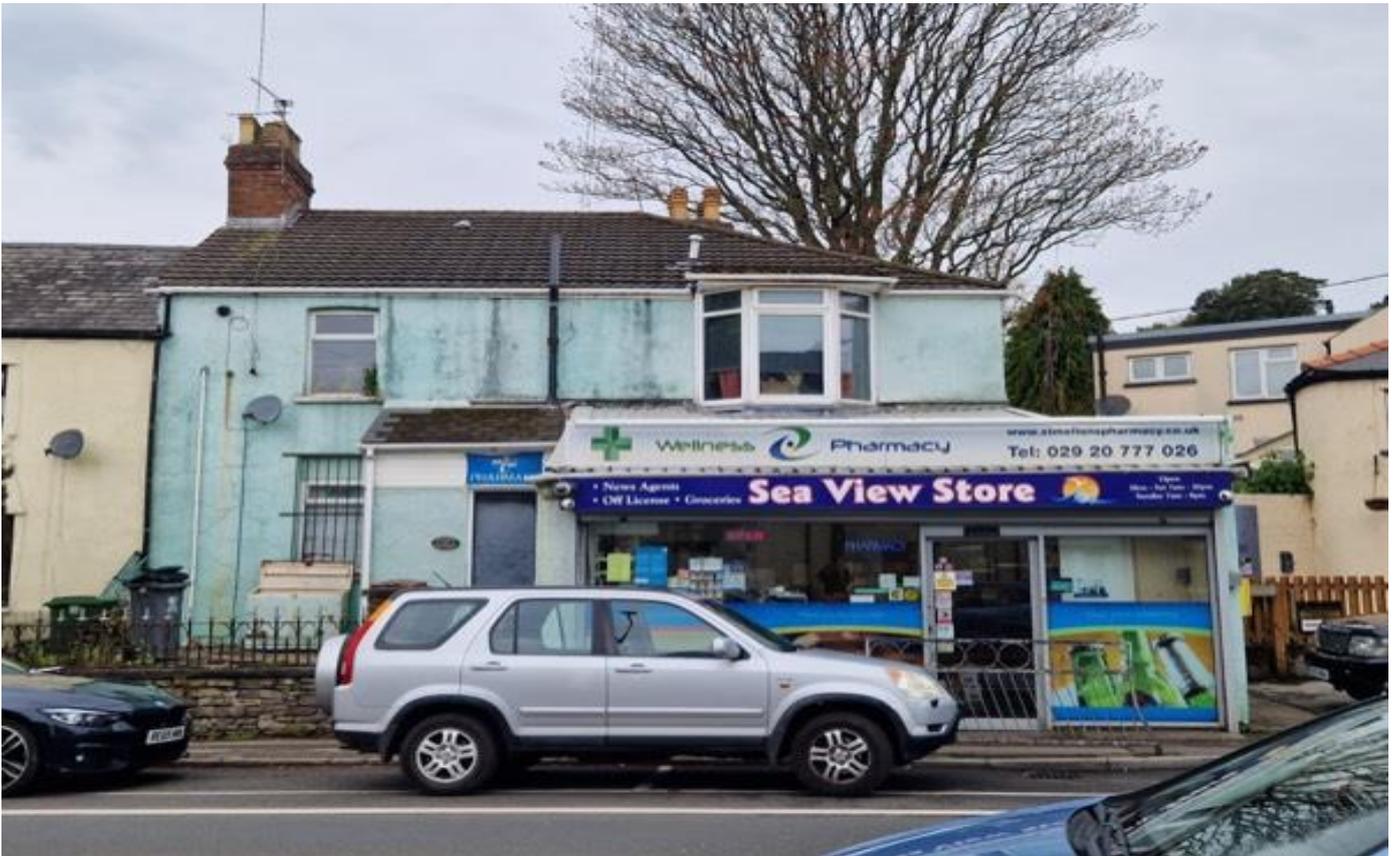
Front Elevation

Location
External
Area Size
External Areas
General Description of Area
<ul style="list-style-type: none"> The Main roof has interlocked concrete tiles to the main roof, with a mono pitched roof with slate tile finish. There are two stacks to the property all in average condition. The shop front is a more modern build with cavity walls and an aluminium profile sheeted roof. Fascia's and rainwater goods are all UPVC all windows are UPVC double glazed. The door to the shop is an automatic aluminium framed door, with the door to the flat a timber unit. There were no suspected ACMs noted to the external parts of the building.
Findings
<ul style="list-style-type: none"> <u>No samples were taken, and no suspect material was identified.</u>
Number of Samples Taken
NONE

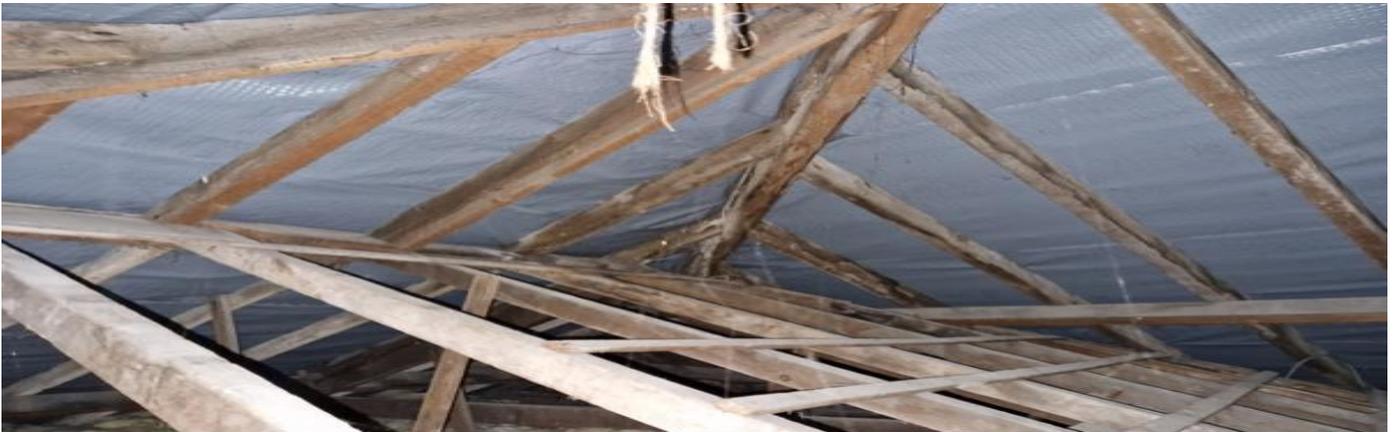
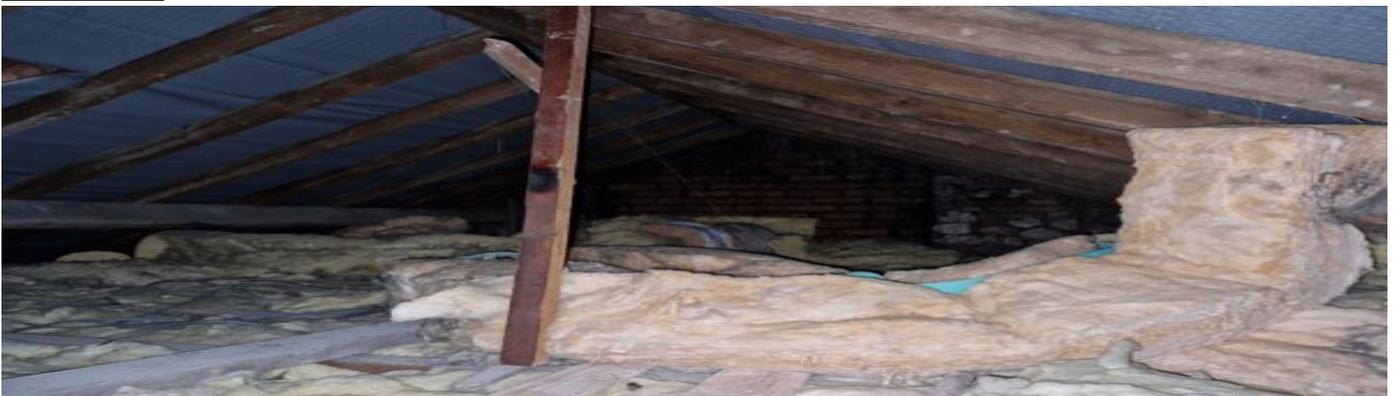
Location
Internal
Area Size
Roof Space
General Description of Area
<ul style="list-style-type: none"> The main roof comprises of a network of rafters and purlins supported by the load bearing walls. The insulation is mineral wire wool with a polyurethane roofing under-felt. There were no suspect ACM's noted within the roof void.
Findings
<ul style="list-style-type: none"> <u>No suspect ACM's identified.</u>
Number of Samples Taken
NONE

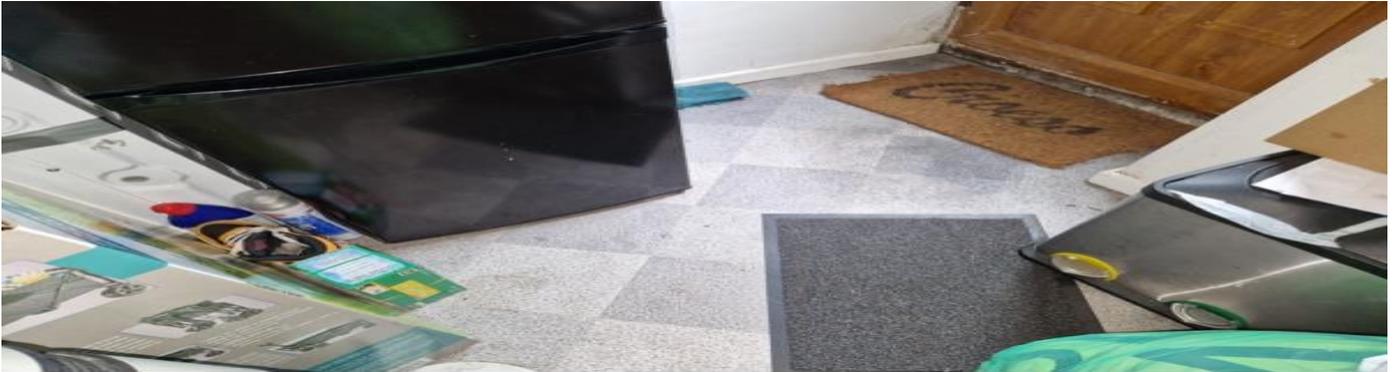
GF Reception Room

- The first floor flat has fixed floor coverings to the solid floor of the ground floor reception area with suspended timber flooring to the first floor of the dwelling. All ceilings were of plasterboard and skim finish with plastered walls, all with an emulsion for the finish. There were no suspected Asbestos containing materials noted to any of the rooms inspected.

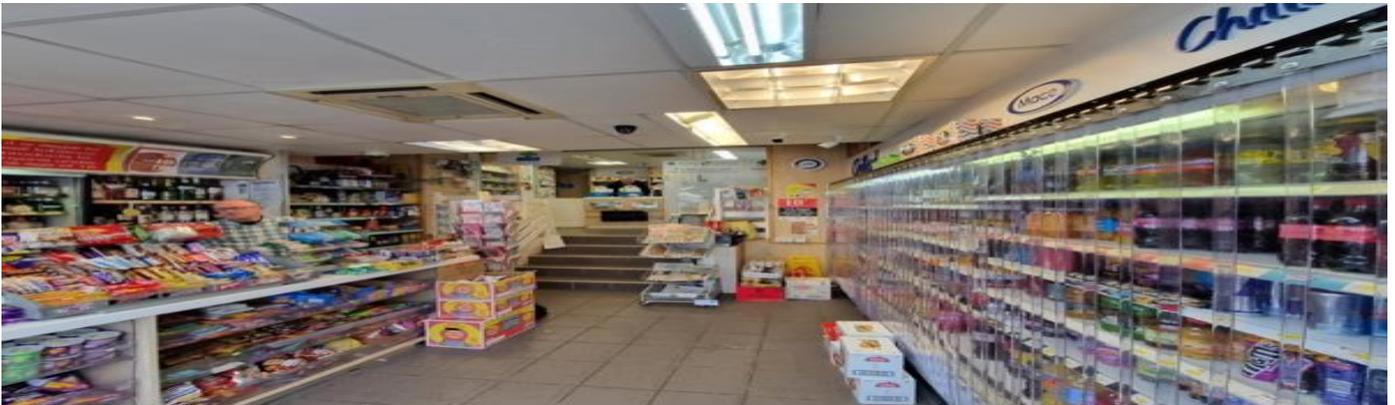
Main Shop Floor (Front)

Location
Internal
Area Size
Shop/Pharmacy
General Description of Area
<ul style="list-style-type: none"> The shop floor is entered through the automatic doors to the front which leads to the lower grocery section. Here there is fitted flooring installed upon the solid floor which leads up a few steps to the raised pharmacy area with the same fitted flooring. From here, to the left leads you to the small corridor to the rear exit and the store, utility and consultancy room. The floor and pharmacy had a suspended ceiling, with plasterboard and skim finishes to the adjacent three rooms. All accessible areas were inspected, and no suspected ACM's were identified.
Findings
<ul style="list-style-type: none"> <u>No suspected asbestos material identified, and no samples were taken.</u>
Number of Samples Taken
NONE

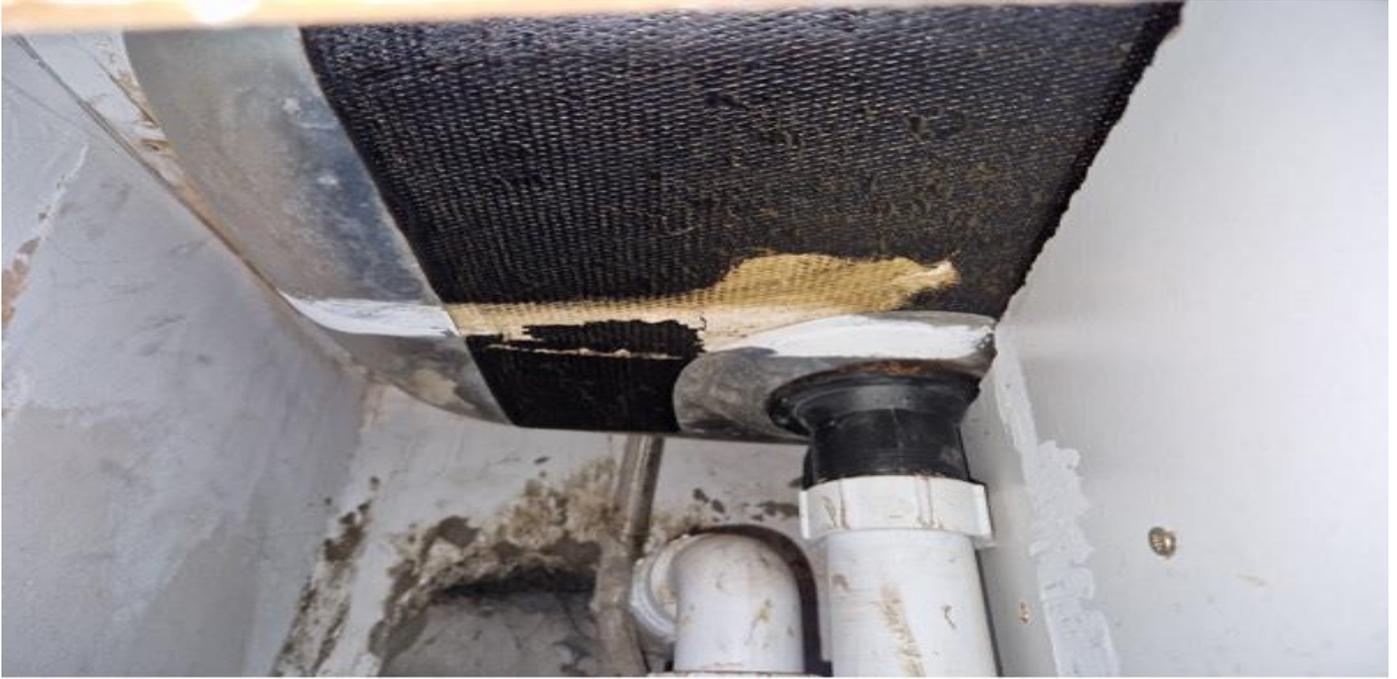
Kitchen Sink Pad (non acm)
