RENEWABLE ENERGY **SURVEY**

Address: 1 QUALITY STREET, UNITED KINGDOM, QU11 8TY

Purpose of Report: ROOF CONDITION SURVEY

Report Reference: RE/MSE/2013

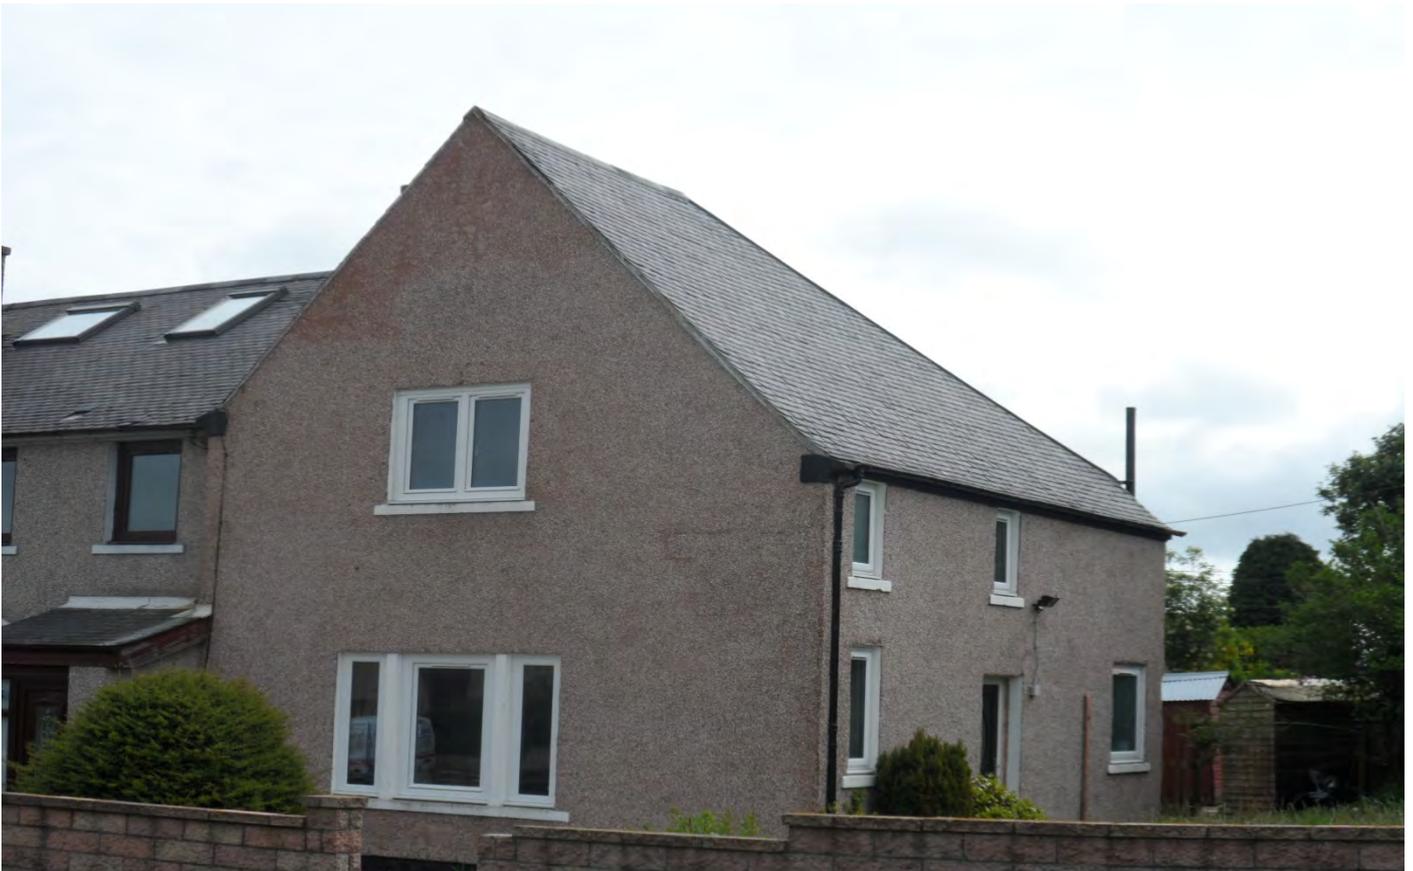
Property Image

The property was ex local authority block/brick render construction with a 45 degree dual pitched slated roof, with a zinc valley located to the front elevation, with mortar finished hipped end to the rear elevation extending from the cast iron gutter line up to the segmented ridge line. The property is approximately 50+ years old with the present owner in full occupation for approximately 2 years.
