ASBESTOS **SURVEY**

Address: UNIT A, QUALITY STREET QUIII 8TY

Purpose of Report: ACM Inspection

Report Reference: ACM/MSE/2013

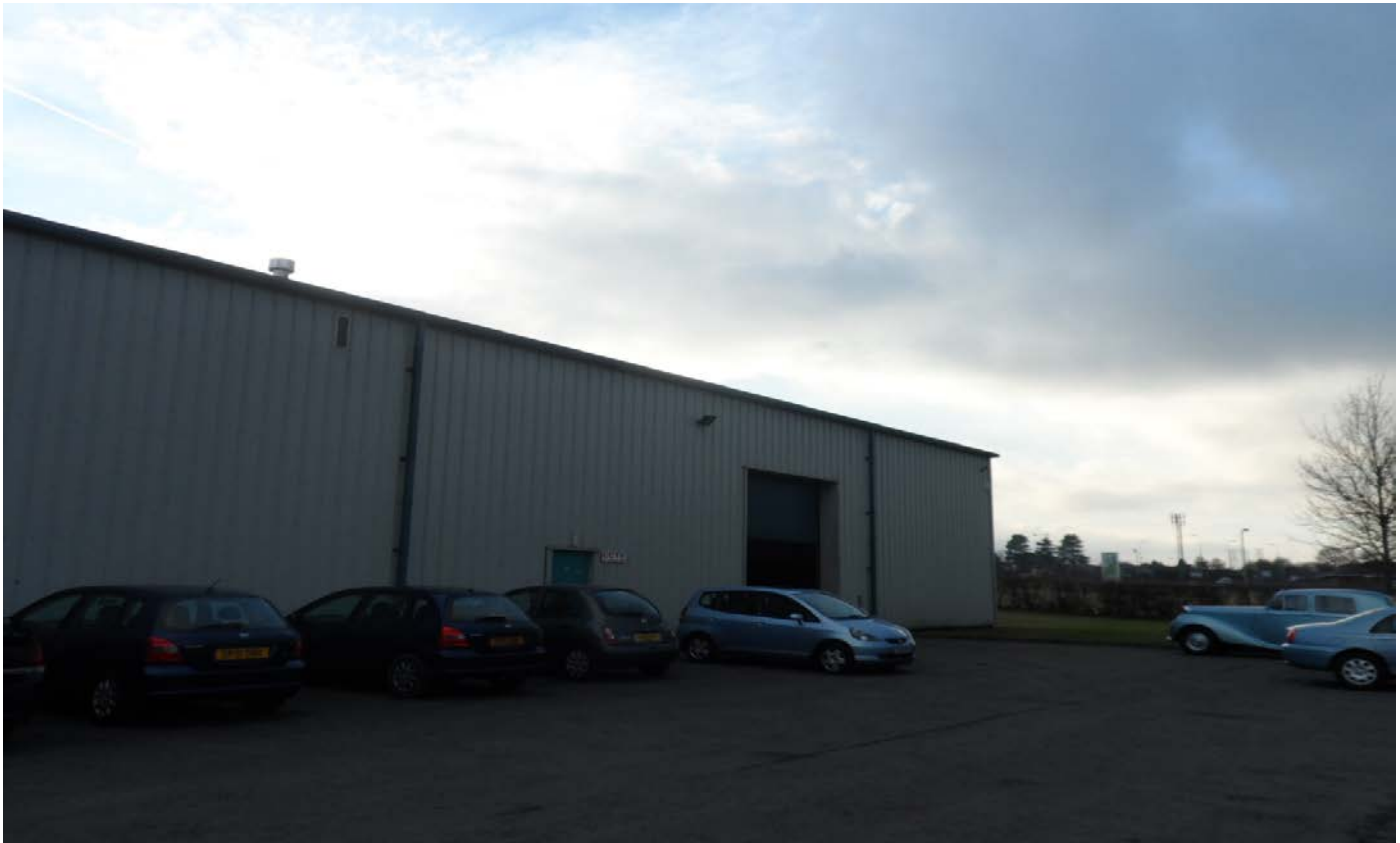
Property Image

The commercial Premises presently used as a car storage facility/Preparation unit was approximately 14 years old. The Building had a steel Frame construction with a metal profile cladding/ dual pitched roof, the Premises is presently let by the owner to a local car dealership.

Average Condition for Age in need of cycle-able maintenance
