INFRARED **SURVEY**

Client Name: XXXX XXXXX
Address: XXXX XXXX. XXXXXX
XXXX XXXXXXXXXXXXX
XXXXXXXXXXXXXX
XXXXXXXXXXXXXX
XXX XXX
Purpose of Report: BUILDING HEAT LOSS QUALITATIVE INFRARED ANALISYS
Report Reference: IAS/MXF/XXXX
Inspection Date: 22 Jan 2023
Surveyor Name: Philip Milne ISO 18436-7 & BINDT CM/GEN
Thermographer Name: Philip Milne ISO 18436-7 & BINDT CM/GEN
Average Ambient Temperature: 46.4 Fahrenheit
Imager Used: FLIR CX3

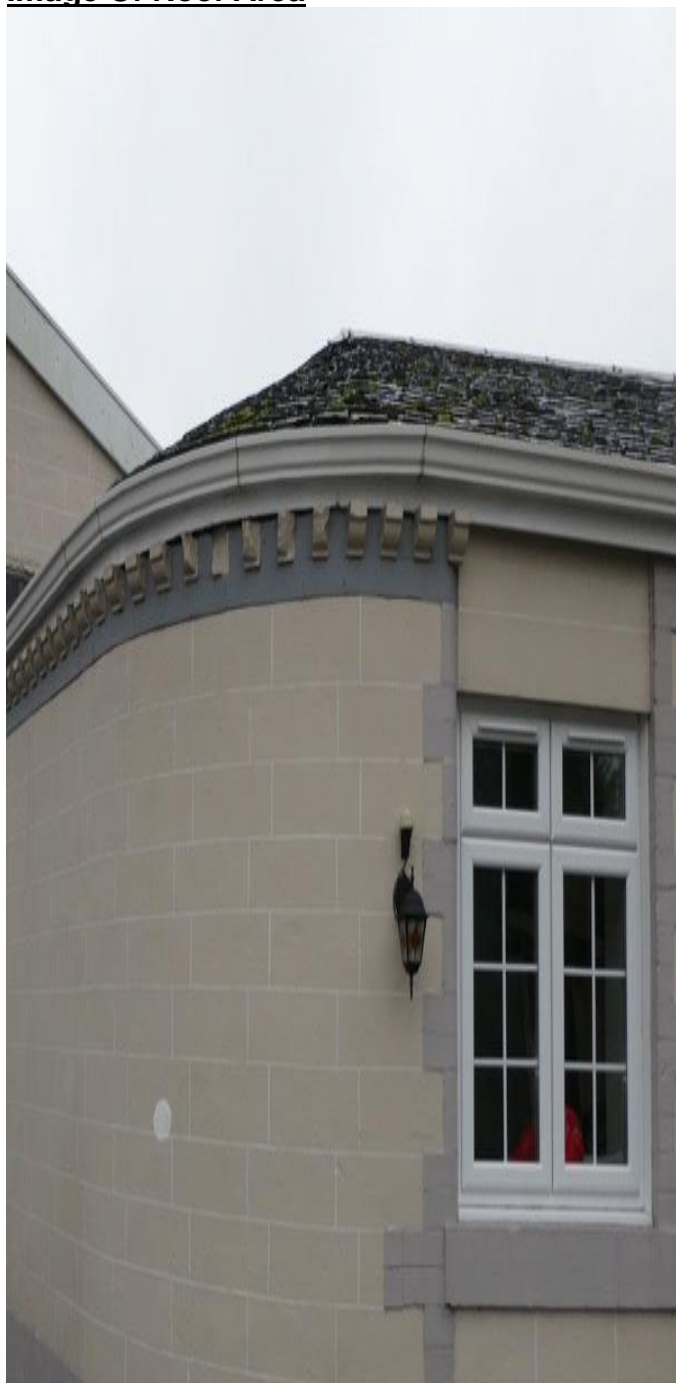
Image Of Roof Area

Thermal Image Shows High Levels Of Heat Loss Through Then Roof Coverings

- A Thermal image inspection of the roof covering revealed high levels of thermal heat loss emissivity to the roof area inspected suggesting missing or insufficient insulating materials, these will require improvement to meet with current building regulations.

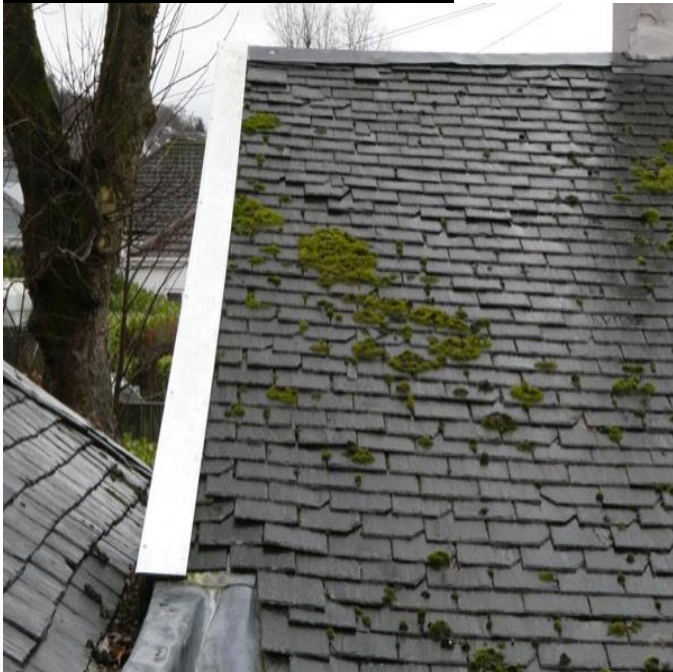
Roof Area Above The Lounge

Vaulted Ceiling In Lounge Shows Missing Or Inadequate Insulation

- Inspection within the loft space has found thermal anomalies in loft space area at the time of survey, inspection revealed missing and insufficient insulation material within the ceiling ties resulting in significant heat loss through the room ceilings exiting through the roof coverings.

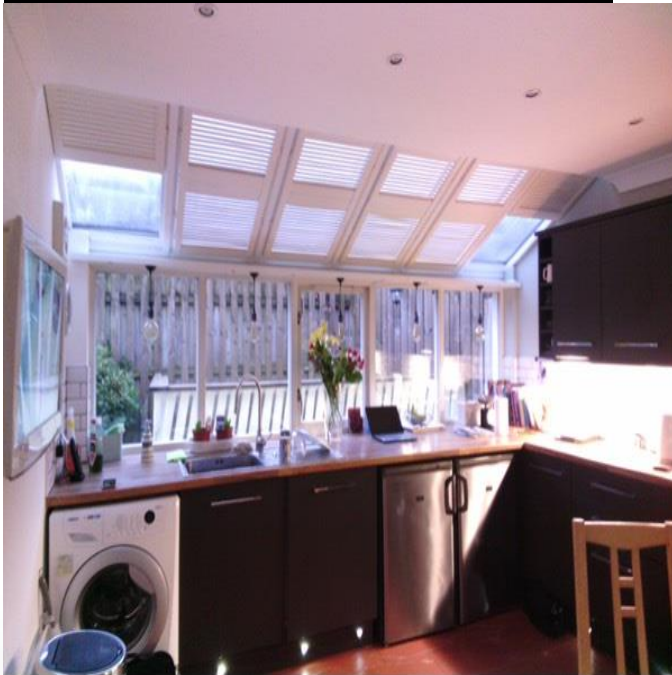
Image Of Glazed Roof Panels In Kitchen

High Levels Of Heat Loss Detected To The Kitchen Glazed Panels

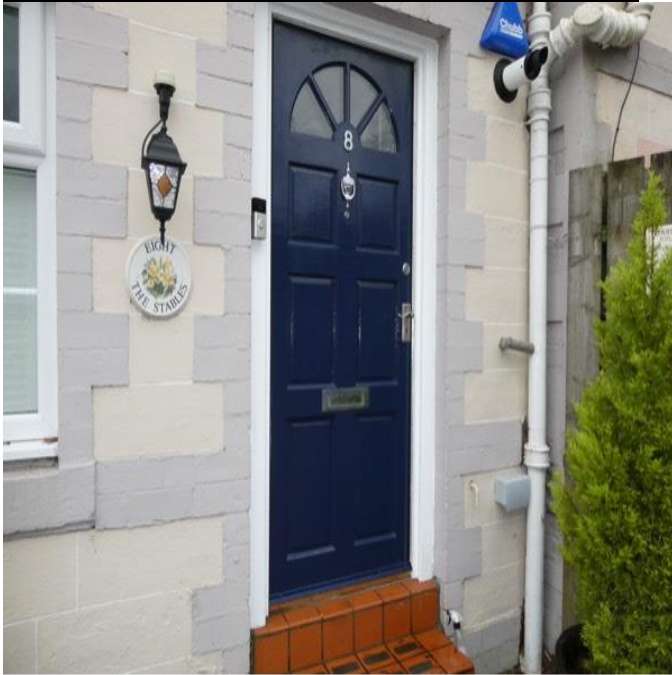
Timber Construction Front Entrance Door

High Levels Of Air Filtration Detected To The Base Of The Door Threshold

- Inspection however has revealed excessive energy loss emissivity around the window and door openings, the dominant cause of break down is confirmed to be resultant from distortion of the UPVC window frame opening sashes, inefficient window seals with holed and missing mortar and mastic seal detected to the frame perimeters at the reveal abutment.

- Inspection of the window and door frames revealed decay and distortion to the timber construction window and door frames due to age.
- Recommend the window frames/seals are replacement or upgraded to a more thermally efficient grade with cam mechanism adjustments carried out mitigate the Heat Loss and create an enhanced compressed seal to all window and door opens to reduce excessive energy loss through the building envelope.

- Consideration should also be given to the replacement of the existing timber construction windows and doors to a modern thermally efficient UPVC high performance secure locking system to enhance the energy efficiency of the building envelope.

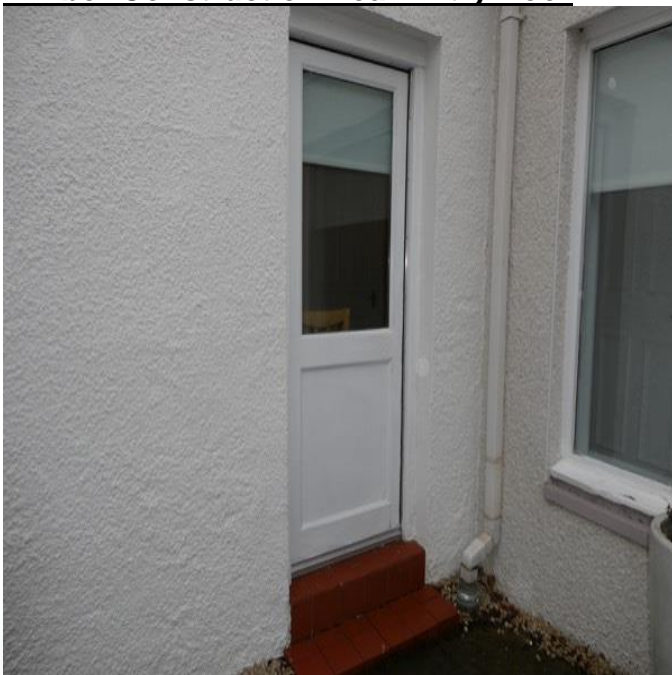
Timber Construction Rear Entry Door

High Levels Of Air Filtration Detected Through The Rear Door

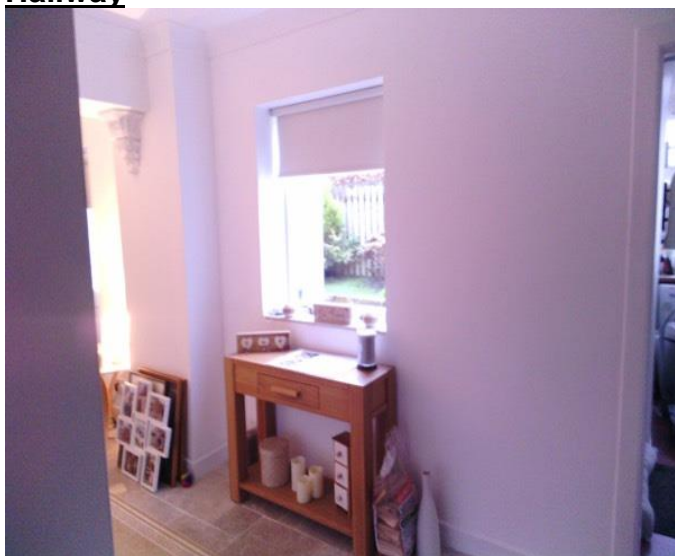
Hallway

High Levels Of Air Filtration Around The Window Location

- Inspection revealed excessive energy loss emissivity around the window and door openings, the dominant cause of break down is confirmed to be resultant from distortion of the window frame opening sashes, inefficient window seals with holed and missing mortar and mastic seal detected to the frame perimeters at the reveal abutment.

- Inspection of the door frames revealed decay and distortion to the timber construction door frames due to age.
- Recommend the window frames/seals are replacement or upgraded to a more thermally efficient grade with cam mechanism adjustments carried out mitigate the Heat Loss and create an enhanced compressed seal to all window and door opens to reduce excessive energy loss through the building envelope.

- Consideration should also be given to the replacement of the existing timber construction doors to a modern thermally efficient UPVC high performance secure locking system to enhance the energy efficiency of the building envelope.

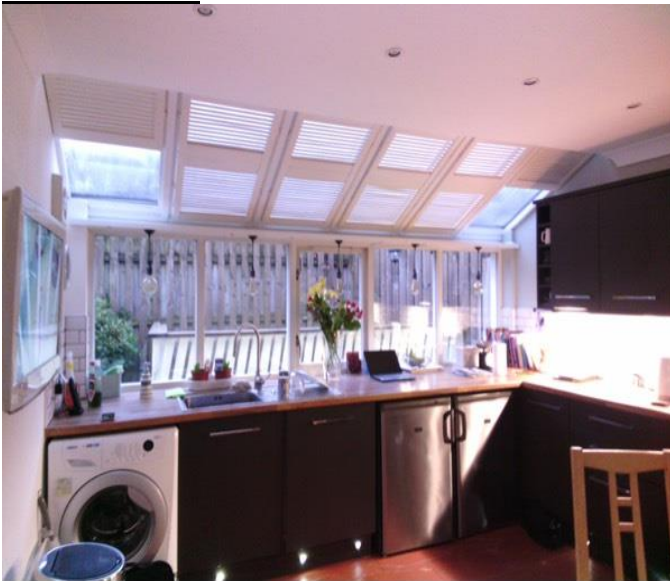
Kitchen Area

Heat Loss Detected To The Glazed Roof, Windows And Entrance Door

- Inspection revealed excessive energy loss emissivity around the vertical and sloping window and door openings.
- Inspection of the door frames revealed decay and distortion to the timber construction door frames due to age.
- Consideration should also be given to the replacement of the existing timber construction doors to a modern thermally efficient UPVC high performance secure locking system to enhance the energy efficiency of the building envelope.
- Consideration should also be given to replacement of the felt flat roof due to age related decay, this would facilitate the introduction of additional Celotex insulating boards to further enhance the room energy efficiency reducing heat loss significantly

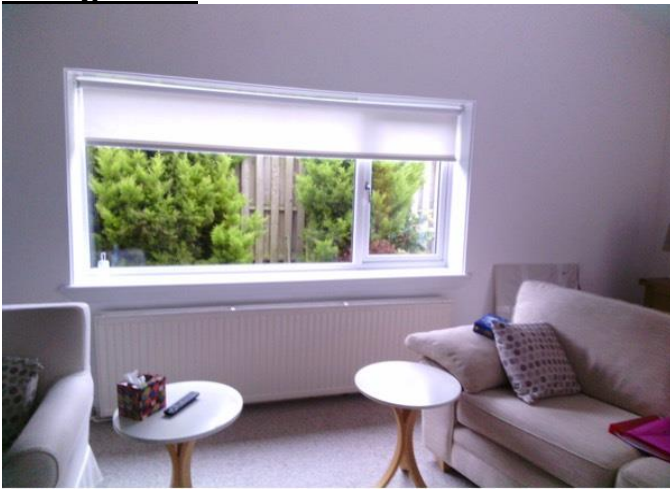
Lounge Area

Thermal Image Shows High Levels Of Heat Loss Around Windows And Walls

- Inspection revealed excessive energy loss emissivity around the window and door openings, the dominant cause of break down is confirmed to be resultant from distortion of the window frame opening sashes, inefficient window seals with holed and missing mortar and mastic seal detected to the frame perimeters at the reveal abutment.

- Inspection of the window frame revealed decay and distortion to the timber construction window frames due to age.
- Thermal images show missing or insufficient insulation to the vaulted ceiling area confirmed by large areas of cold spots detected, recommend that the ceiling is over boarded with the introduction of a 50-75mm Celotex insulation PIR board to enhance the room energy efficiency and increase warm air retention.

- Recommend the window frames/seals are replacement or upgraded to a more thermally efficient grade with cam mechanism adjustments carried out mitigate the Heat Loss and create an enhanced compressed seal to all window and door opens to reduce excessive energy loss through the building envelope.

- Consideration should also be given to the replacement of the existing timber construction window to a modern thermally efficient UPVC high performance secure locking system to enhance the energy efficiency of the building envelope.

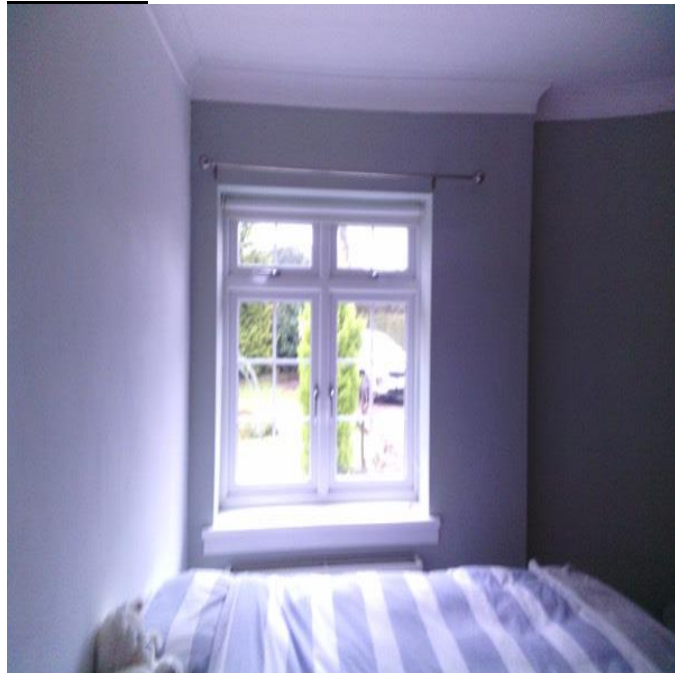
Bedroom

Thermal Image Shows High Levels Of Heat Loss And Excessive Air Filtration
