# Building Survey

## Customer Details

## Property Image

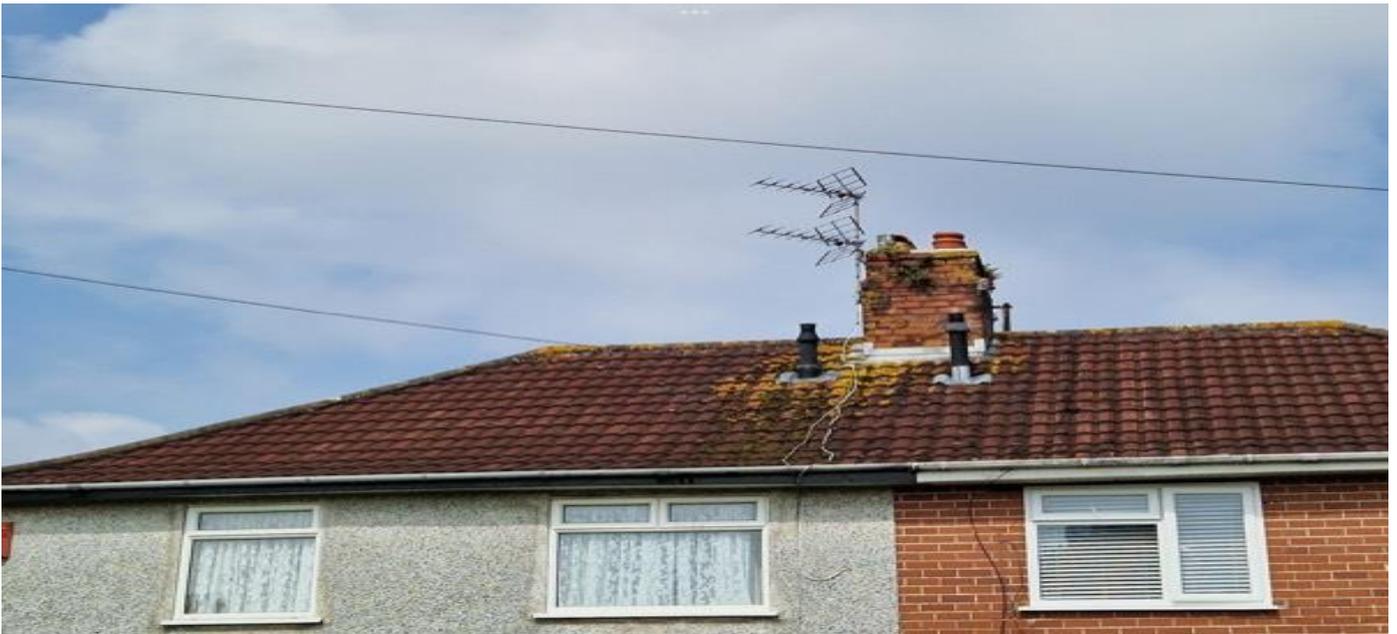
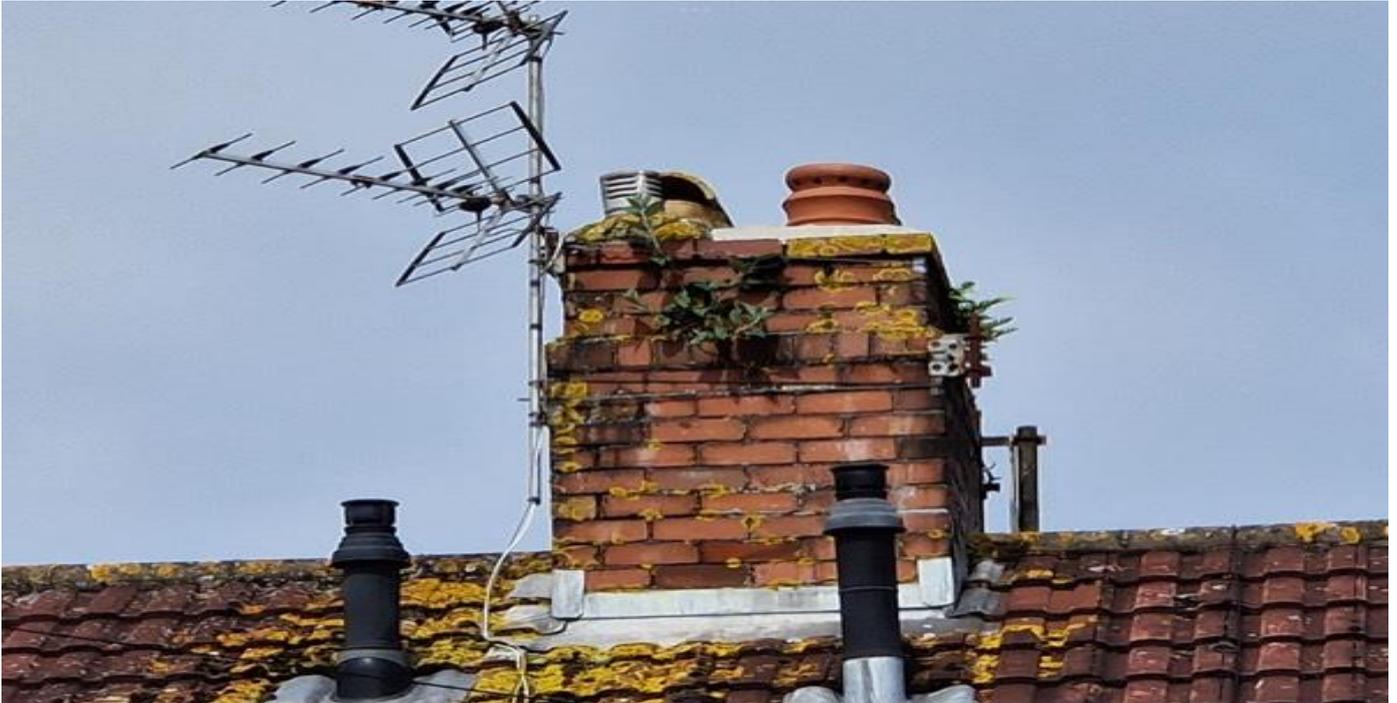
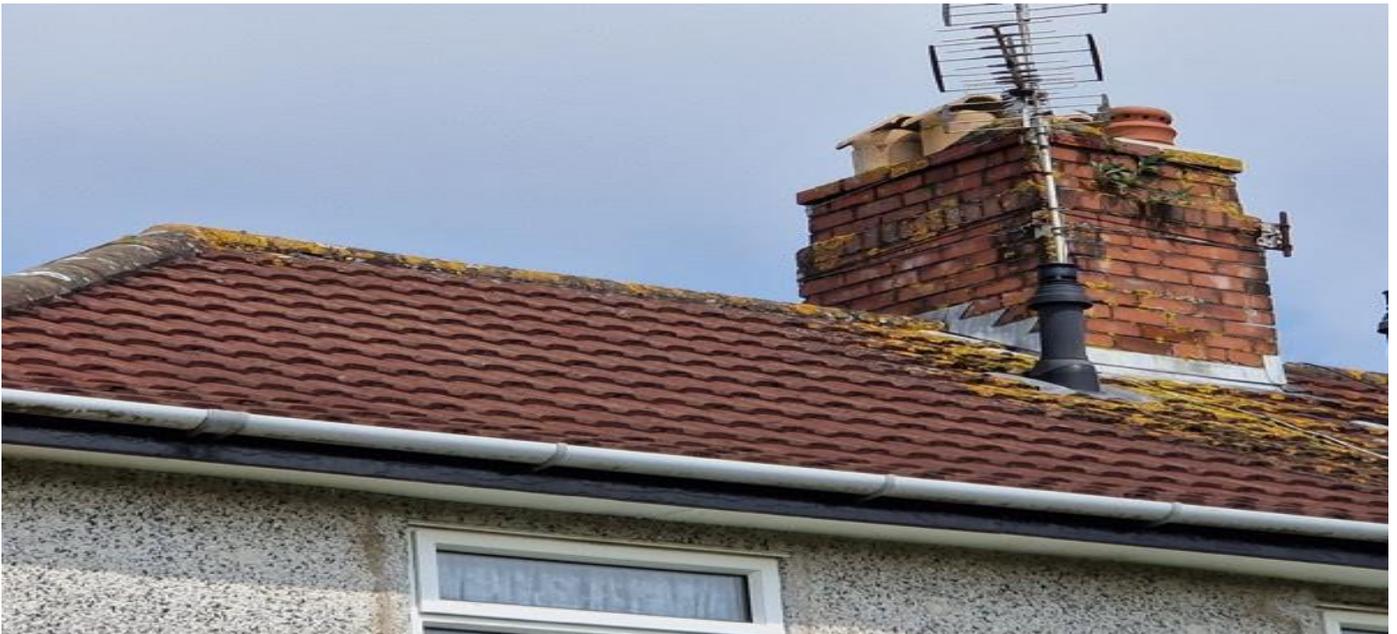
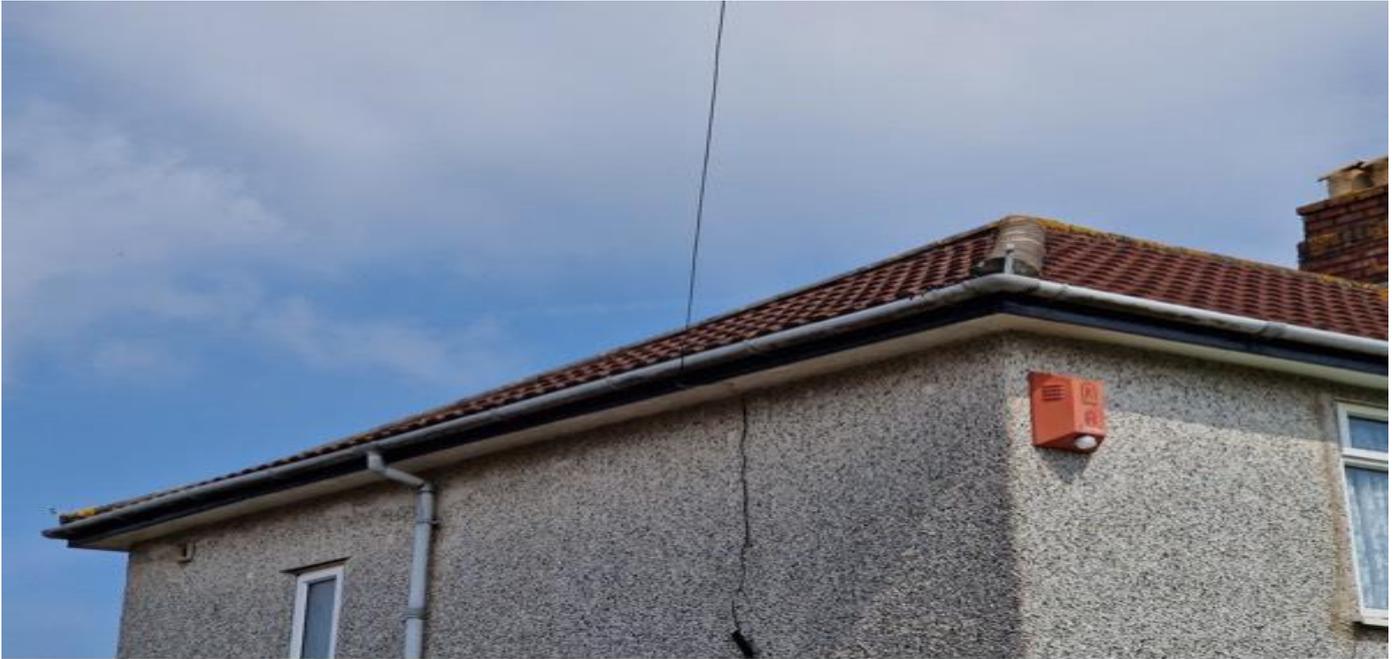
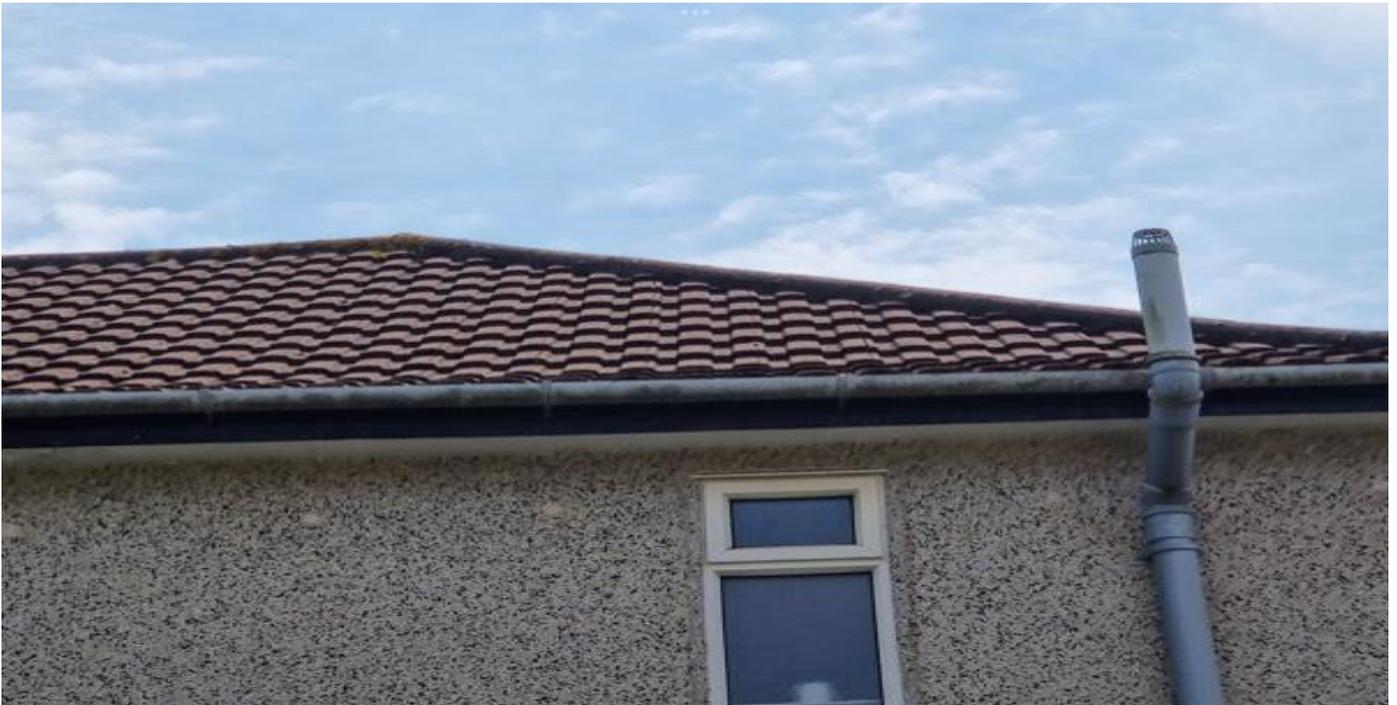
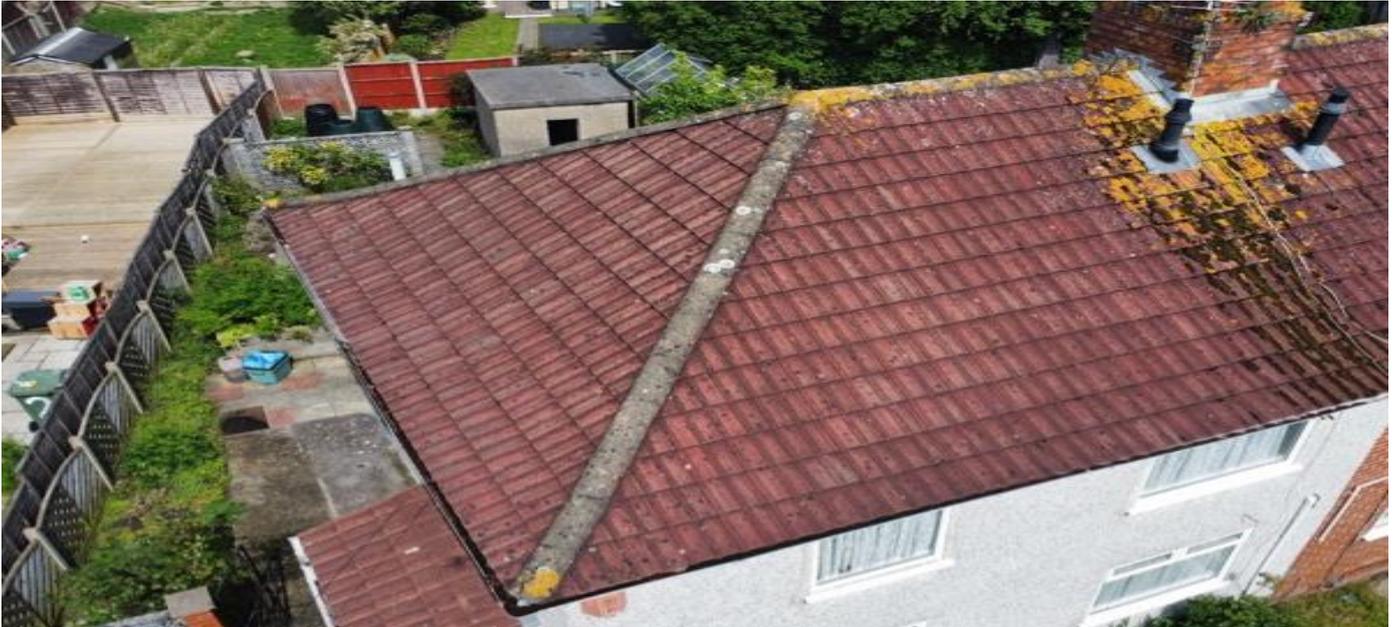
## Main Roof

- The stack is in poor condition with vegetation growth noted to front, side, and rear. There have been remedial repairs carried out to the neighboring side.

- Internally, there is little evidence of weakening of the timber structure, principally the only indication of roof spread is from horizontal cracks or 'shakes' to one of the purlins. This could also be historic and would be difficult to ascertain as the other timbers appear sound. The roof structure was found to be generally sound with only slight deflection on the underside of the original timber rafters which appears to be within tolerable limits.

- Due to the cracking beneath to many of the wall and ceiling junctions however, it is recommended that strengthening of the roof is undertaken.

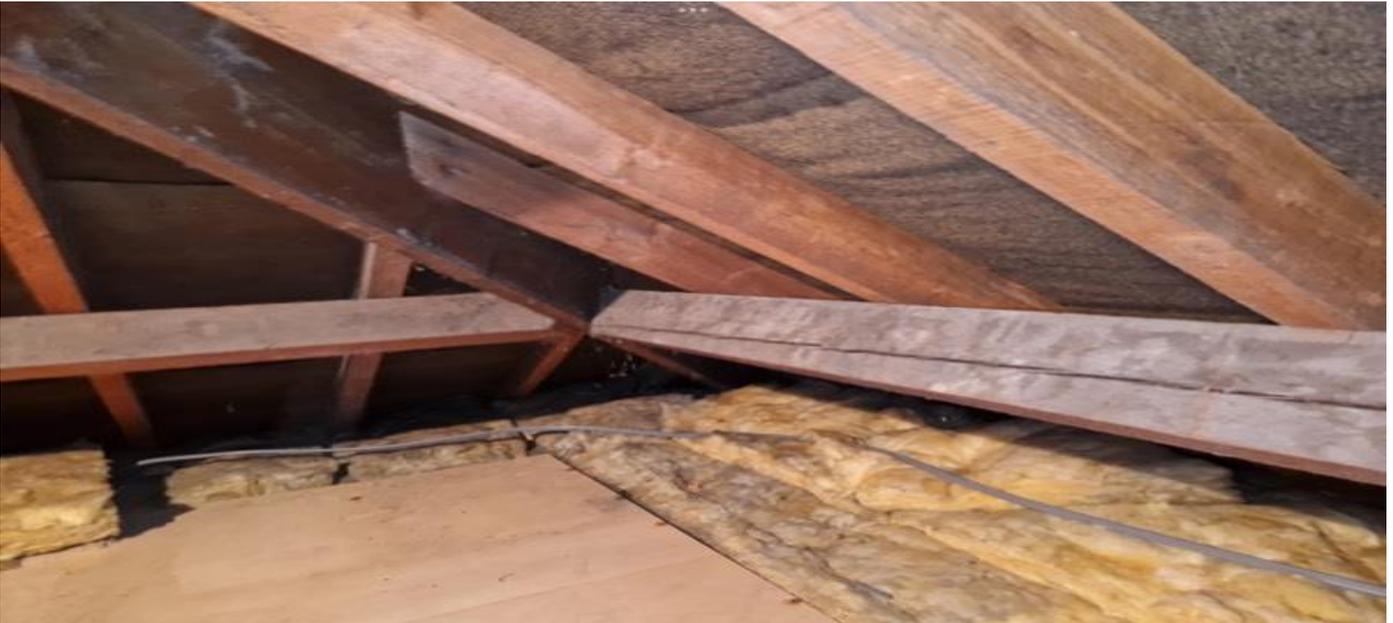
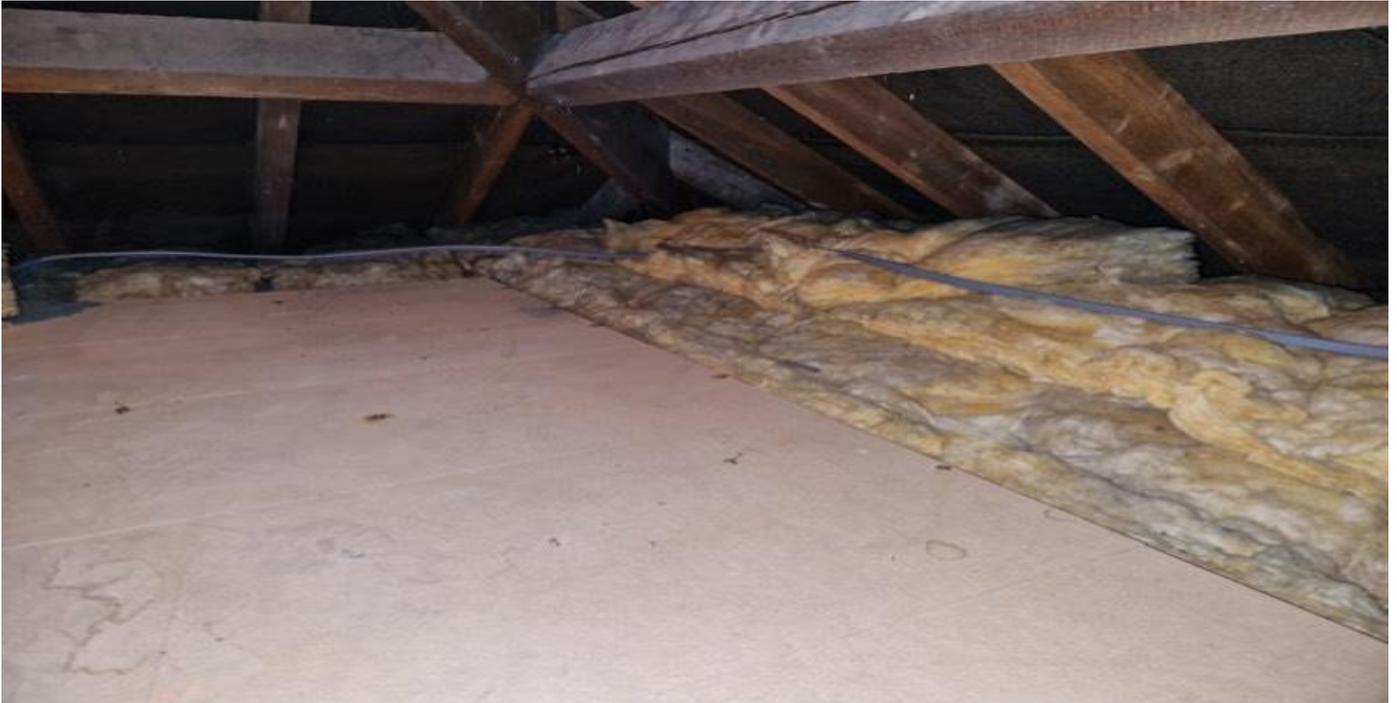
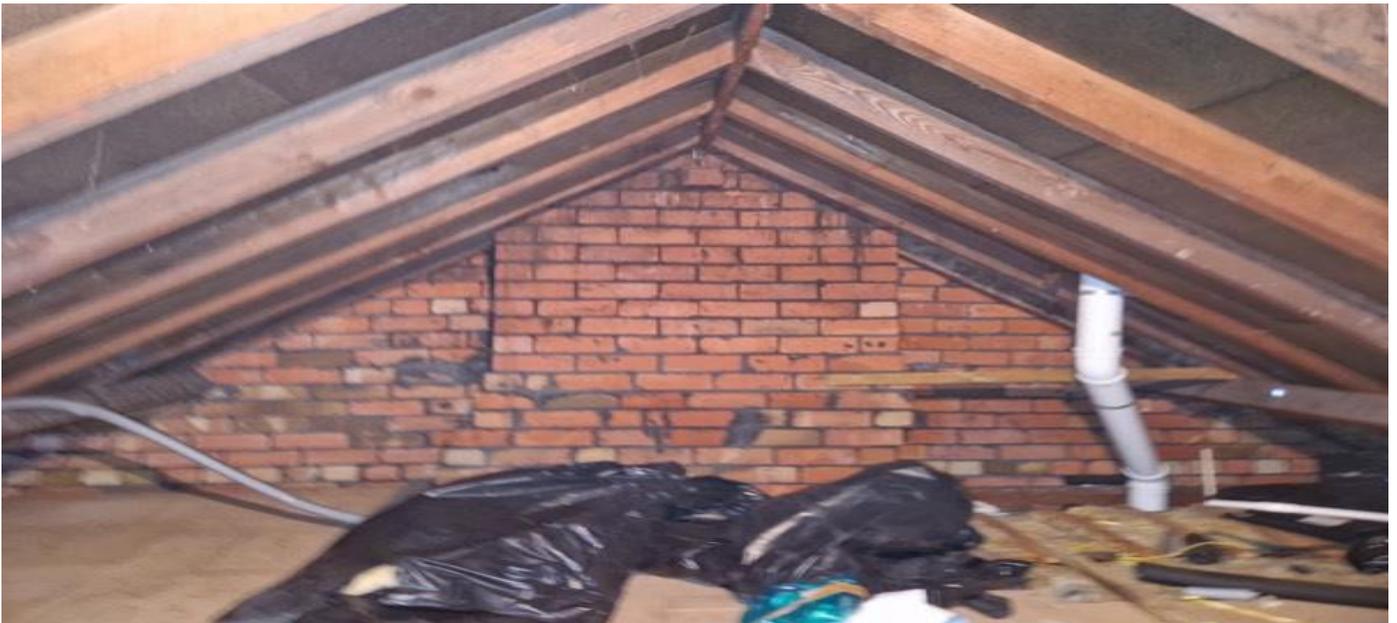
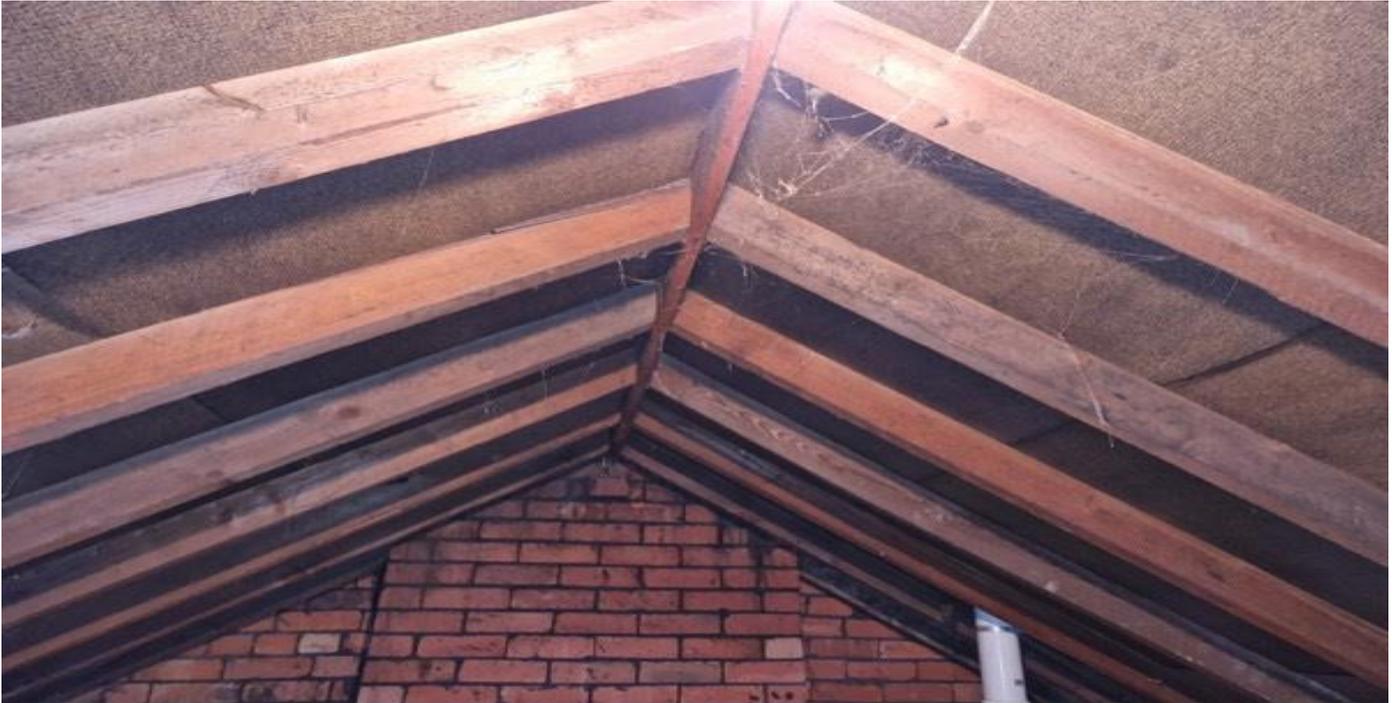
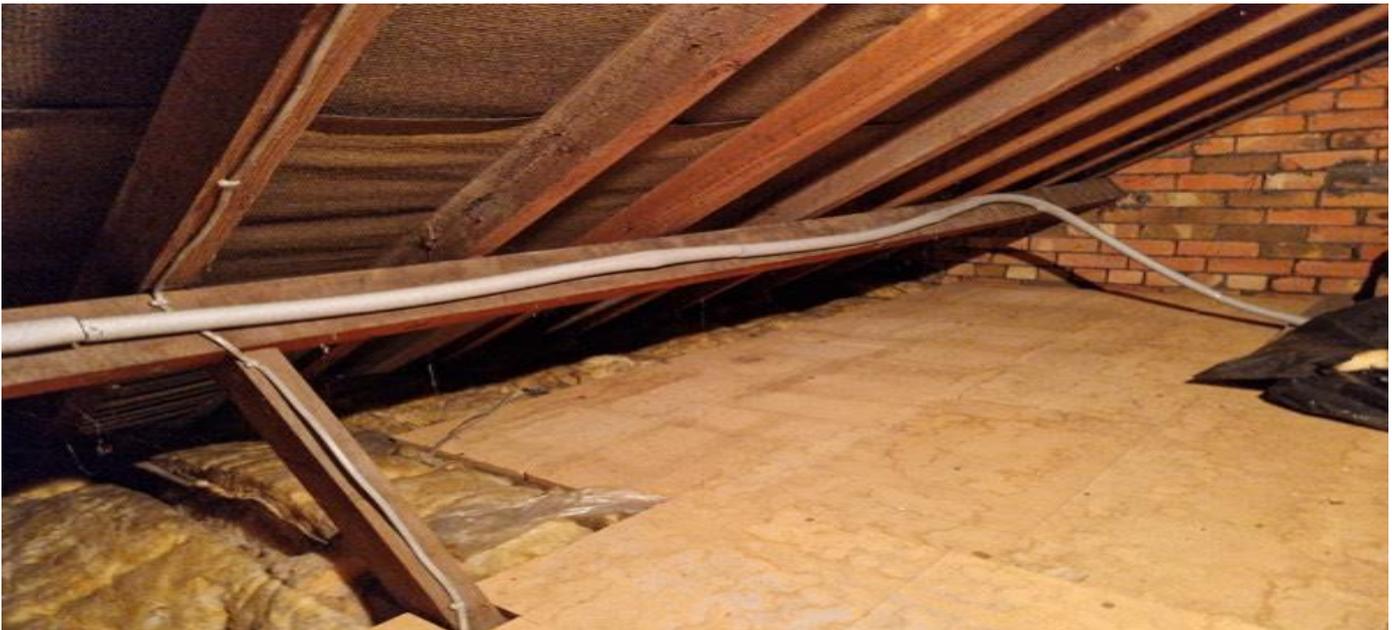
## Internal Loft Space

- The roof slopes are generally even. Where they are undulating, this is on a small scale and there is no immediate evidence to suggest the distortion will get worse. Most of the structural members are adequately sized. Any struts and other supports are taken to load bearing walls. The loft was found to be dry with no evidence of leaks.

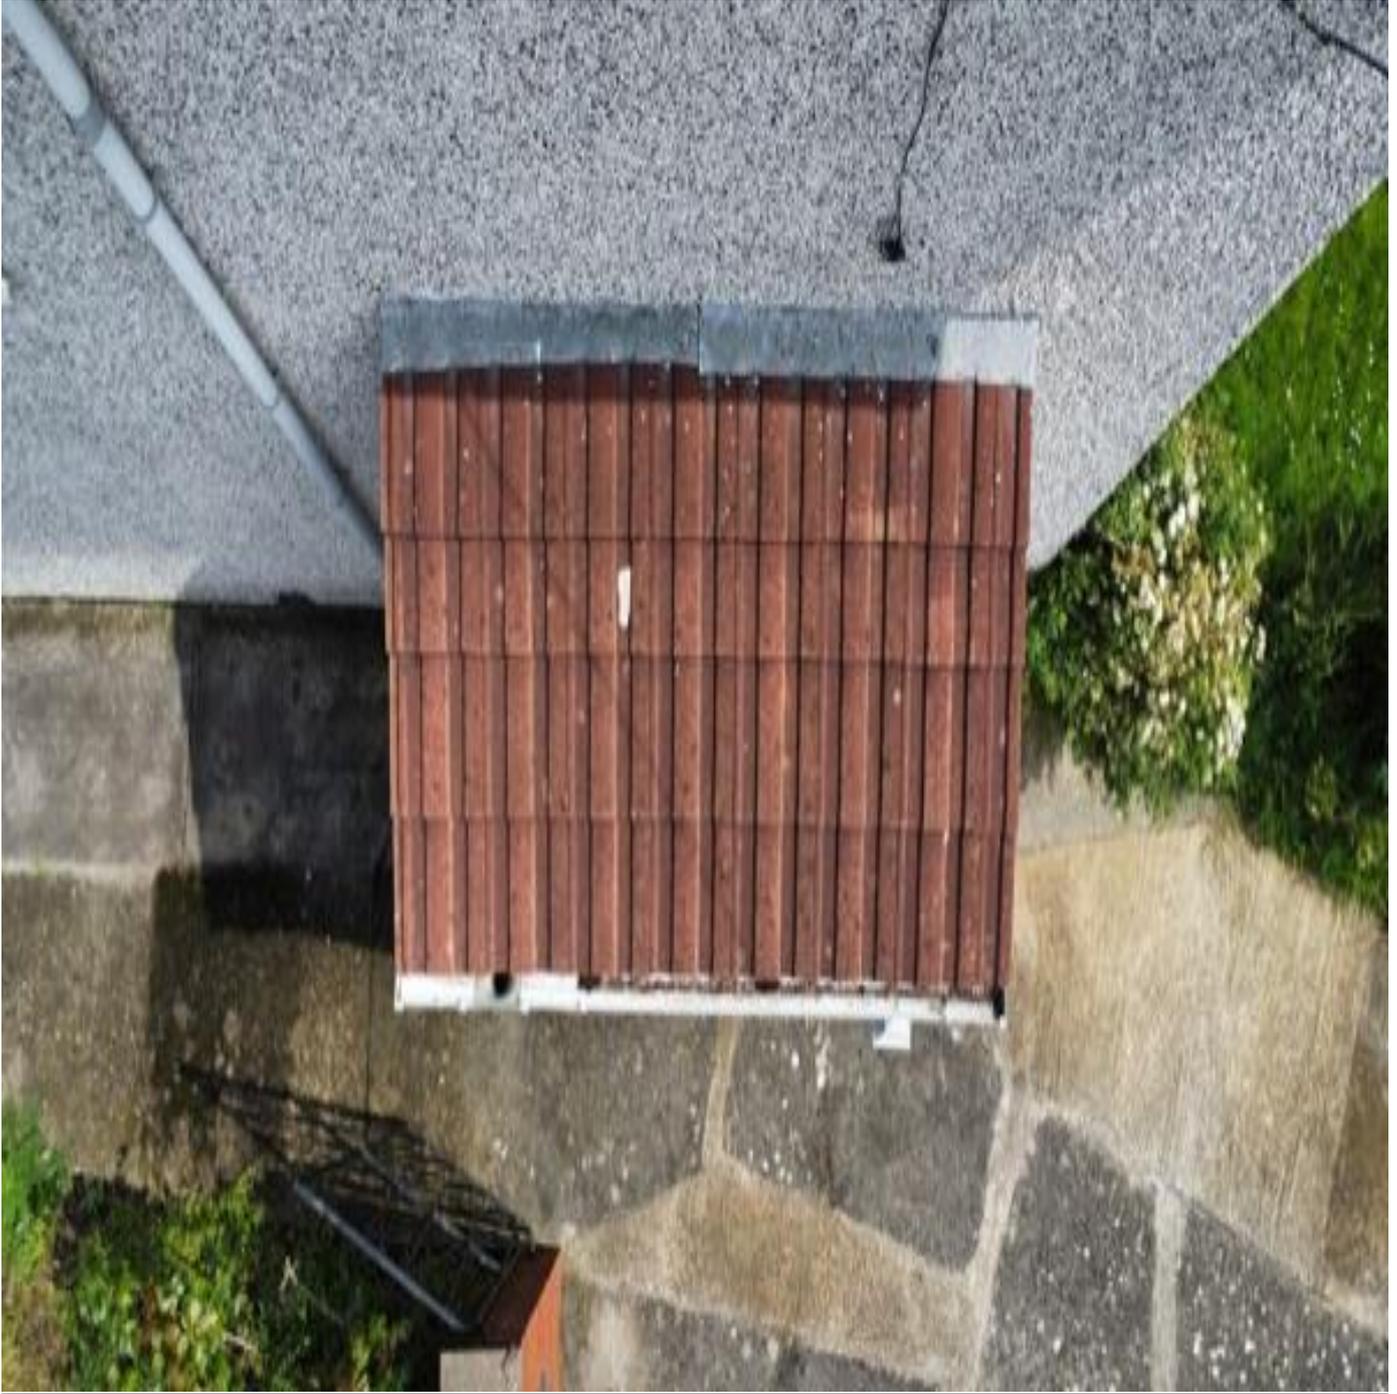
## Secondary Roof

- There is a secondary cut timber roof to the ground floor porch. This is a mono pitched roof with gabled finish with the same concrete interlocked roof coverings as the main roof. The roof was noted to be in satisfactory condition with no evidence internally to suggest issues with the waterproof values of the structure or 'know on' effects flowing slight spread of the main roof.

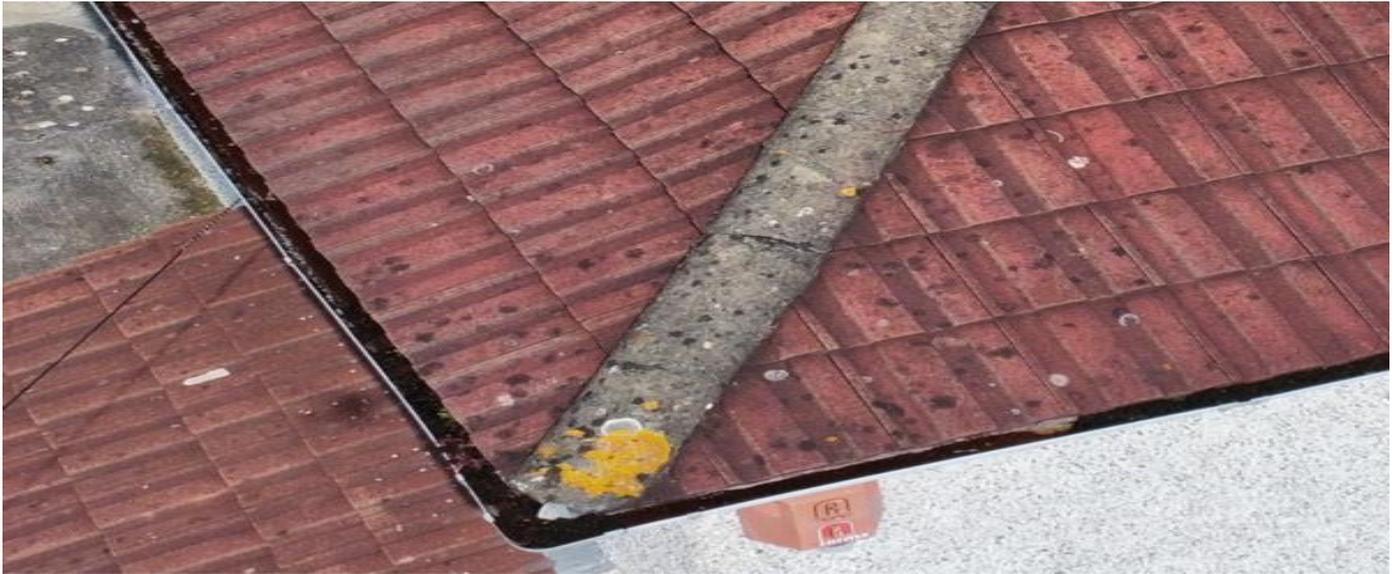
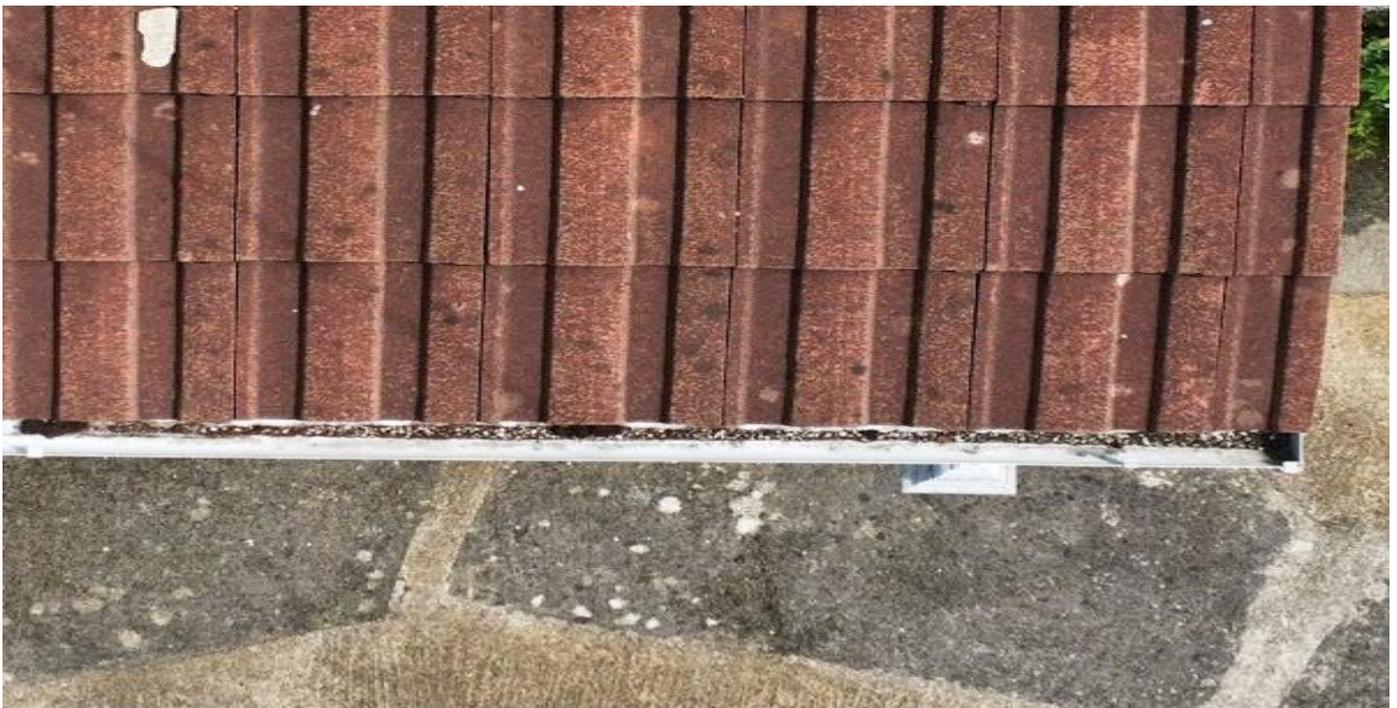
## Rainwater Goods

- Water is discharged from the roof via a PVCU gutter section rainwater system with outlet downpipes hold fast fixed to the external elevations.
- The gutter section rainwater system shows physical evidence of blockages with debris causing restrictions to the water flow leading to the rainwater outlets.
- Recommend these are cleared and repaired to prevent water penetration to the building.

- 1: Remove Vegetation Growth from Chimney Stack (See Main Roof)
- 2: Repoint defective ridge tiles and areas of missing mortar (See Main Roof)
- 3: Unblock gutters and ensure Rainwater Goods operate effectively (See RWG)
- 4: Repair hairline cracking around window reveals and poor render (render approaching the end of its lifespan, replacement should be considered). (See photos attached)
- 5: Windows are poorly installed due to depth of window reveals (consider replacing). (Photos attached)
