Client Name: XXX XXXXXXXXXX
Address: X XXX XXXXX
XXXXXXXX
XXXXX
XXX XXXX
Purpose of Report: STRUCTURAL BUILDING SURVEY
Report Reference: SBS|XXX|XXXX
Inspection Date: 0X MXX 20XX
Surveyor Name: XX XXXXX XXXXX BSc Hons, MCIQB, CSRT, CSSW, DipDEA, UKAS-P402/P405
Building Surveyor Engineer Name: XXXX XXXXXXXX BSc (Hons) C Build E, MCABE.

State of repair: Poor Condition

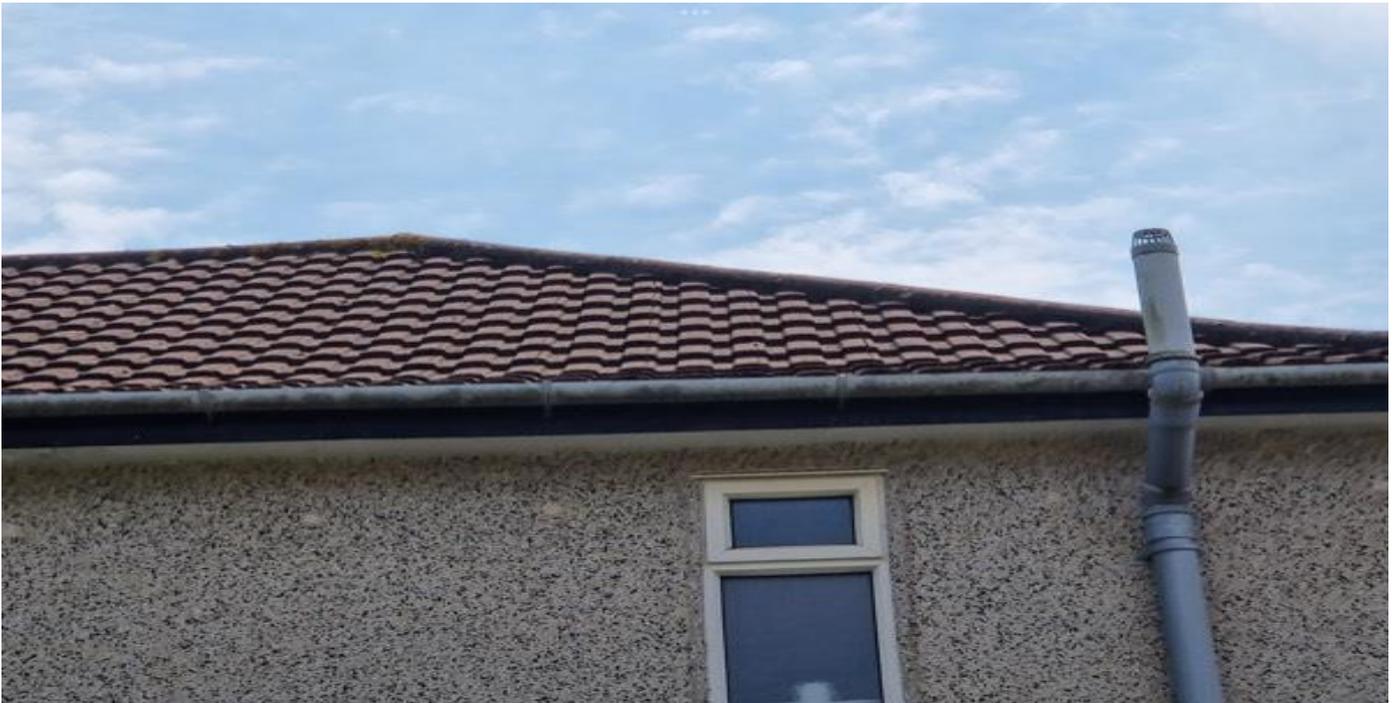
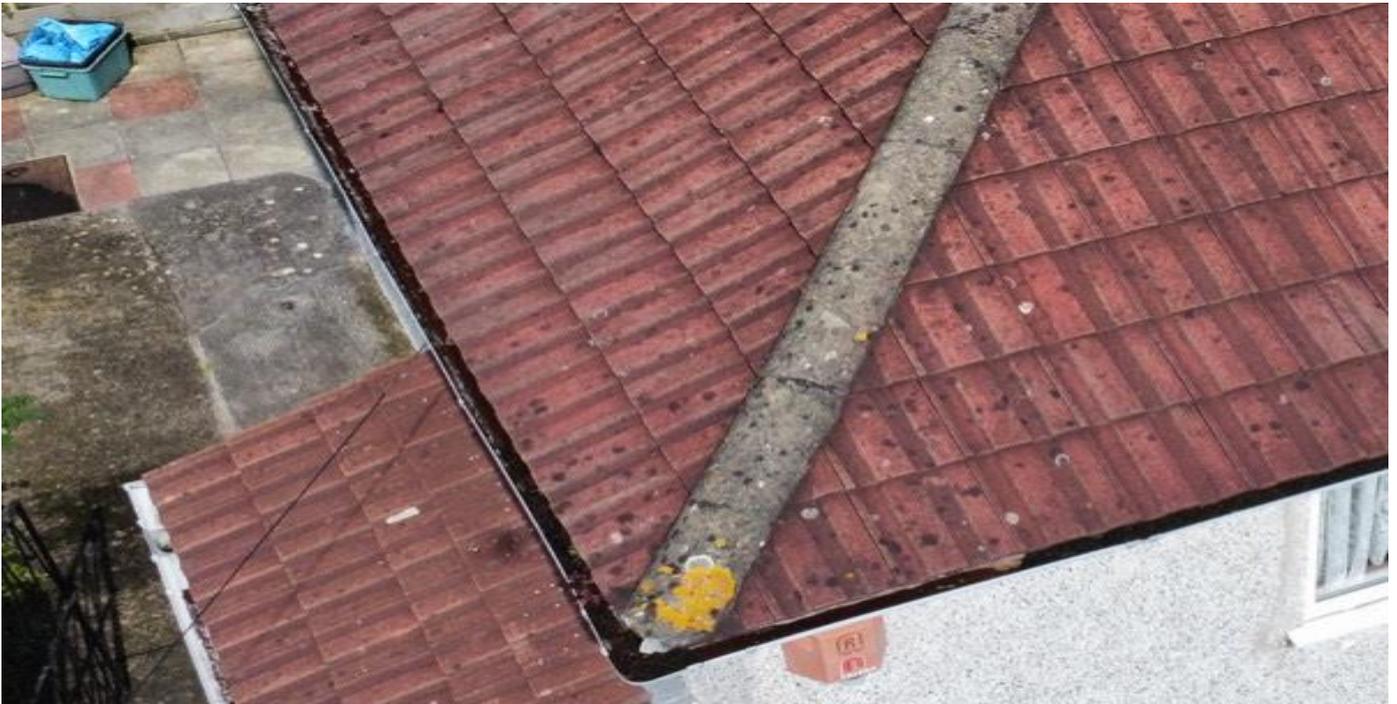
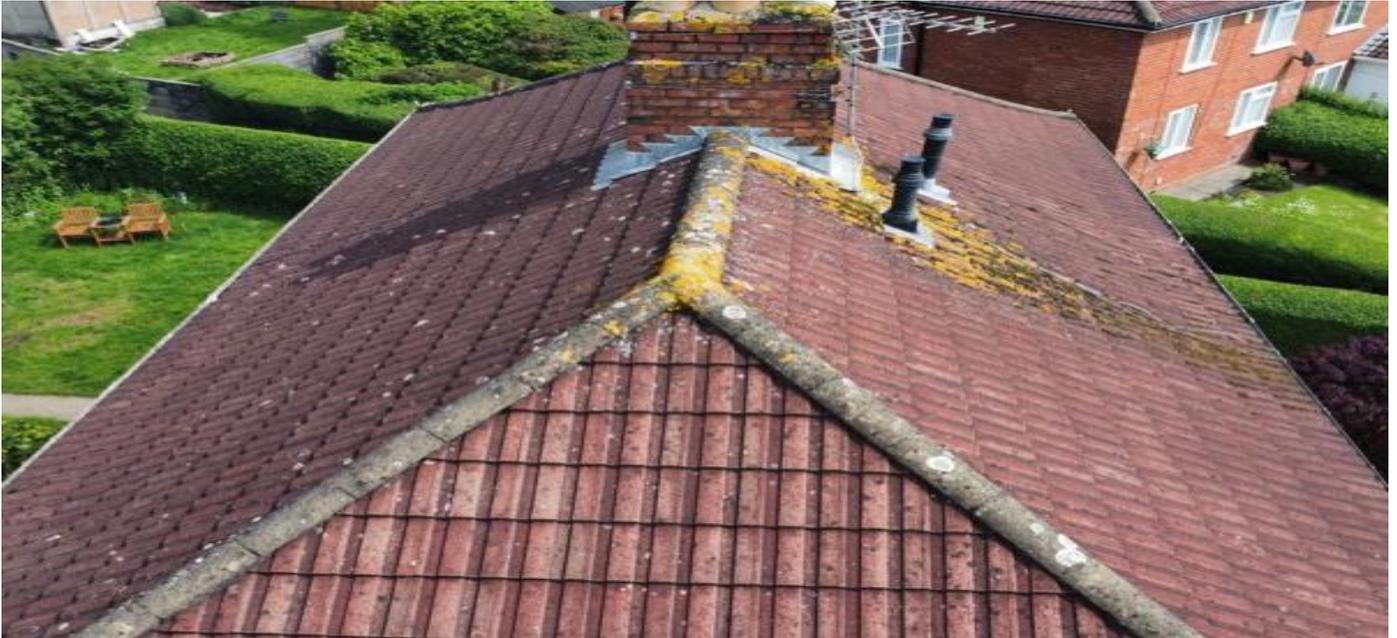
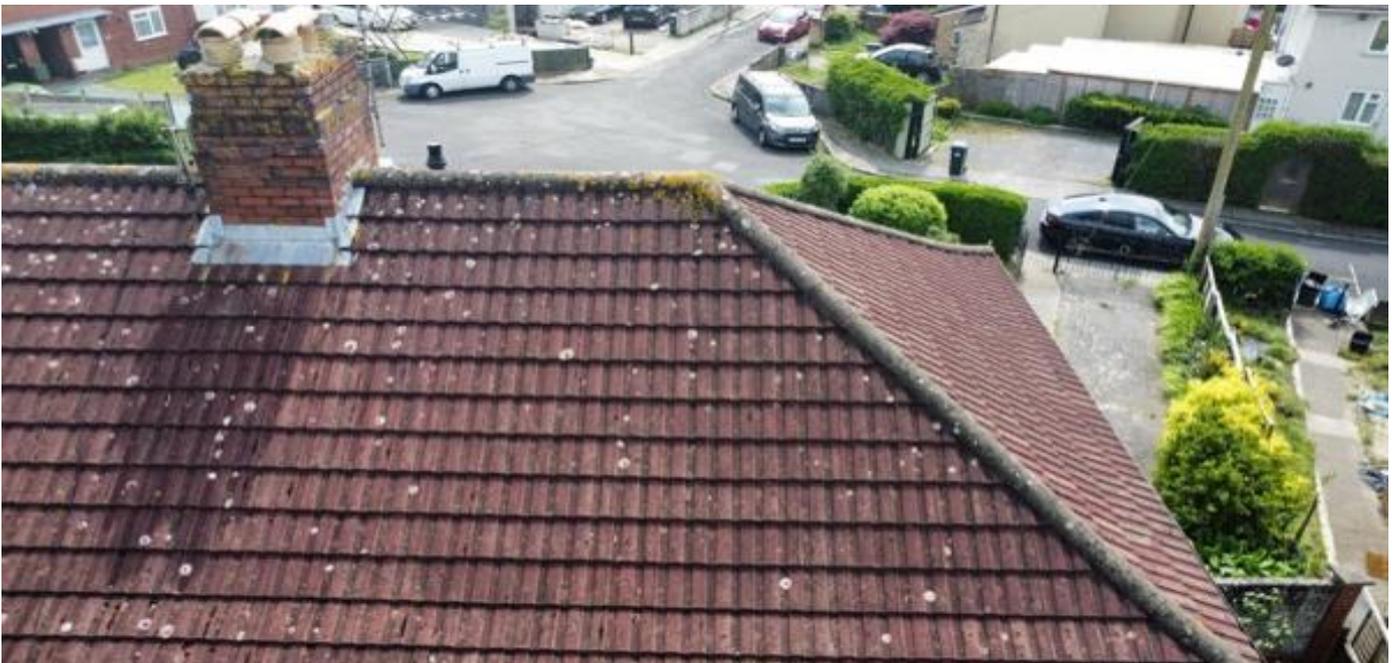
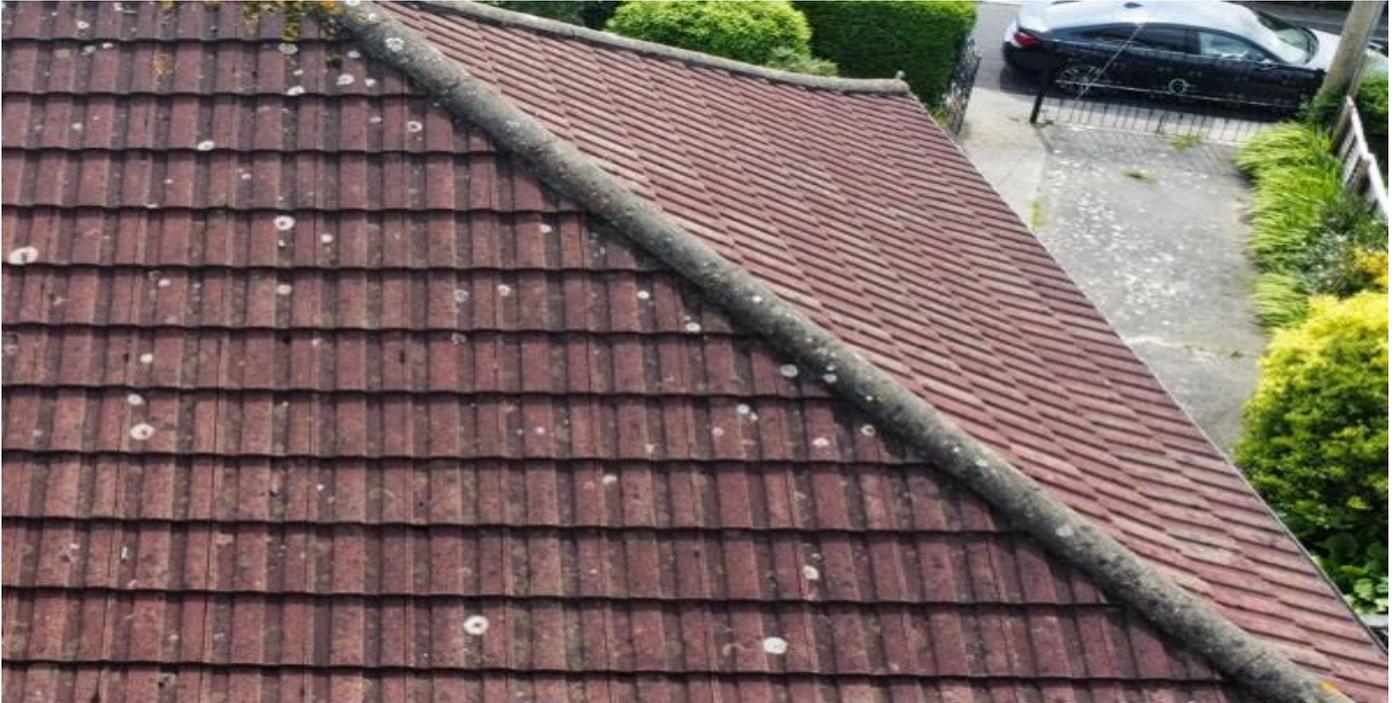
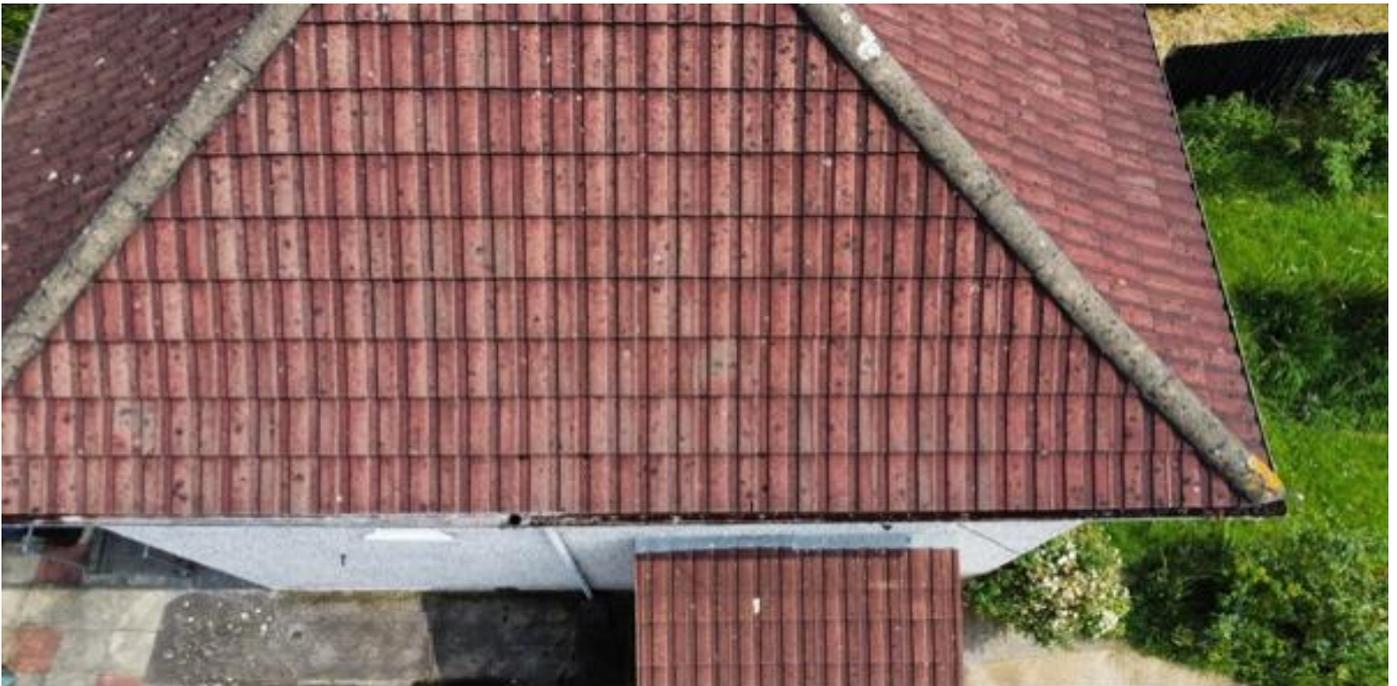
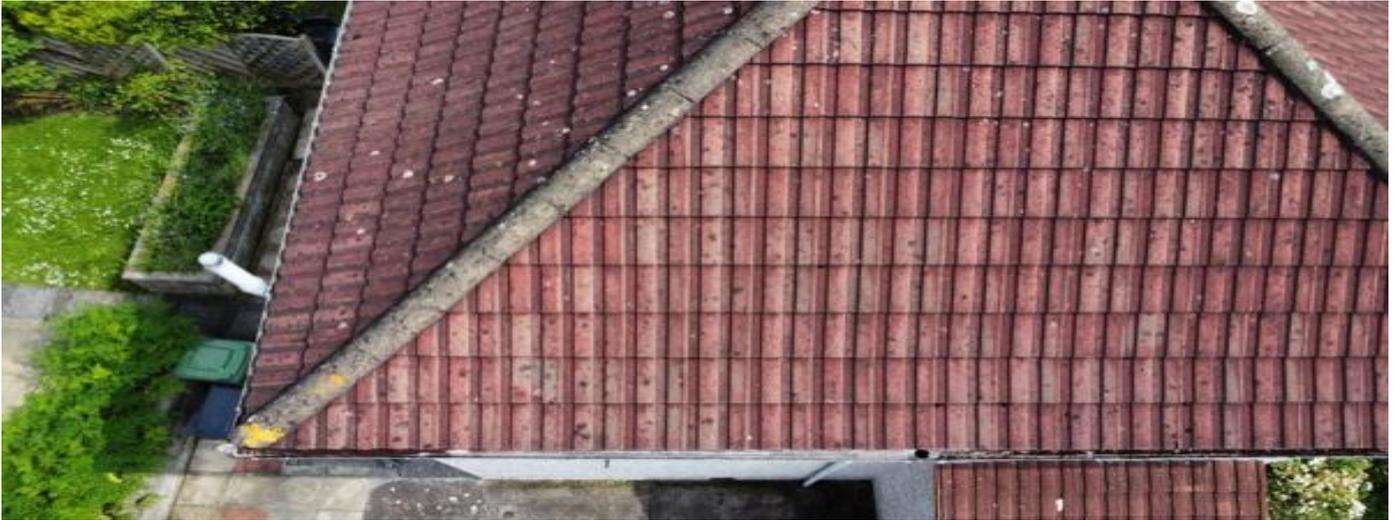
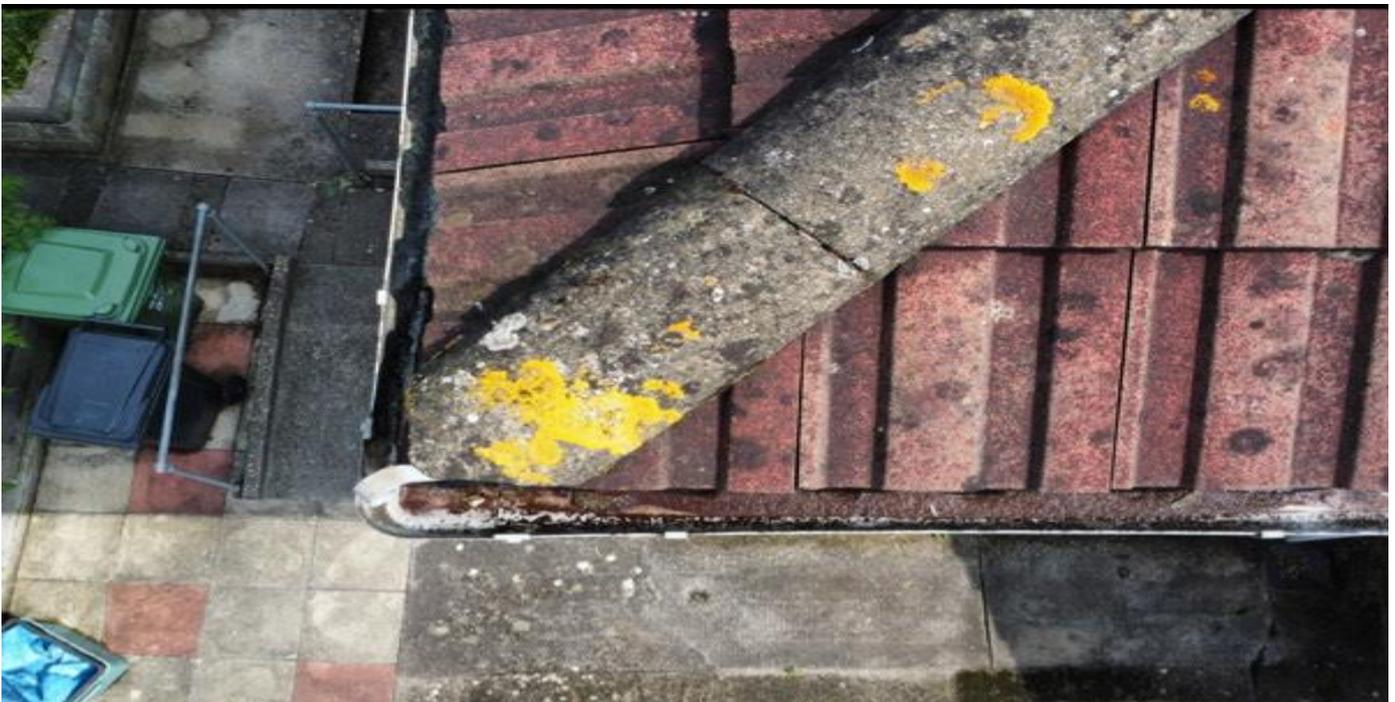
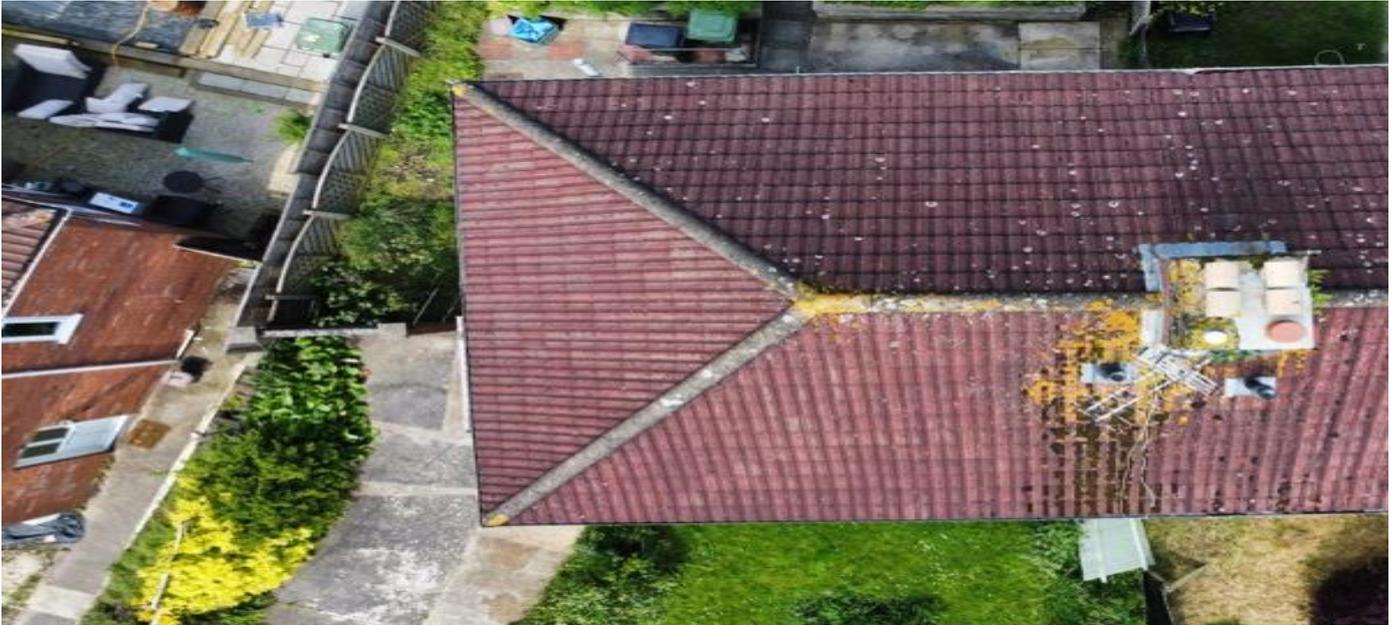
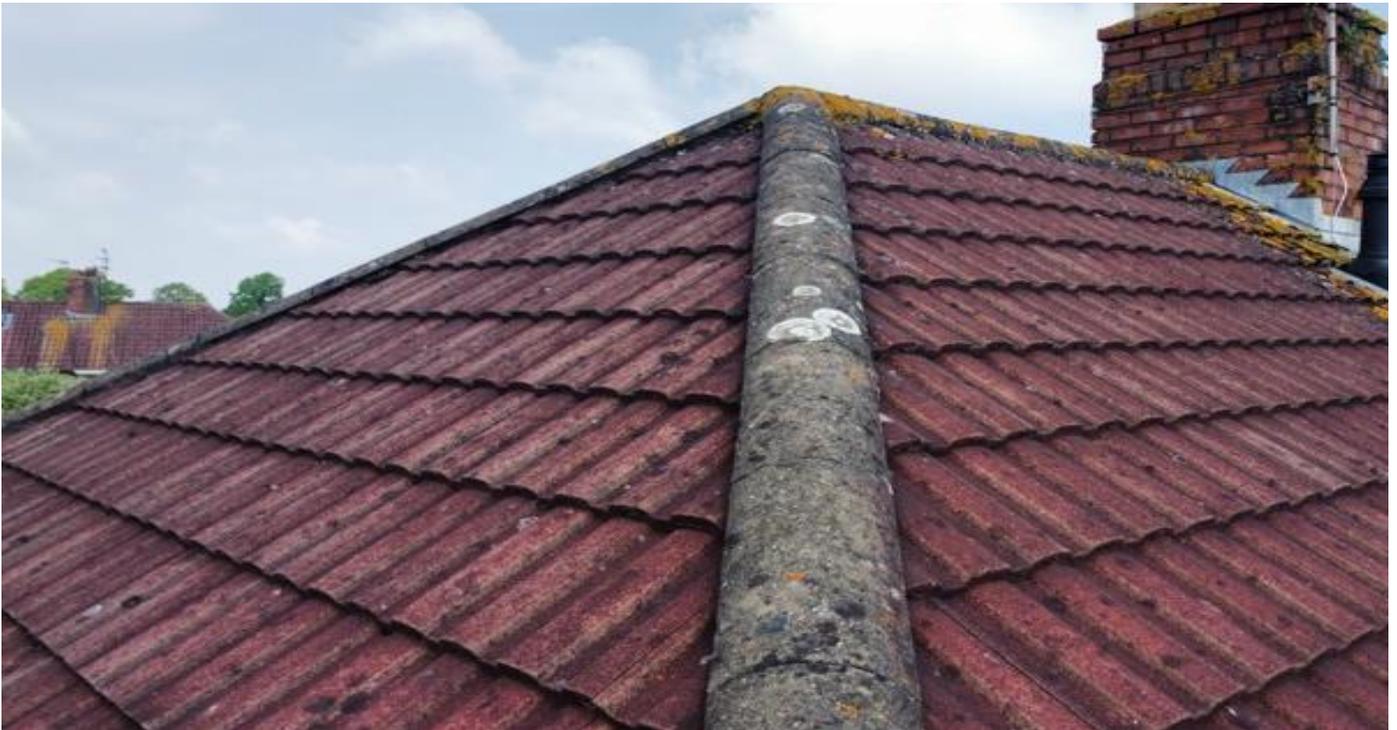
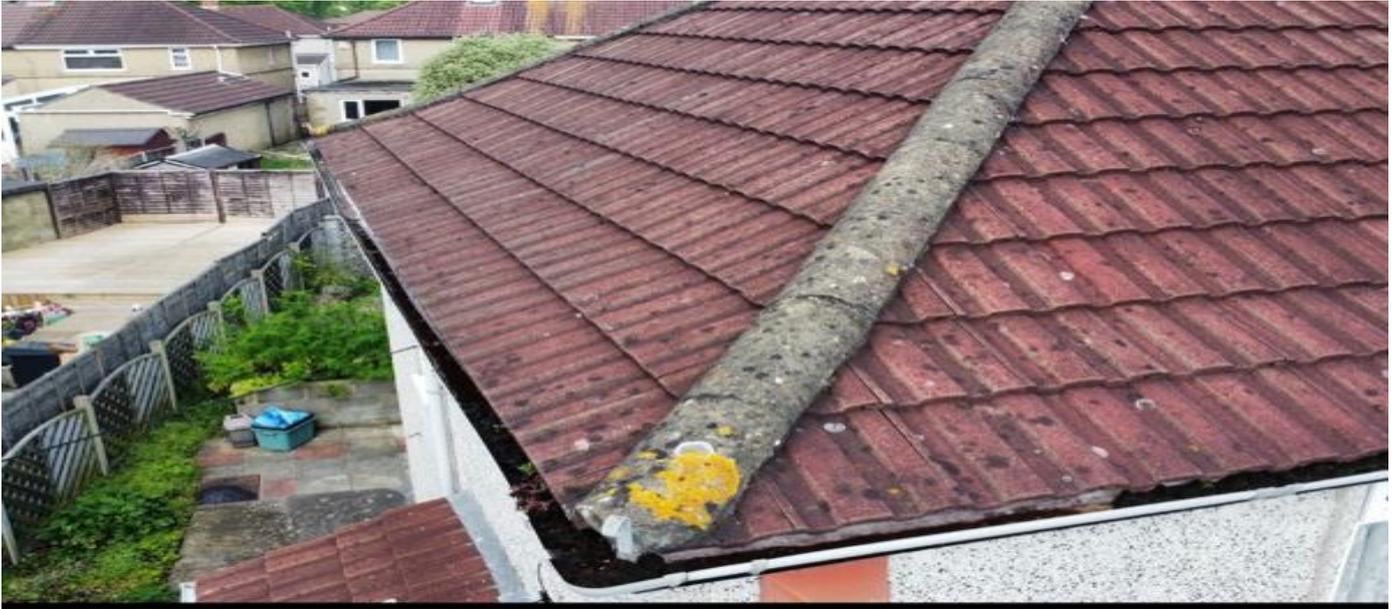
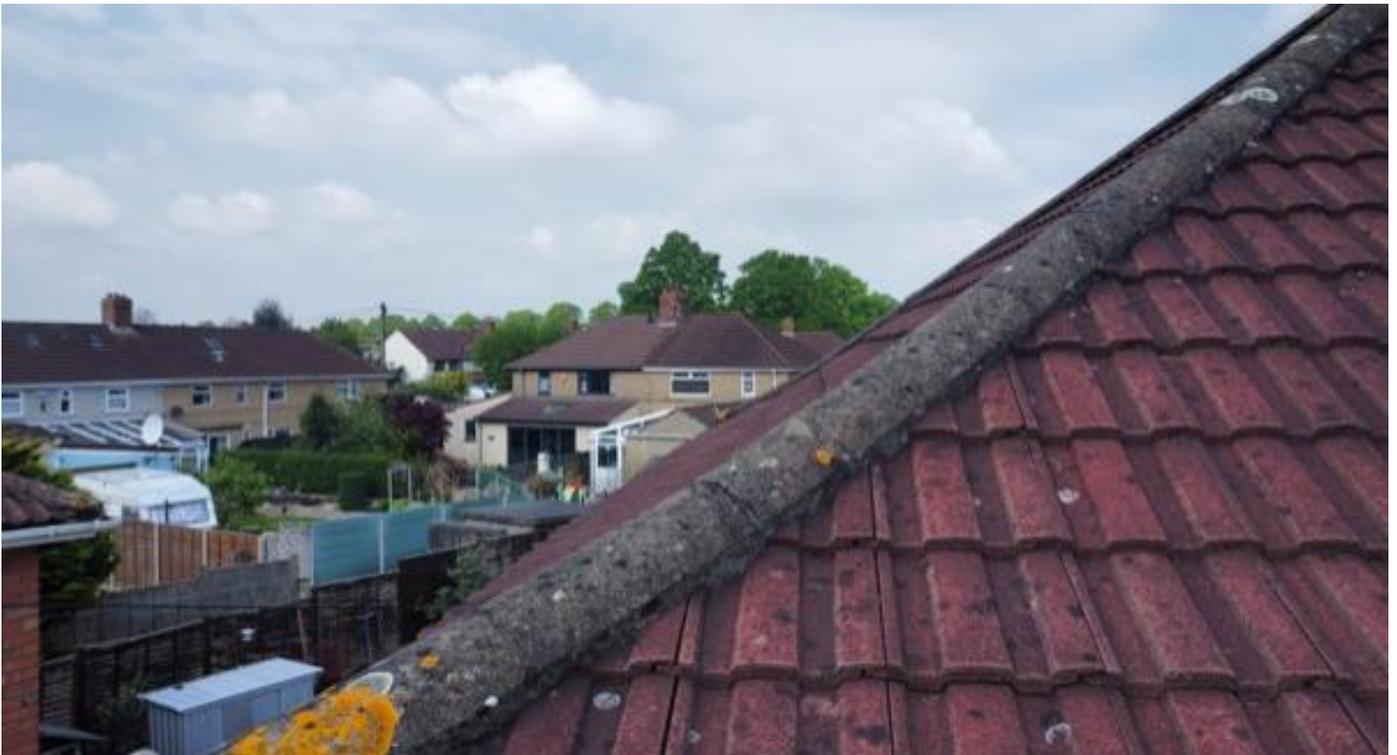
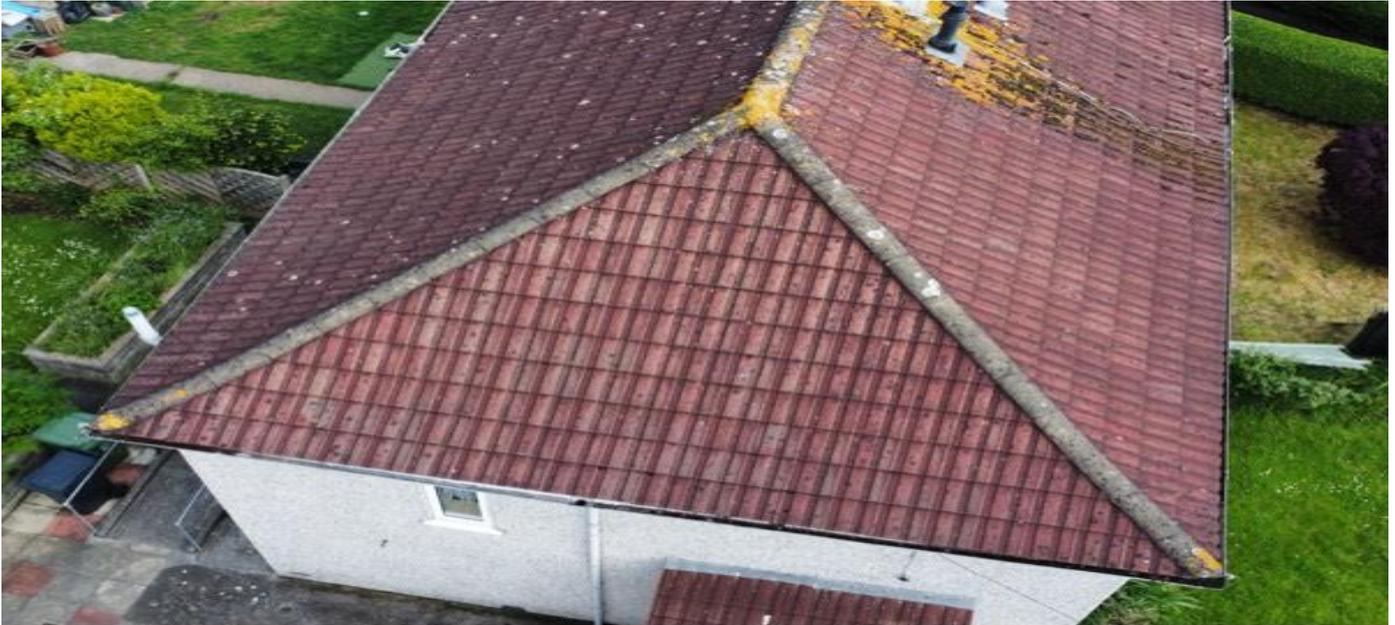
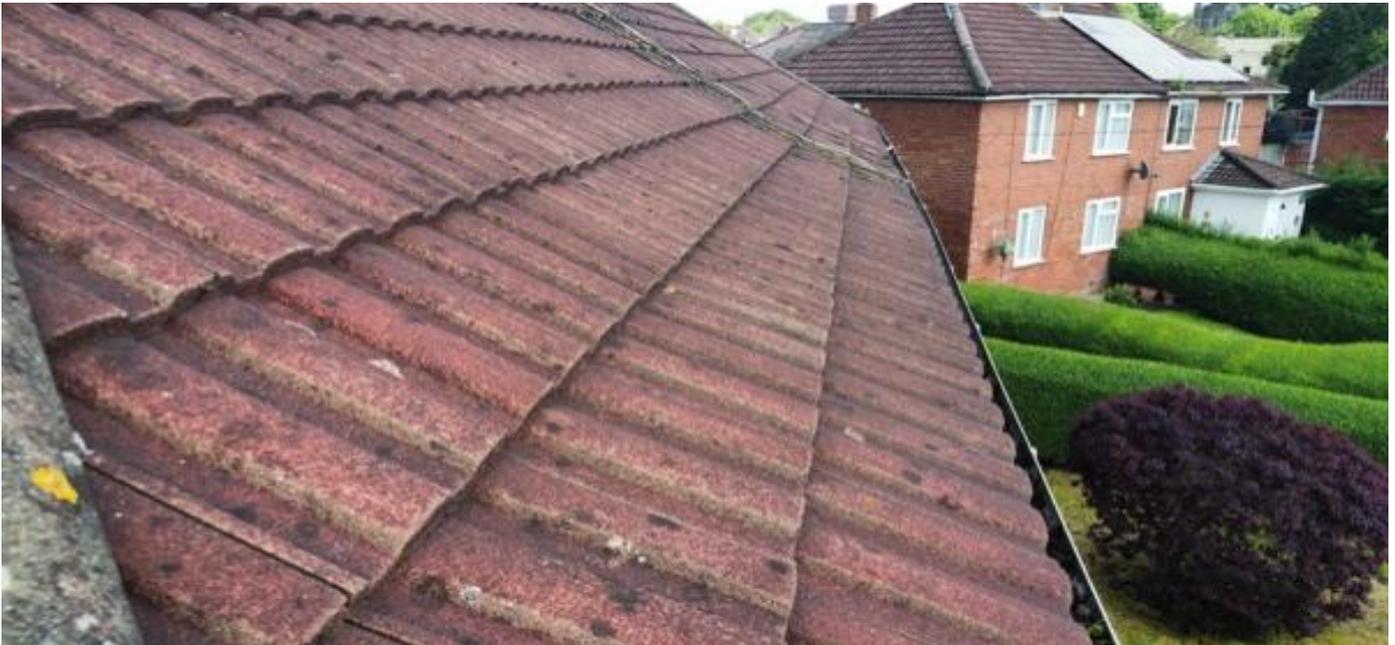
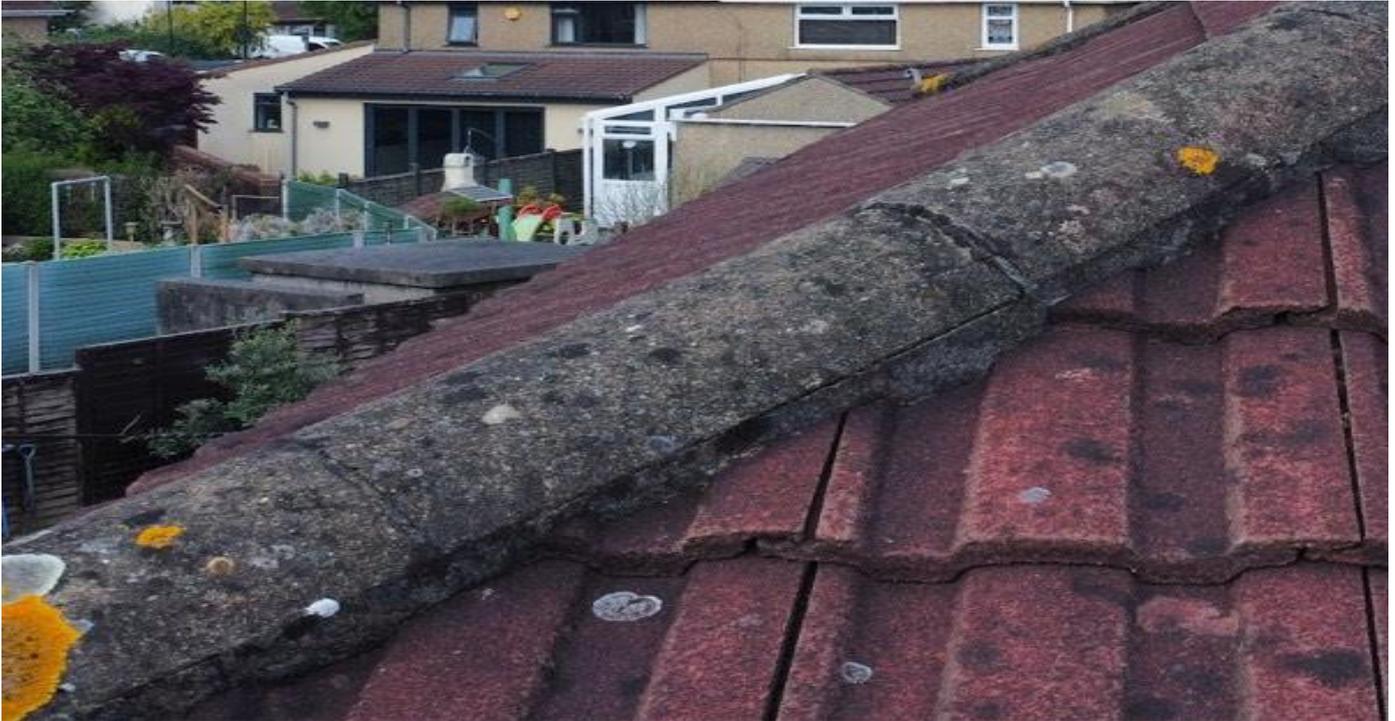
Main Roof

- The coverings are in satisfactory condition and consistent with age, and no damaged or slipped units noted. The ridge tiles appear to be well bedded with no immediate issues noted around the mortar joints.

- The stack is in poor condition with vegetation growth noted to front, side, and rear. There have been remedial repairs carried out to the neighboring side.

- 1: Remove Vegetation Growth from Chimney Stack (See Main Roof)
- 2: Repoint defective ridge tiles and areas of missing mortar (See Main Roof)
- 3: Unblock gutters and ensure Rainwater Goods operate effectively (See RWG)
- 4: Repair hairline cracking around window reveals and poor render (render approaching the end of its lifespan, replacement should be considered). (See photos attached)
- 5: Windows are poorly installed due to depth of window reveals (consider replacing). (Photos attached)

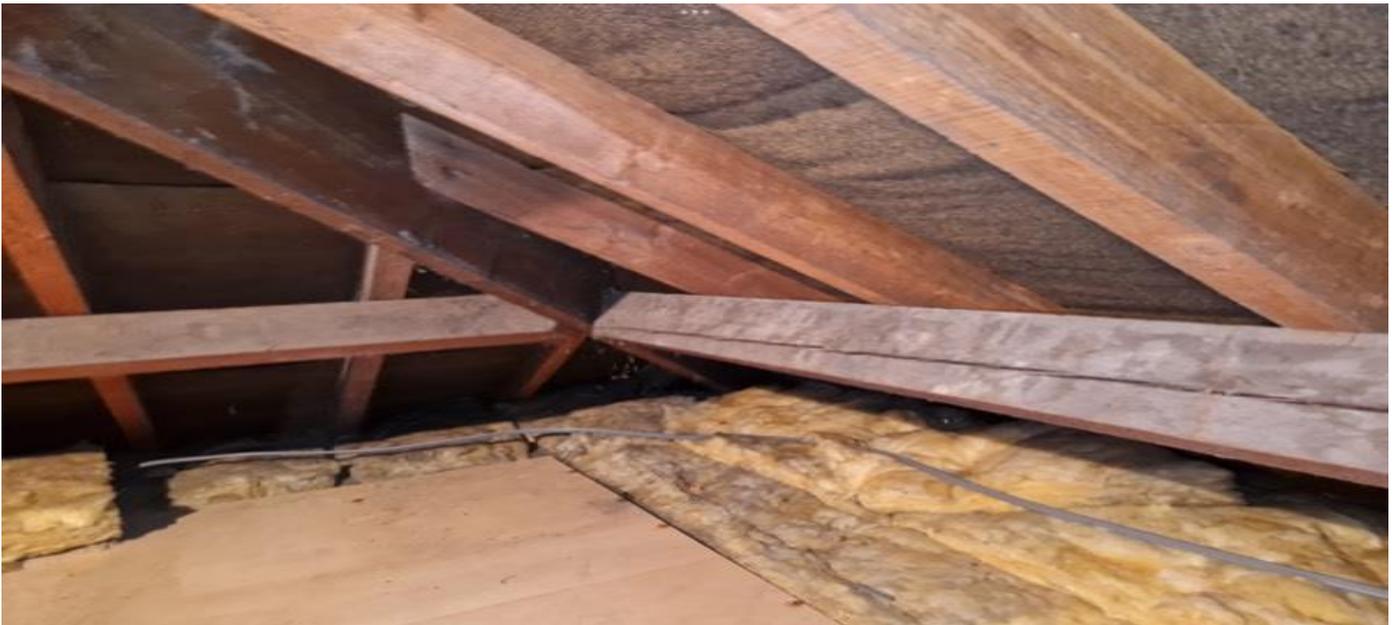
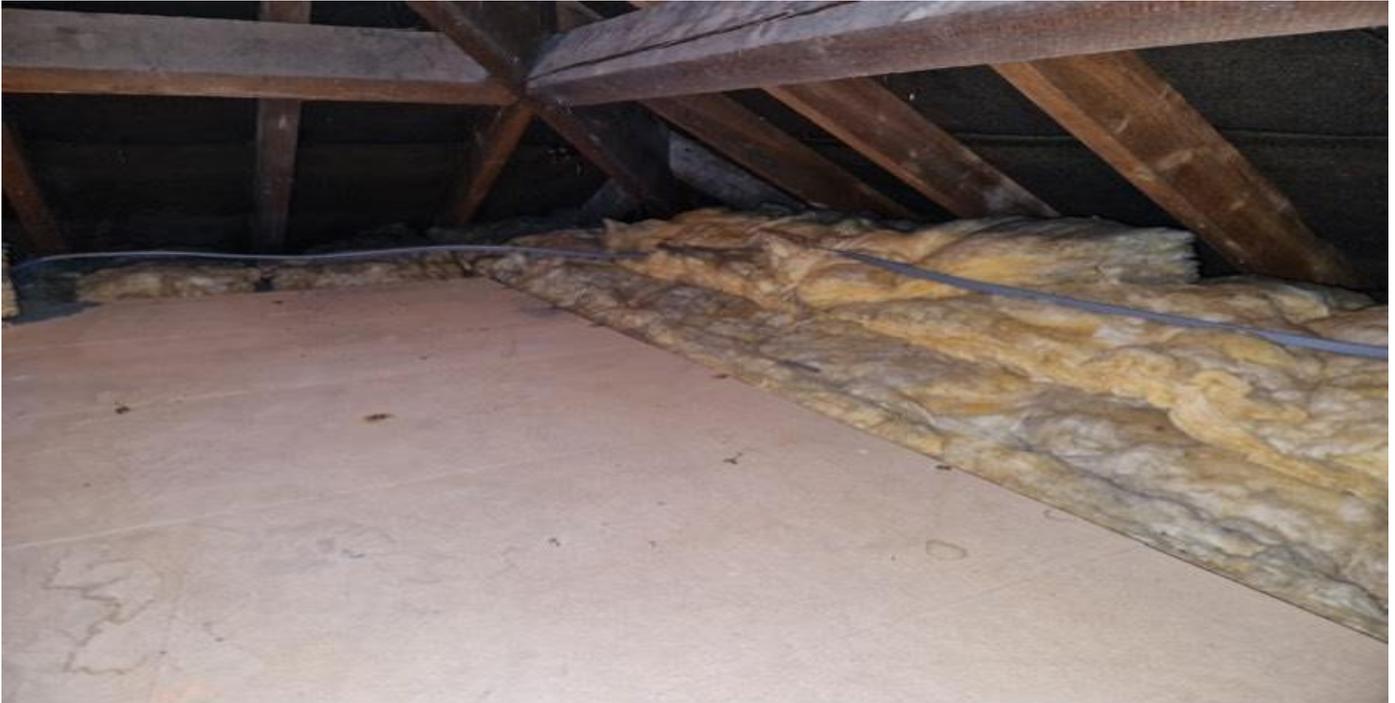
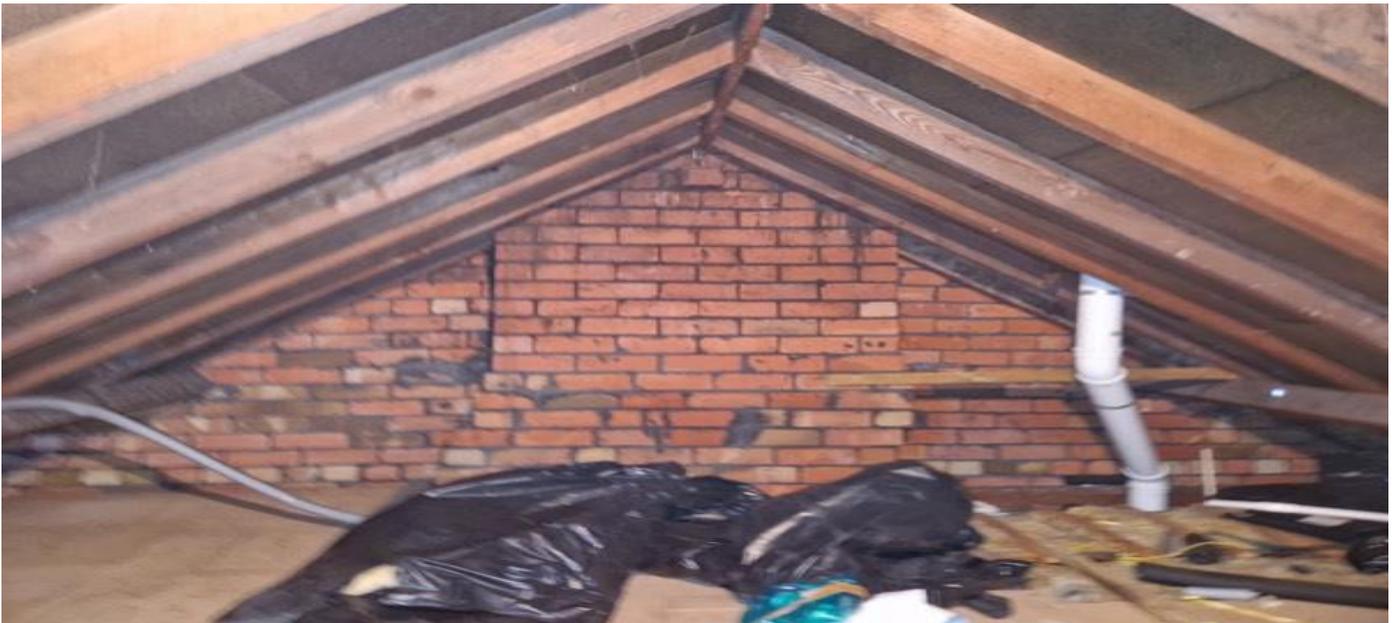
Internal Loft Space

- Internally, there is little evidence of weakening of the timber structure, principally the only indication of roof spread is from horizontal cracks or 'shakes' to one of the purlins. This could also be historic and would be difficult to ascertain as the other timbers appear sound. The roof structure was found to be generally sound with only slight deflection on the underside of the original timber rafters which appears to be within tolerable limits.

- The roof slopes are generally even. Where they are undulating, this is on a small scale and there is no immediate evidence to suggest the distortion will get worse. Most of the structural members are adequately sized. Any struts and other supports are taken to load bearing walls. The loft was found to be dry with no evidence of leaks.

- Due to the cracking beneath to many of the wall and ceiling junctions however, it is recommended that strengthening of the roof is undertaken.

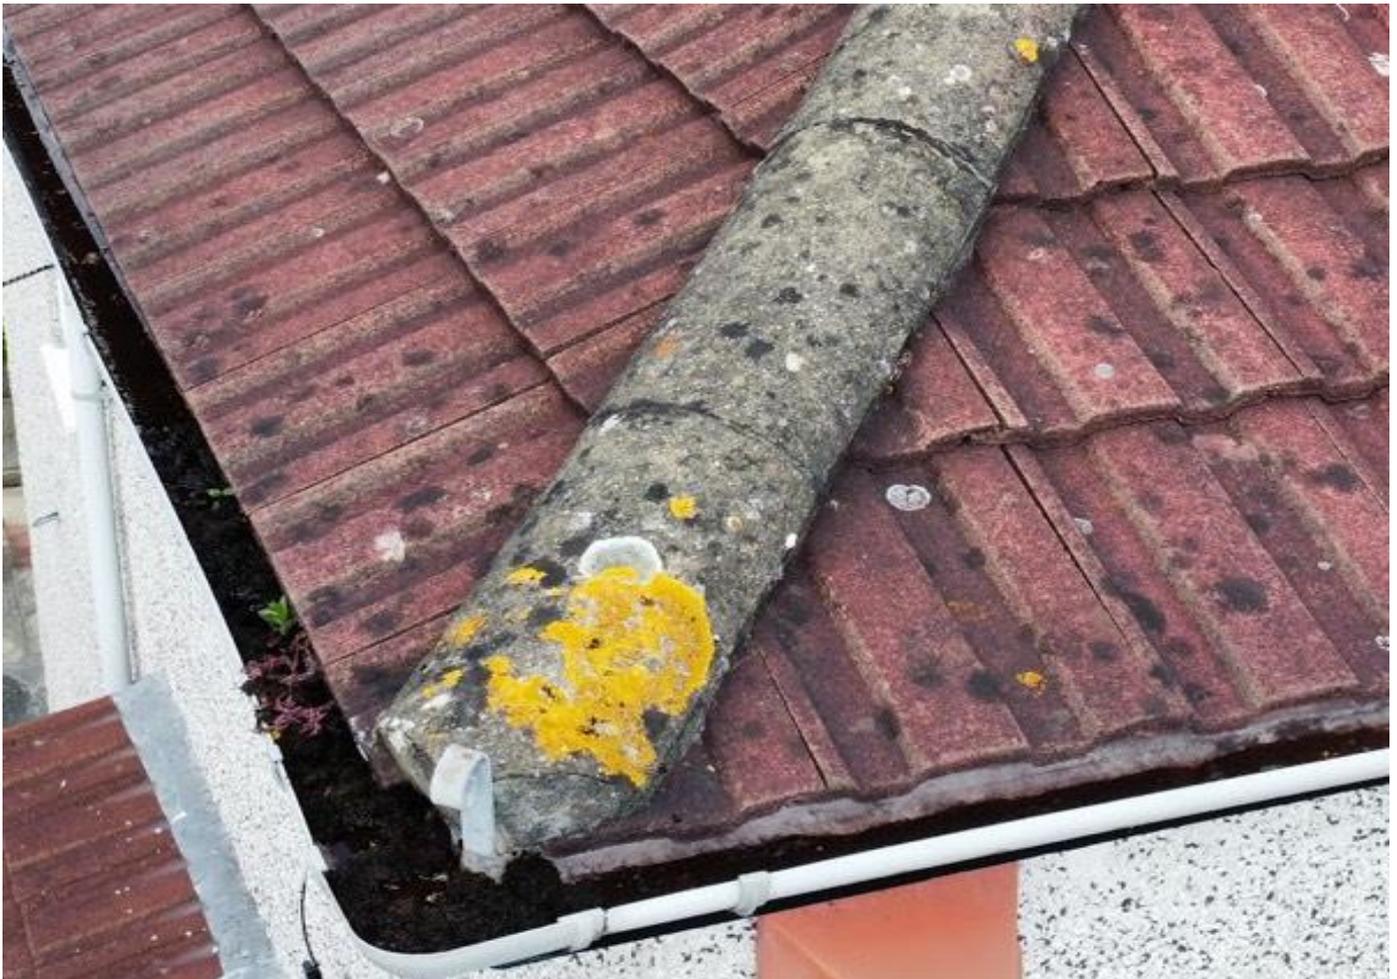
Rainwater Goods

- Water is discharged from the roof via a PVCU gutter section rainwater system with outlet downpipes hold fast fixed to the external elevations.
- The gutter section rainwater system shows physical evidence of blockages with debris causing restrictions to the water flow leading to the rainwater outlets.
- Recommend these are cleared and repaired to prevent water penetration to the building.

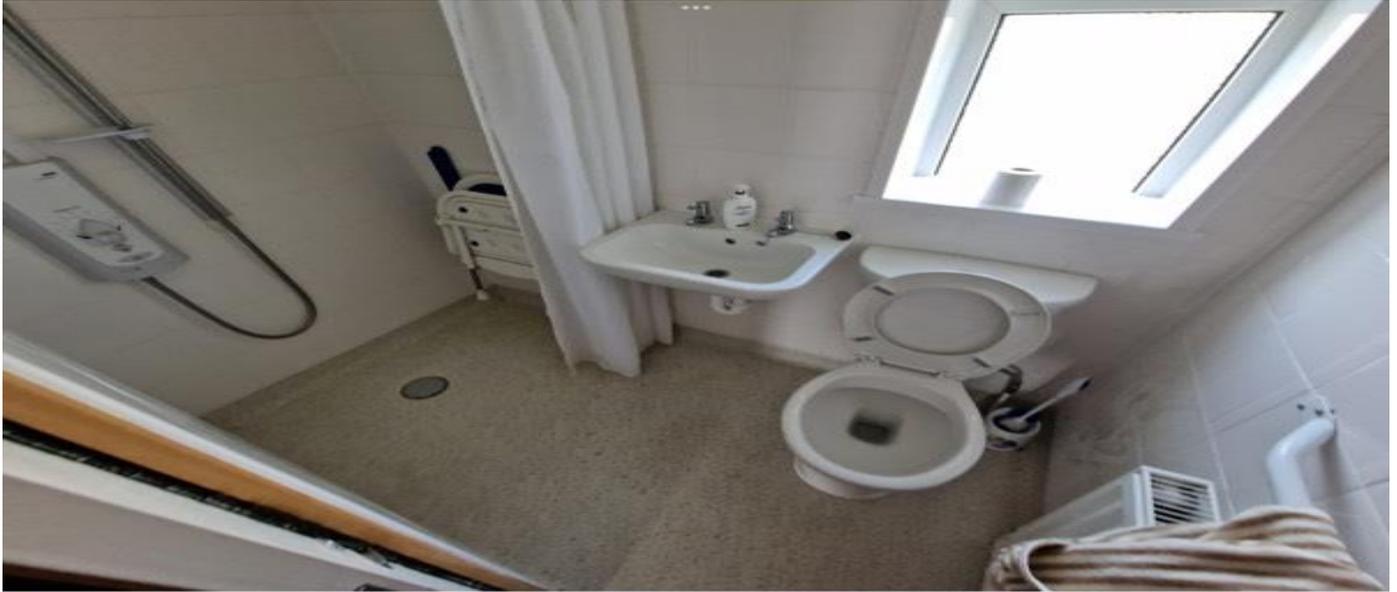
General Internal Condition

- These comprised of simple type papered and painted wall surfaces and gloss painted wood work, all found to be in an average condition consistent with age in need of modernisation.
