PROPERTY SURVEY

Client Name: XXX XXXXX XXXXX
Address: XX XXXXX XXXXXX
XXXXXX XXXXXX
XXXXXX
XX7 0XX
Purpose of Report: STRUCTURAL BUILDING SURVEY
Report Reference: SBS/XXX/2022
Inspection Date: 16 May 2022
Surveyor Name: XXXXX XXXXX BSc (Hons), ASSOC RICS, BCI, CII, BDMA
Building Surveyor Engineer Name: XXXX XXXX BSc (Hons) C Build E, MCABE.

- The property inspected was a farm located on a large plot of open fields of a country road and comprised of two main buildings to include a large stone-built building and a good-sized stone built detached bungalow within the grounds. The main building was found to comprise of a traditionally constructed stone-built structure which had a timber roof with a network of trusses and purlins and rafters supported on load-bearing walls. The roof has been covered with a natural slate roof covering and had a segmented decorative ridge tiles to the ridge line. There were several additions to the main building including a dormer projection at the front, a two-story extension at the front and a glazed conservatory at the rear.

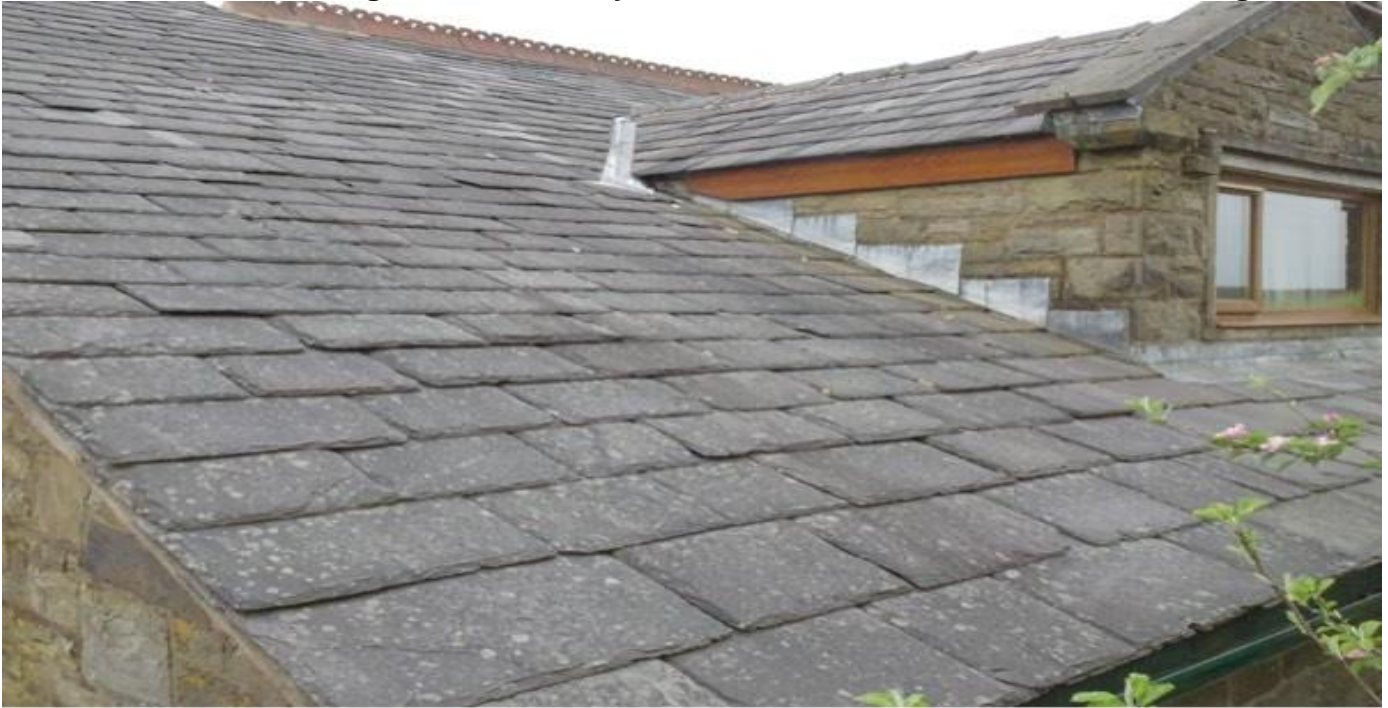
View of the roof covering to the two story addition at the front of the main building.
