Roof Survey

Client Name: XXXXX XXXXXXXX
Address: XX XXXXX XXXXXXX
XXXXXXXXXX
XXX XXX
Purpose of Report: ROOF CONDITION SURVEY (Part 35 Compliant)
Report Reference: RCS/XXX/20XX
Inspection Date: 0X May 20XX
Surveyor Name: XXXXX XXXXXXX BSc, (Hons) MCIQB, CSRT, CSSW, DipDEA, UKAS-P402/P405

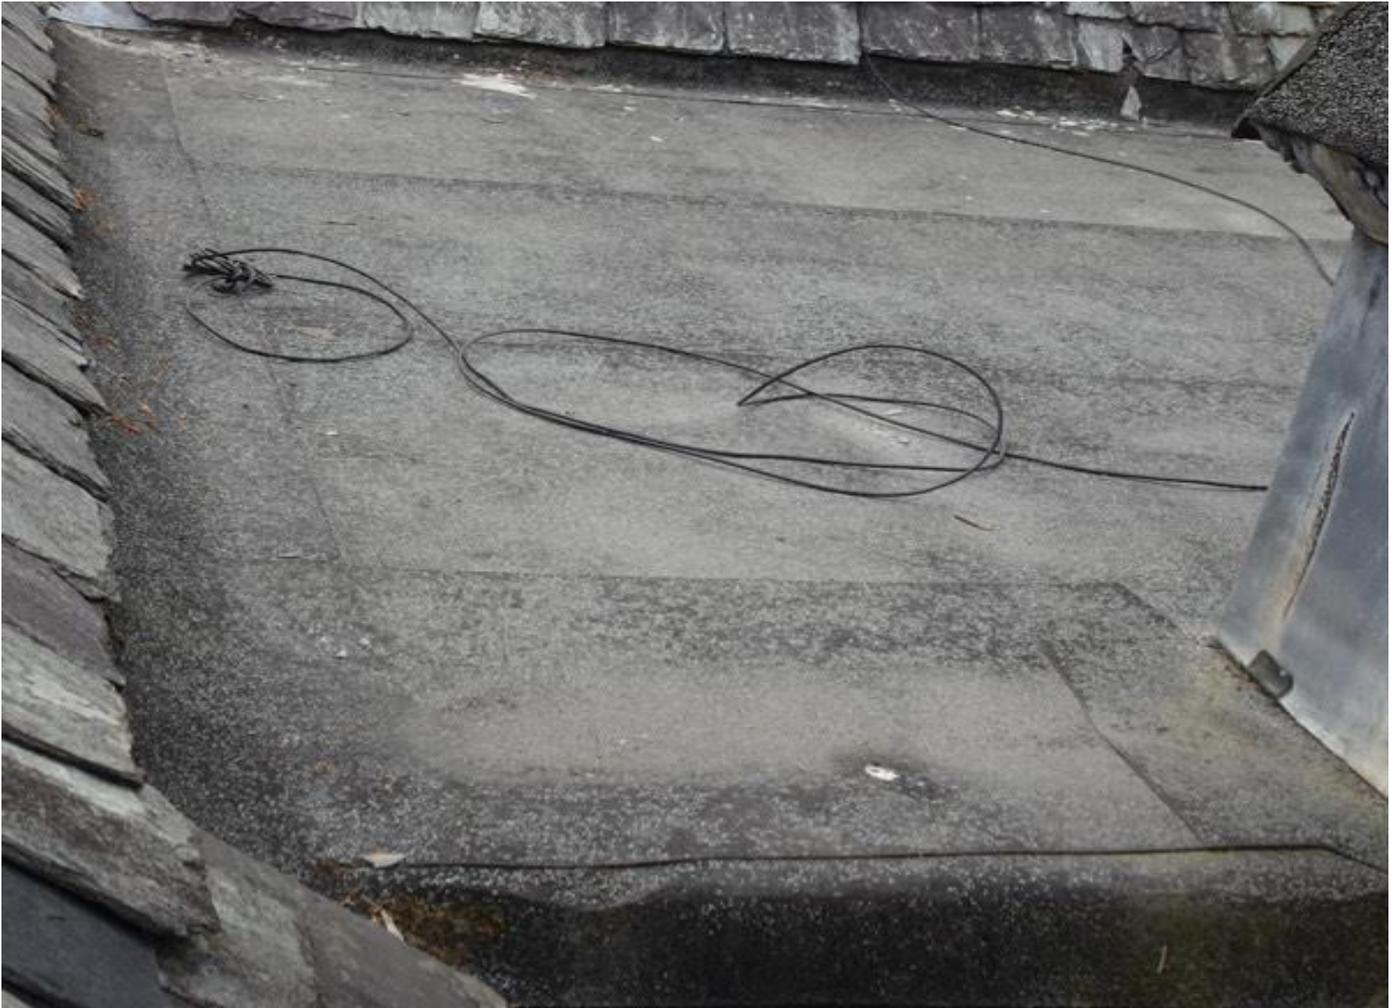
Felt roof area

- The felt flat roof areas showed no physical defects adversely affecting the water proof values of the roof coverings at the time of the inspection, inspection did reveal that a section of abutment flashing appeared loose or insecure fixed which may lead to a degree of water penetration.
- Recommend the flashings are repaired in the short term with consideration given to the replacement of all the perimeter flashings in the long term.
