ROOF SURVEY

XXXXXX XXXXXXXX
XXXX XXXXXX
XXXXXX
XXXX XXXX XXXXXX
GXX 8XX
ROOF CONDITION SURVEY
RCS/XXX/2022
21st Jan 2022
XXXXX XXXXXX BCI, CII, BDMA, MIOR

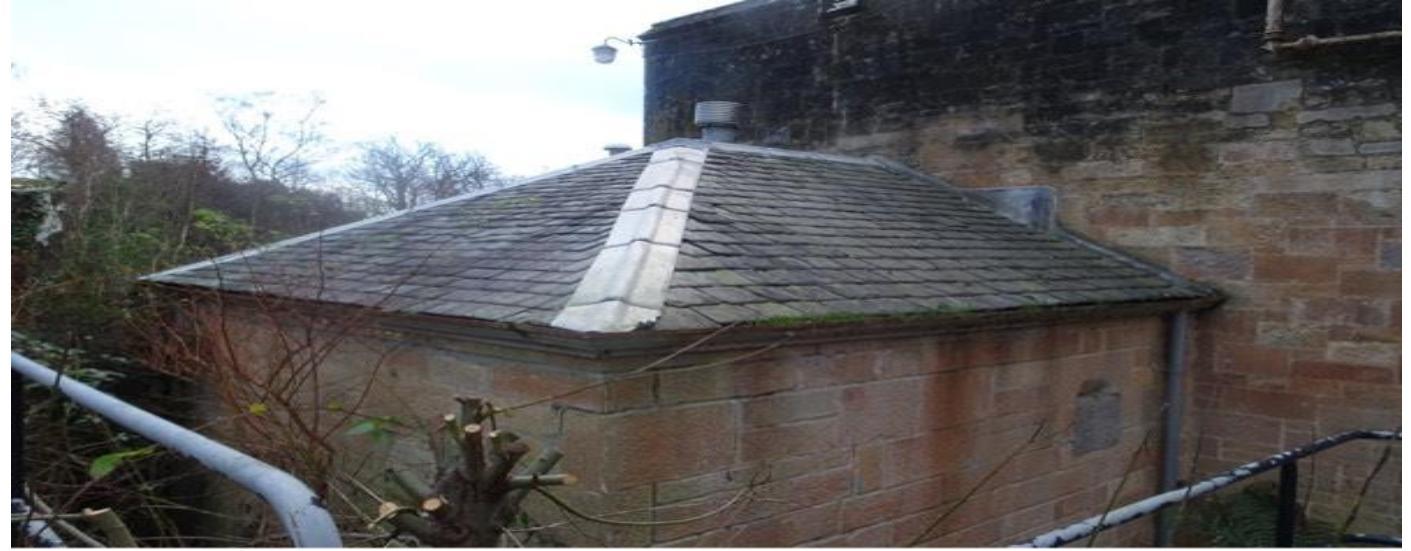
Rear elevation extension pitched hipped slate roof

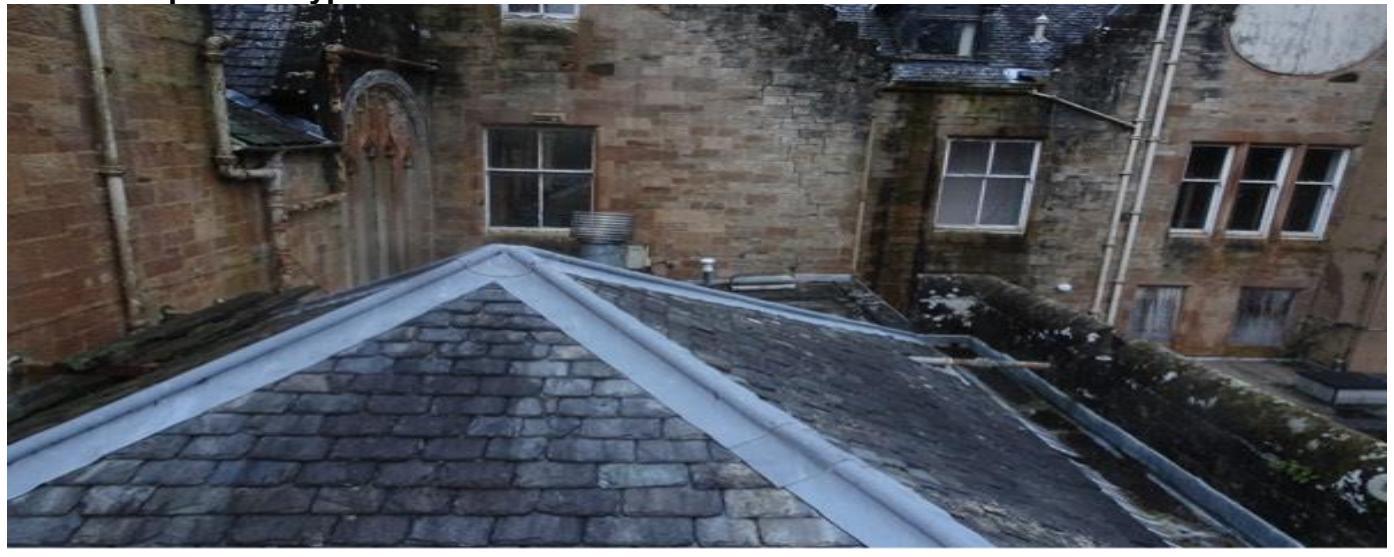
Extension pavilion type slate roof

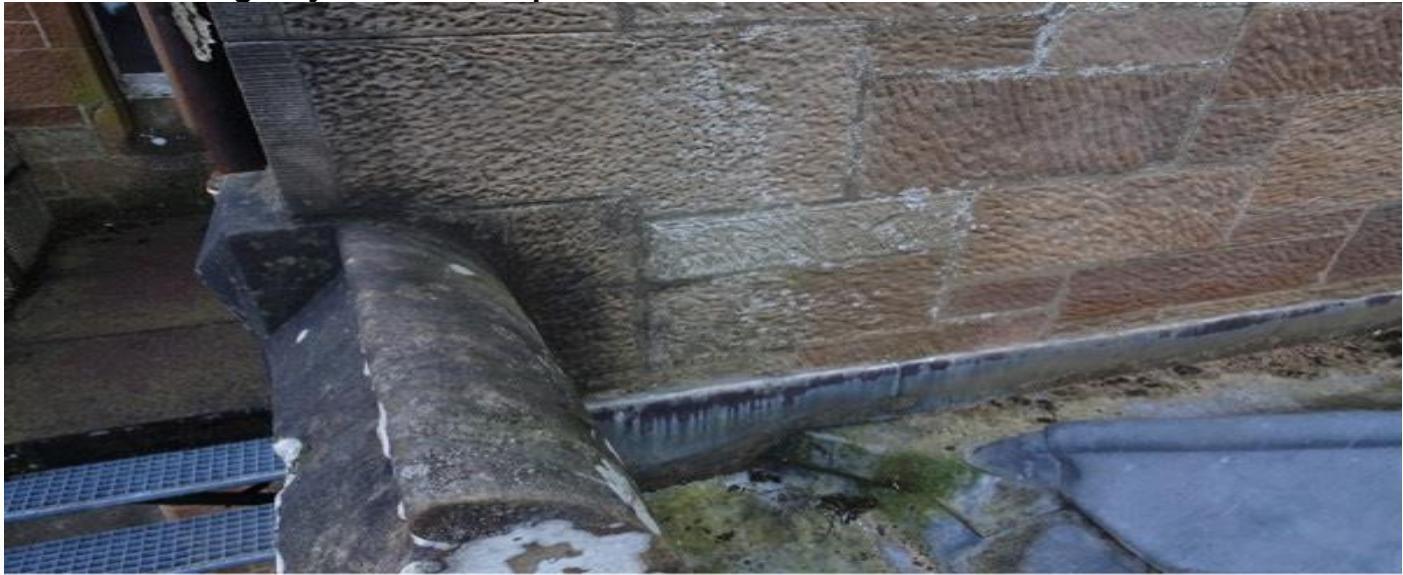
Perimeter lead gulley to extension pavilion roof

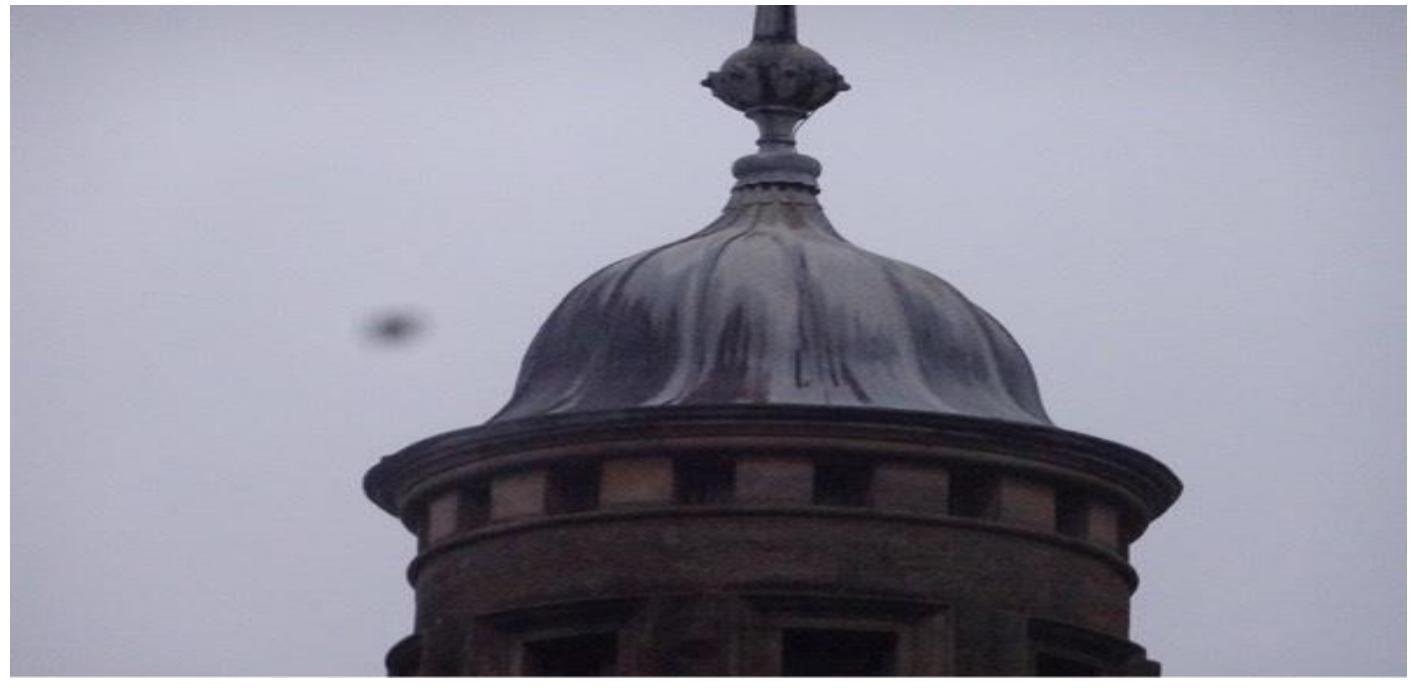
Lead sheet central turret roof

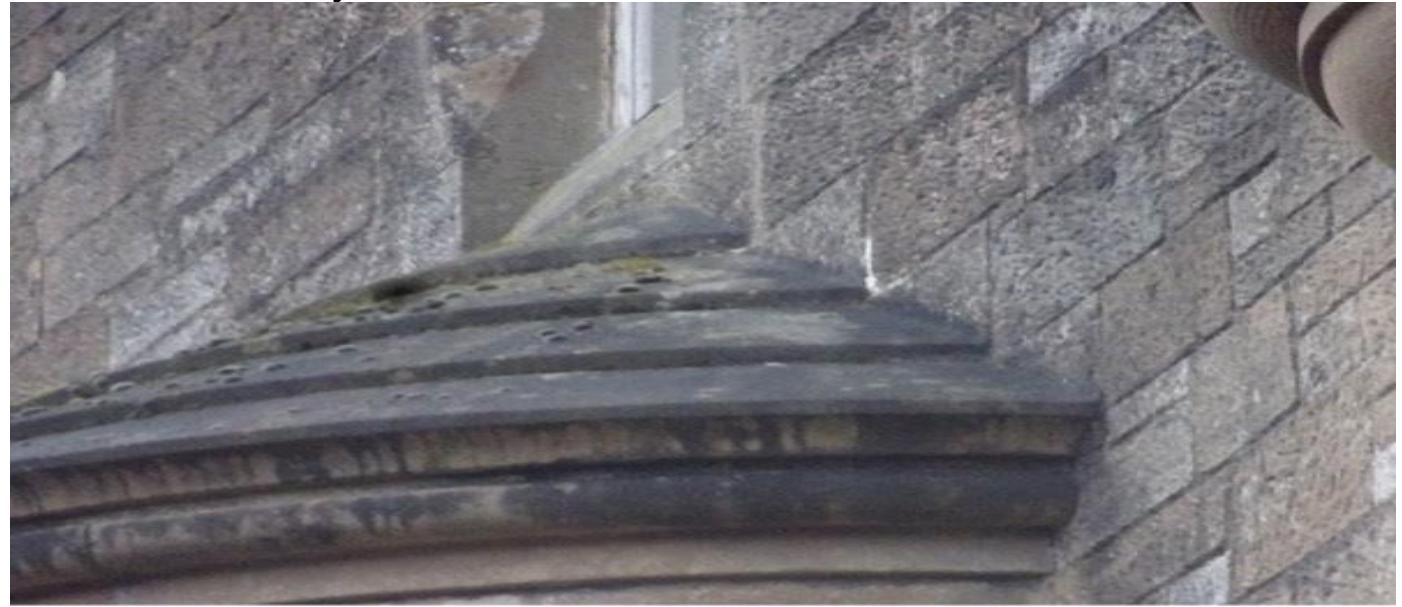
• The bay window radius & quadrant roof coverings have a pitched stone roofs (natural stone slate) these appear to be in good condition with no physical defects adversely affecting the water proof values of the roof coverings detected at the time of the inspection

Stone slate radius bay window roof

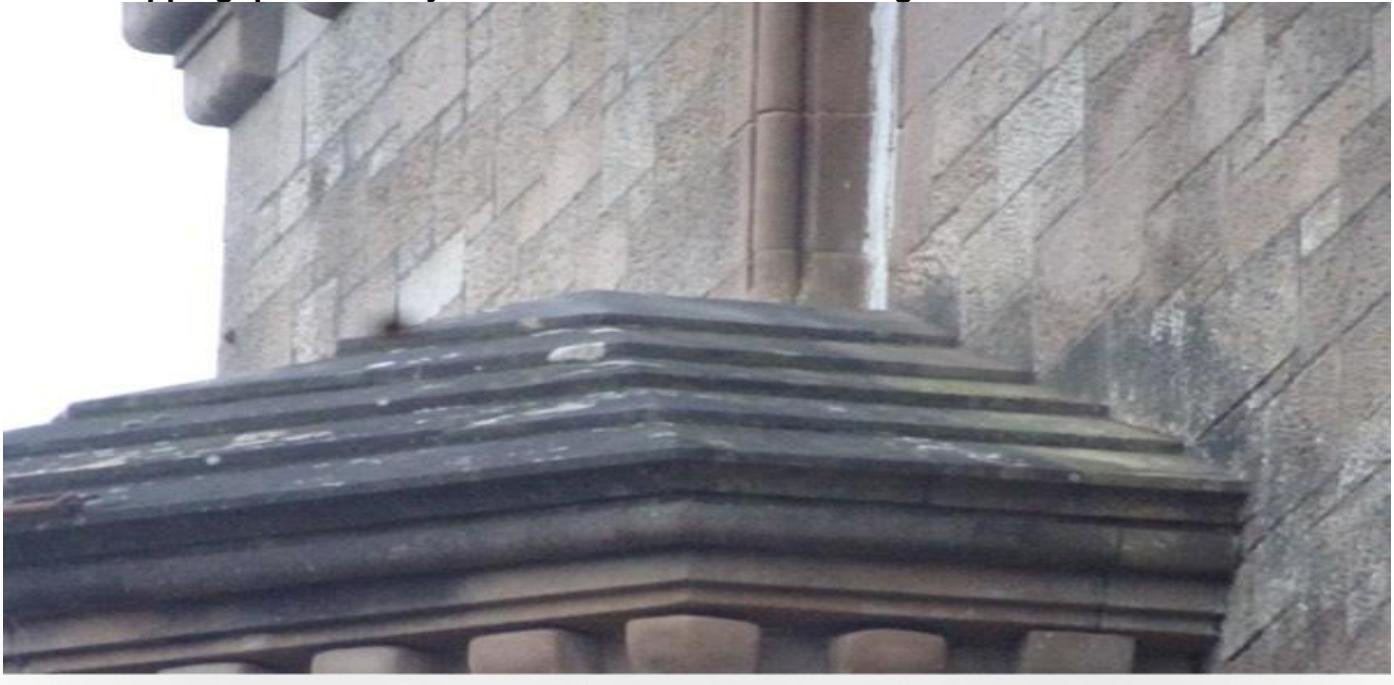
Stone slopping quadrant bay window roof to the east facing

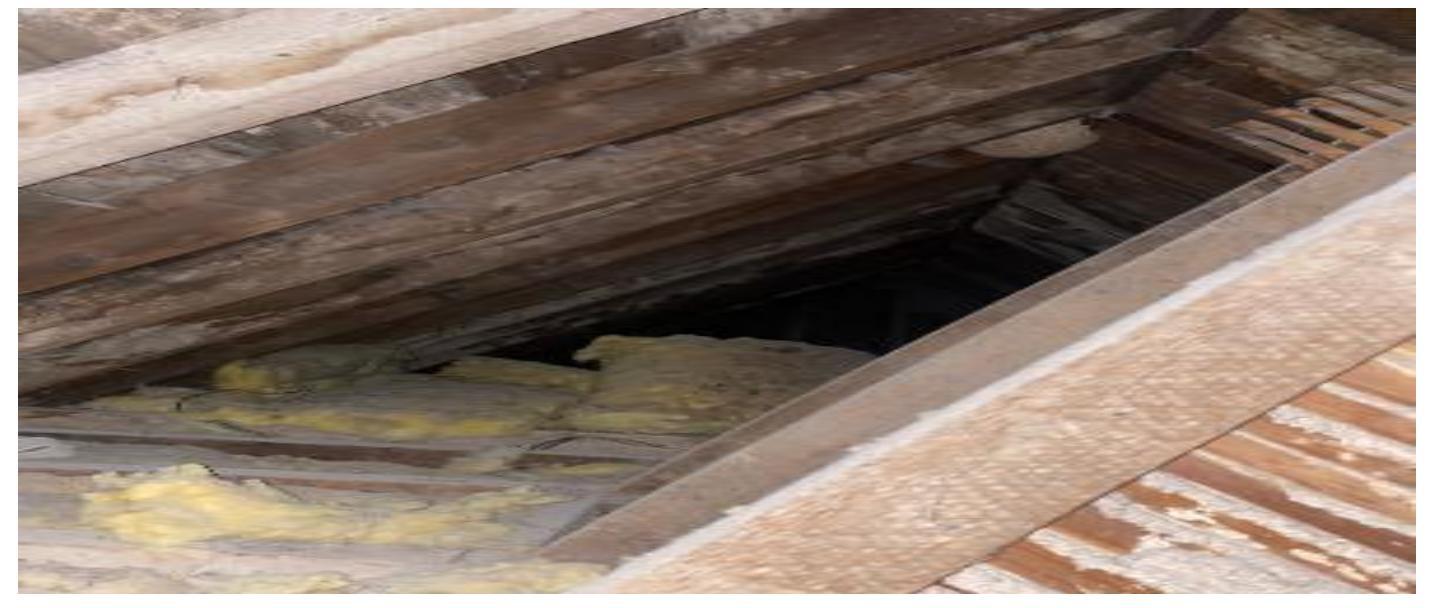
• Inspection of the roof timbers was restricted however no visible wood decay was noted to any of the structural timbers and all appeared to be in satisfactory condition.

No evidence of decay detected to the visible roof supporting structures

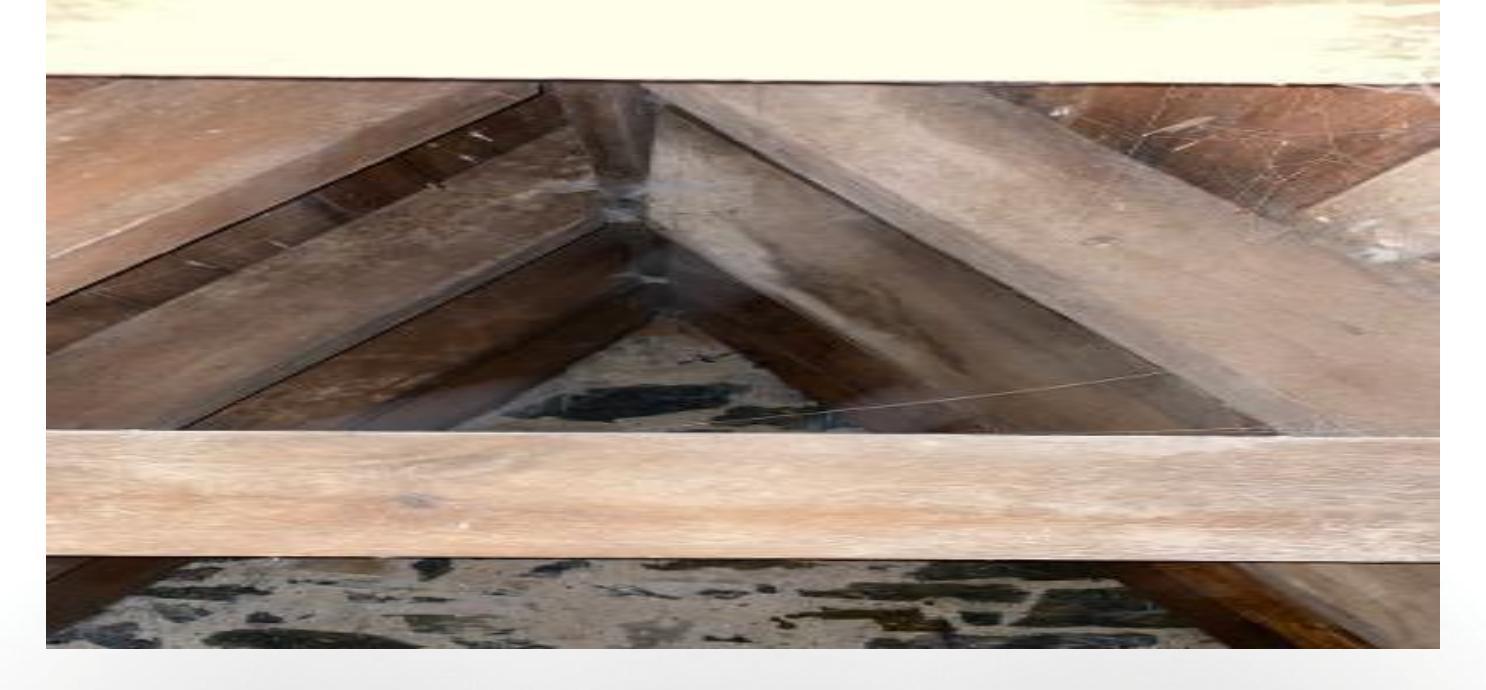
No evidence of decay detected to the visible roof supporting structures
