PROPERTY SURVEY

Client Name: XXX XXXXX XXXXX
Address: XX XXXXX XXXXXX
XXXXXX XXXXXX
XXXXXX
XX7 0XX
Purpose of Report: STRUCTURAL BUILDING SURVEY
Report Reference: SBS/XXX/2022
Inspection Date: 16 May 2022
Surveyor Name: XXXXX XXXXX BSc (Hons), ASSOC RICS, BCI, CII, BDMA
Building Surveyor Engineer Name: XXXX XXXX BSc (Hons) C Build E, MCABE.

- The property inspected was a farm located on a large plot of open fields of a country road and comprised of two main buildings to include a large stone-built building and a good-sized stone built detached bungalow within the grounds. The main building was found to comprise of a traditionally constructed stone-built structure which had a timber roof with a network of trusses and purlins and rafters supported on load-bearing walls. The roof has been covered with a natural slate roof covering and had a segmented decorative ridge tiles to the ridge line. There were several additions to the main building including a dormer projection at the front, a two-story extension at the front and a glazed conservatory at the rear.

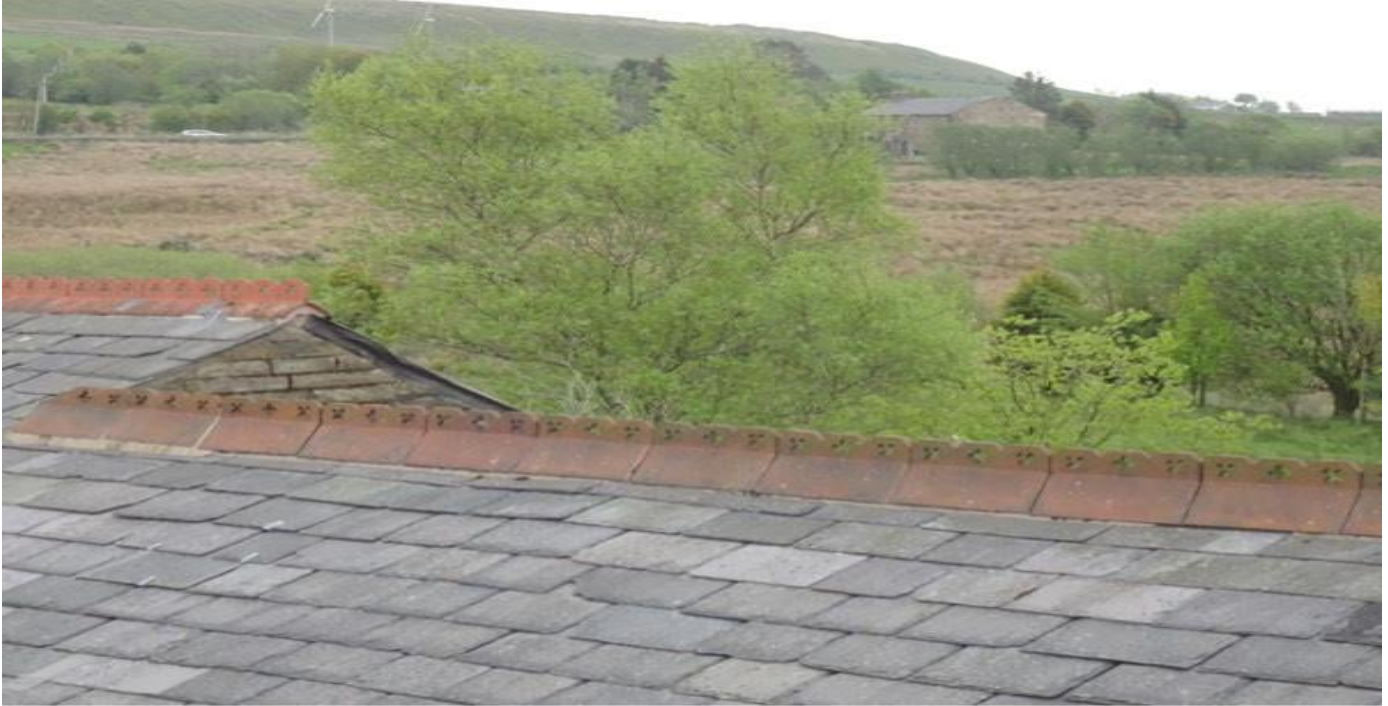
View of the ridge tiles to the central portion of the main building from the front.

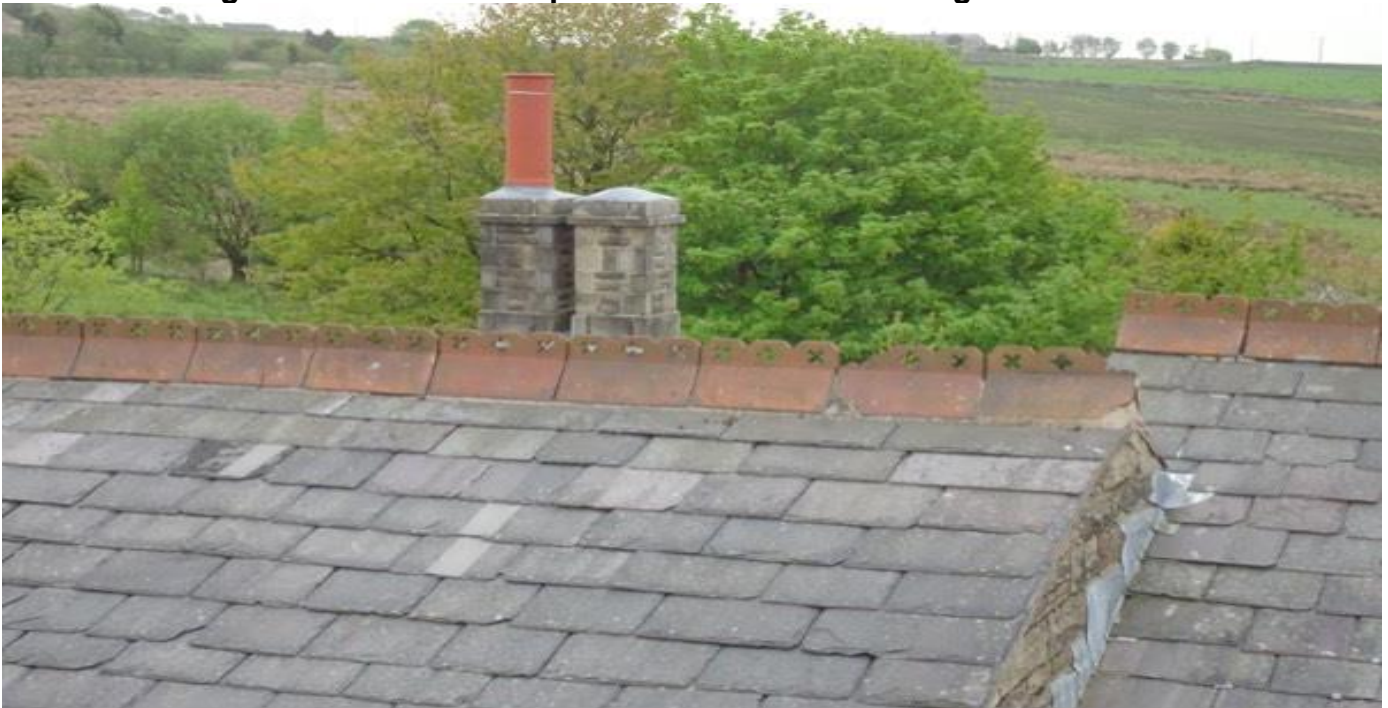
View of the ridge tiles to the central portion of the main building from the front.

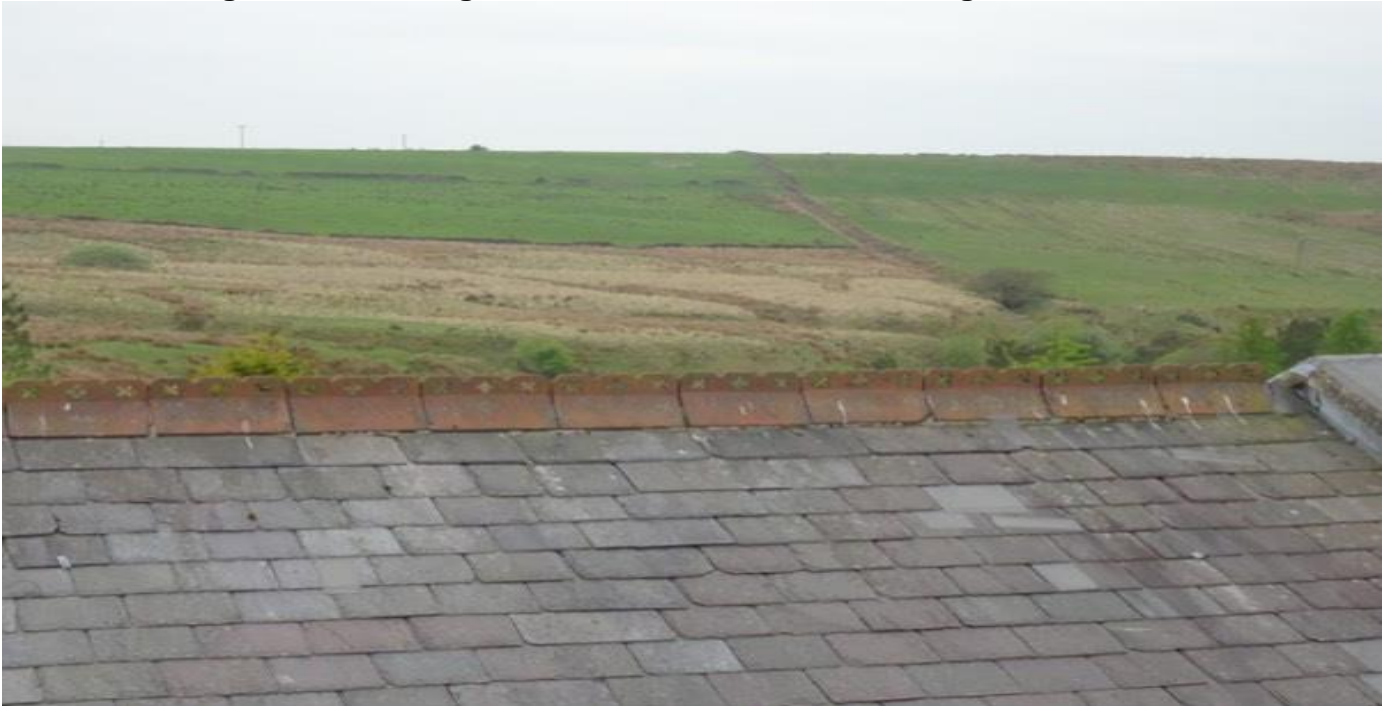
View of the ridge tiles to the right hand side of the main building from the front.

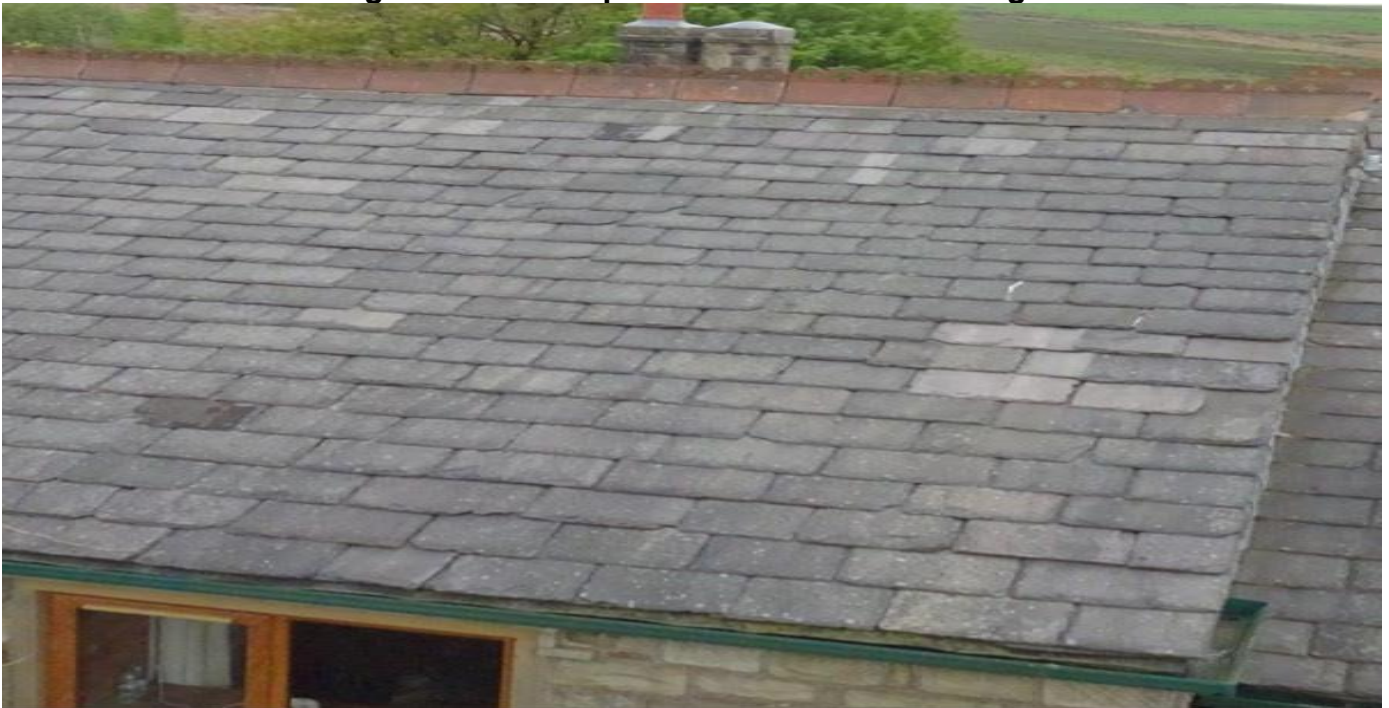
- The inspection of the main roof coverings across the natural slate services found these to be in poor condition with evidence of excessive historical repairs, lead tabs indicating nail fatigue, slipped and missing slates isolated areas, cracked slates in isolated areas, perished mortar flaunching and mortar pointing to the chimney with dated and deformed leading to the abutments and to the copings all of which would require renewal info to ensure water tightness of the roof structure.

View of the roof covering to the central portion of the main building from the front.

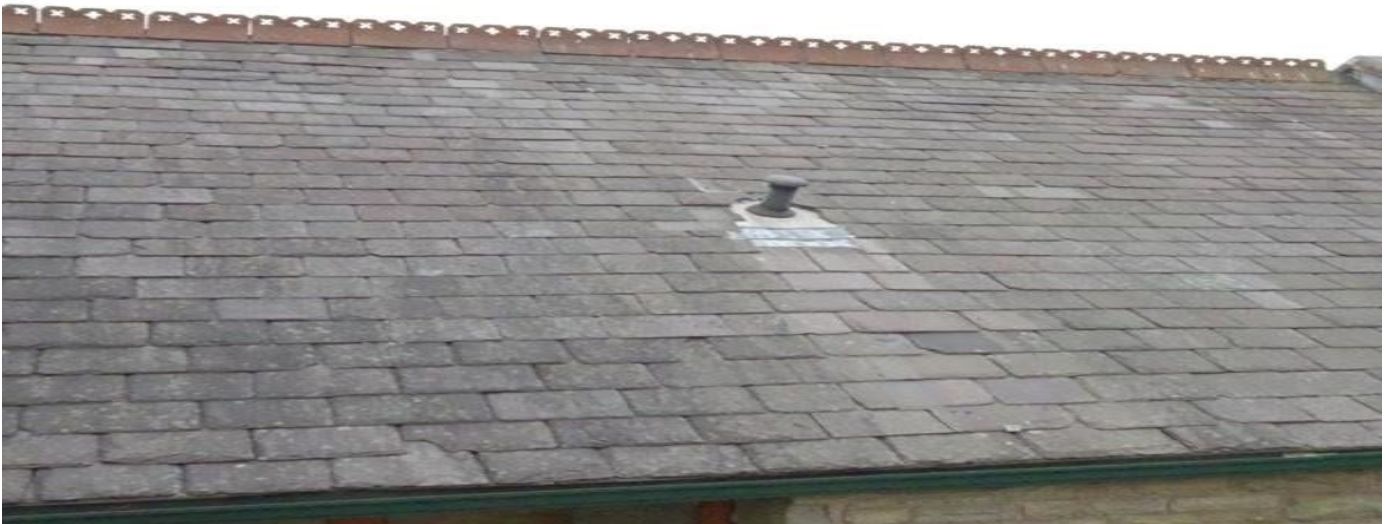
View of the roof covering to the right hand side of the main building from the front.

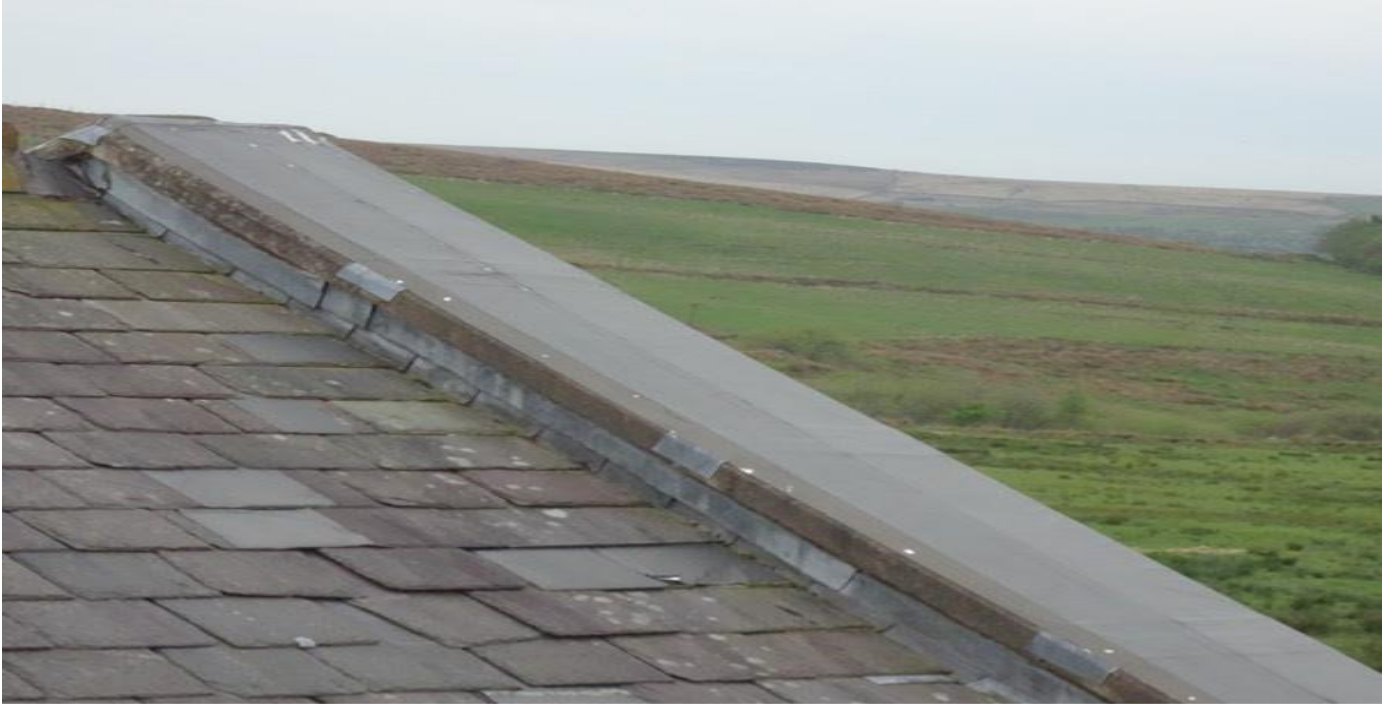
- There was evidence of whether sealant applied to the top of the chimneys and strip with the sealant to the top of the stone coping indicating that there is progressive deterioration of the materials in the area all of which will require full restorations to bring up to a acceptable and modern standard.

View of leaded abutments and the strip weather sealant to the stone coping at the right-hand side of the main building at the front.

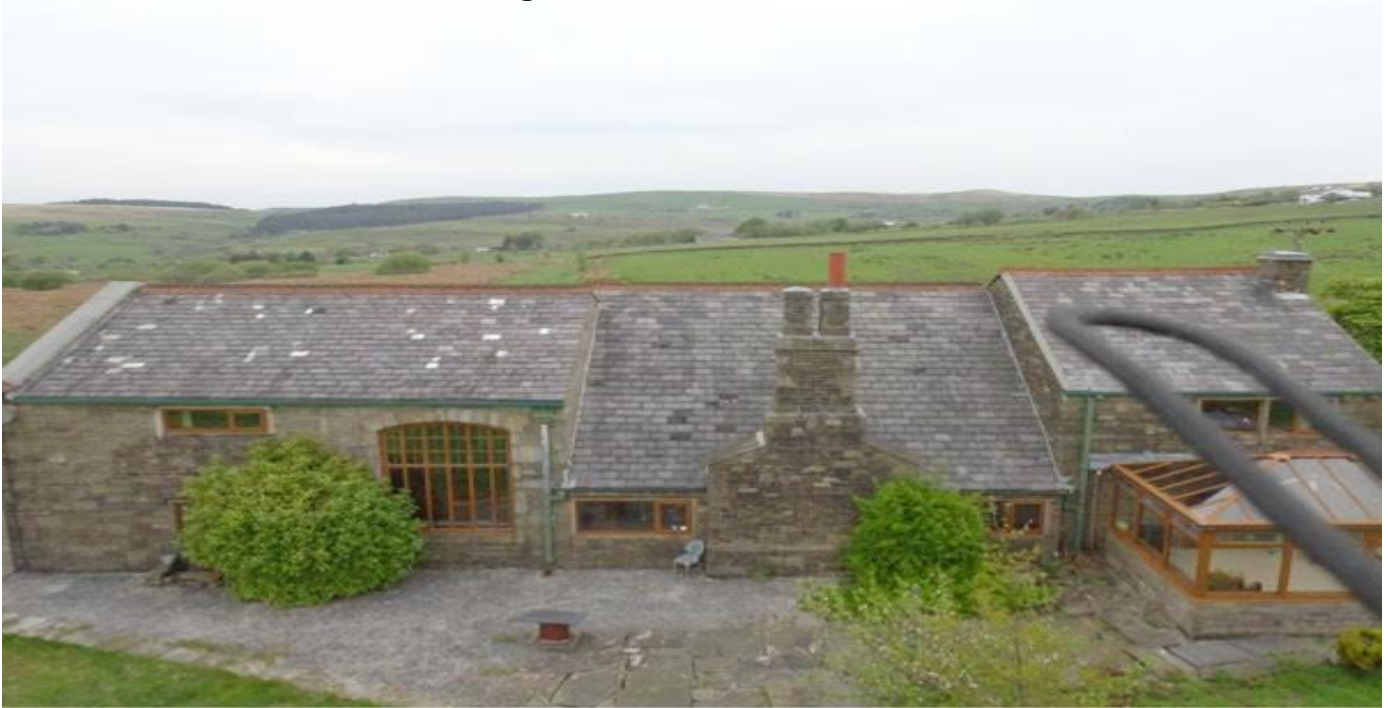
Overview of the main roof coverings and additions at the rear.

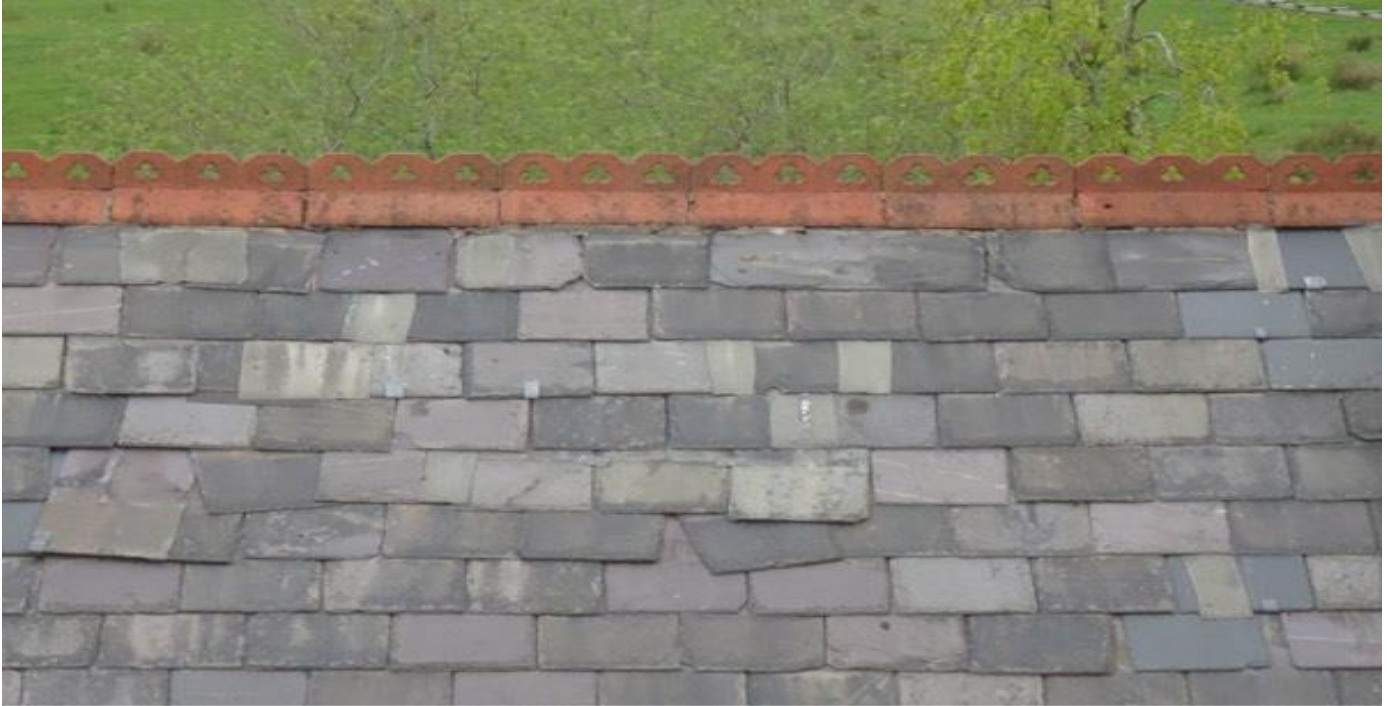
View of the ridge tiles and roof covering to the right hand side of the main building from the rear.

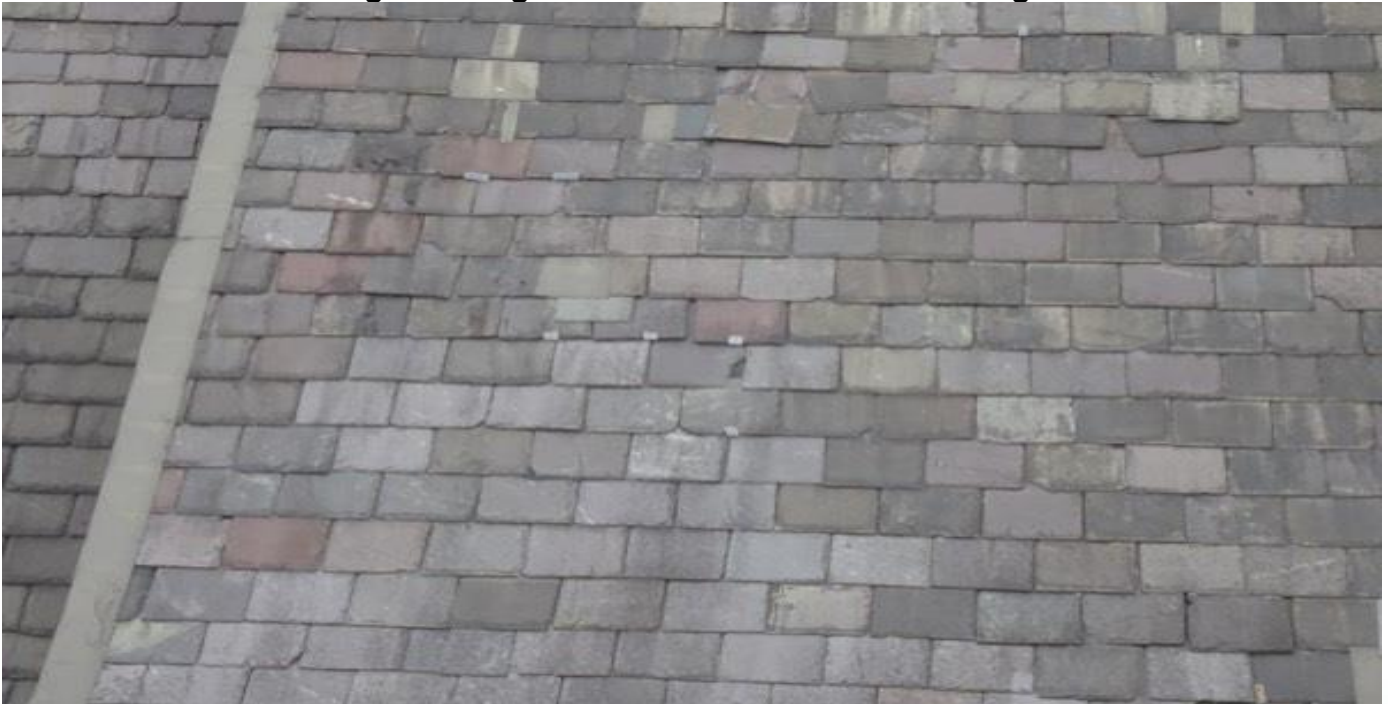
View of the roof covering to the right hand side of the main building from the rear.

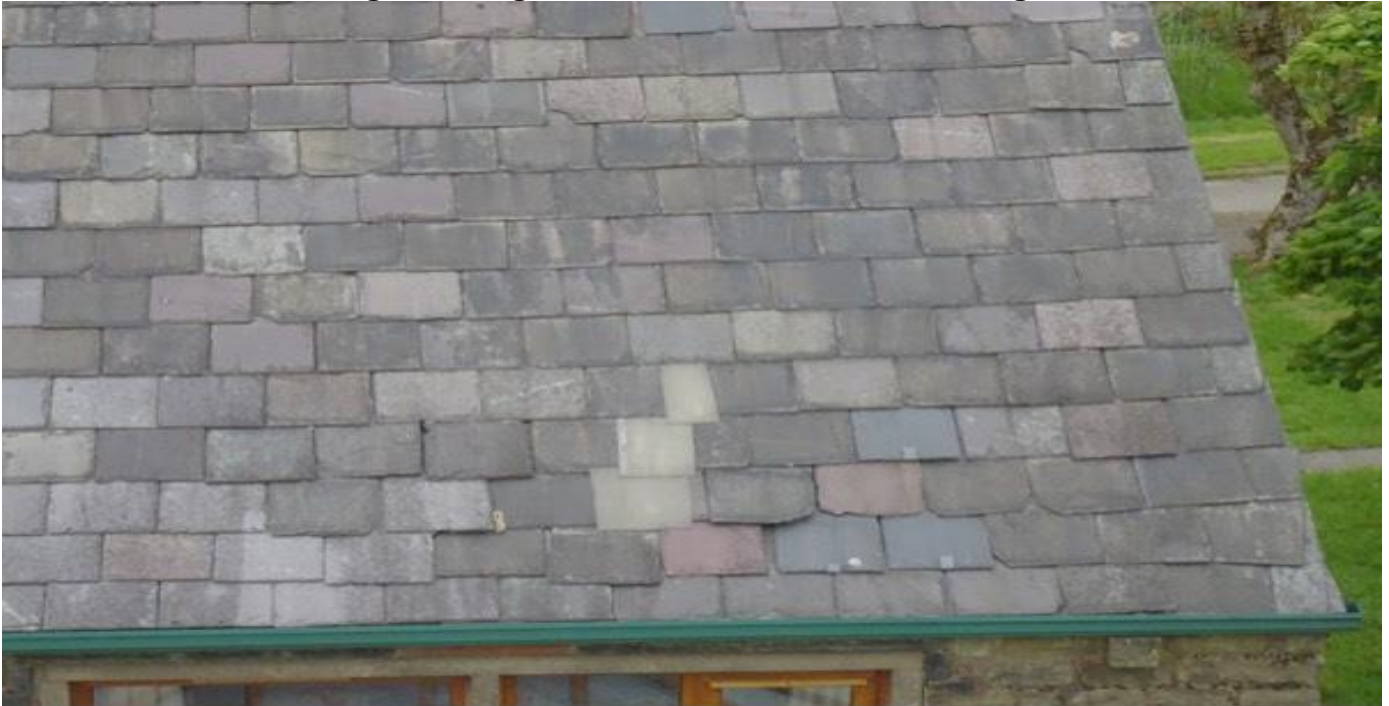
View of the roof covering to the right hand side of the main building from the rear.

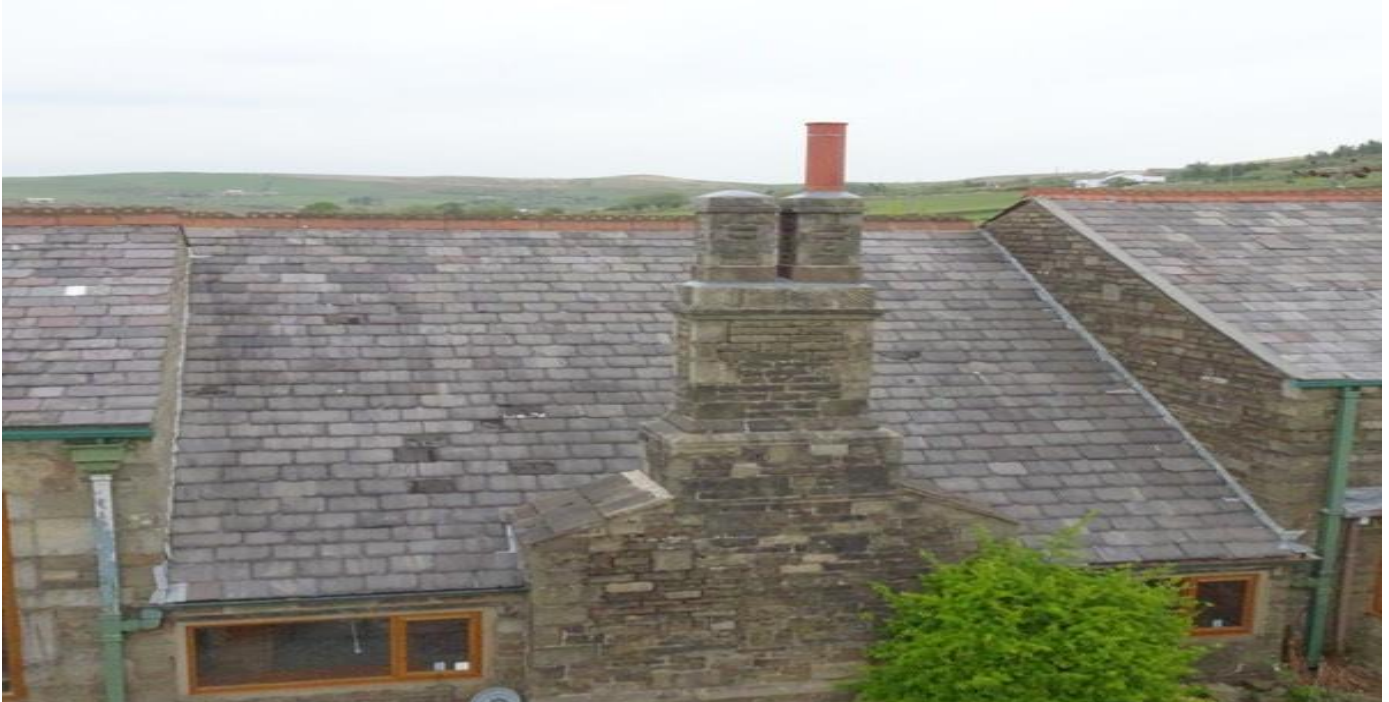
Overview of the roof and stone built chimney to the central portion of the main building at the rear.

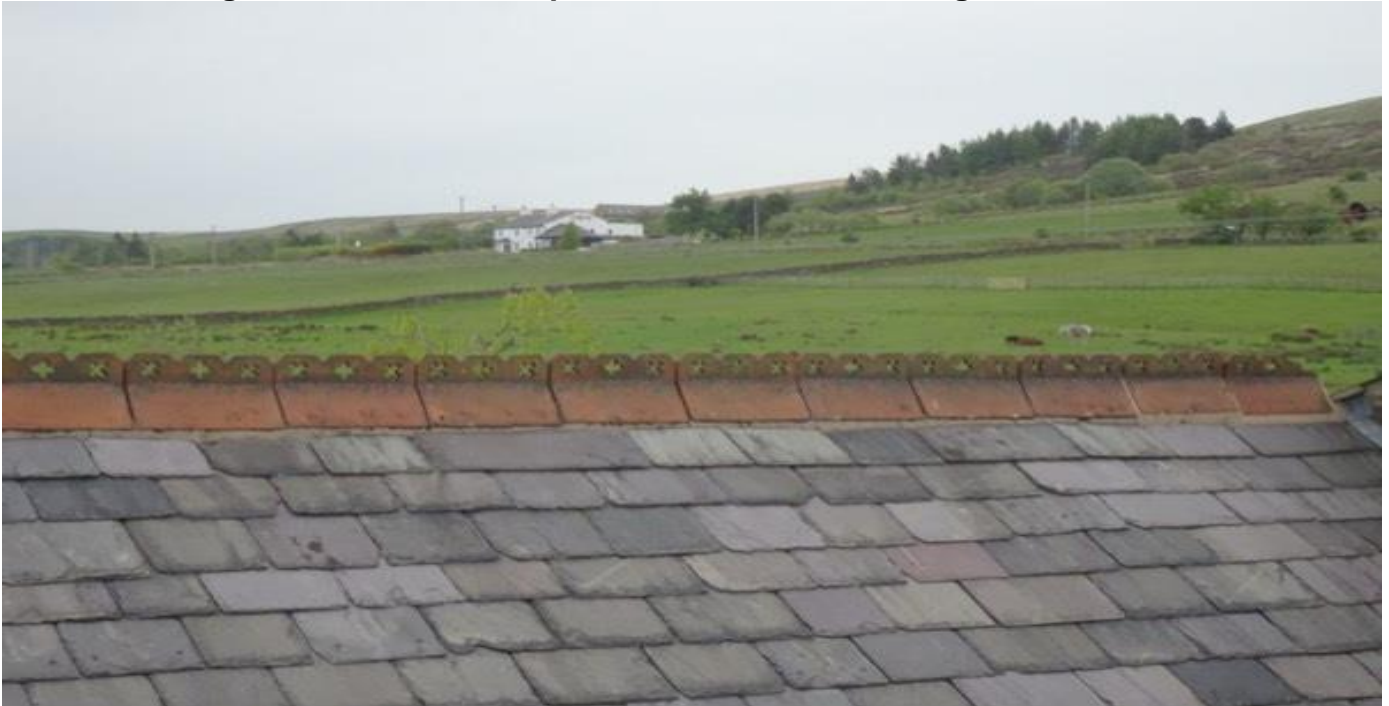
View of the ridge tiles to the central portion of the main building at the rear.

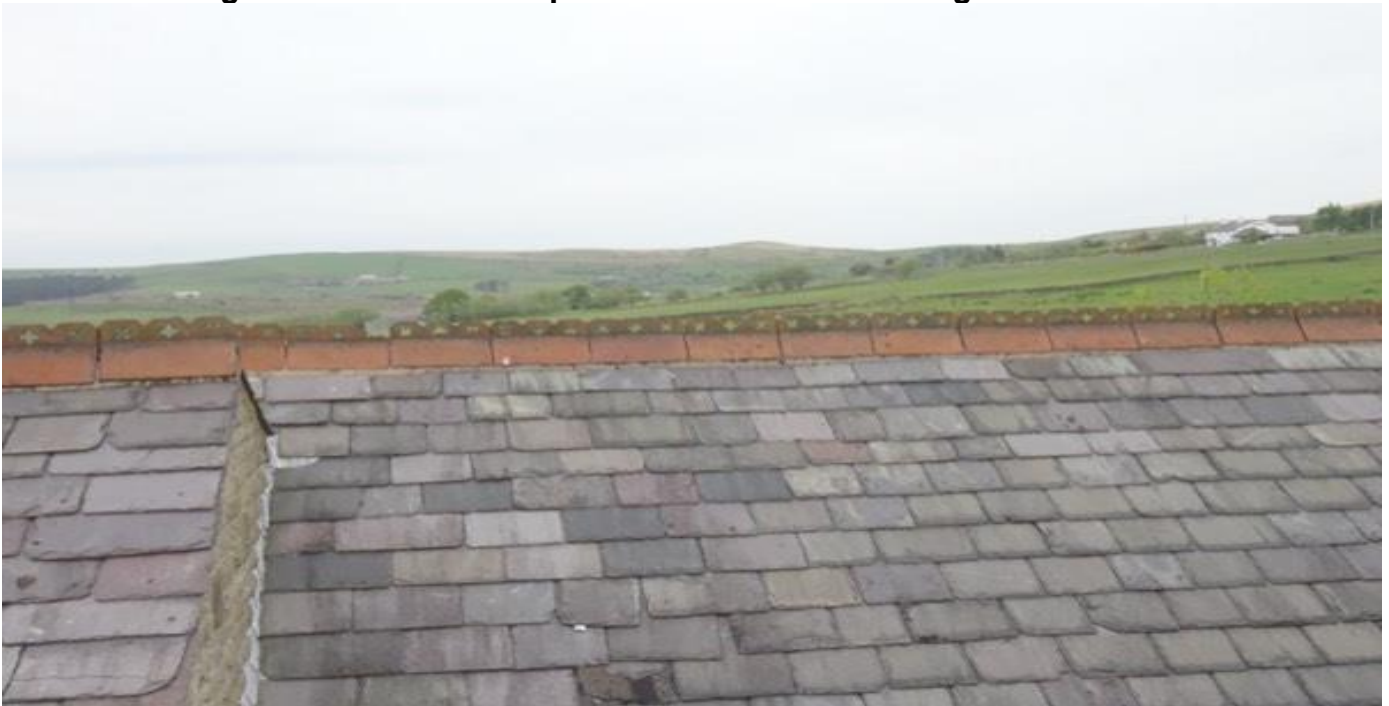
View of the ridge tiles to the central portion of the main building at the rear.

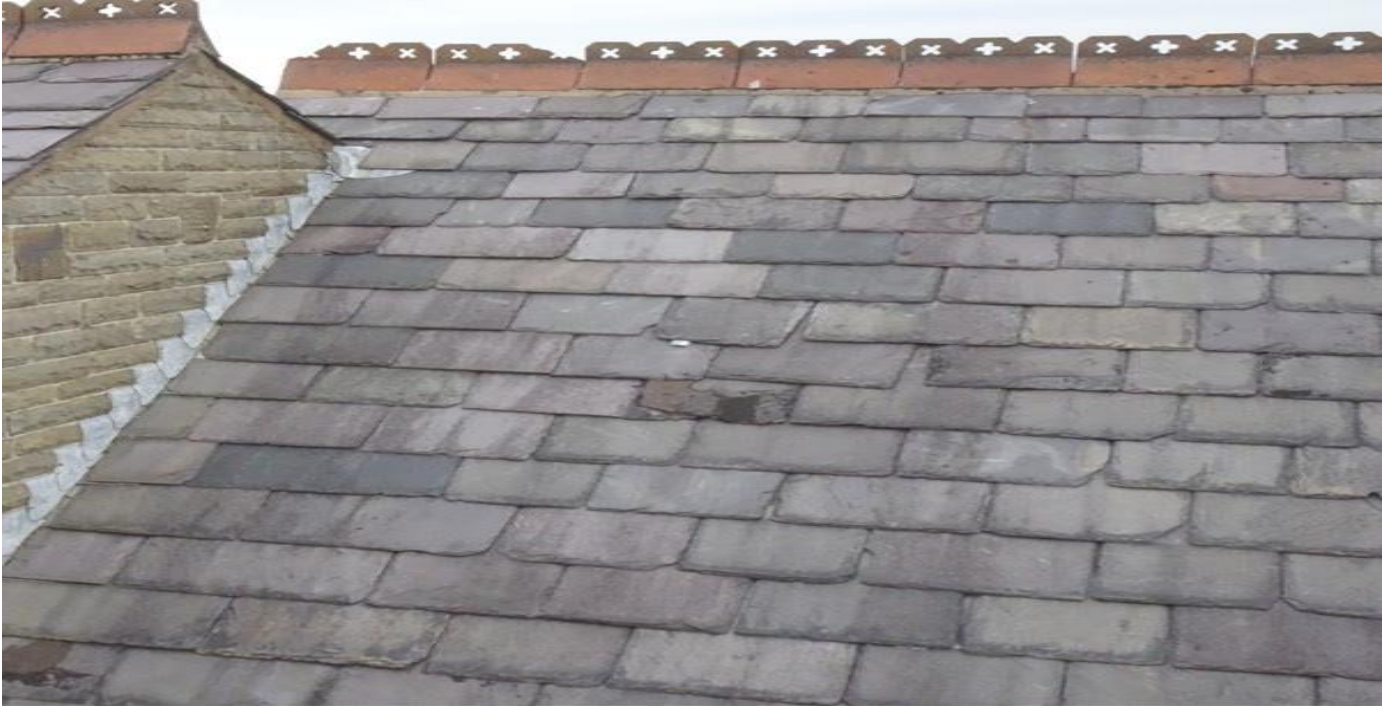
View of the roof covering and leaded abutments to the central portion of the main building at the rear.

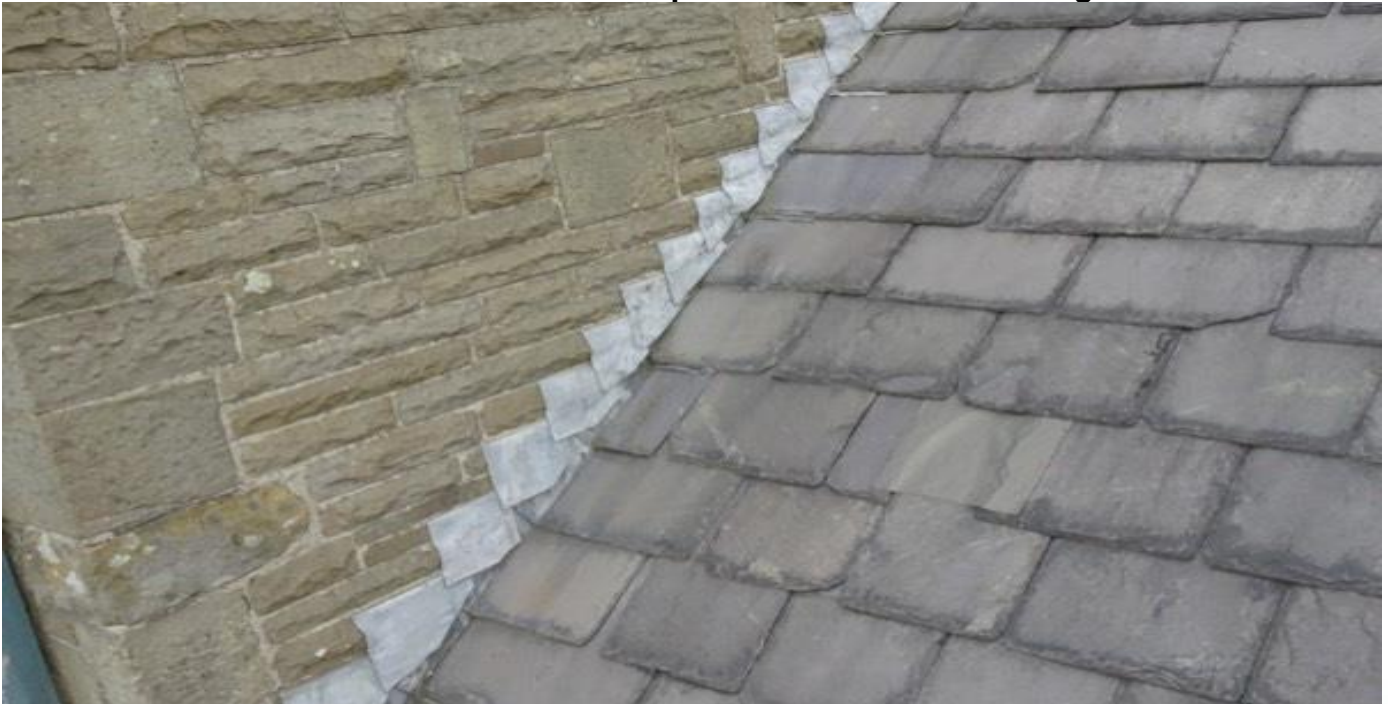
View of the leaded abutments to the central portion of the main building at the rear.

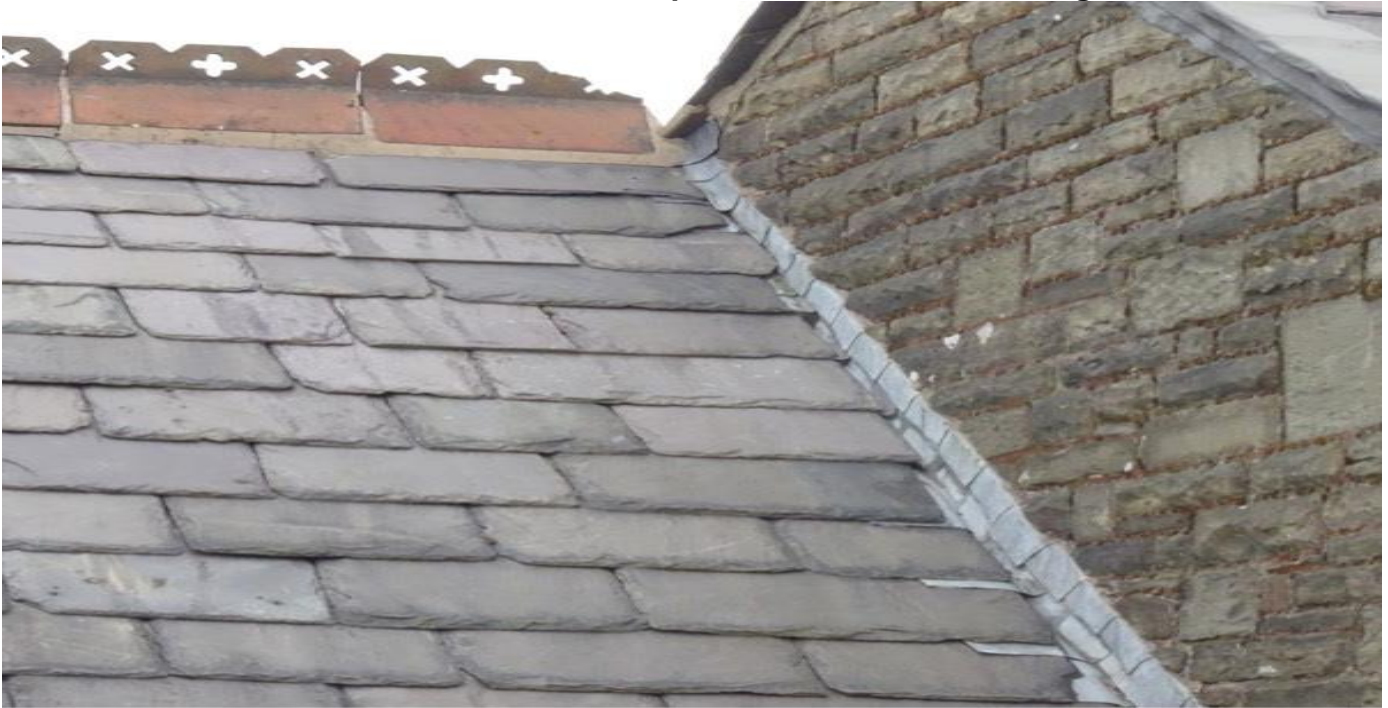
View of the leaded abutments to the central portion of the main building at the rear.

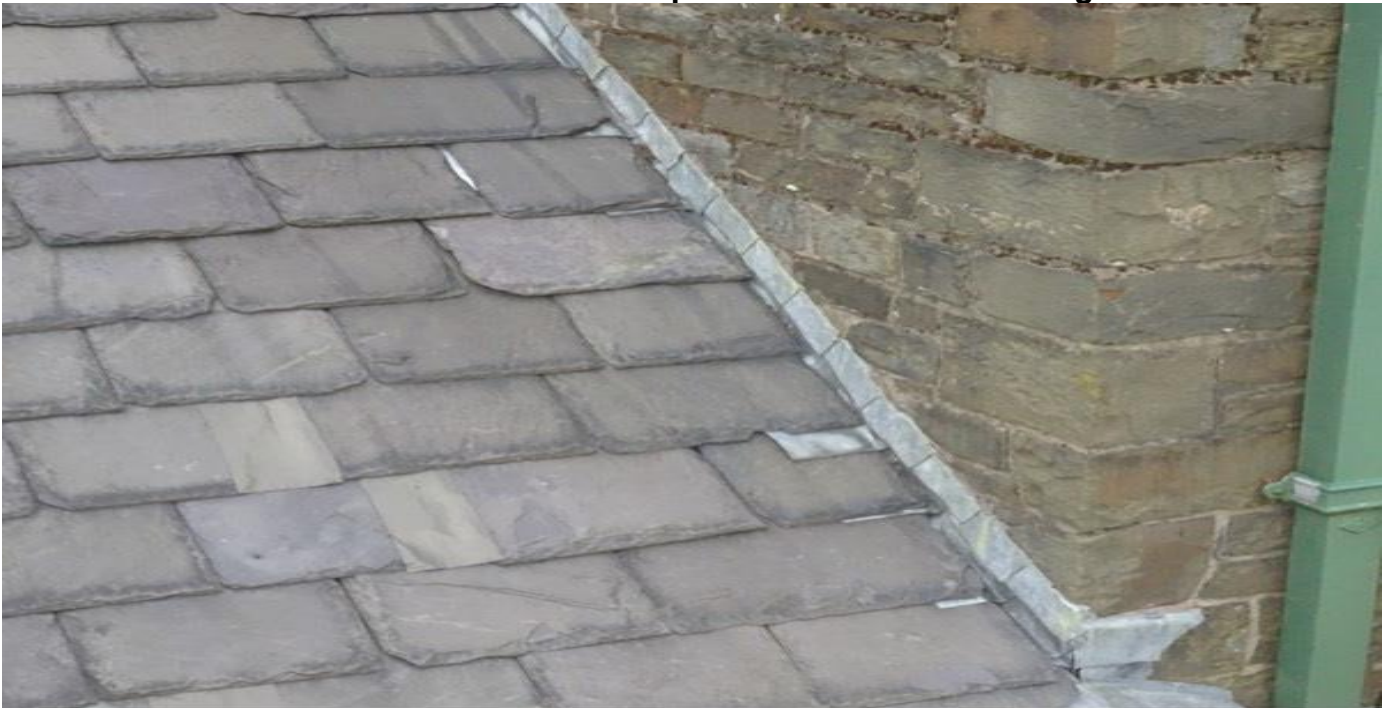
View of the leaded abutments to the central portion of the main building at the rear.

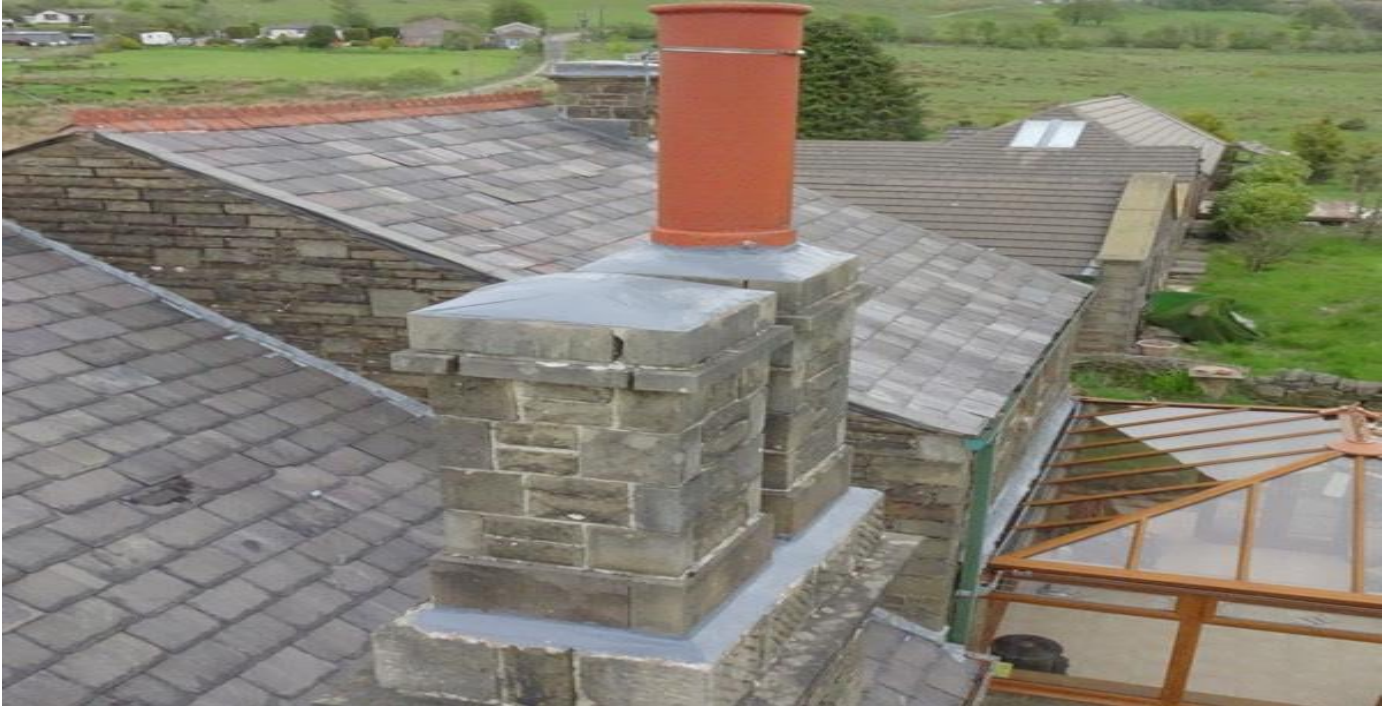
View of the chimney pots and mortar flaunching to the stone built chimney to the central portion of the main building at the rear.

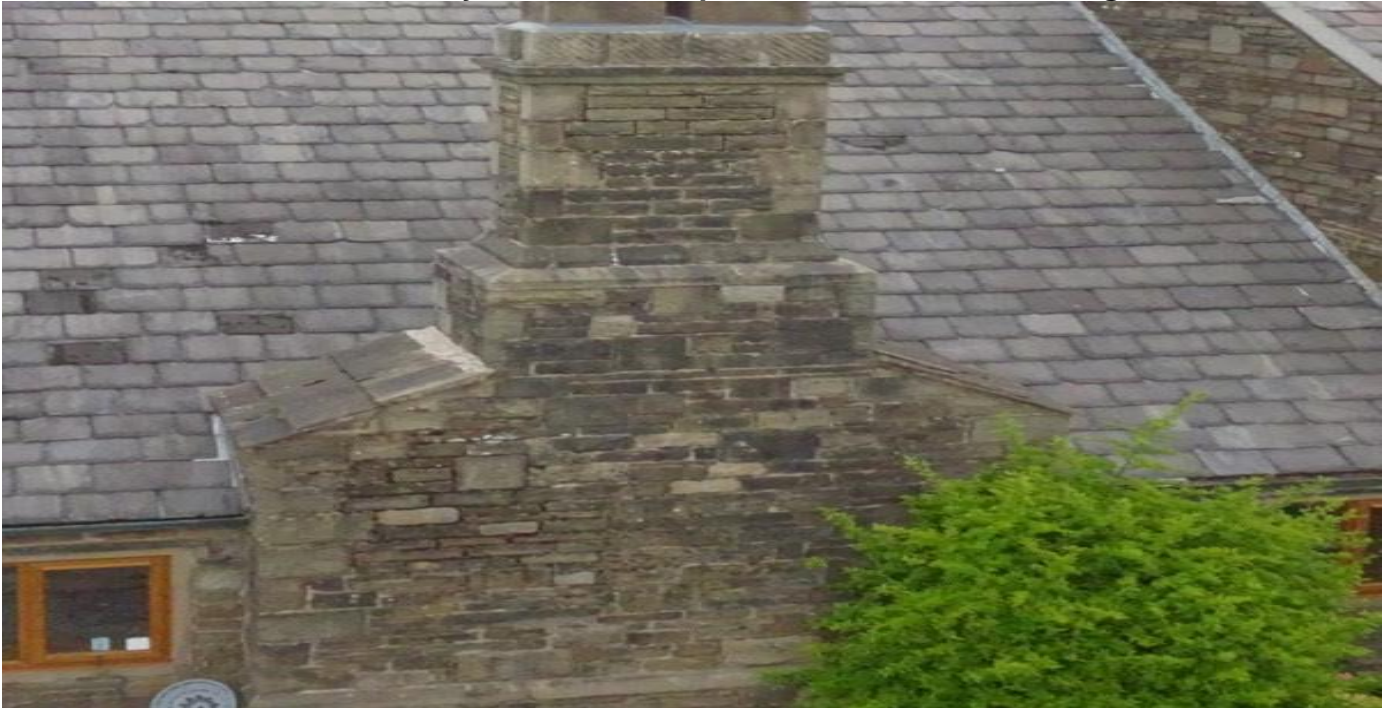
View of the stone built chimney to the central portion of the main building at the rear.

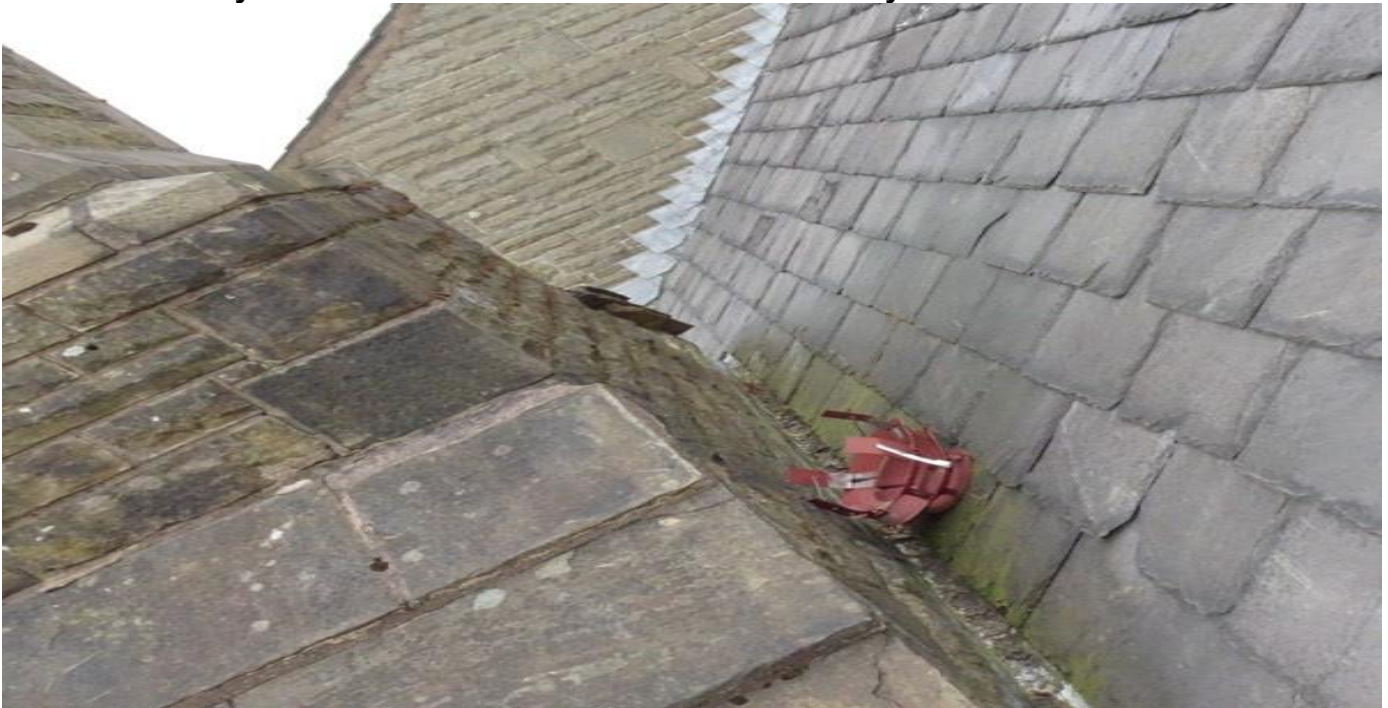
View of chimney cowl to the rear of the stone built chimney.

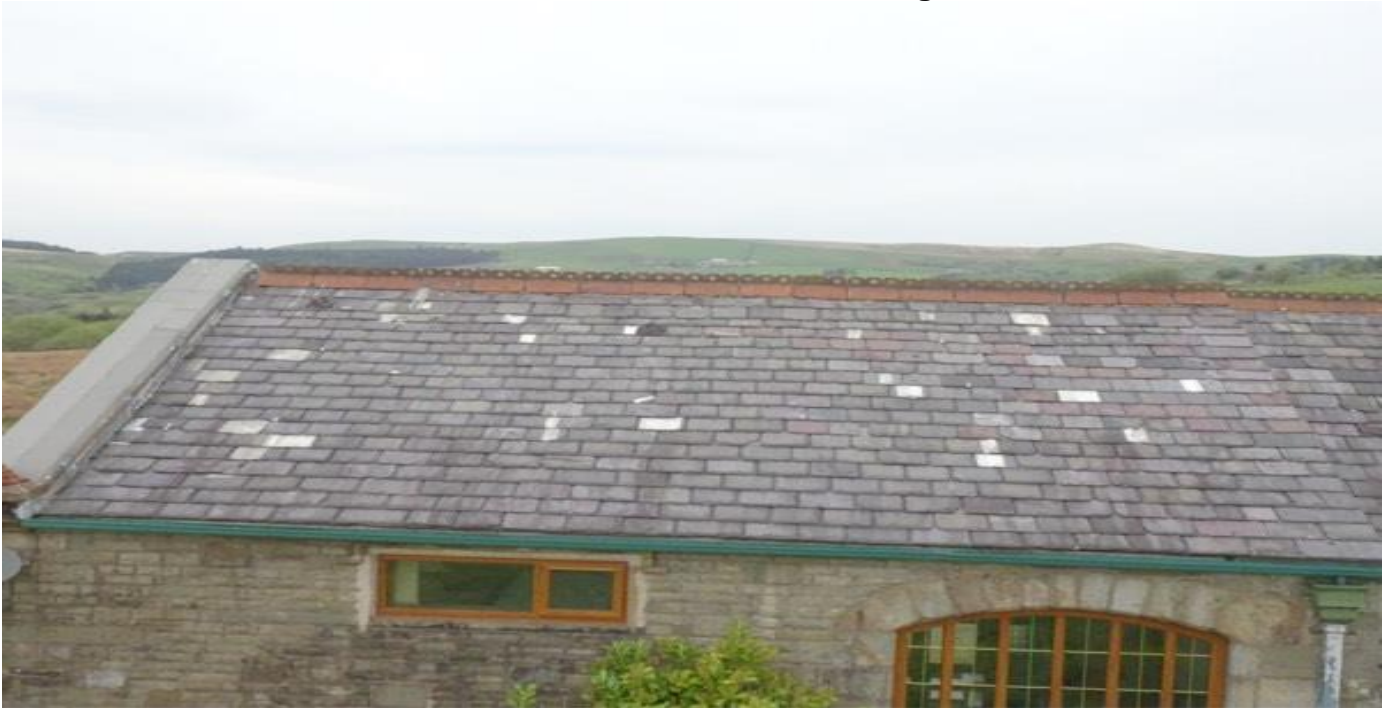
Overview of the roof to the left hand side of the main building from the rear.

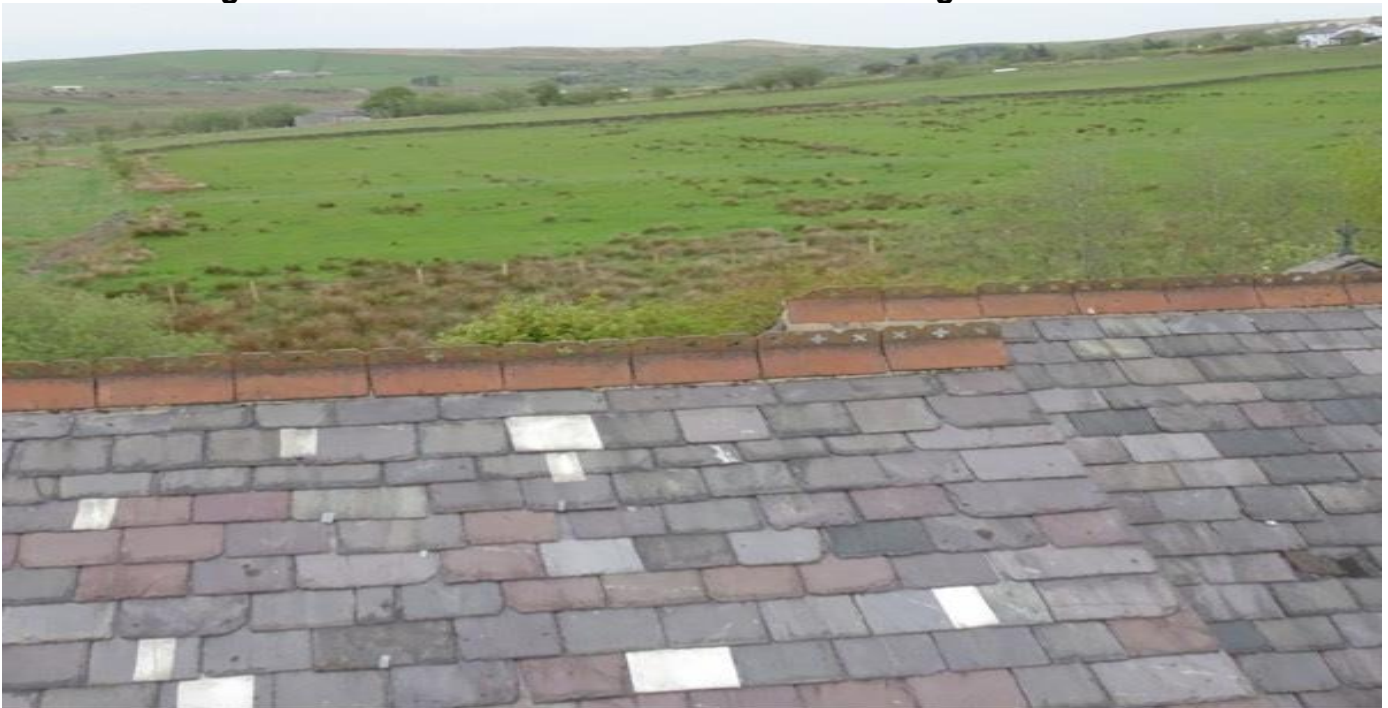
View of the ridge tiles to the left hand side of the main building from the rear.
