PROPERTY SURVEY

Client Name: XXX XXXXX XXXXX
Address: XX XXXXX XXXXXX
XXXXXX XXXXXX
XXXXXX
XX7 0XX
Purpose of Report: STRUCTURAL BUILDING SURVEY
Report Reference: SBS/XXX/2022
Inspection Date: 16 May 2022
Surveyor Name: XXXXX XXXXX BSc (Hons), ASSOC RICS, BCI, CII, BDMA
Building Surveyor Engineer Name: XXXX XXXX BSc (Hons) C Build E, MCABE.

- The property inspected was a farm located on a large plot of open fields of a country road and comprised of two main buildings to include a large stone-built building and a good-sized stone built detached bungalow within the grounds. The main building was found to comprise of a traditionally constructed stone-built structure which had a timber roof with a network of trusses and purlins and rafters supported on load-bearing walls. The roof has been covered with a natural slate roof covering and had a segmented decorative ridge tiles to the ridge line. There were several additions to the main building including a dormer projection at the front, a two-story extension at the front and a glazed conservatory at the rear.

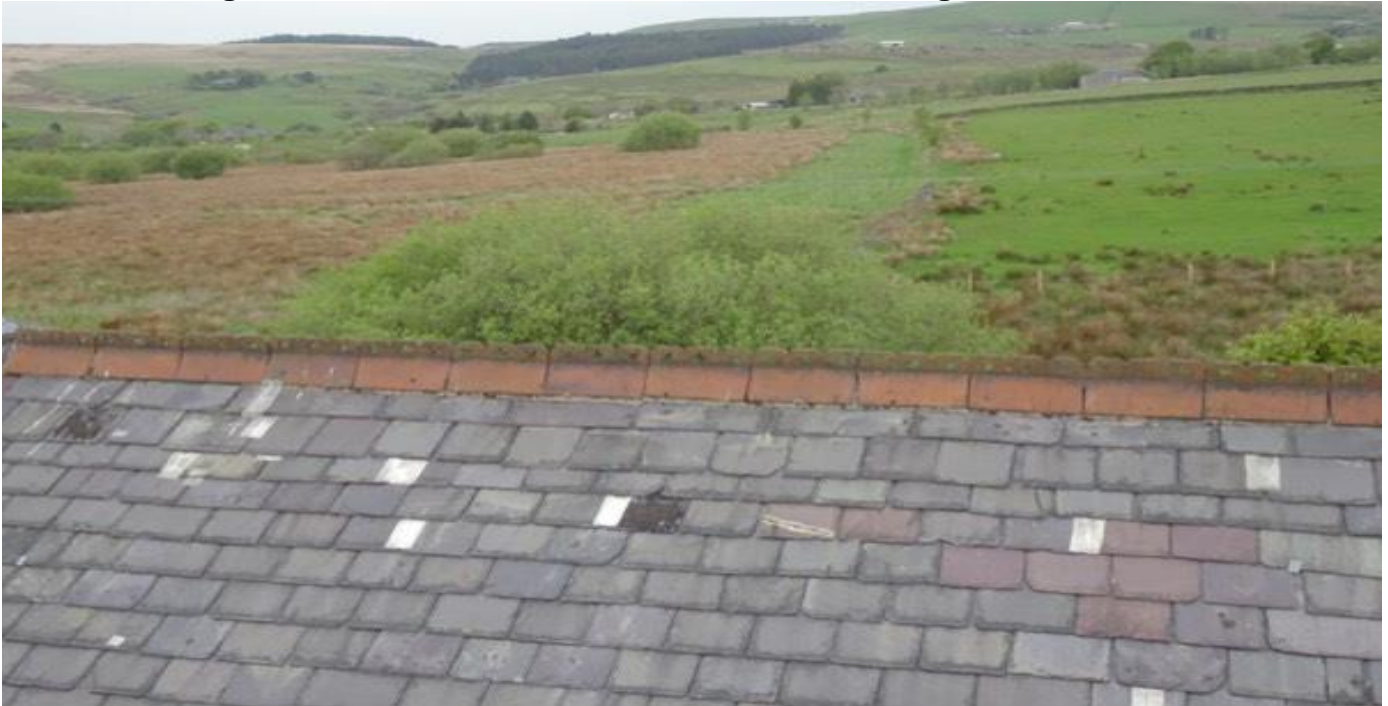
View of the ridge tiles to the left hand side of the main building from the rear.

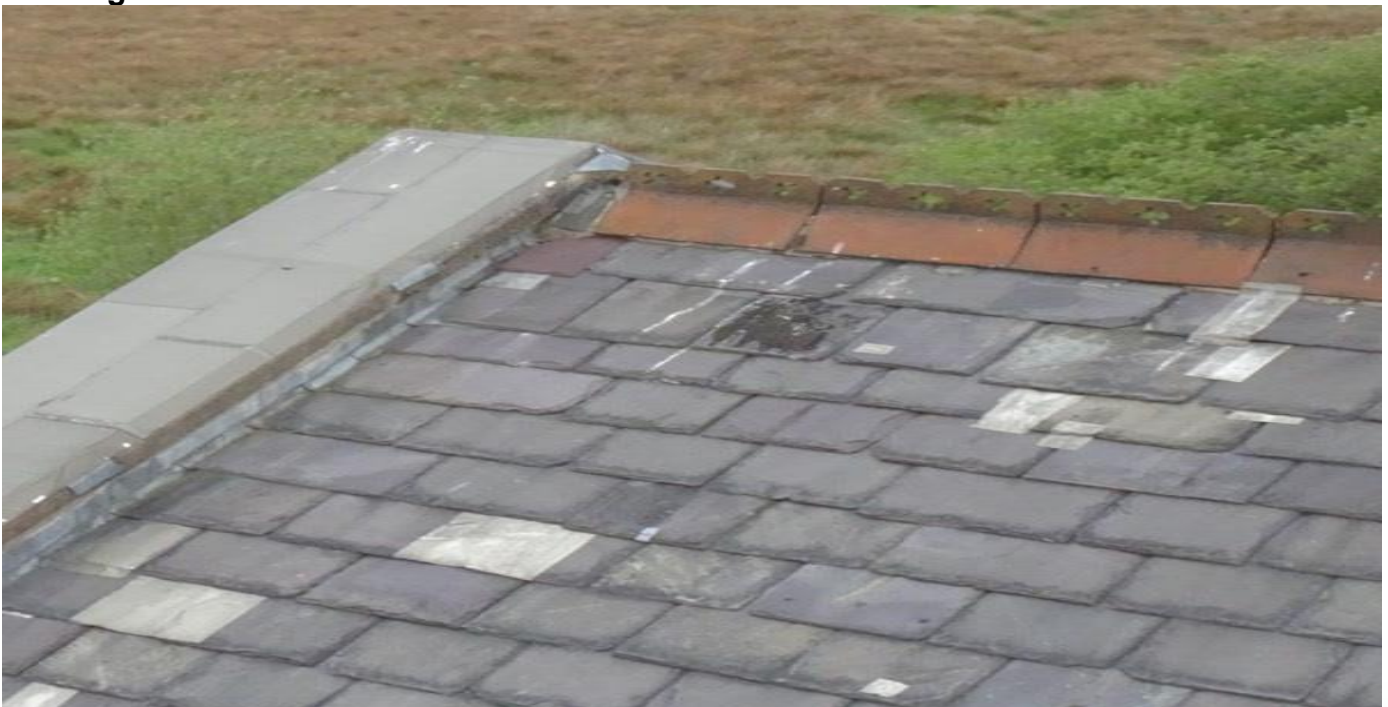
View of the ridge tiles, leaded abutments and coping to the left hand side of the main building from the rear.

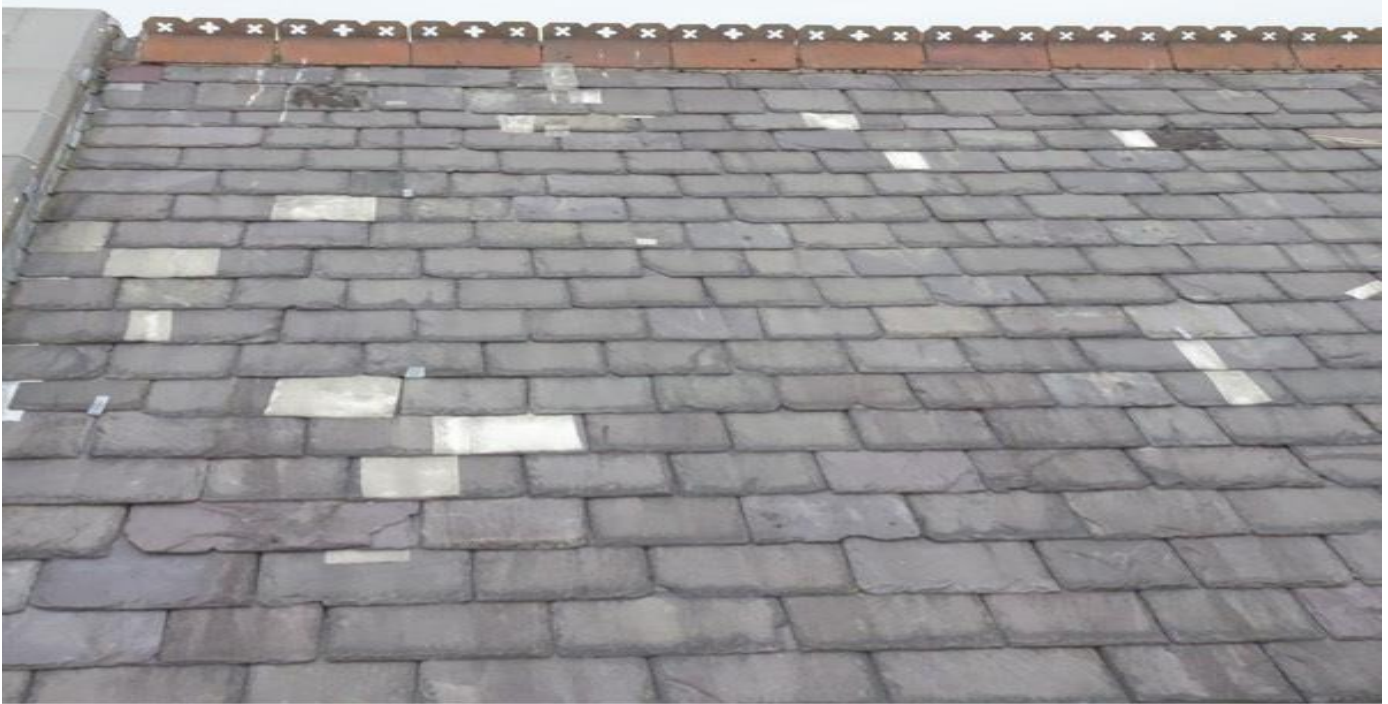
View of the roof covering to the left hand side of the main building from the rear.

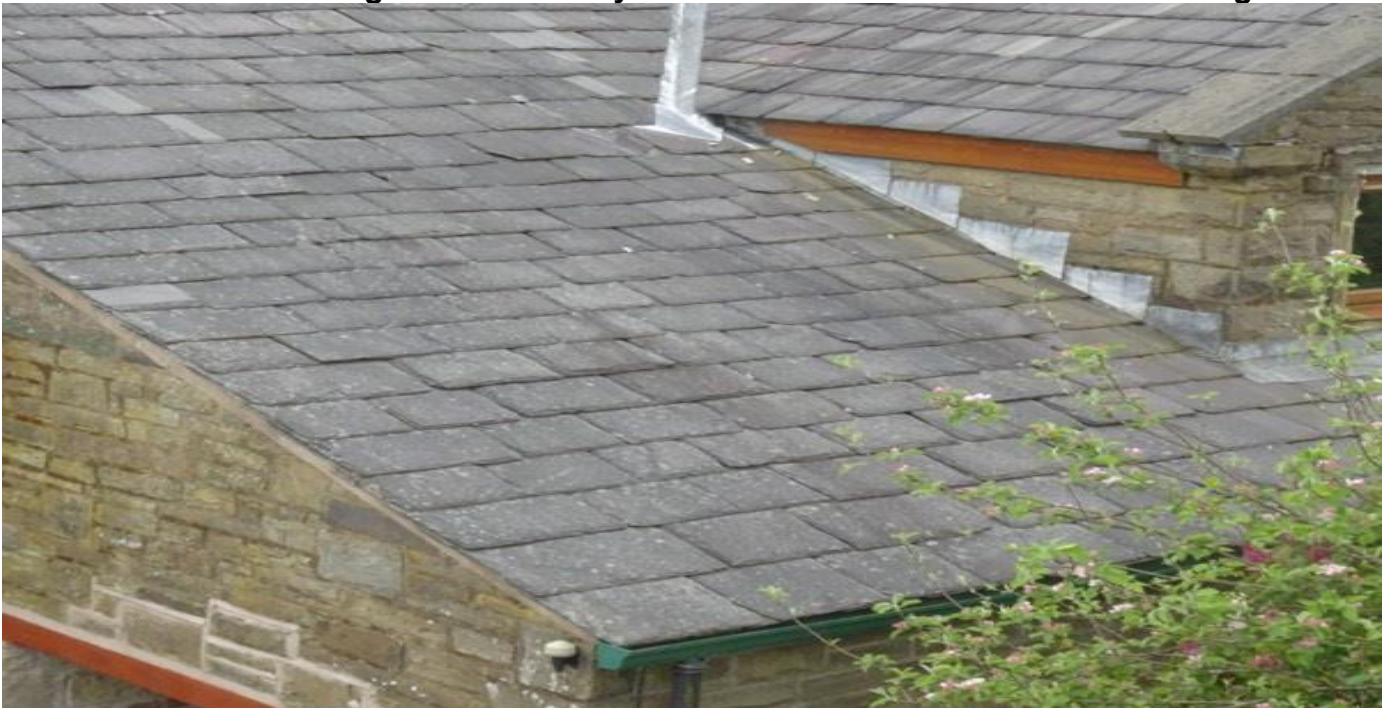
View of the roof covering to the two story addition at the front of the main building.

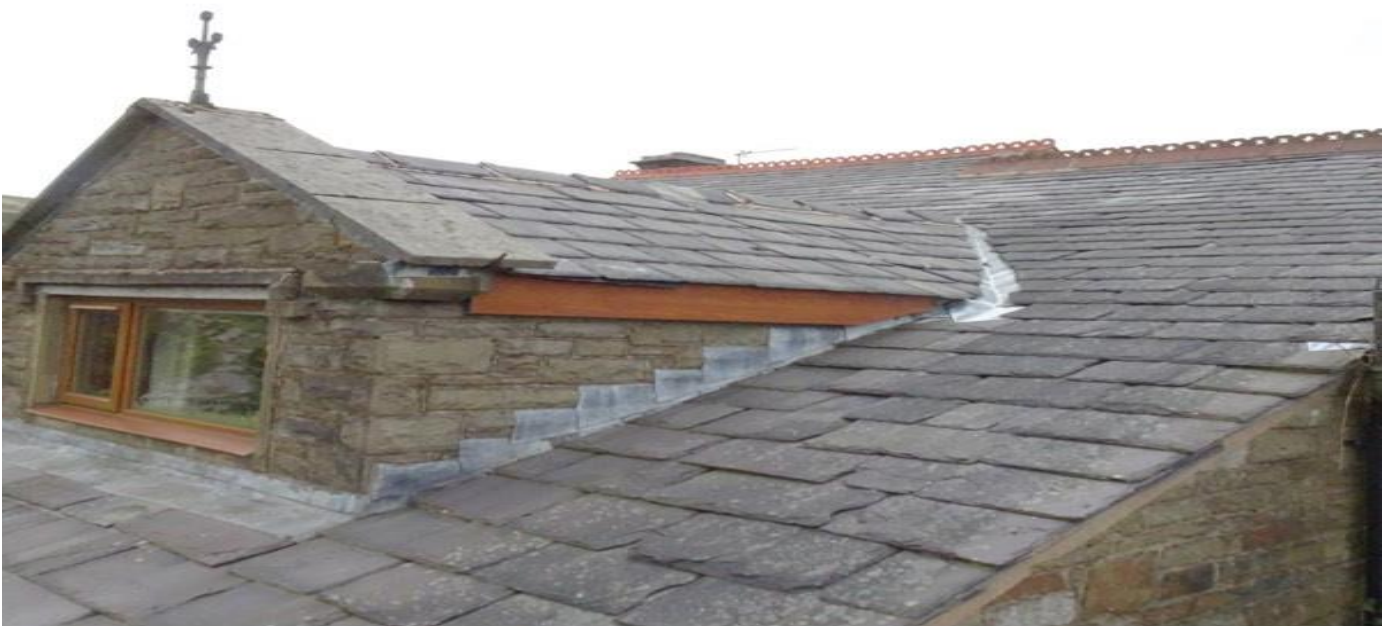
View of the roof covering to the two story addition at the front of the main building.

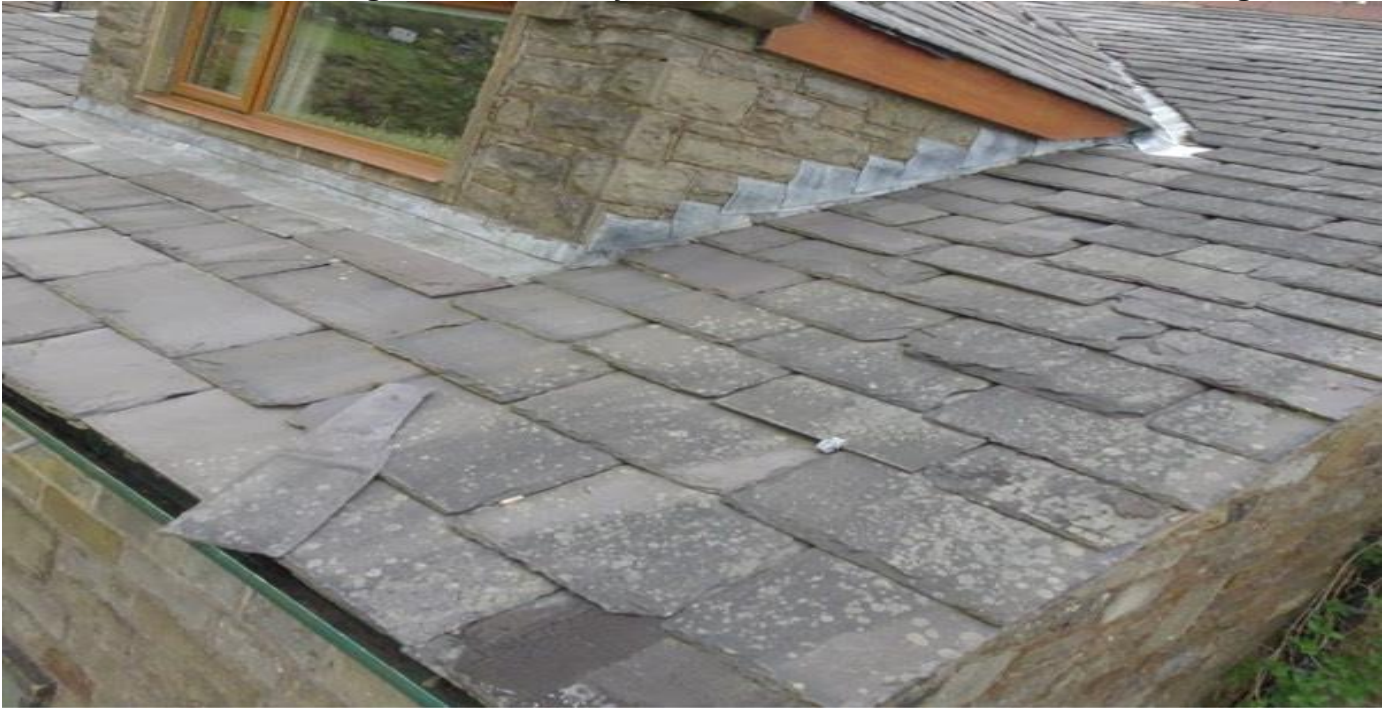
View of the roof covering to the two story addition at the front of the main building.

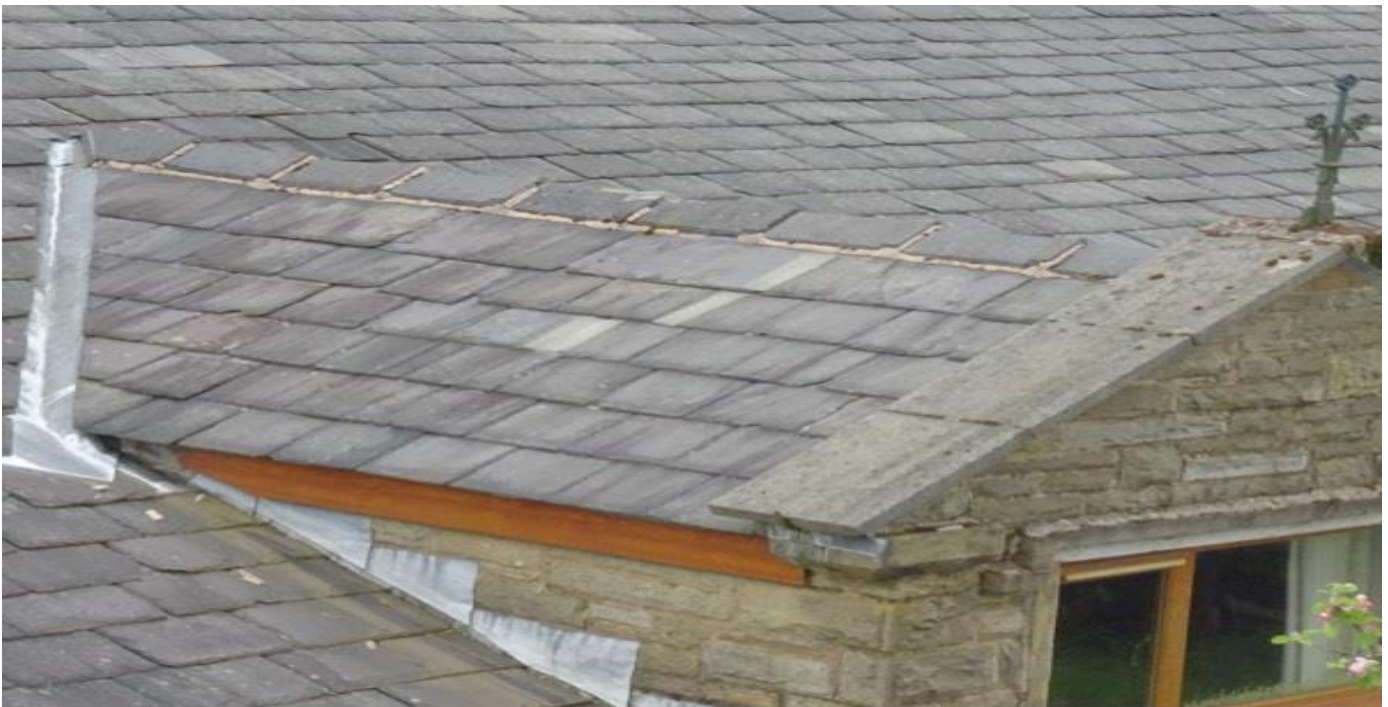
View of the roof covering to the dormer projection at the front of the main building to the left hand side.

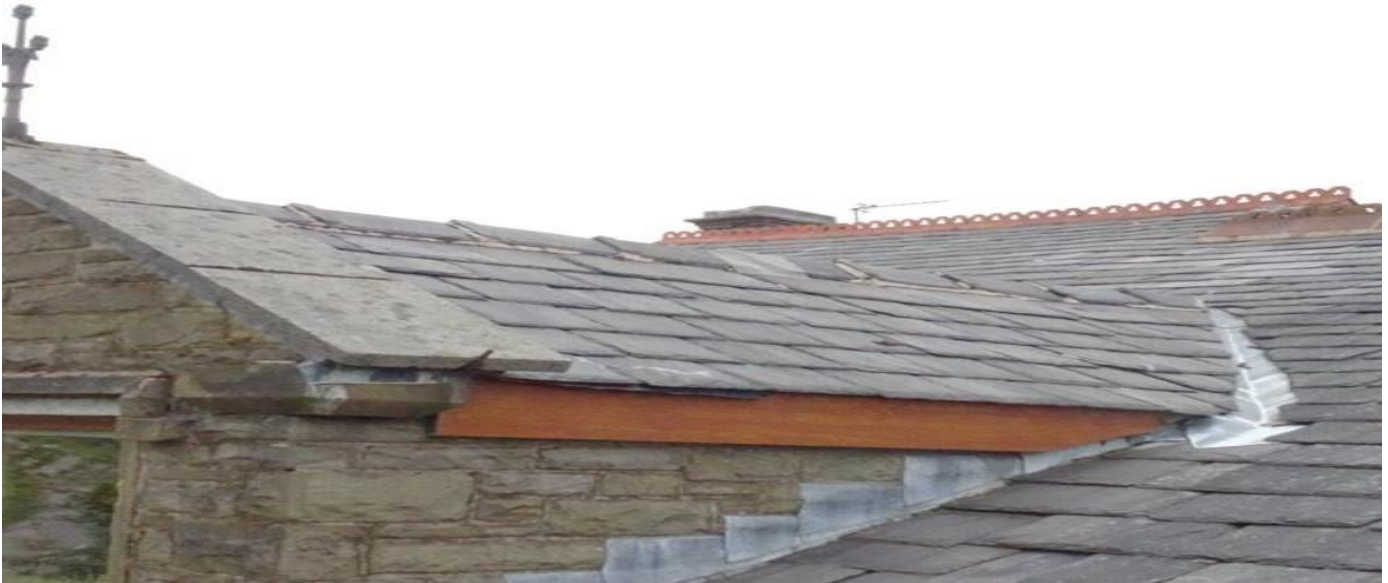
View of the roof covering to the dormer projection at the front of the main building to the left hand side.

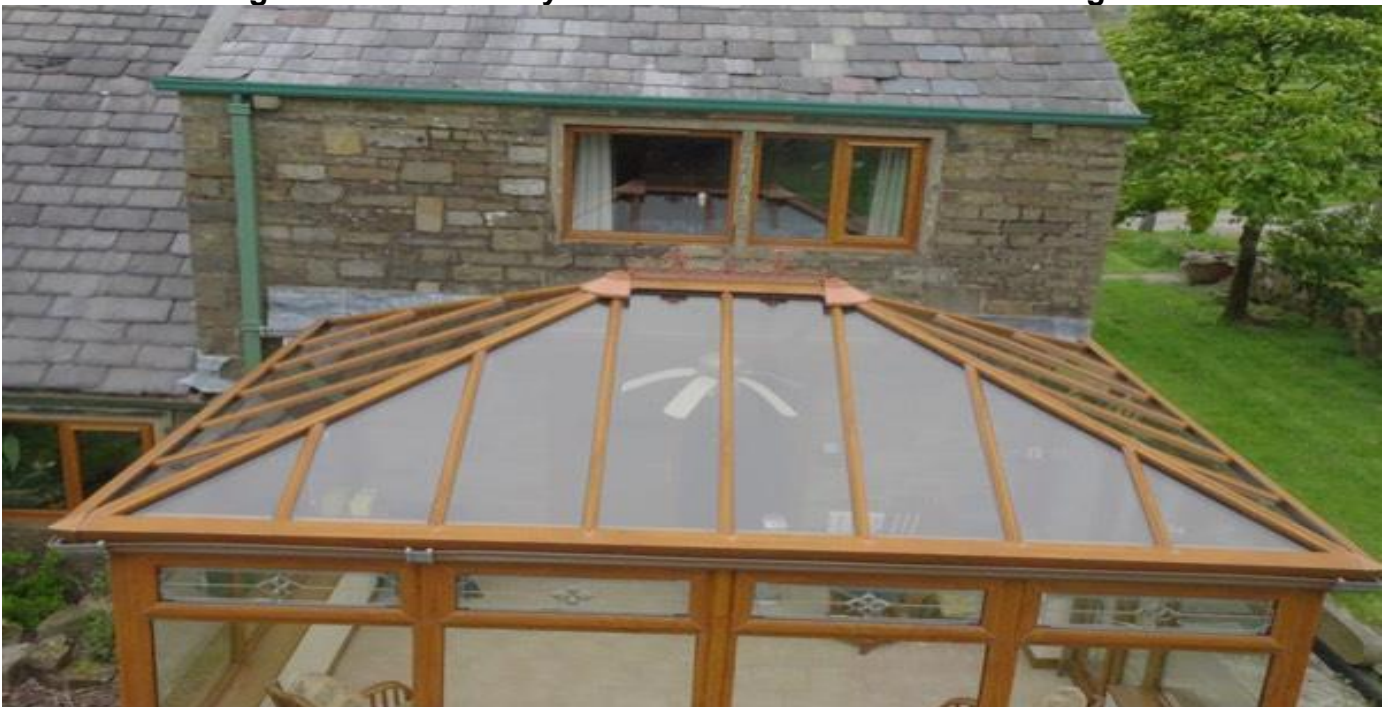
Overview of the glazed conservatory roof at the rear of the main building.

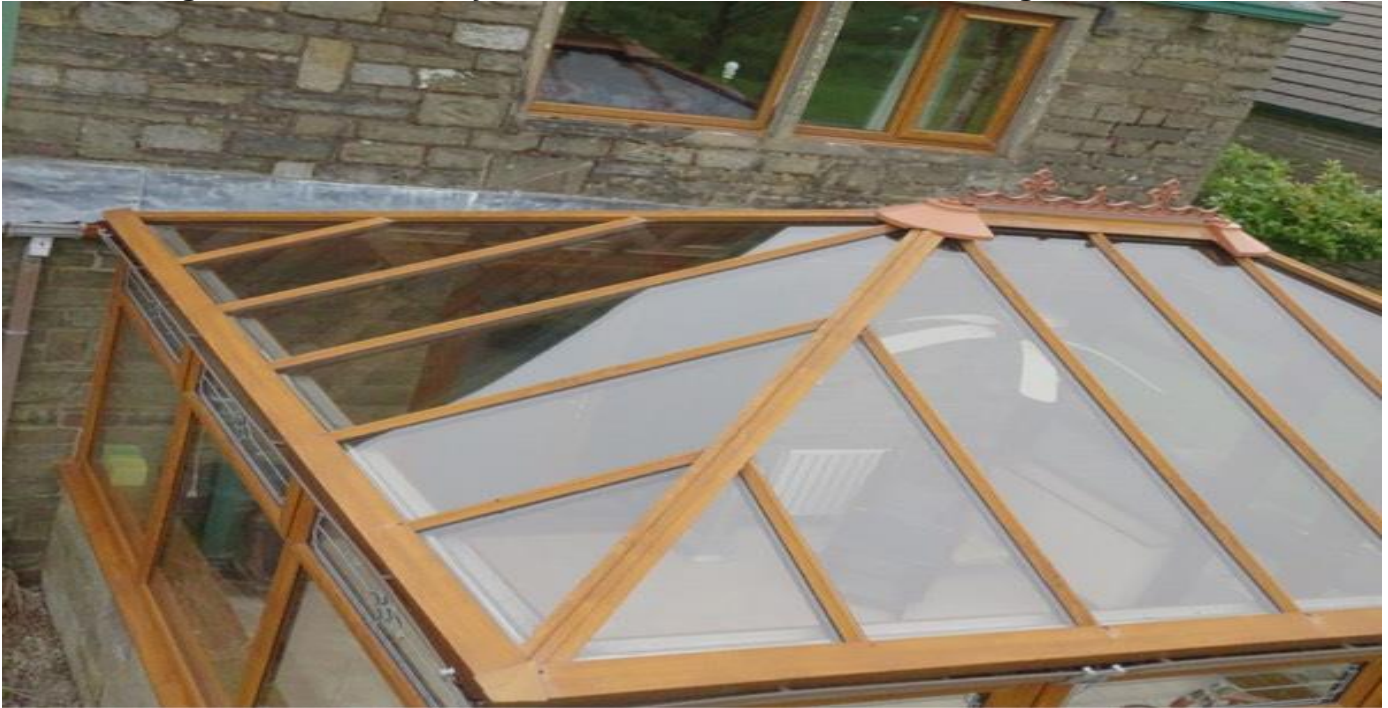
View of the glazed conservatory roof at the rear of the main building.

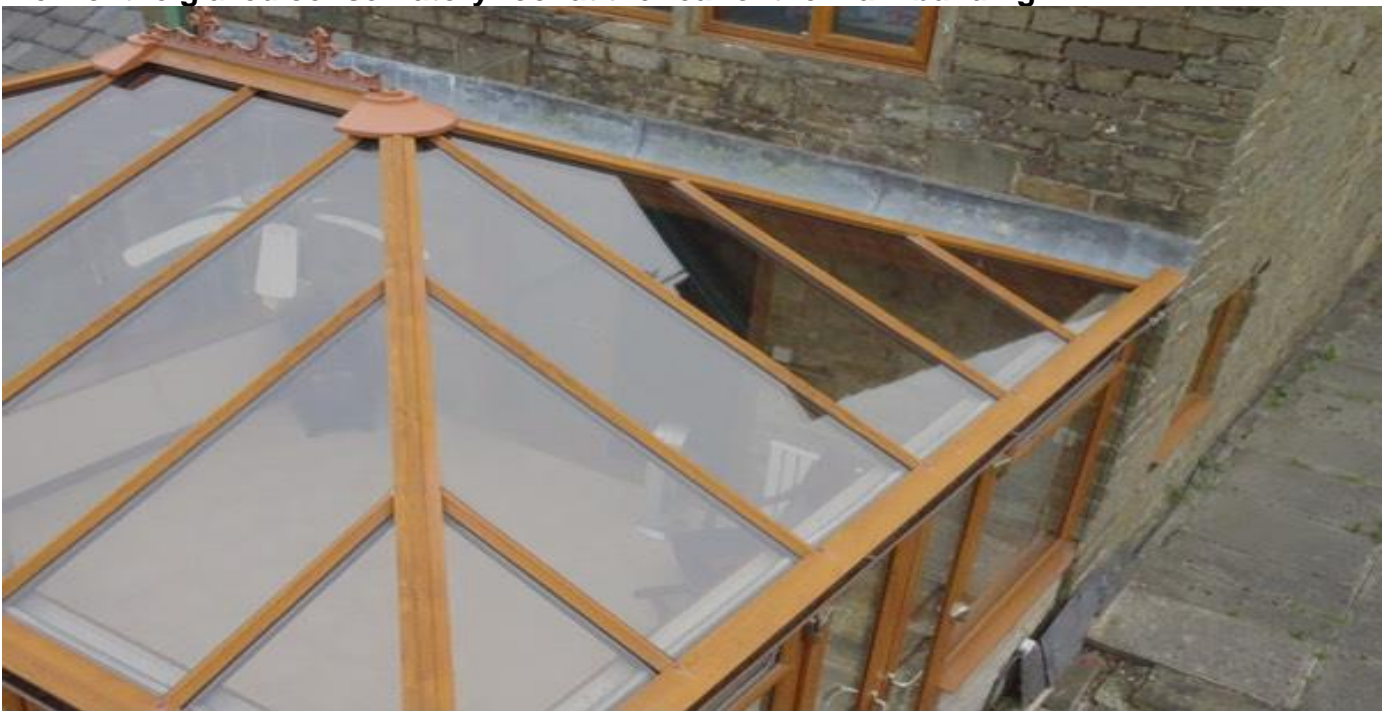
View of the glazed conservatory roof at the rear of the main building.

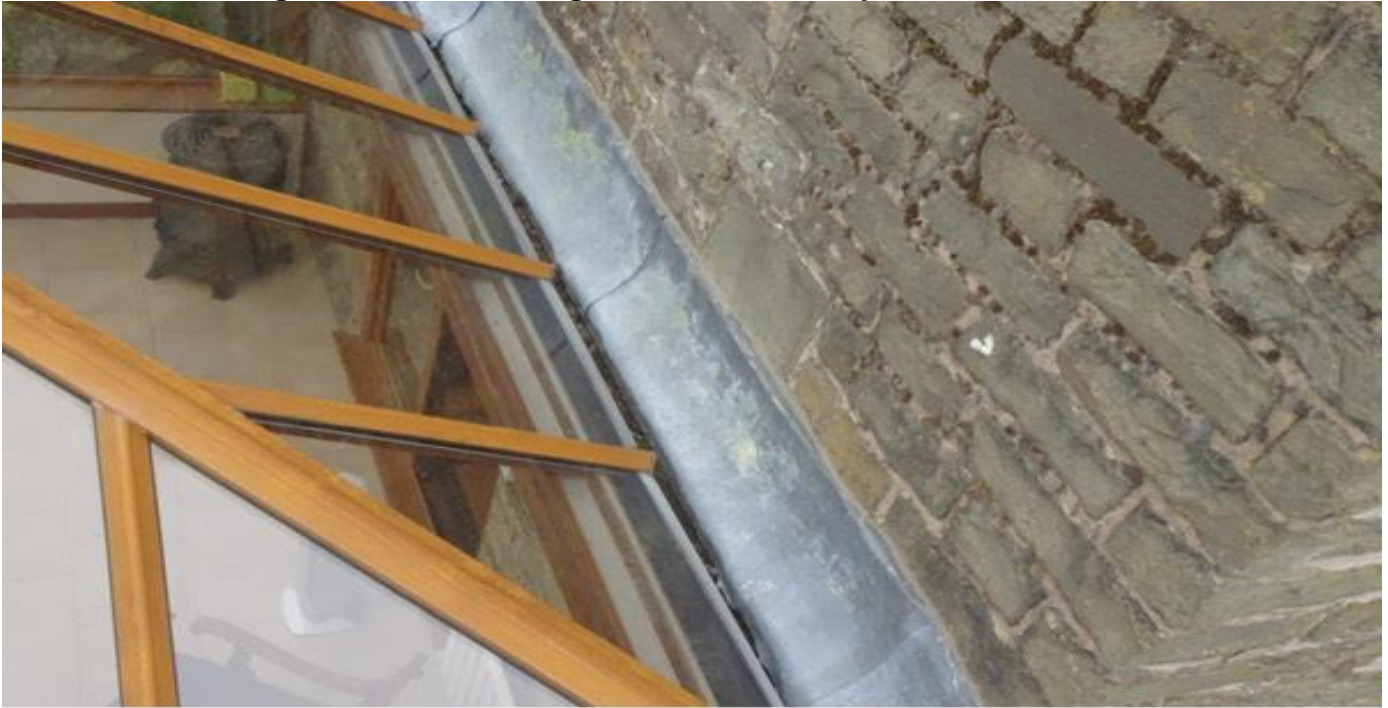
View of the leading abutments to the glazed conservatory roof at the rear.

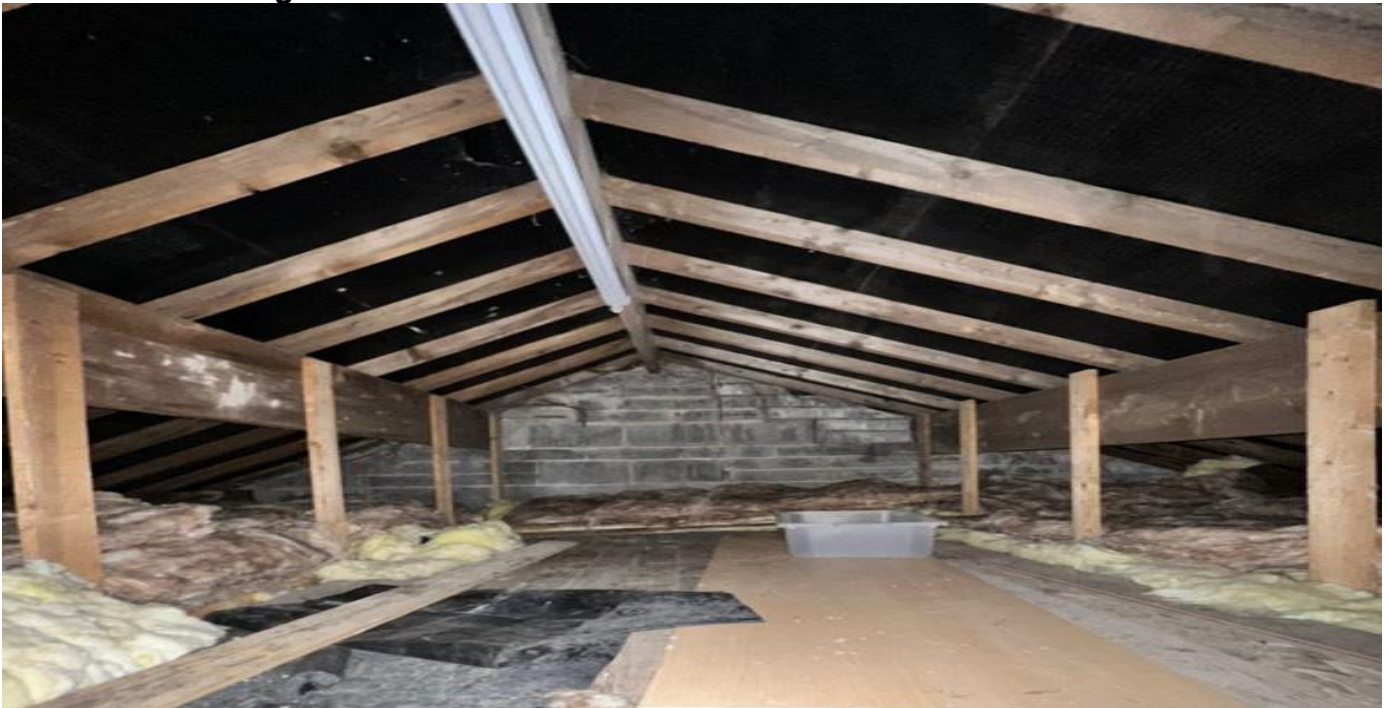
- The inspection of the timber roof structure from within the loft space found that there had been secondary supporting structures installed to the purlins and there has been alterations and repairs to the rafters.

- The inspection also found there to be evidence of heavy wetting and rotting to isolated areas within the loft space and it is anticipated that when the roof covering is removed, timber repairs will be required required to the roof.

View of the sarking and internal timber roof structure.

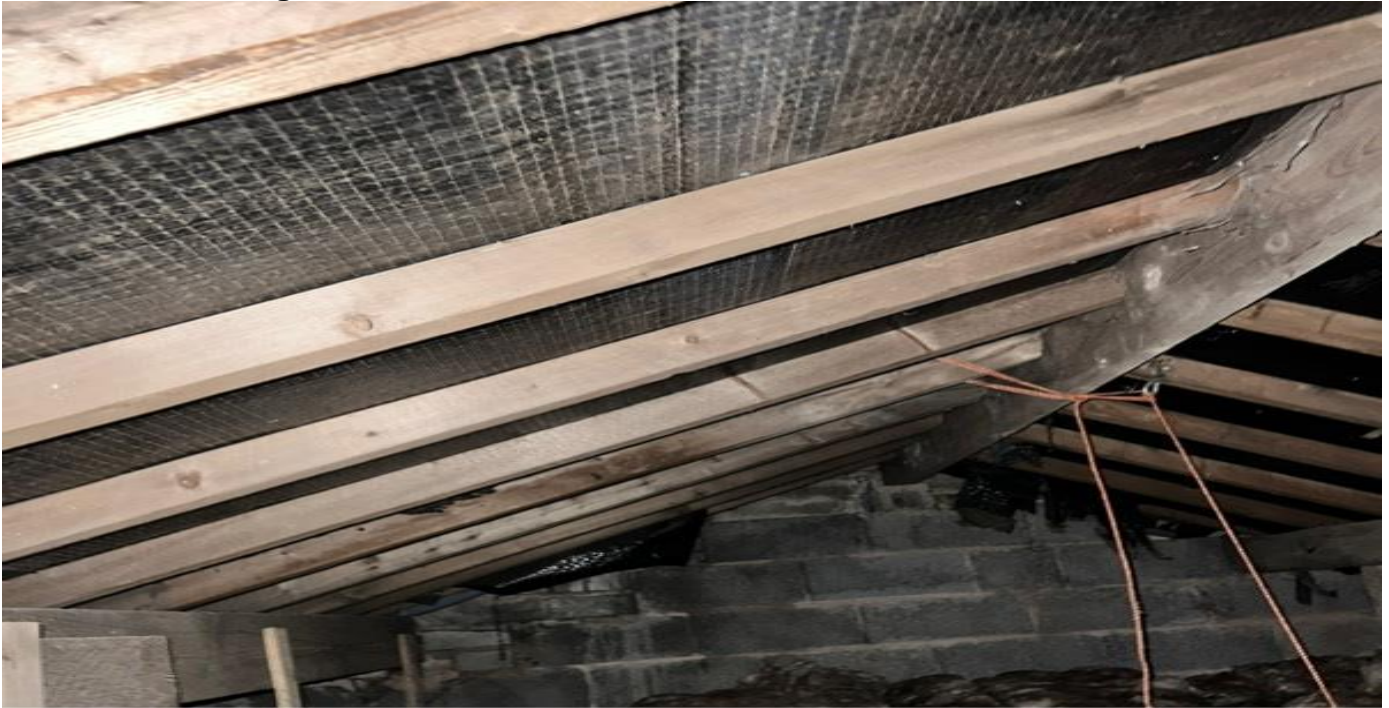
View of the sarking and internal timber roof structure.

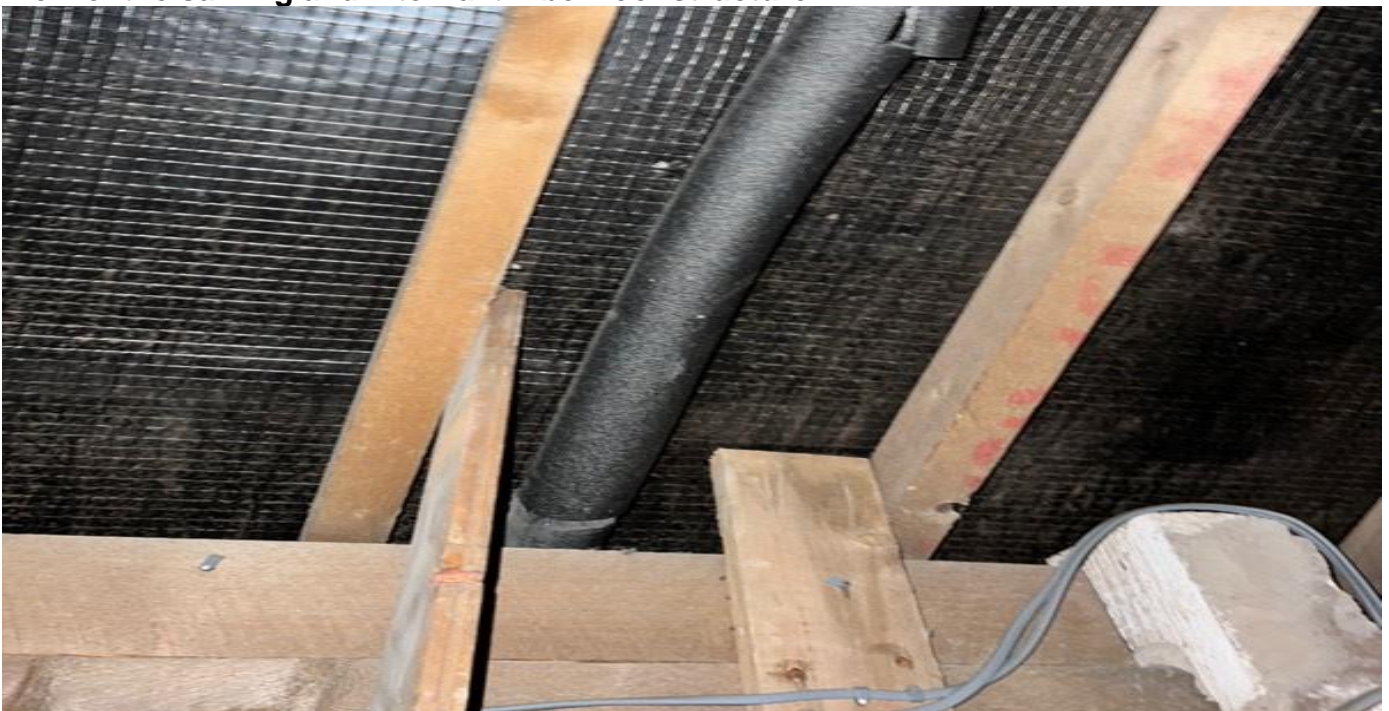
View of the sarking and internal timber roof structure.

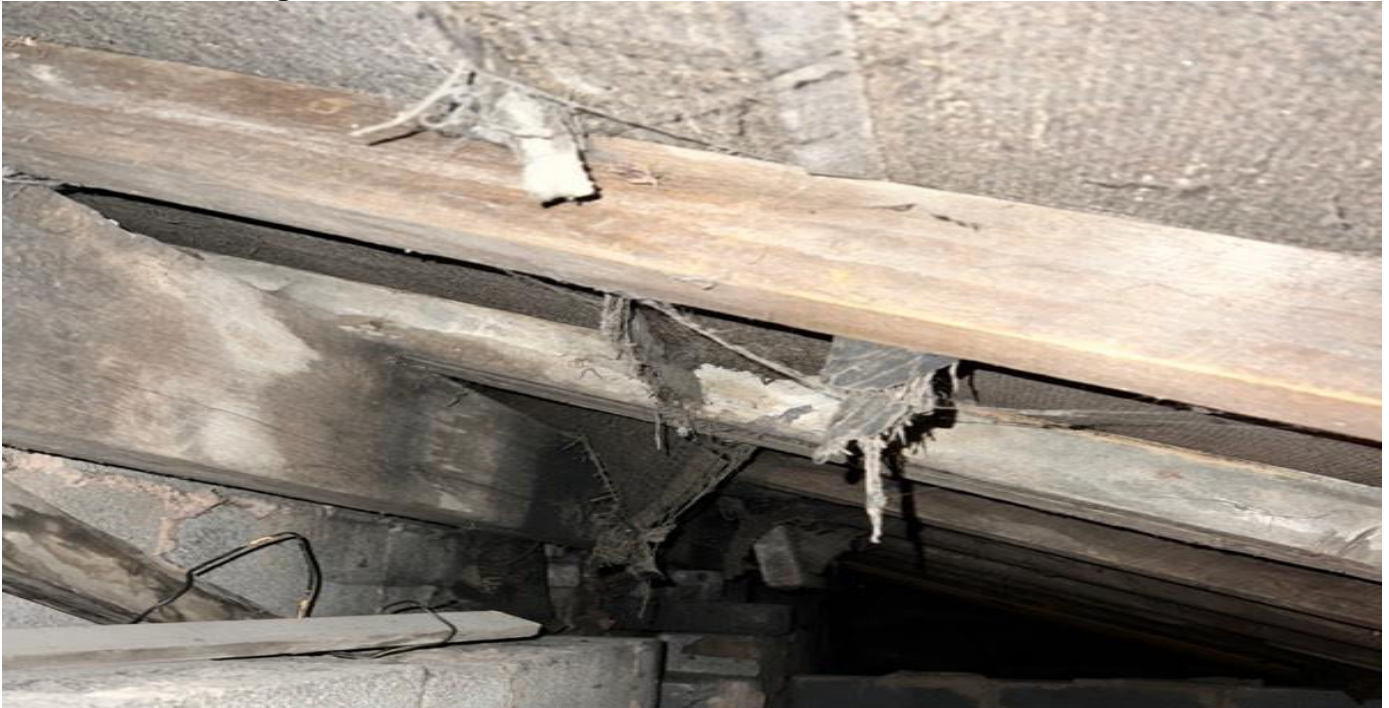
View of the sarking and rotting to the internal timber roof structure.
