PROPERTY SURVEY

Client Name: XXX XXXXX XXXXX
Address: XX XXXXX XXXXXX
XXXXXX XXXXXX
XXXXXX
XX7 0XX
Purpose of Report: STRUCTURAL BUILDING SURVEY
Report Reference: SBS/XXX/2022
Inspection Date: 16 May 2022
Surveyor Name: XXXXX XXXXX BSc (Hons), ASSOC RICS, BCI, CII, BDMA
Building Surveyor Engineer Name: XXXX XXXX BSc (Hons) C Build E, MCABE.

- The property inspected was a farm located on a large plot of open fields of a country road and comprised of two main buildings to include a large stone-built building and a good-sized stone built detached bungalow within the grounds. The main building was found to comprise of a traditionally constructed stone-built structure which had a timber roof with a network of trusses and purlins and rafters supported on load-bearing walls. The roof has been covered with a natural slate roof covering and had a segmented decorative ridge tiles to the ridge line. There were several additions to the main building including a dormer projection at the front, a two-story extension at the front and a glazed conservatory at the rear.

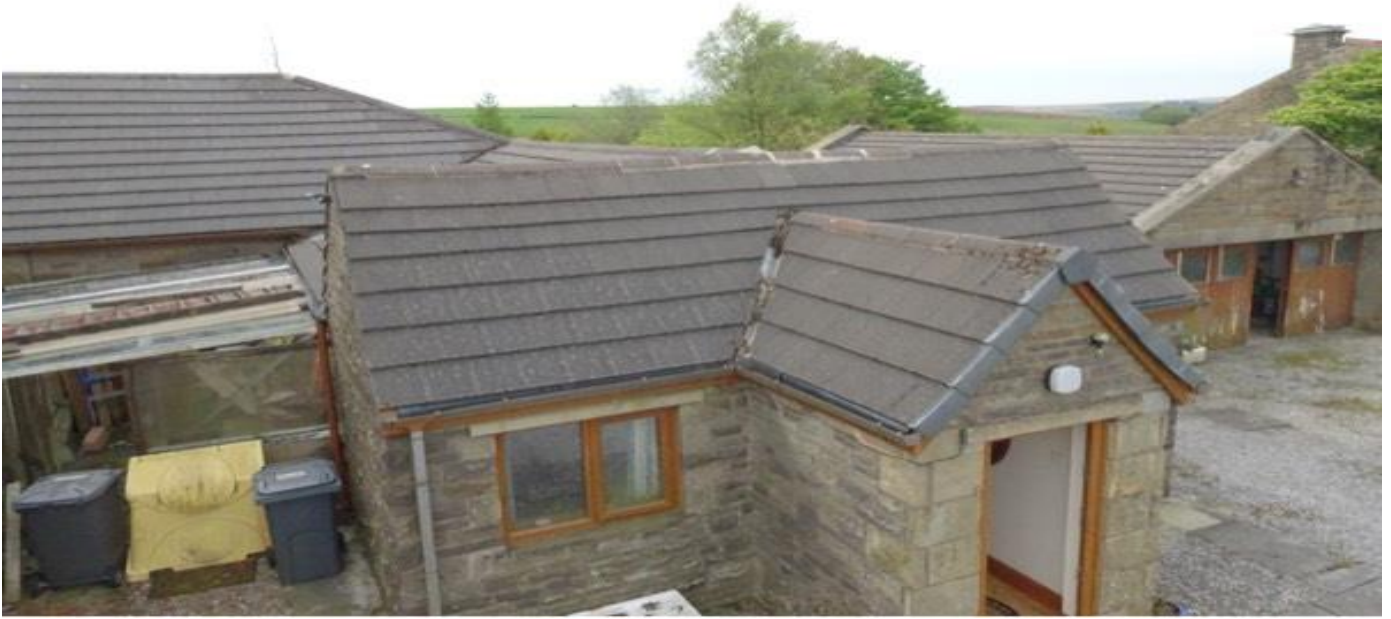
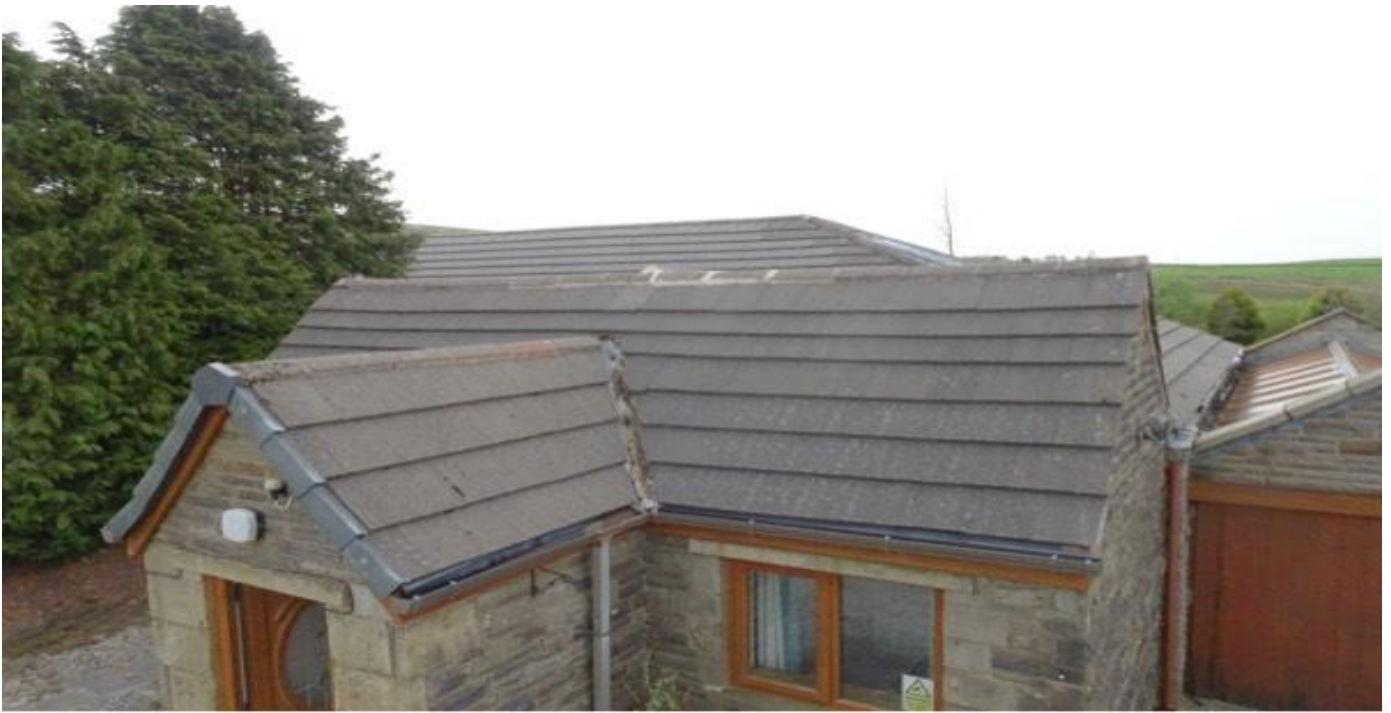
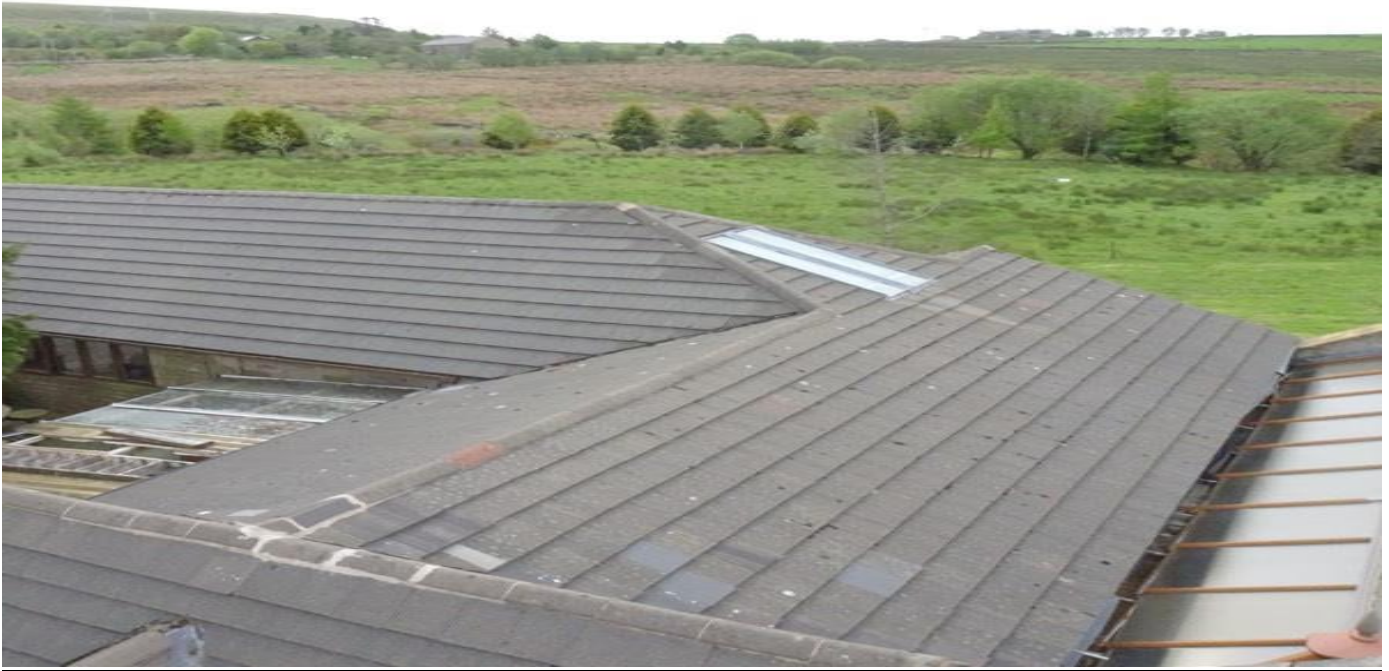
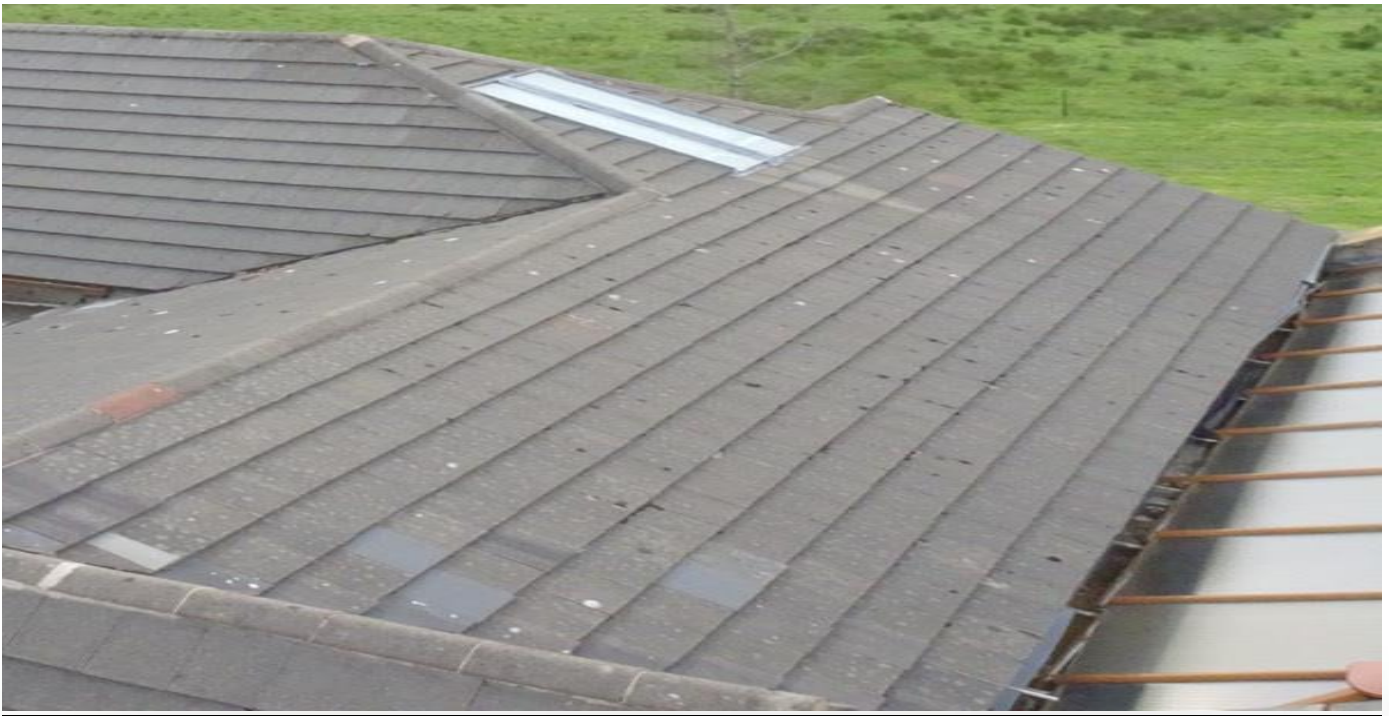
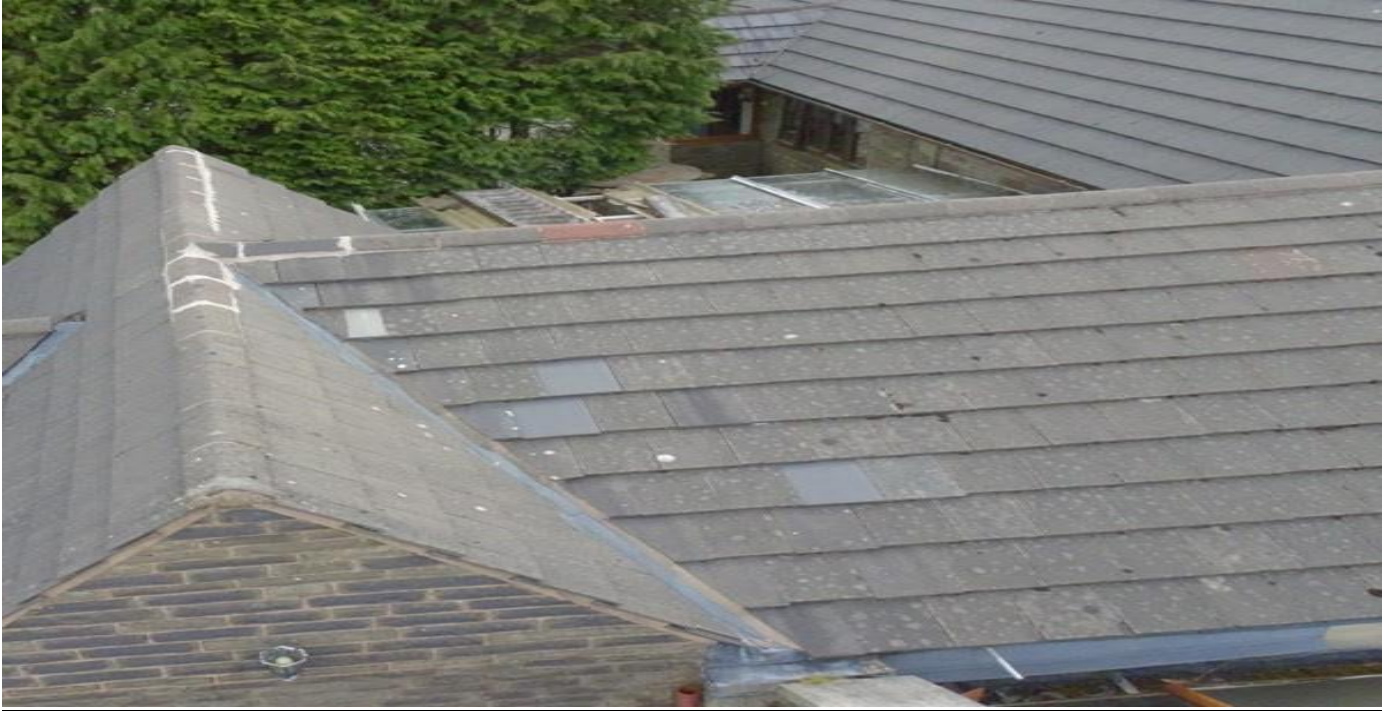
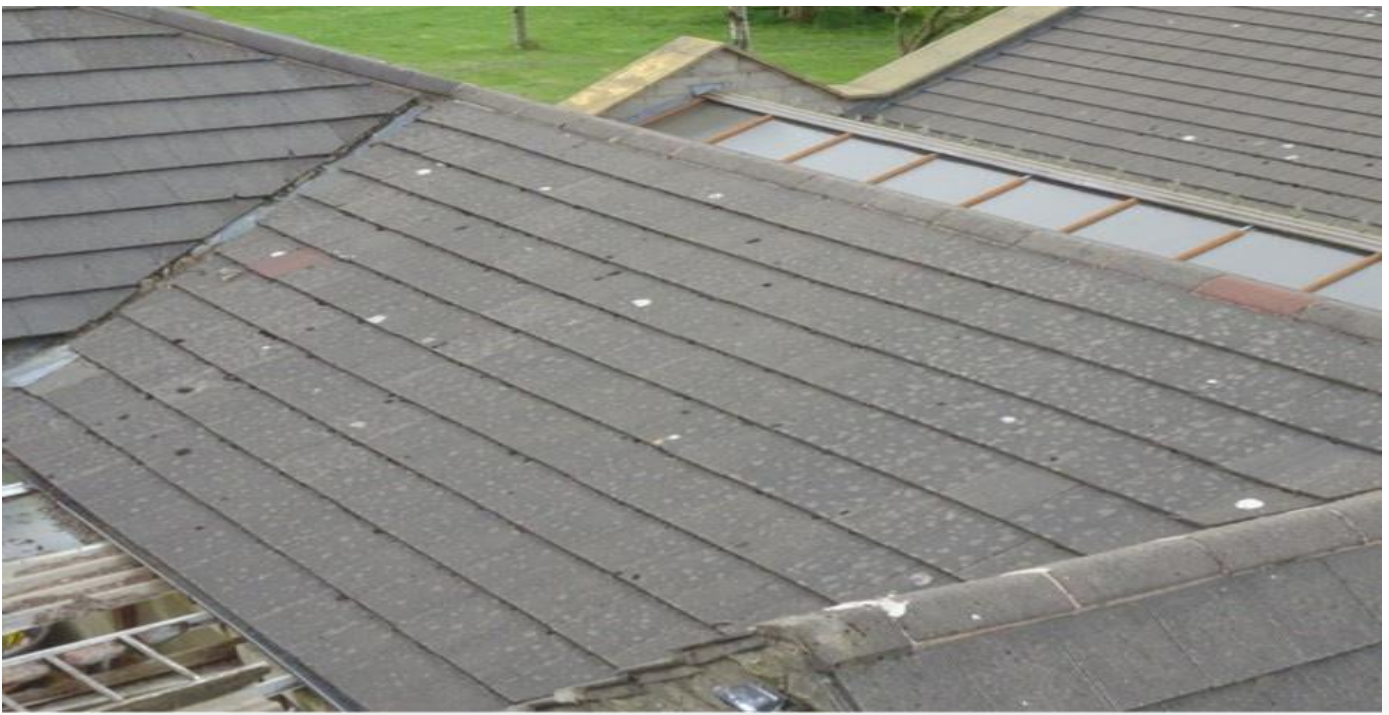
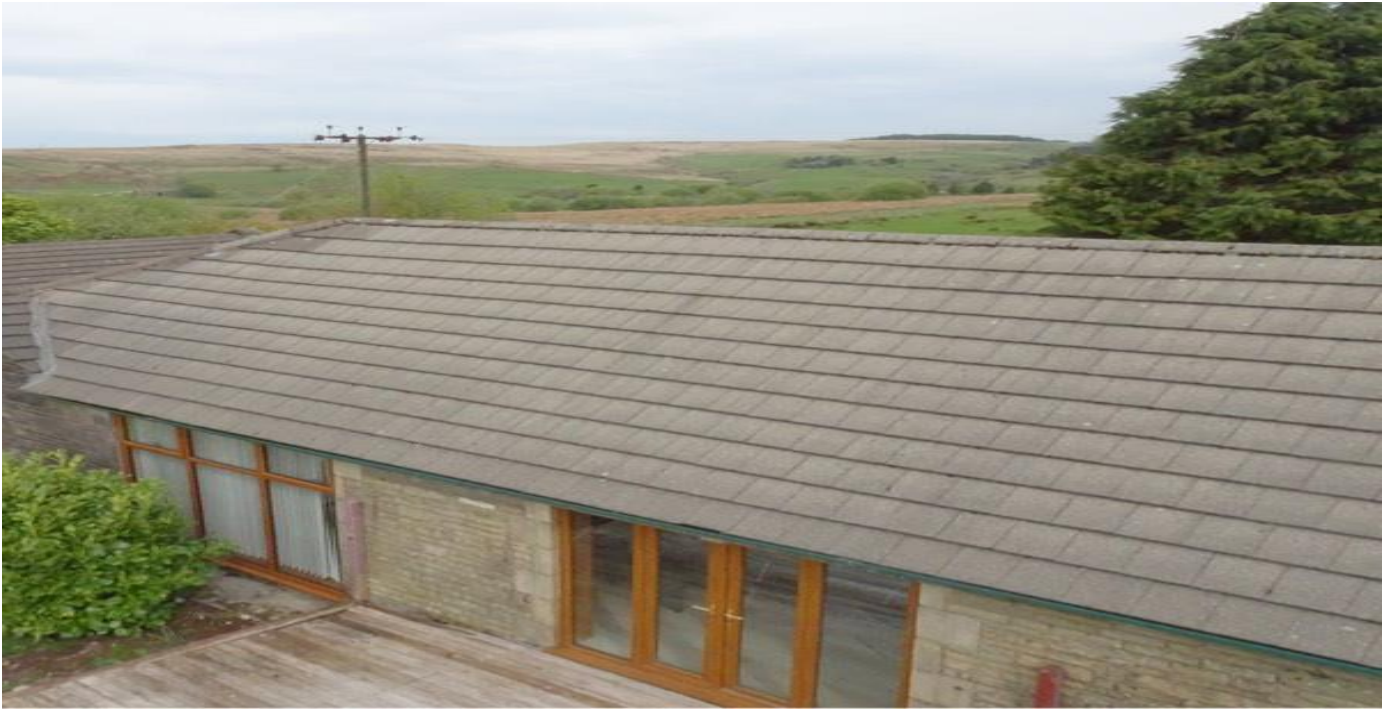
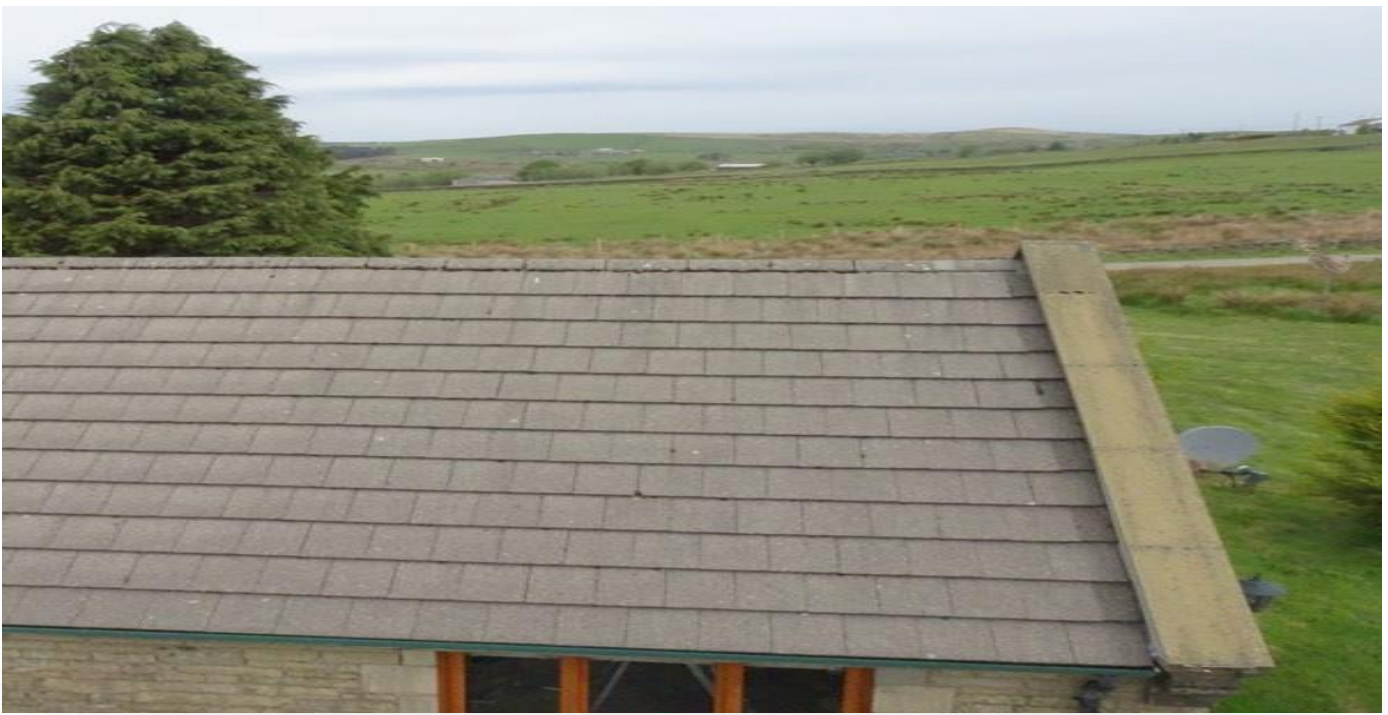
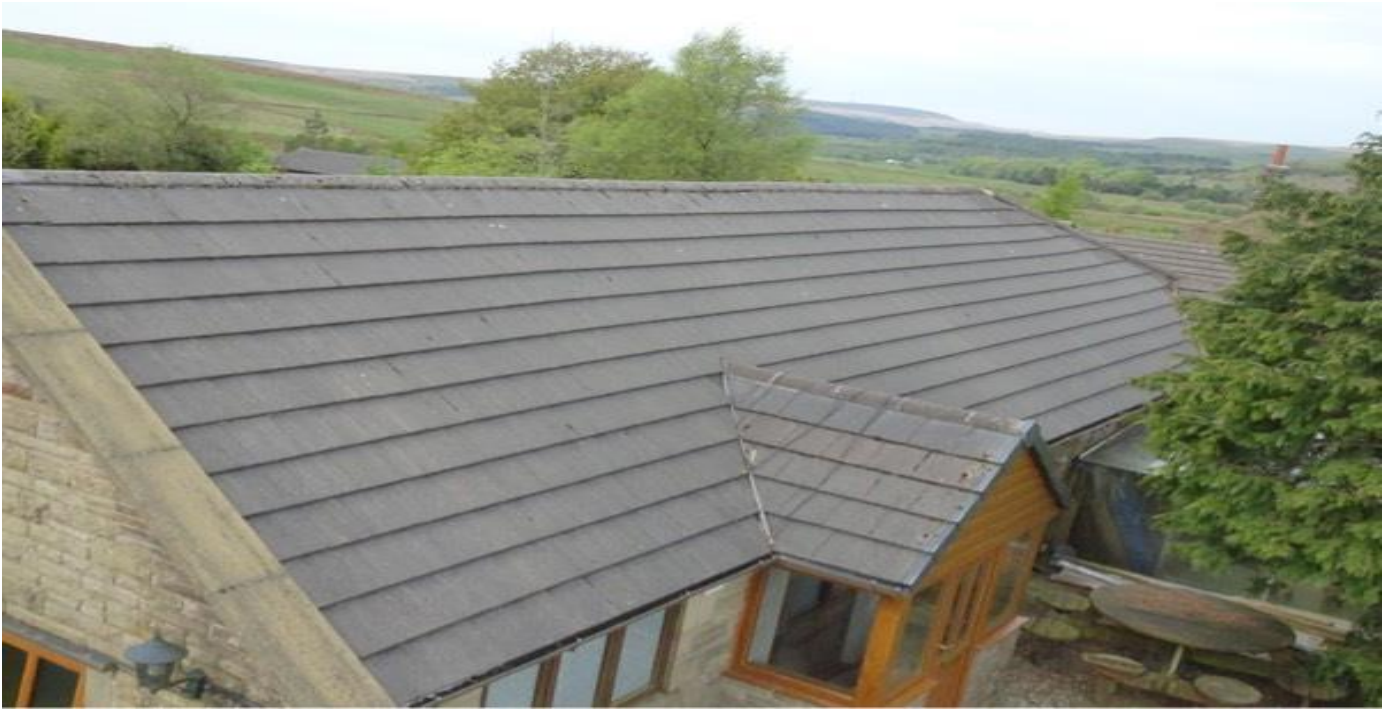
- The inspection of the roof covering to the main area of the detached bungalow found this to be in generally reasonable condition however there was areas of concern to the mortar pointing to the ridge line, the mortar and pointing to the water beds of the coping to the perimeter walls, isolated tile repairs indicating progressive damage to the roof structure and general wear and tear and decay of materials which would require either replacement or restoration to bring up to a acceptable and modern standard.

View of the main roof to the detached bungalow.

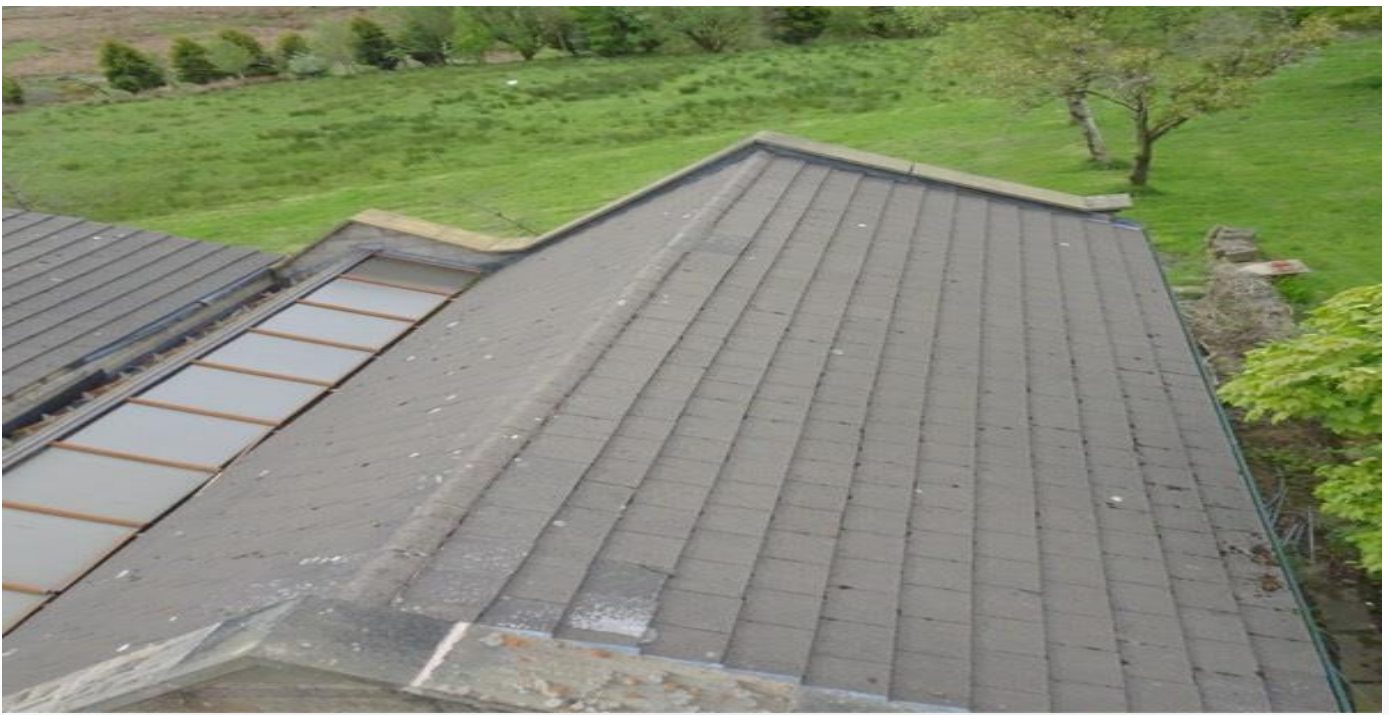
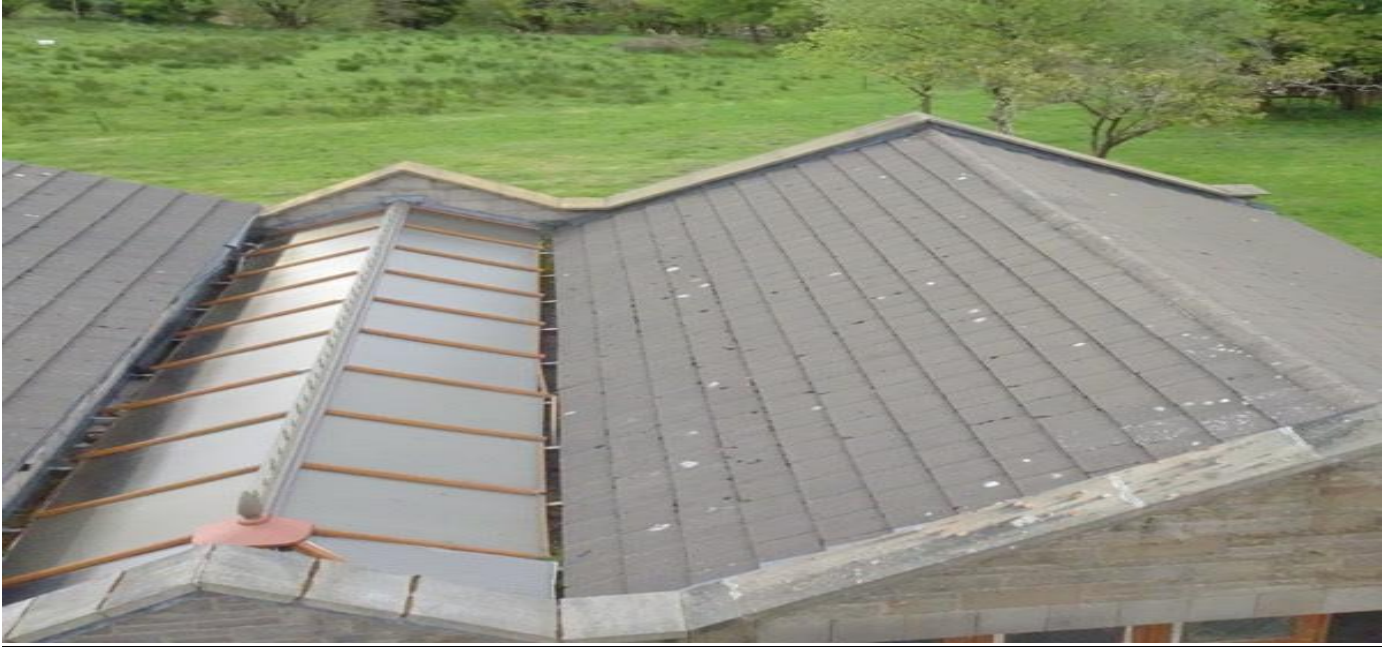
- The roof coverings to the garages at the right-hand side from the interlocking concrete tile roof covering and ridge tiles to be in generally reasonable condition with no evident points of water ingress into the garage.

View of the main roof to the garages of the detached bungalow.

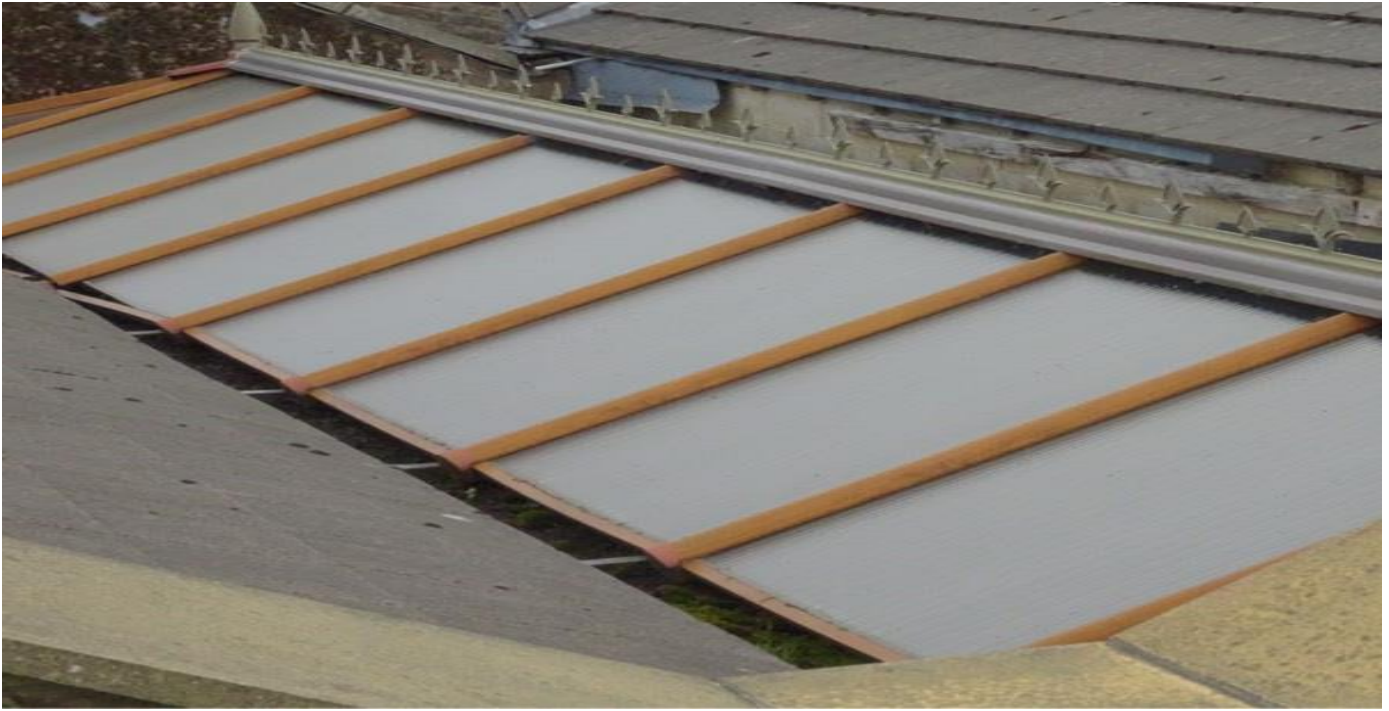
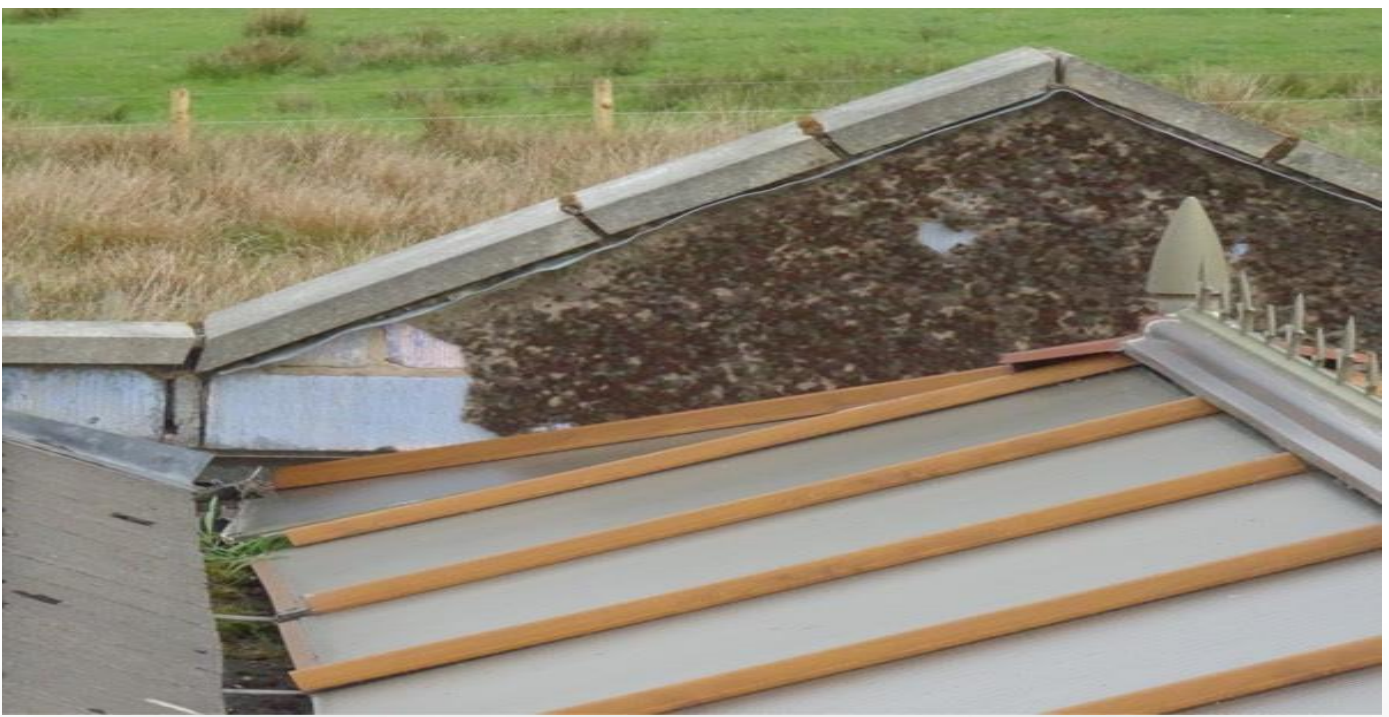
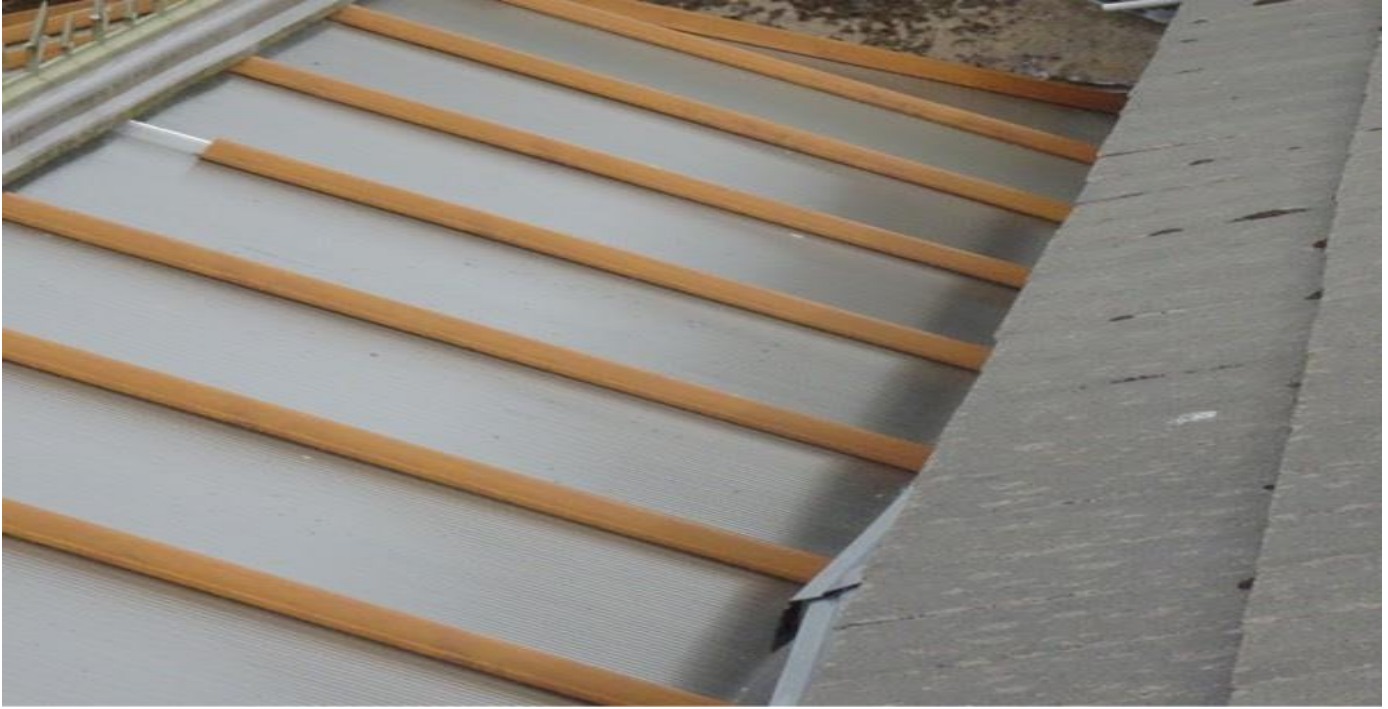
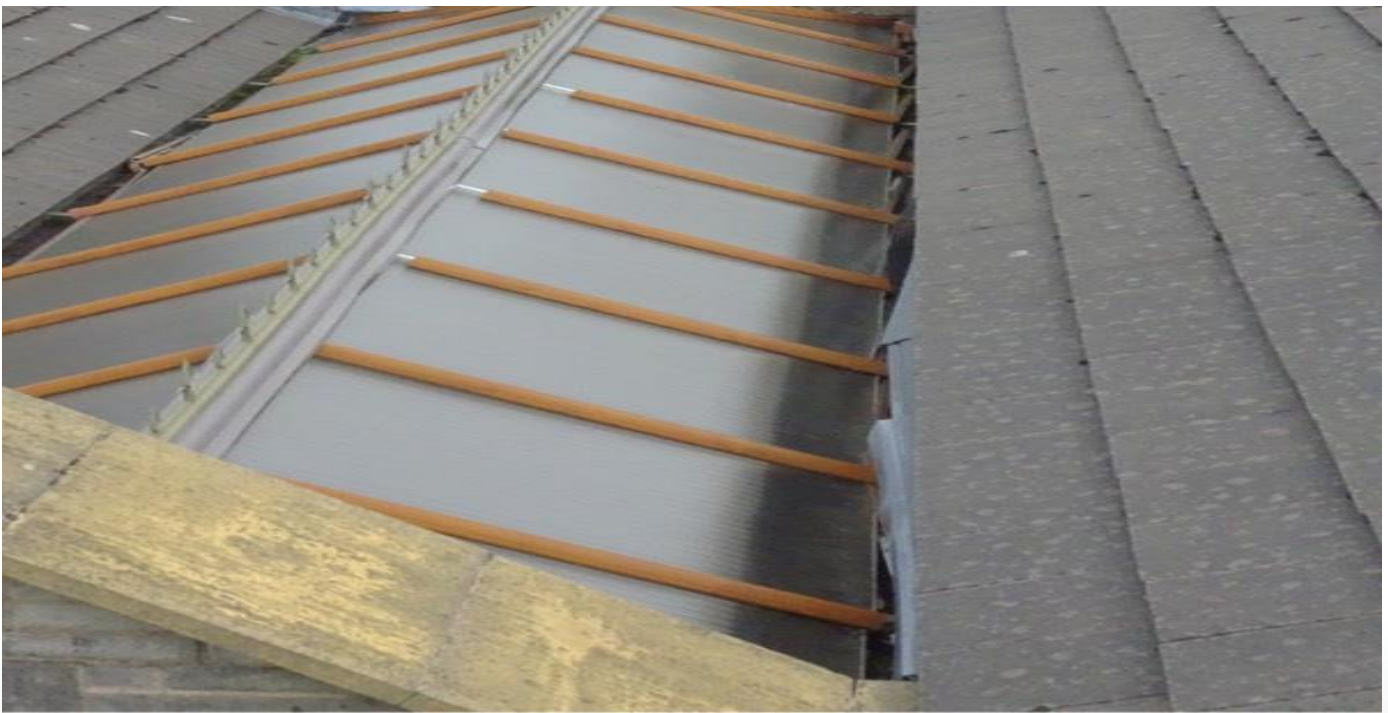
- The inspection of the central polycarbonate roof covering above the garage found this to be in poor condition with evidence of age-related decay suffering from a natural breakdown of materials over the time.

- The roof structure to the polycarbonate roof above the garage was found to be suffering from movements and had internal support due to deterioration of materials because of water ingress through the blocked box gutters and full renewal of the roof will be required to make an effective repair.

View of the polycarbonate roof to the detached bungalow.

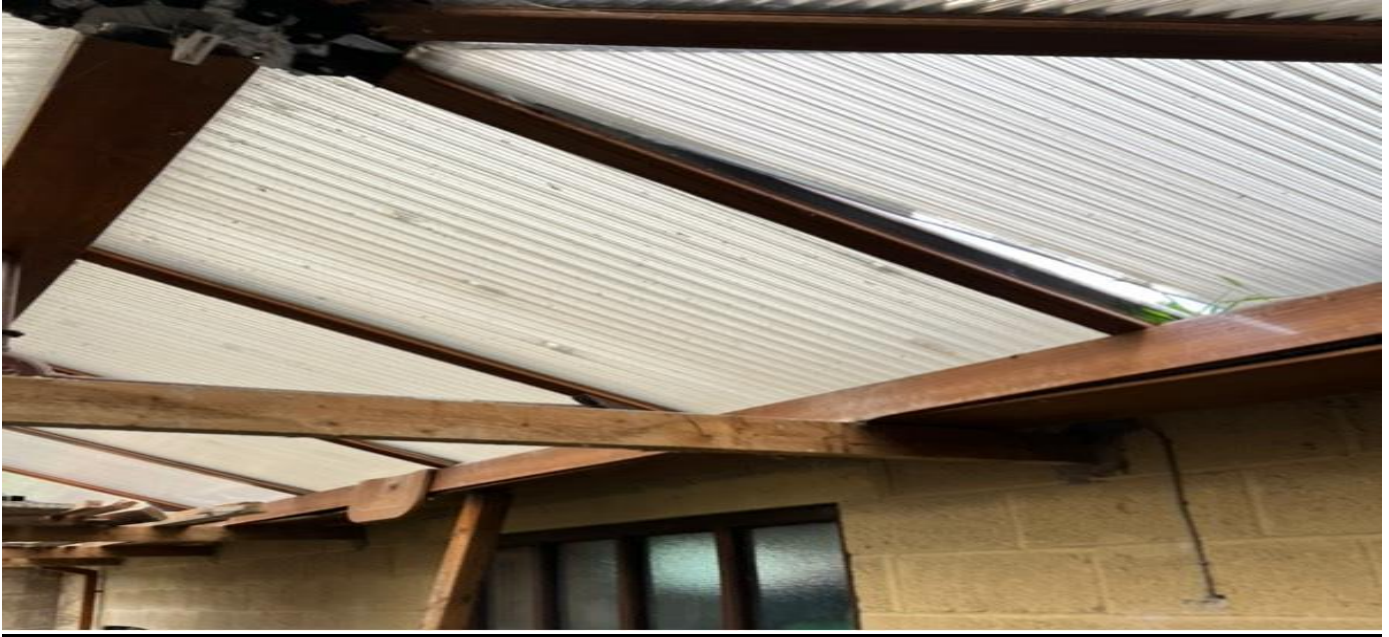
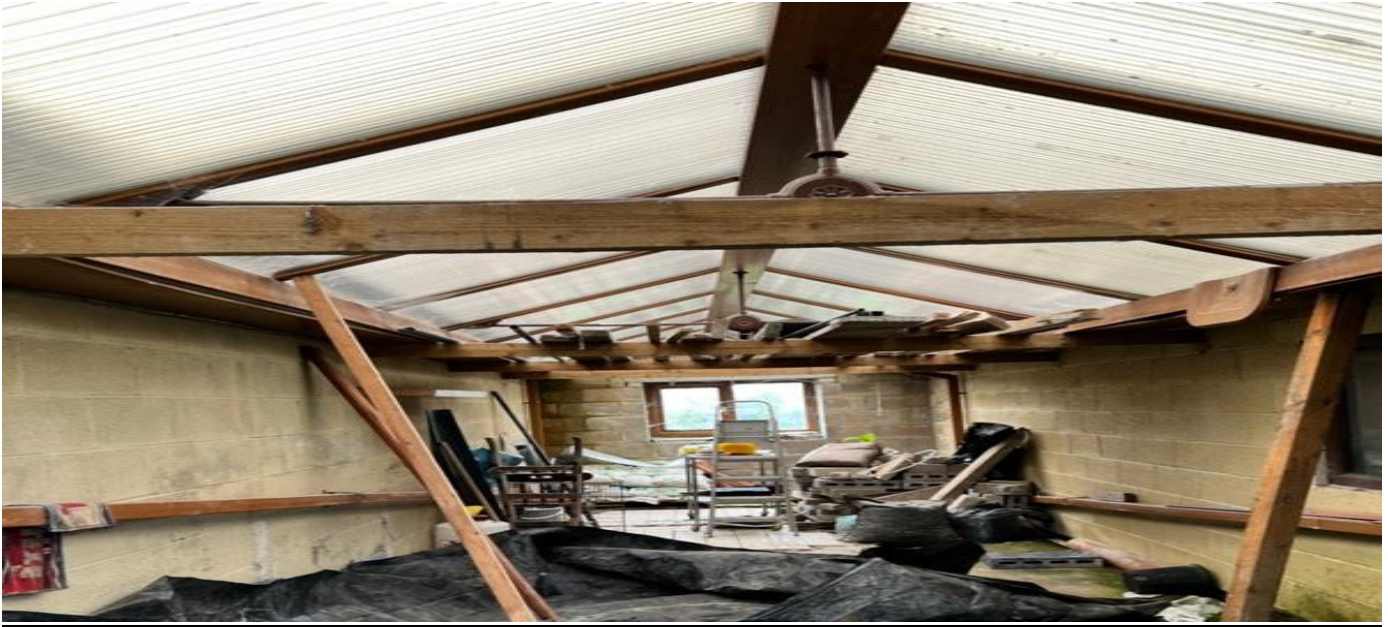
View of the internal supports to the polycarbonate roof to the garages of the detached bungalow.

- Inspection of the box gutter to the polycarbonate roof found this to be in poor condition with evidence of blockages and rainwater ingress which is causing damage to the timber structure resulting in the requirement for internal supports pending full refurbishment of the roof.
