PROPERTY SURVEY

Client Name: XXX XXXXX XXXXX
Address: XX XXXXX XXXXXX
XXXXXX XXXXXX
XXXXXX
XX7 0XX
Purpose of Report: STRUCTURAL BUILDING SURVEY
Report Reference: SBS/XXX/2022
Inspection Date: 16 May 2022
Surveyor Name: XXXXX XXXXX BSc (Hons), ASSOC RICS, BCI, CII, BDMA
Building Surveyor Engineer Name: XXXX XXXX BSc (Hons) C Build E, MCABE.

- The property inspected was a farm located on a large plot of open fields of a country road and comprised of two main buildings to include a large stone-built building and a good-sized stone built detached bungalow within the grounds. The main building was found to comprise of a traditionally constructed stone-built structure which had a timber roof with a network of trusses and purlins and rafters supported on load-bearing walls. The roof has been covered with a natural slate roof covering and had a segmented decorative ridge tiles to the ridge line. There were several additions to the main building including a dormer projection at the front, a two-story extension at the front and a glazed conservatory at the rear.

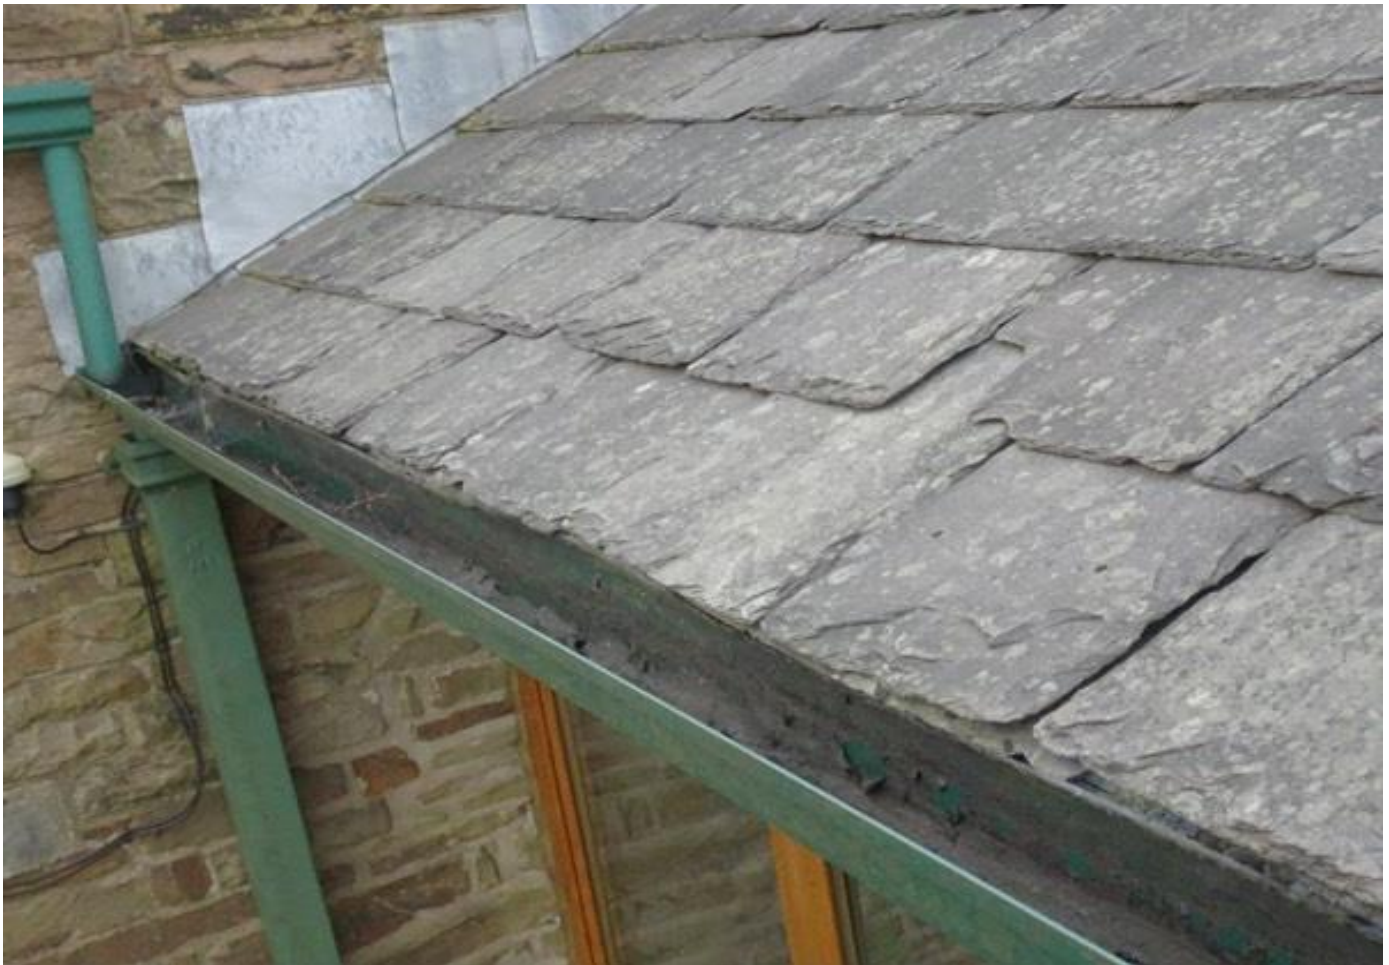
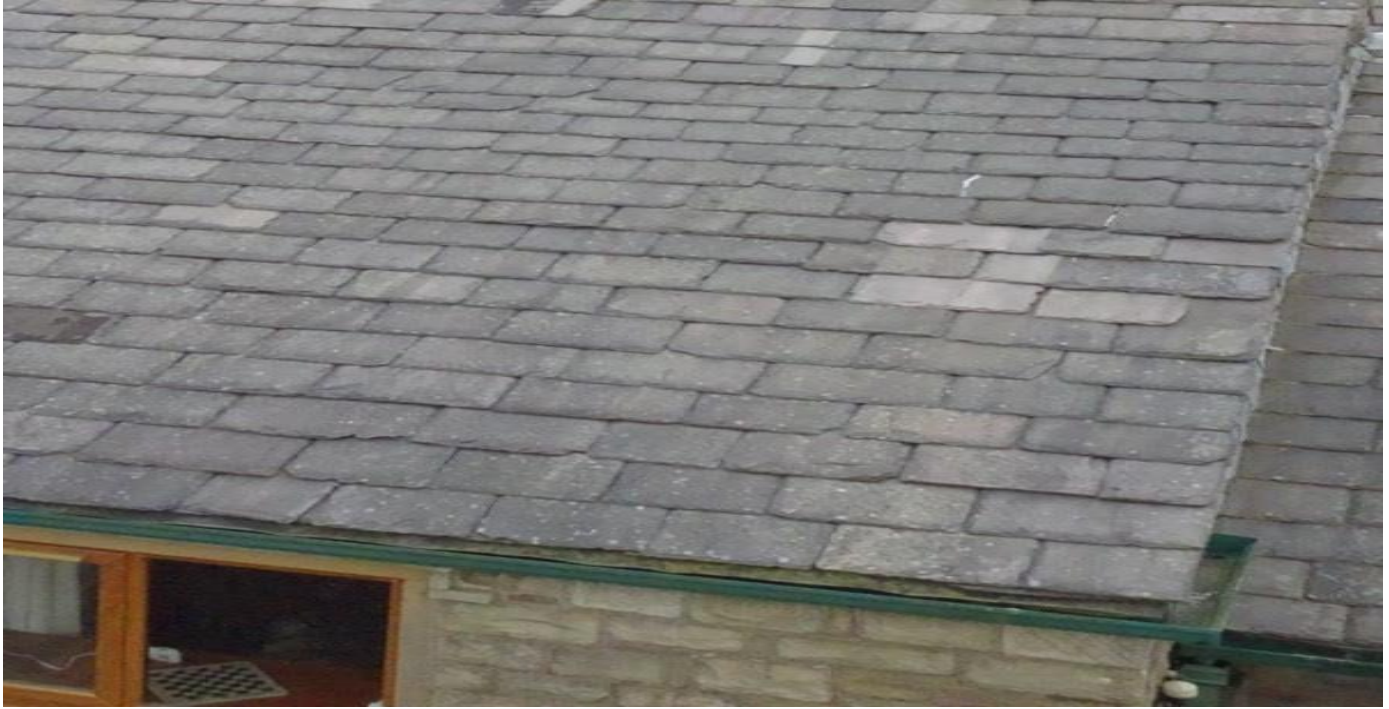
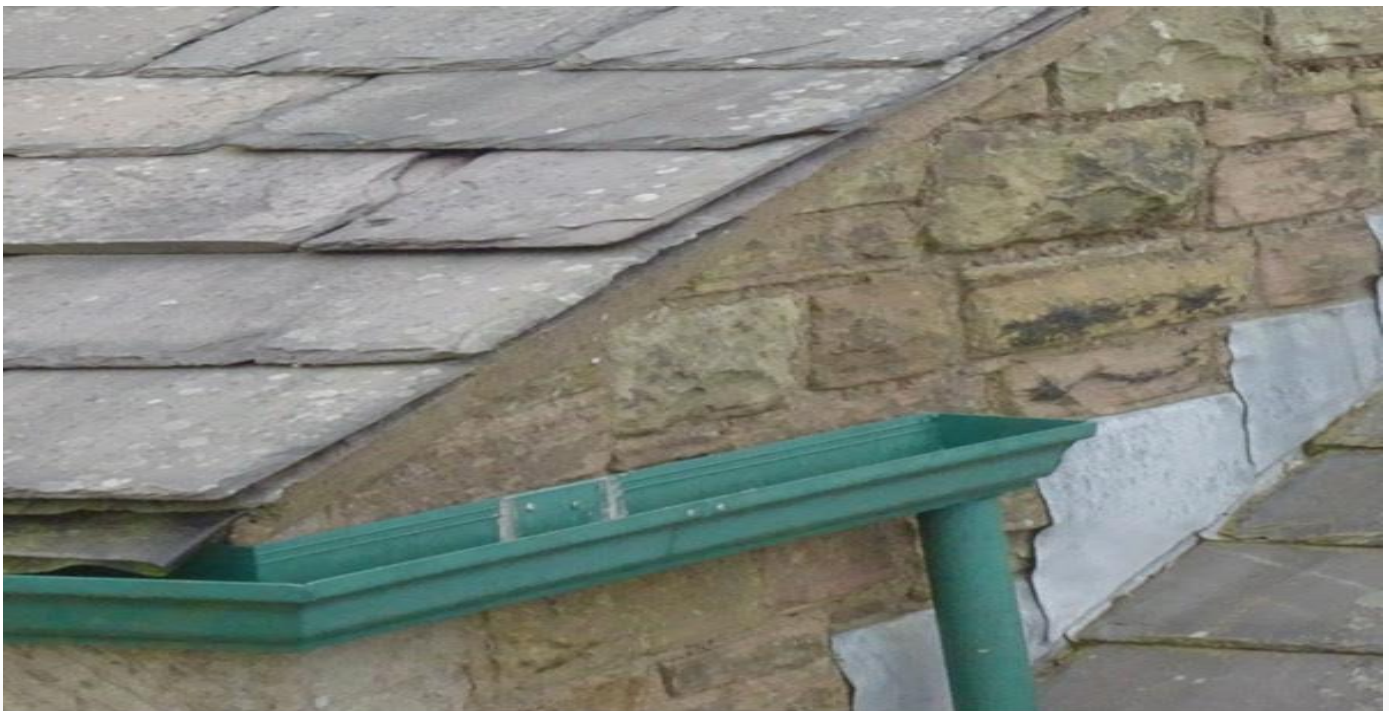
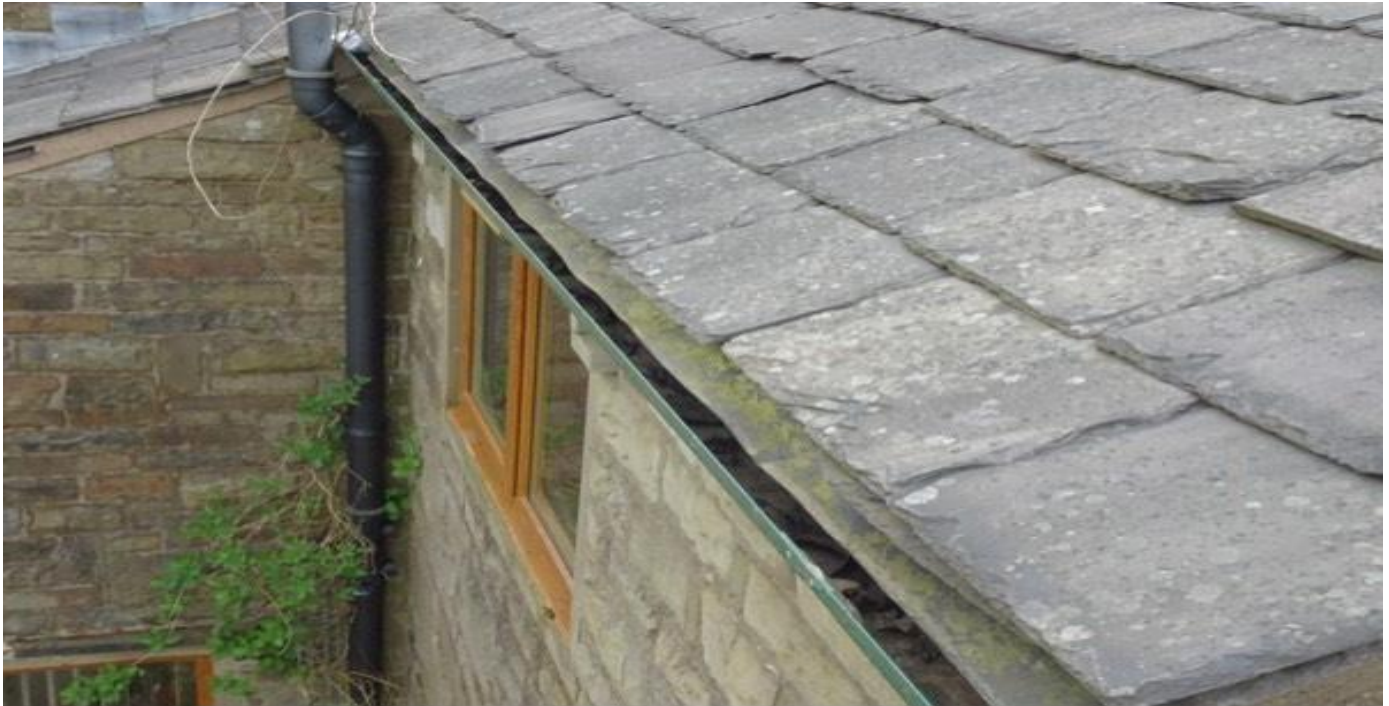
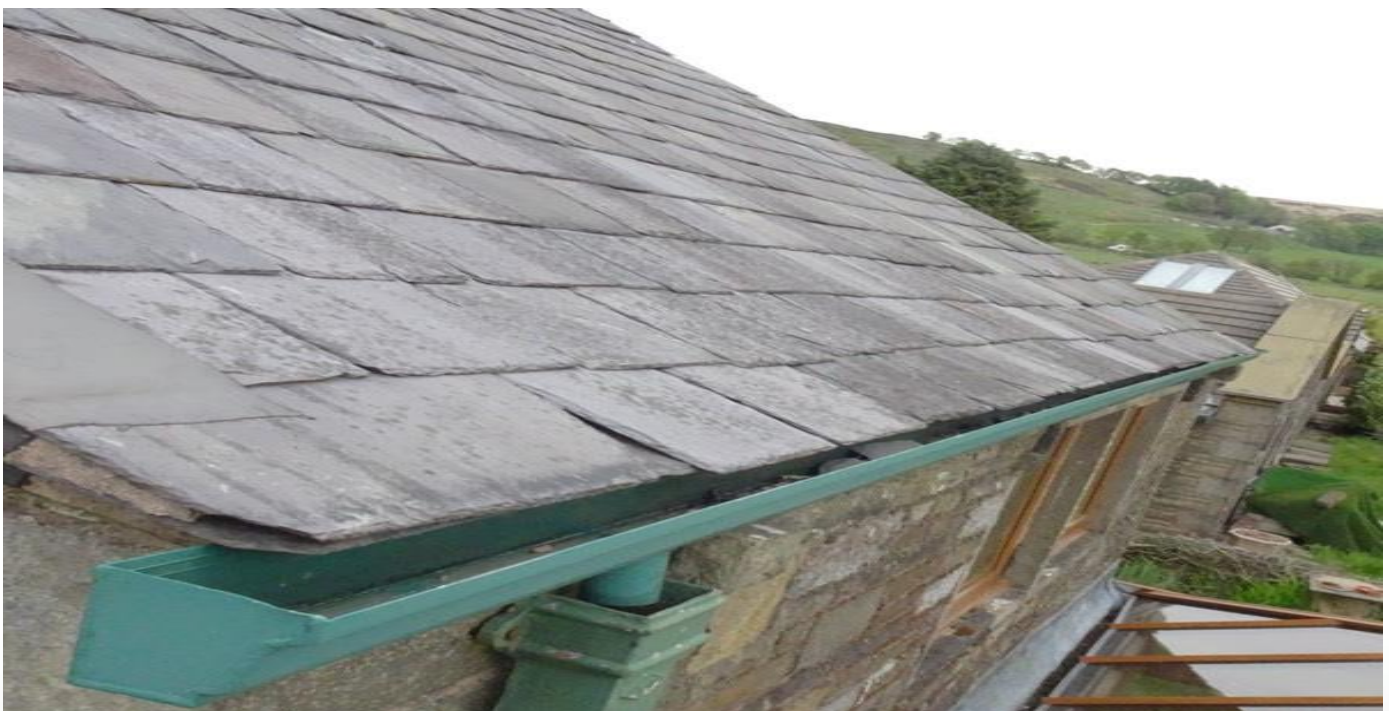
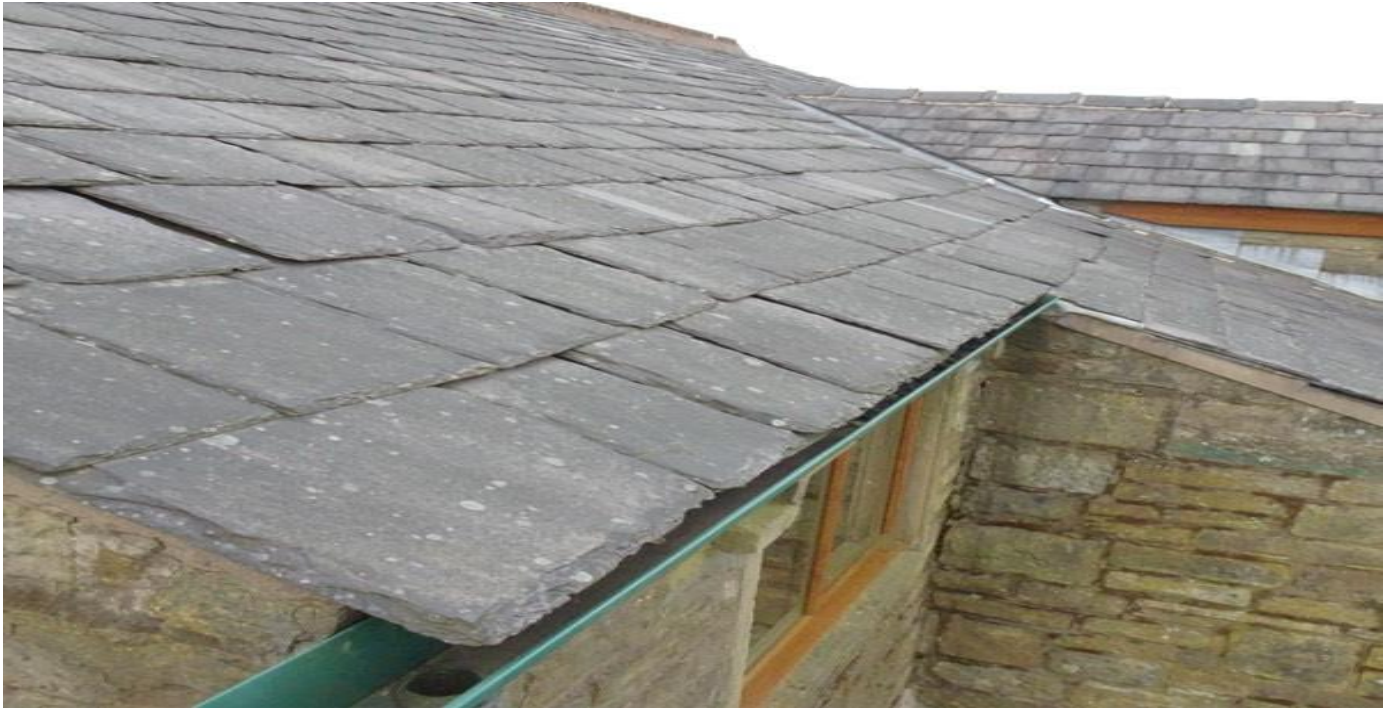
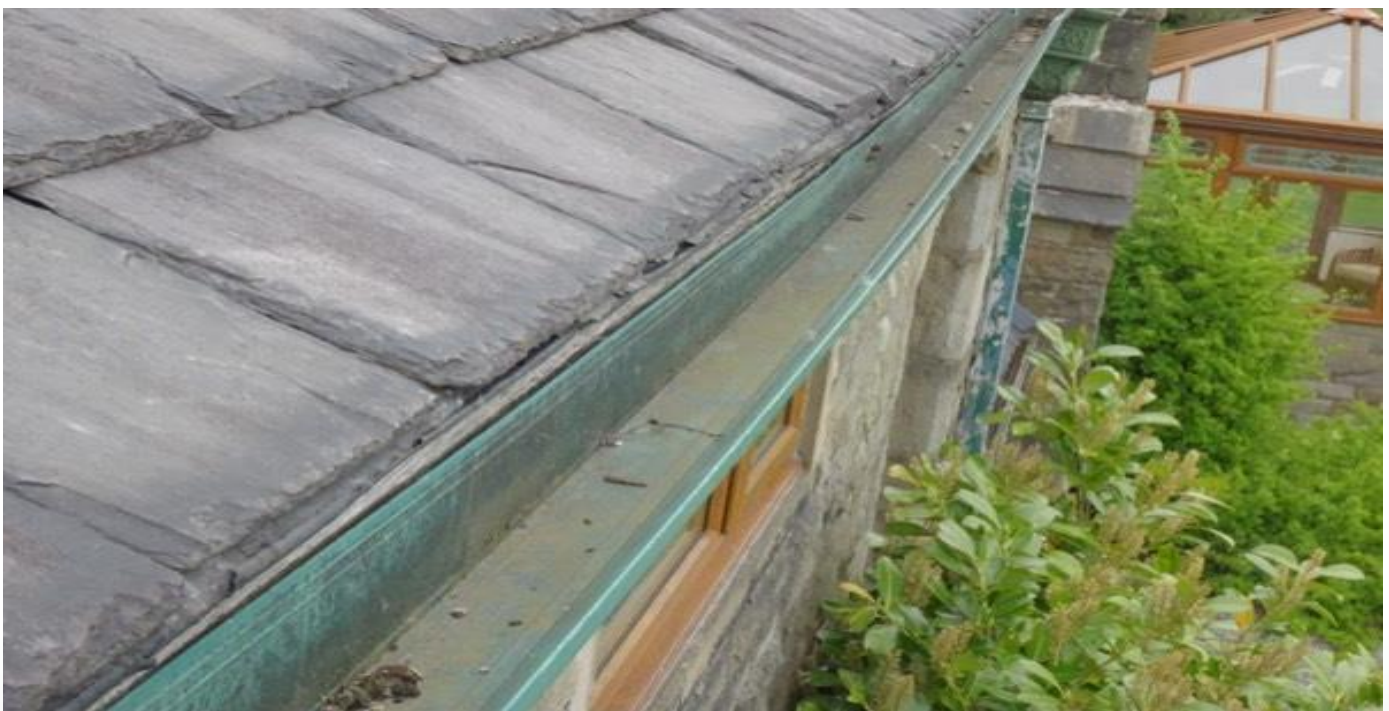
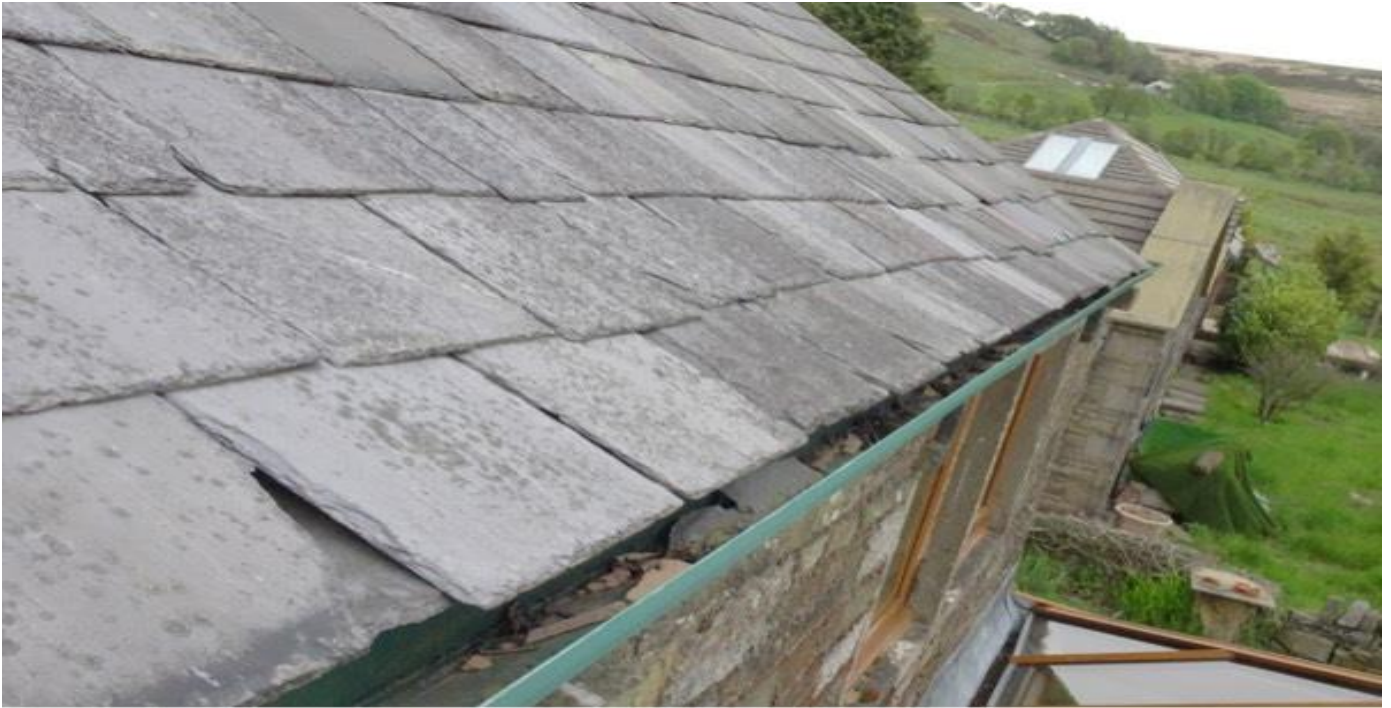
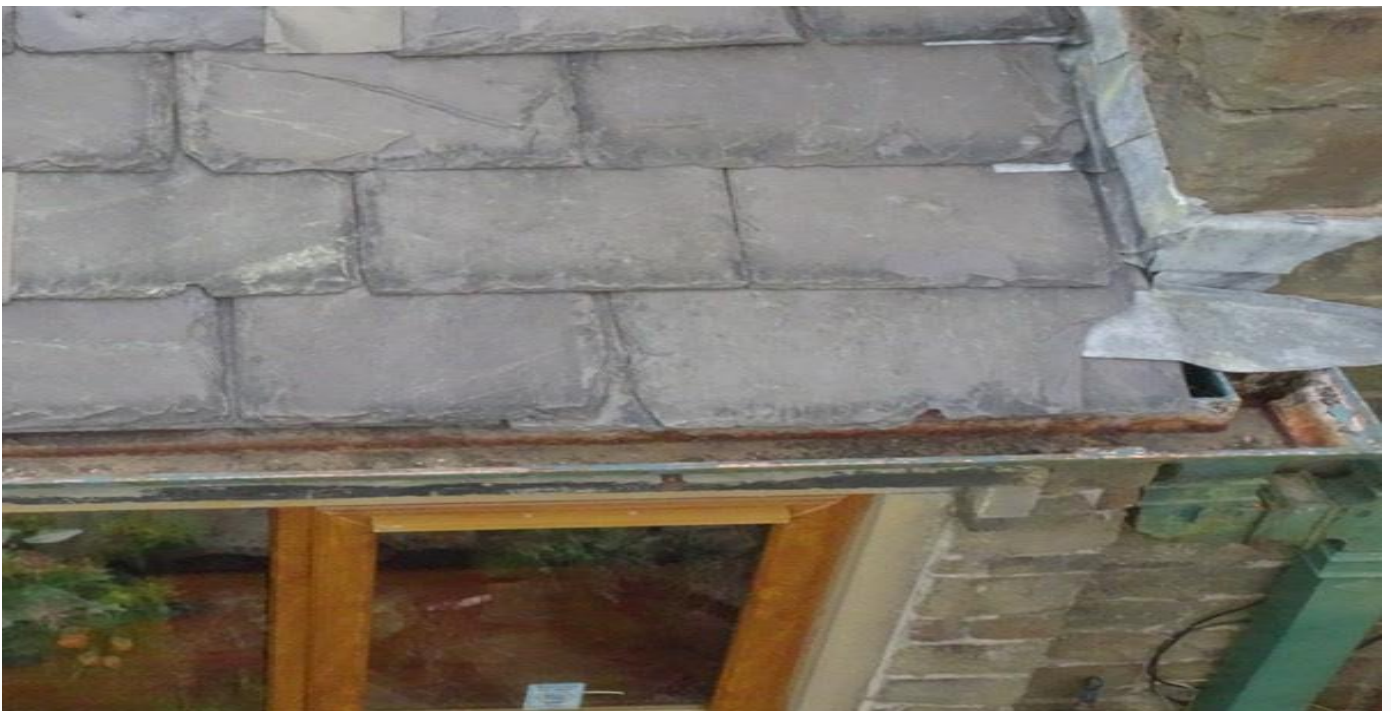
- Inspection of the rainwater gutter systems found these to be in poor condition with evidence of corrosion and blockages to the metallic gutters, and the PVC guttering sections were found to be dated and in need of restoration.

View of metallic guttering to the main building.

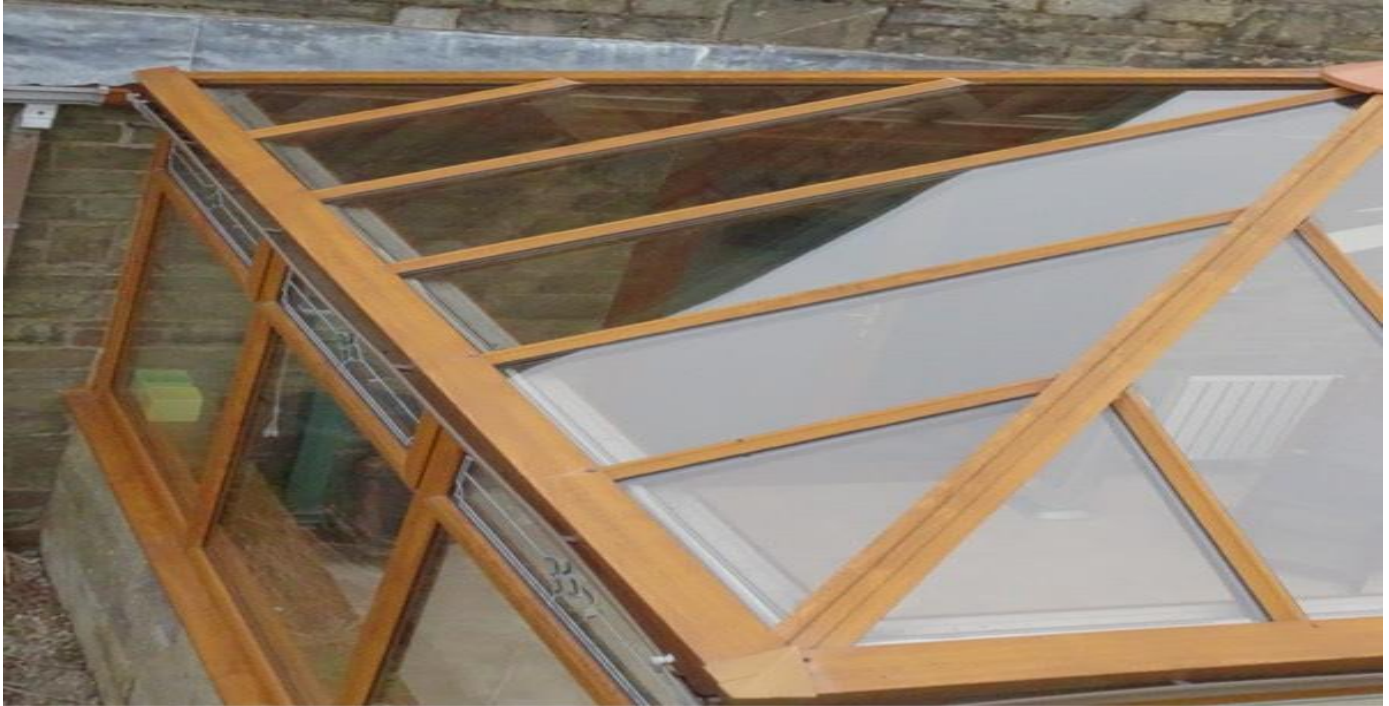
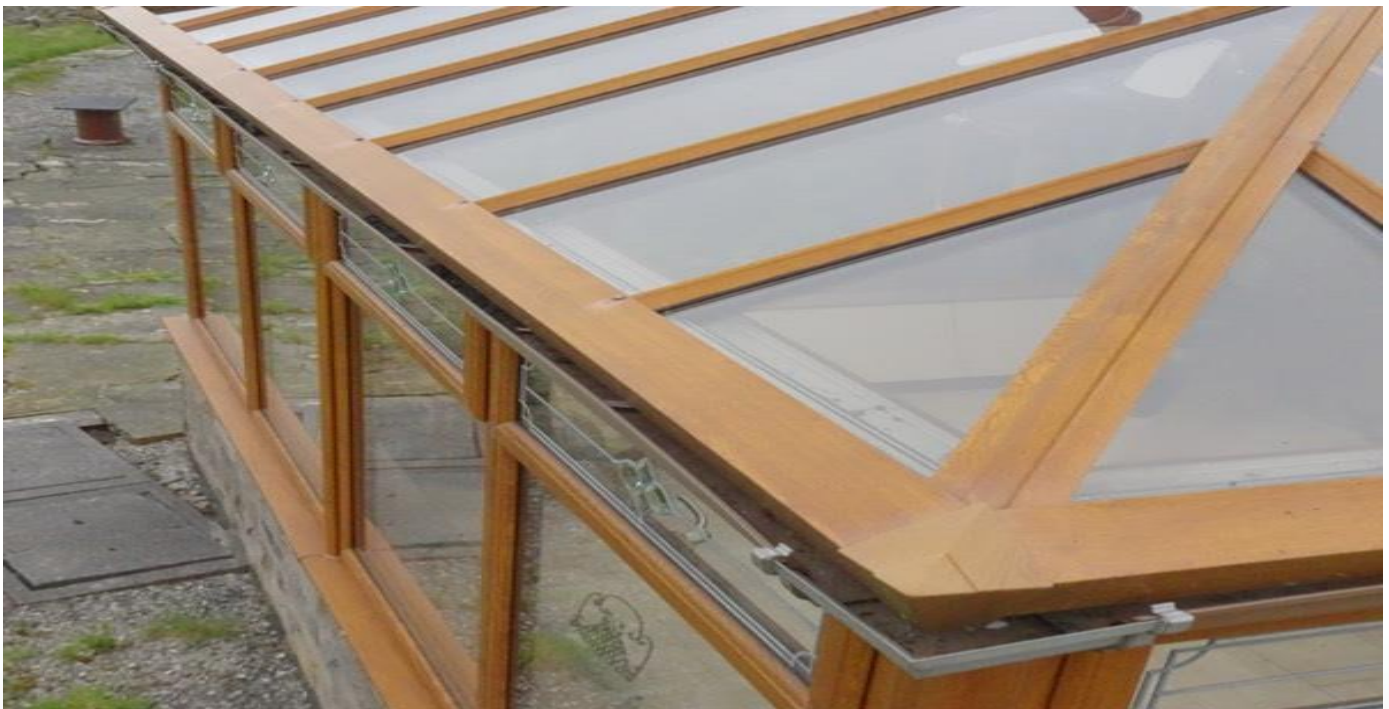
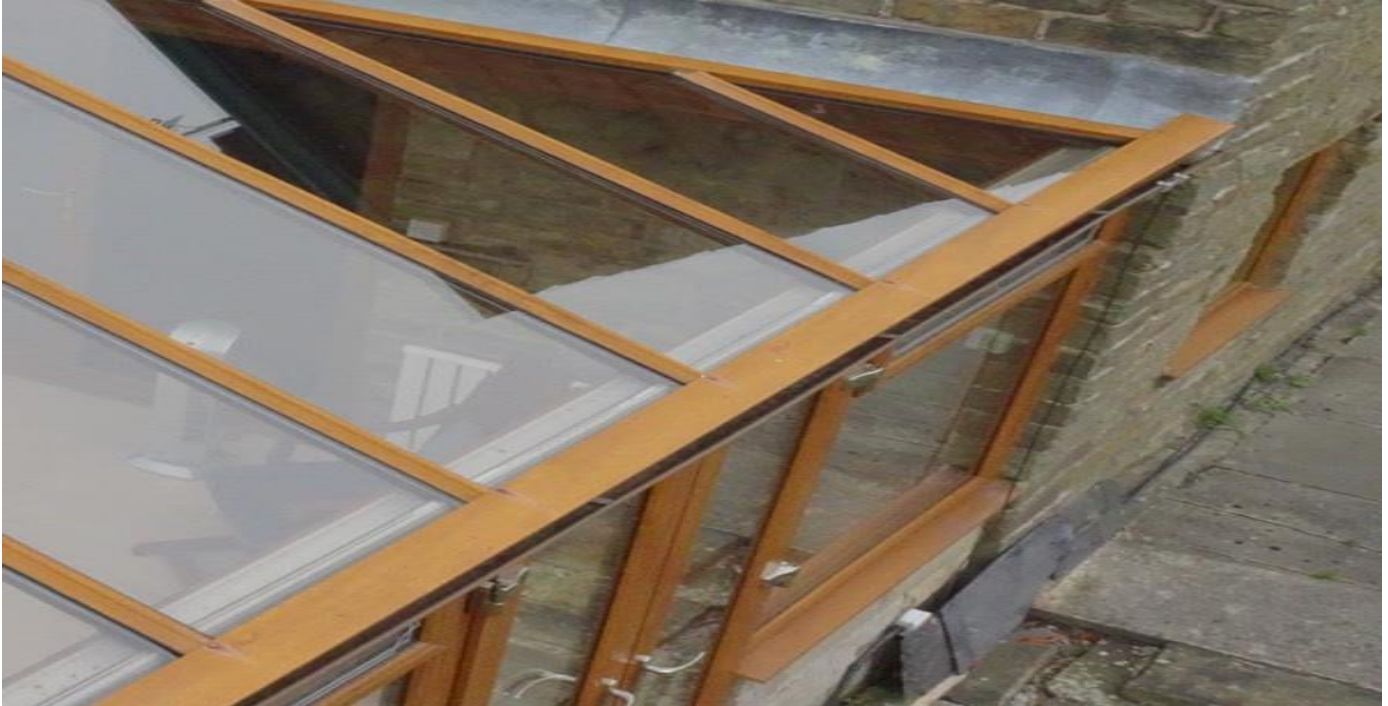
View of PVC guttering to the conservatory roof.

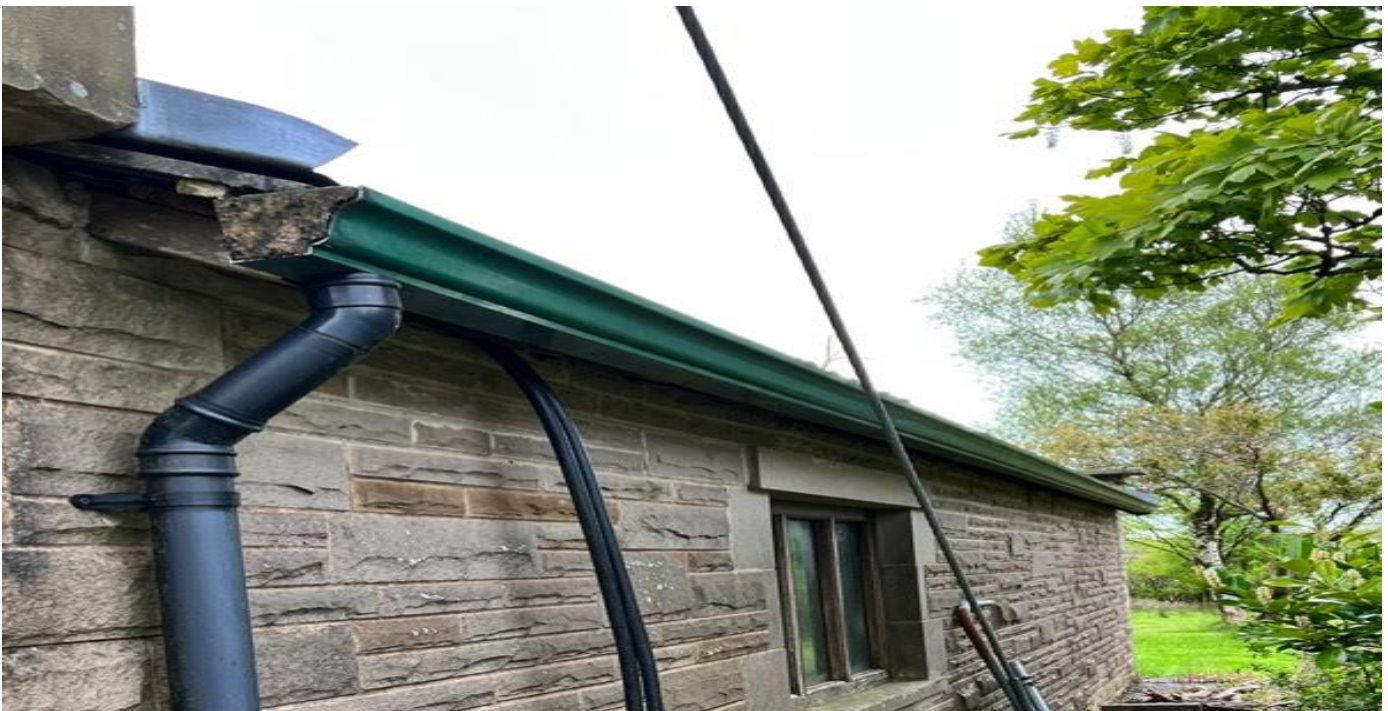
View of metallic guttering to the detached bungalow.

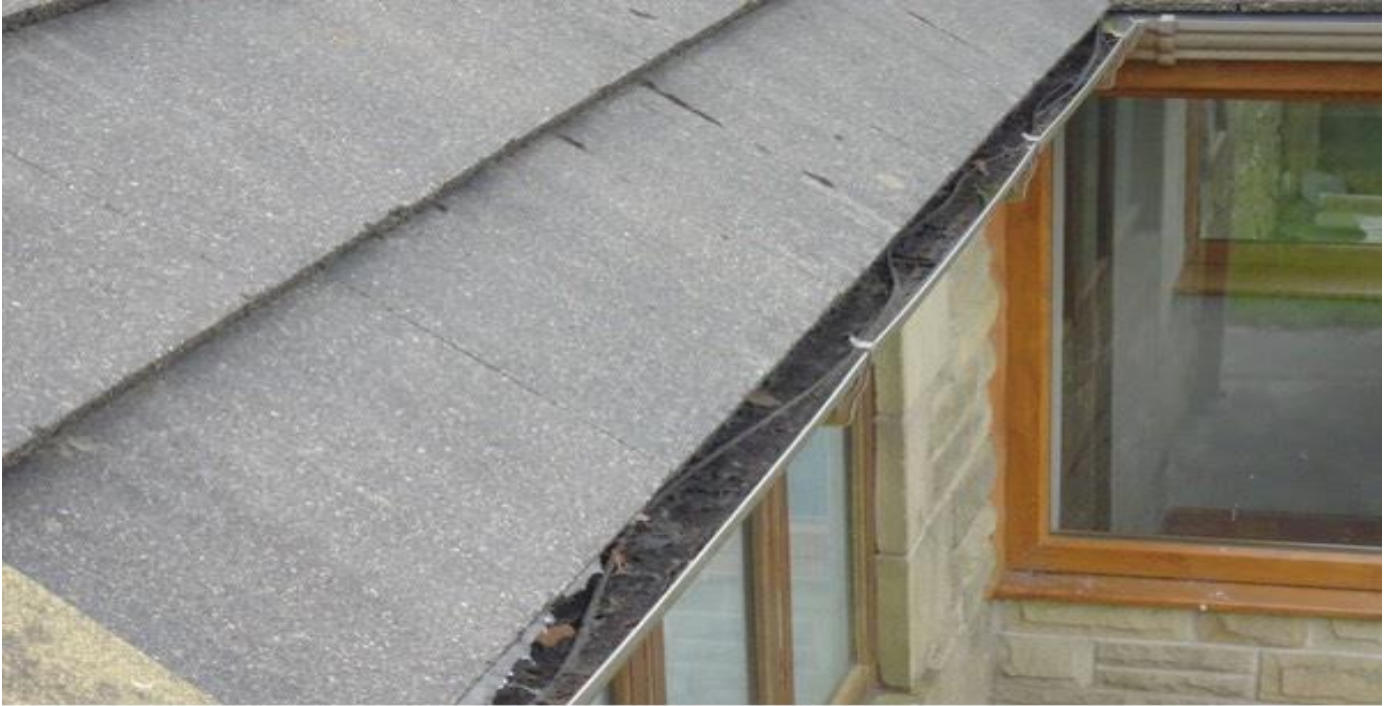
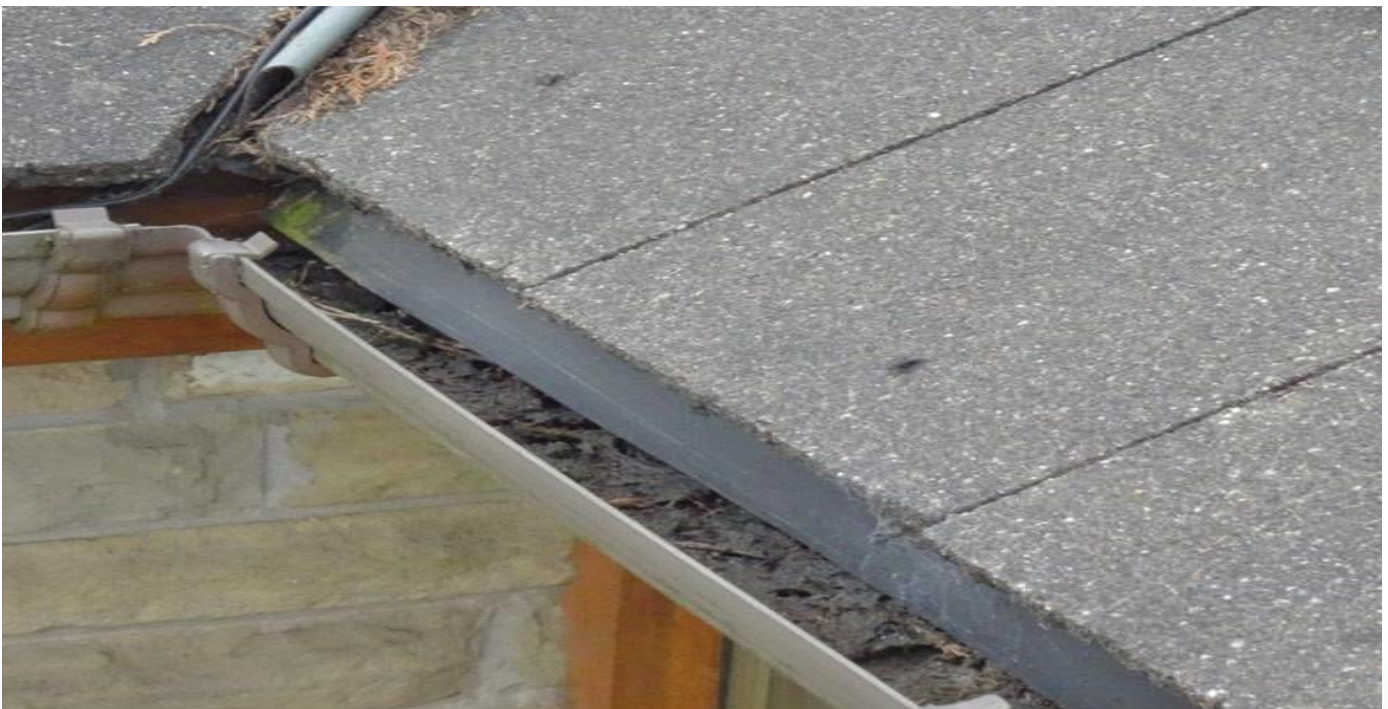
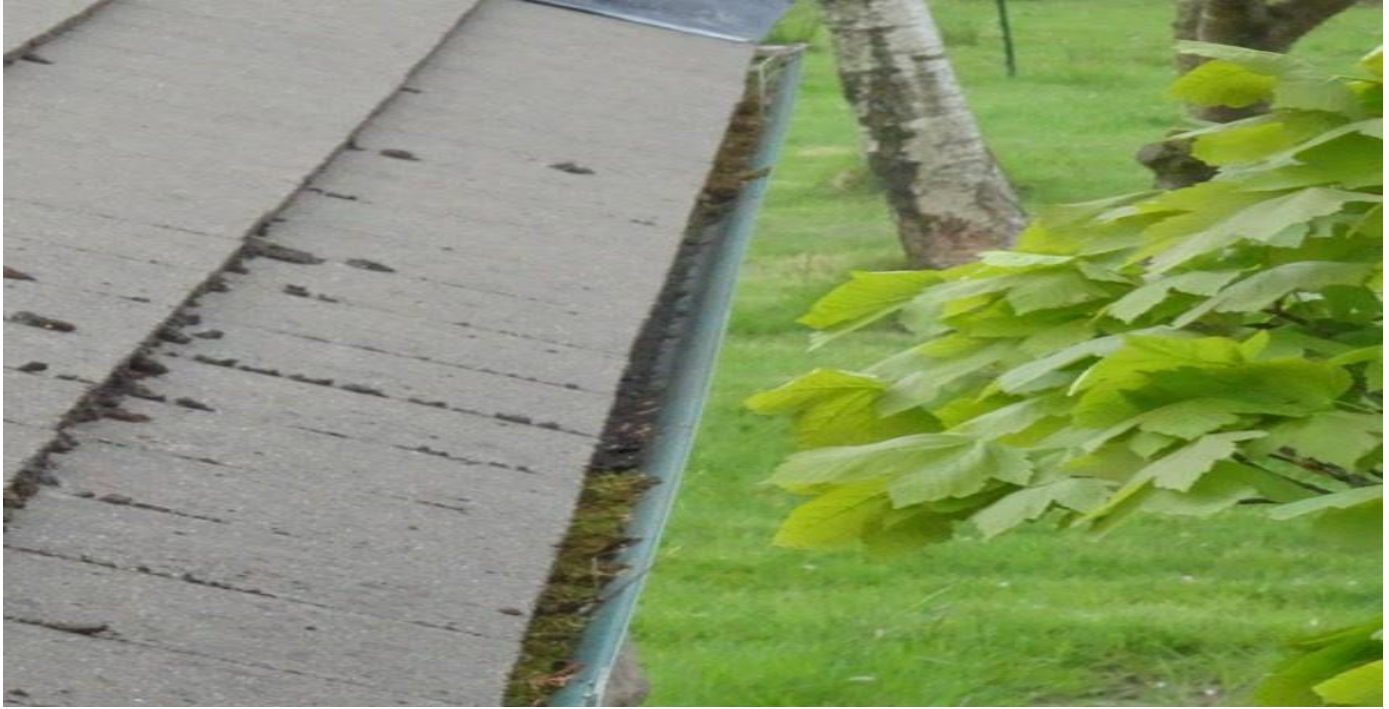
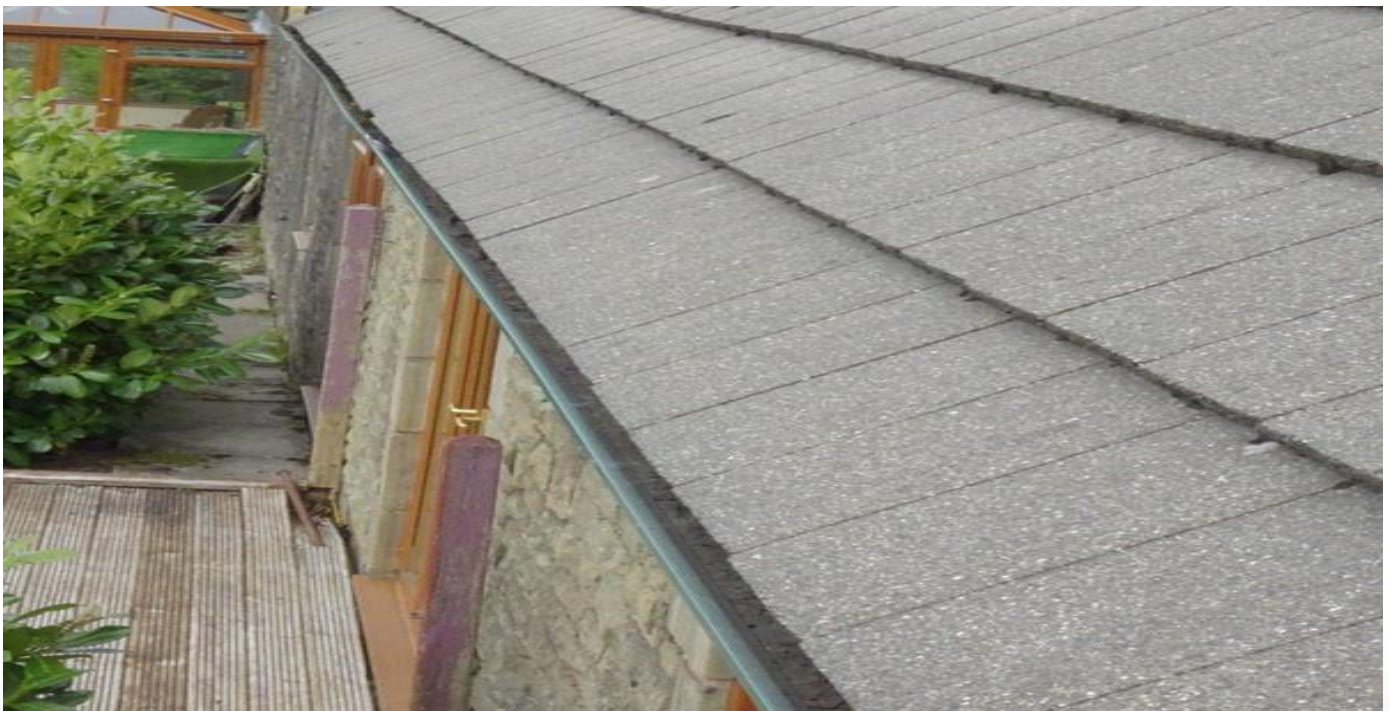
View of PVC guttering to the detached bungalow.
